## **NATIONAL TRANSPORTATION SAFETY BOARD**

### **SITE and ON-SCENE INFORMATION (Rev A)**

**NTSB Accident: WPR18FA251  
Accident Date: September 4, 2018**

Location: Palo Alto, California  
Date: September 4, 2018  
Aircraft: Mooney M20J, N701JM, Serial # 24-3281  
NTSB IIC: Michael Huhn

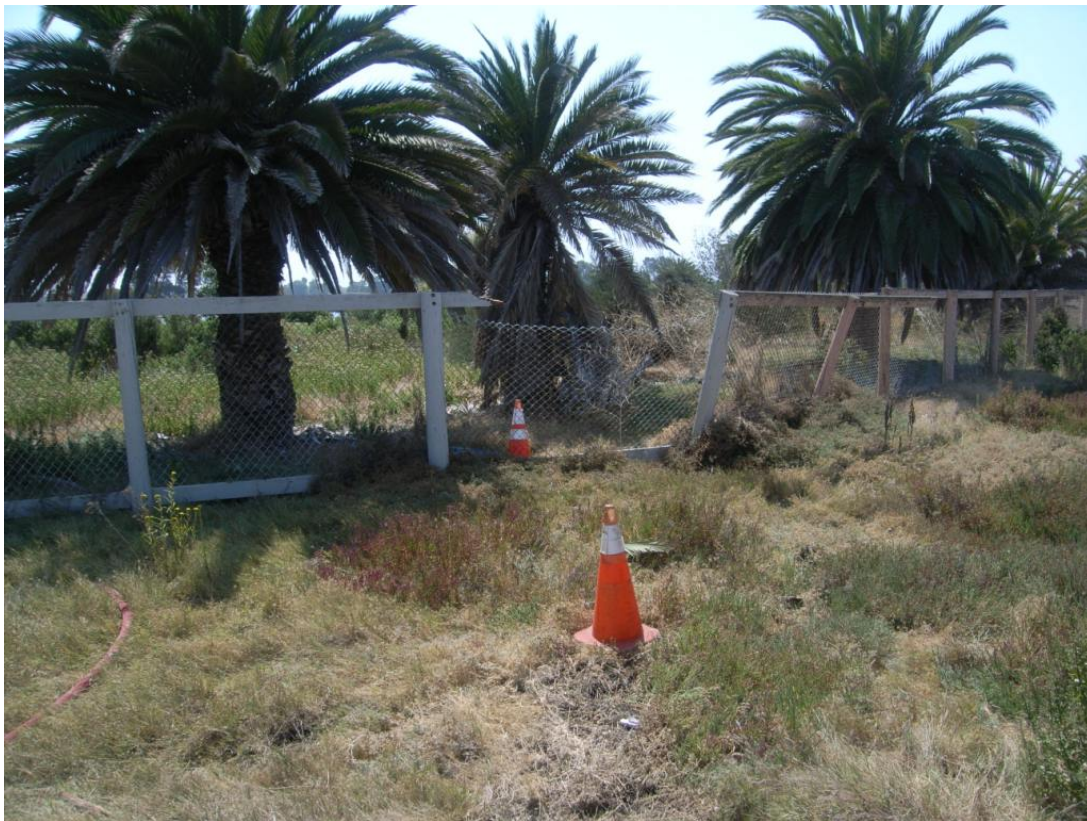
- The fence was a wood structure that supported a chain-link mesh
  - The ground scar direction was about 003° True
  - The fence was located about 50 feet from the shoreline, and was about 6 feet high

- One top crosspiece of the fence was shattered and thrown in the direction of flight
  - The mesh was deformed and partially separated from the wood posts, but was not torn or cut

**Figure 3 - Fence and Ground Scar (looking back along flight path)**

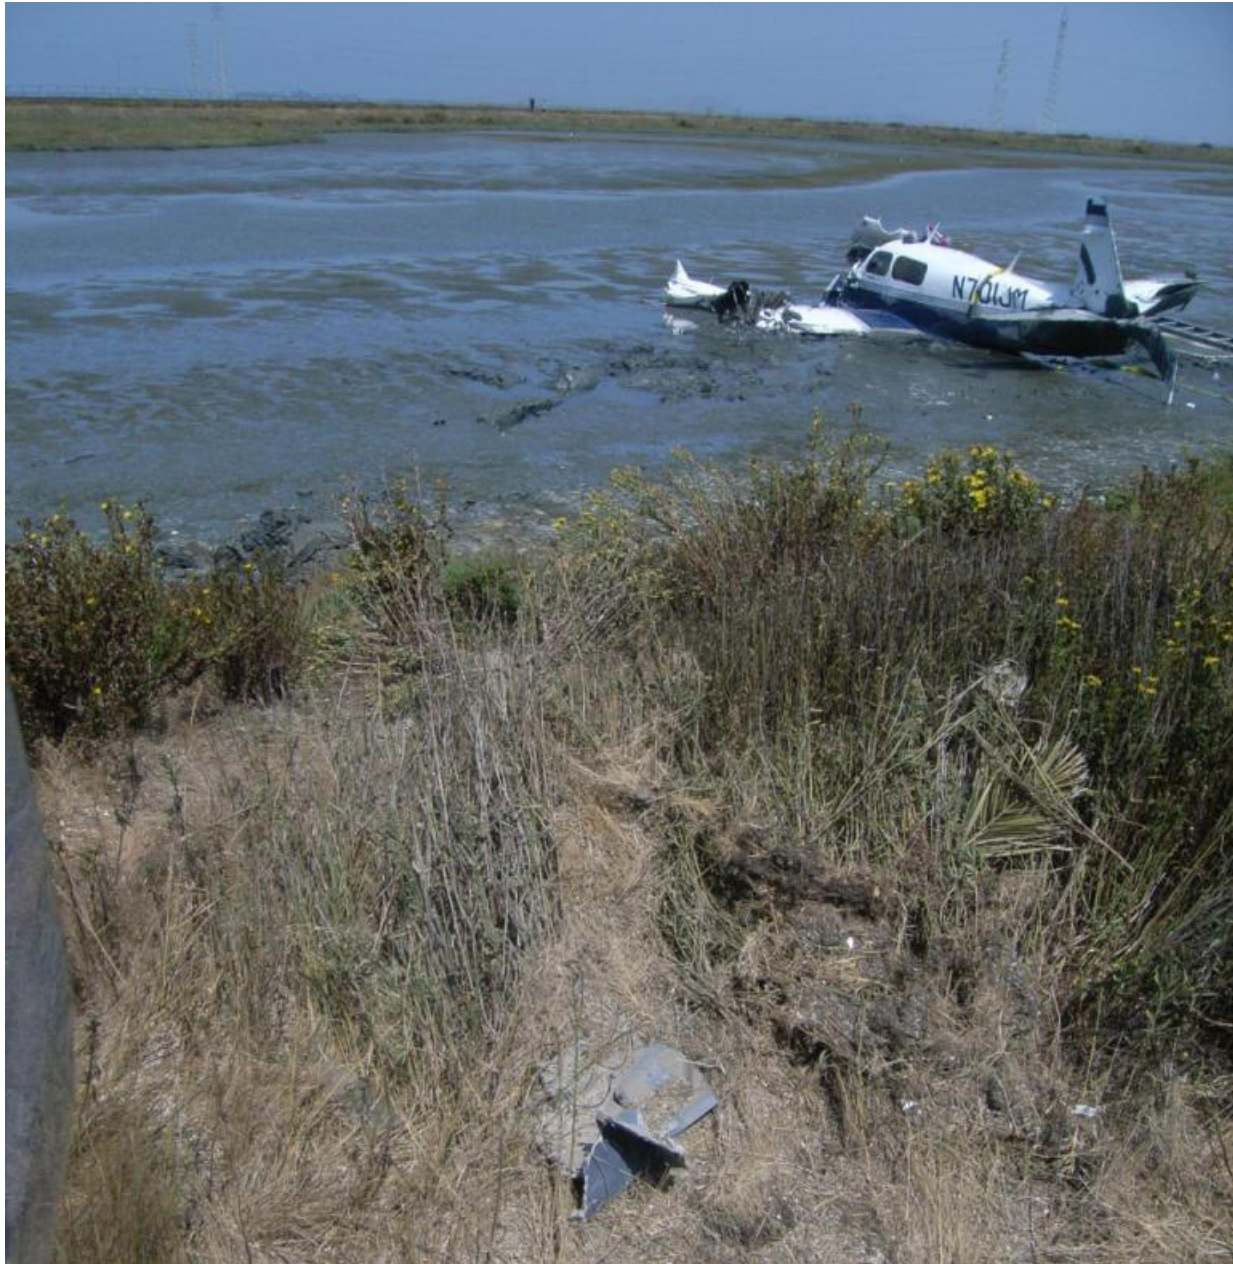
- The airplane was upright, pointed on a heading of approximately 340° magnetic
- The airplane was approximately 20 feet from shore, in a tidal flat.
  - The tide was receding at the time of the accident

**Figure 4 - Site Overview**

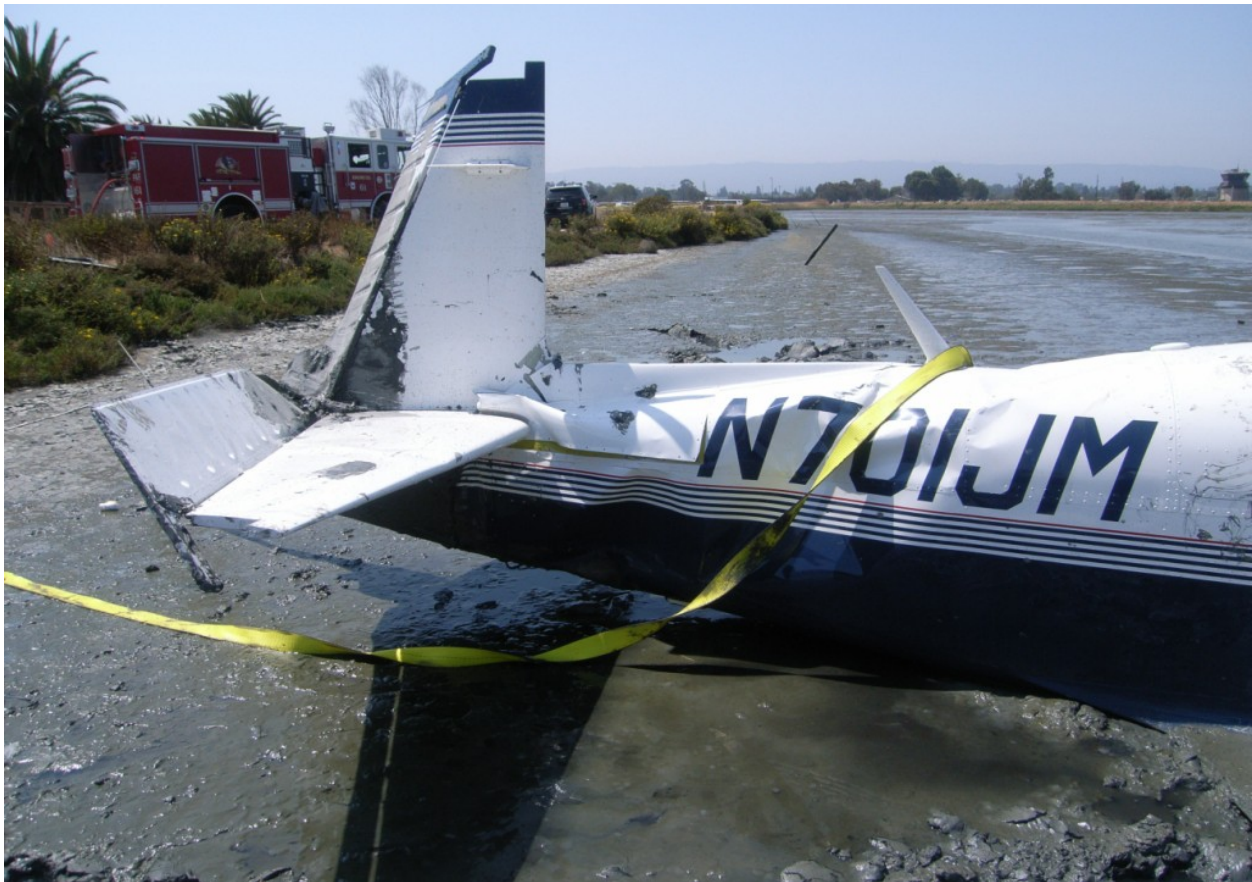
- All other components remained attached to the airplane
- The left elevator was partially torn from its hinges
- The forward fuselage/cockpit was moderately crushed/deformed

- The instrument panel was severely disrupted
- The aft cabin/seating area retained its normal occupiable volume
- The fuselage aft of the cabin displayed light to moderate crumpling

**Figure 7 - Aft Fuselage and Empennage**

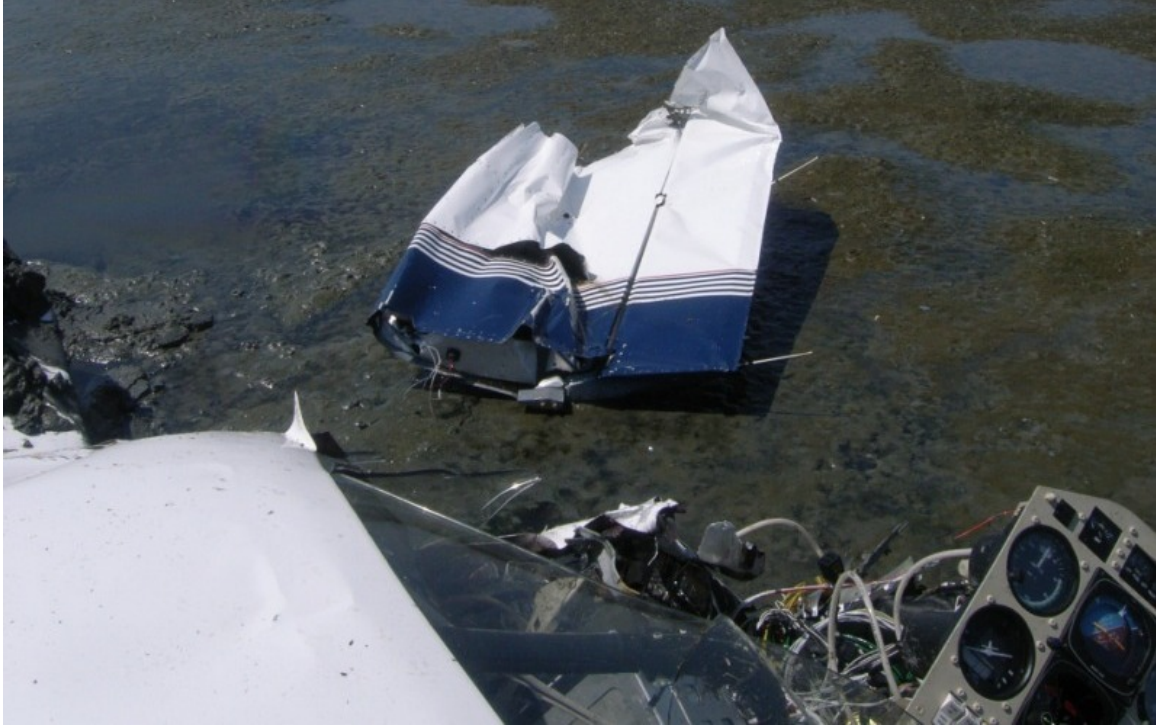
- Some small metal fragments were found on the shore between the fence and shoreline
- The left composite wingtip was found about 5 feet offshore
- An approximate 5 foot section of the outboard left wing was situated about 10 feet forward and left of the fuselage

**Figure 8 - Left Outboard Wing**

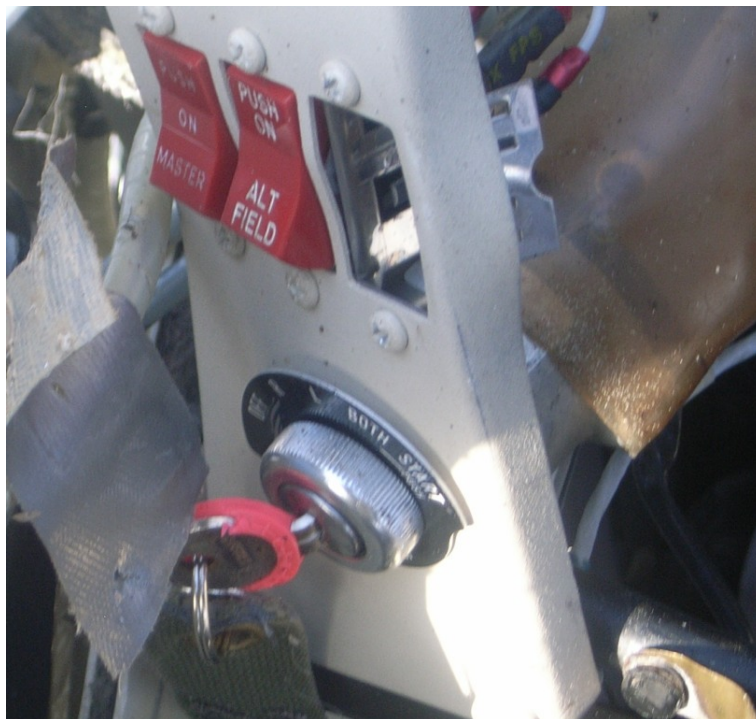
- The two master switches were set to the ON position
- The ignition key remained in place, and the switch was set to the BOTH position
- The speedbrakes were found in the stowed position on each wing

**Figure 9 - Ignition and Master Switches**

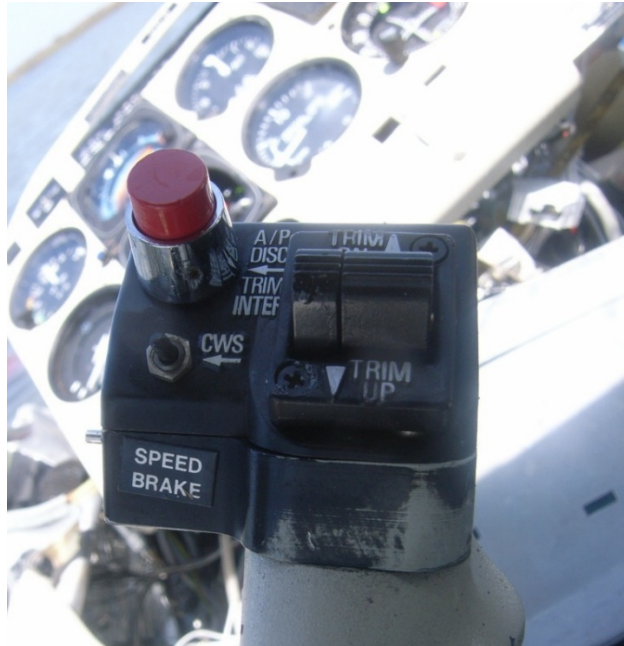
- The fuel cap remained securely installed
- There were no indications of pre- or post-impact fire
- An iPad mount was found attached to the pilot's yoke, and remnants of an iPad were found in the cockpit

**Figure 12 - Pilot's Yoke (Left horn)**

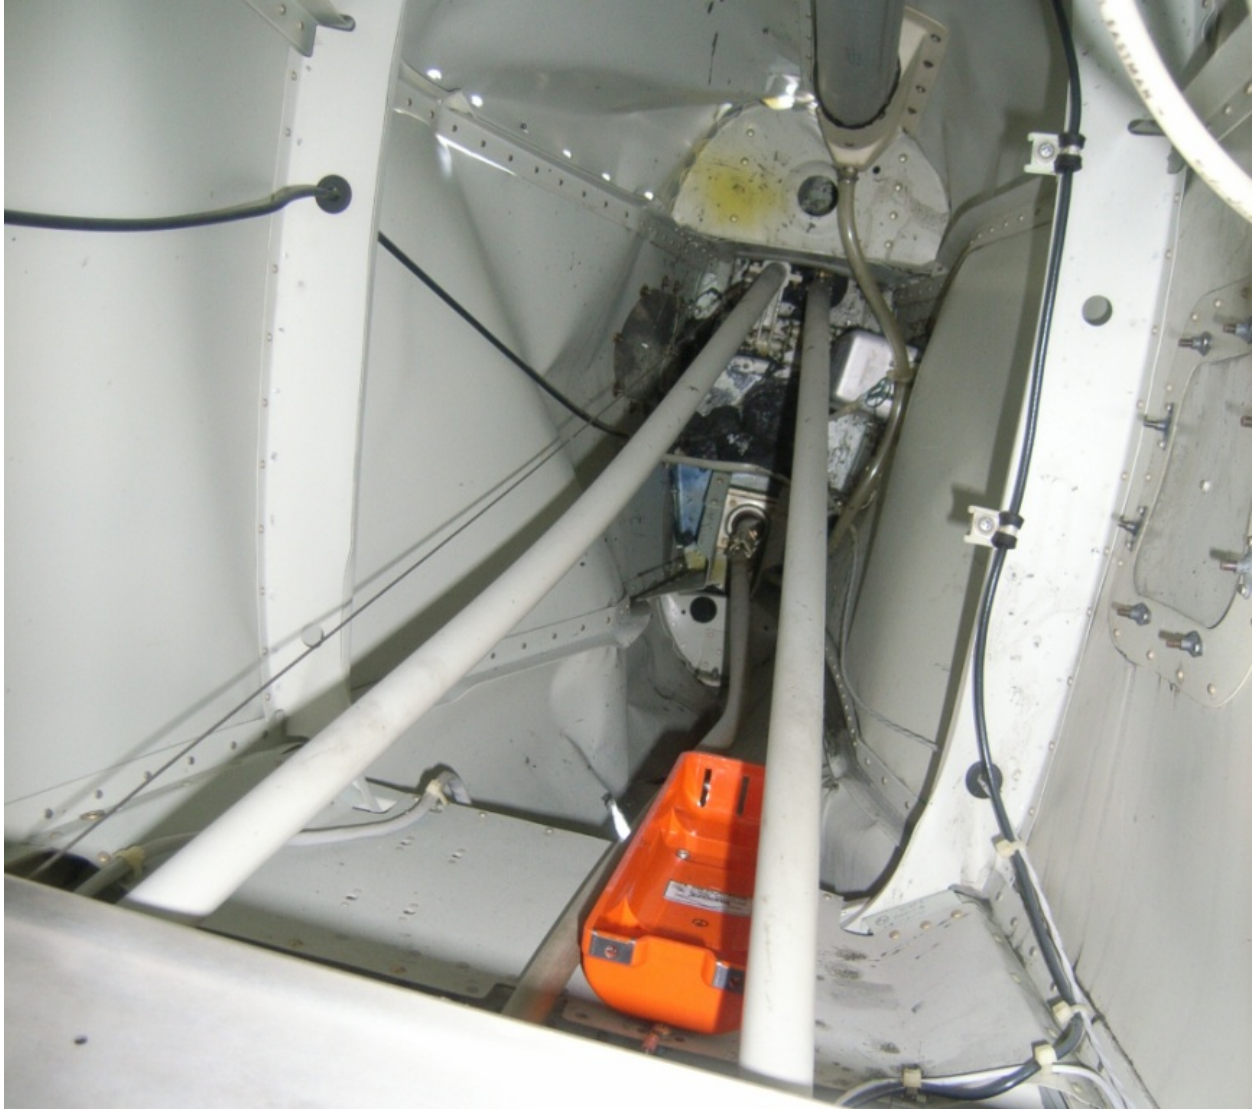
- The ELT was reported to have been activated and transmitting
  - The ELT remained installed and attached to its antenna
  - The ELT switch was turned to the OFF position, the antenna cable was disconnected from the device by investigators, and the device was removed from its cradle

- The elevator control rods and linkage were intact from the aft end of the cabin to the elevator
- The pitch trim control rod and linkage were intact from the aft end of the cabin to the forward end of the pitch trim jackscrew assembly

- The rudder control rods and linkage were intact from the aft end of the cabin to the rudder
- The two elevator and one rudder balance weights were present and securely attached

Figure 15 - ELT Cradle and Empennage Flight Control Rods

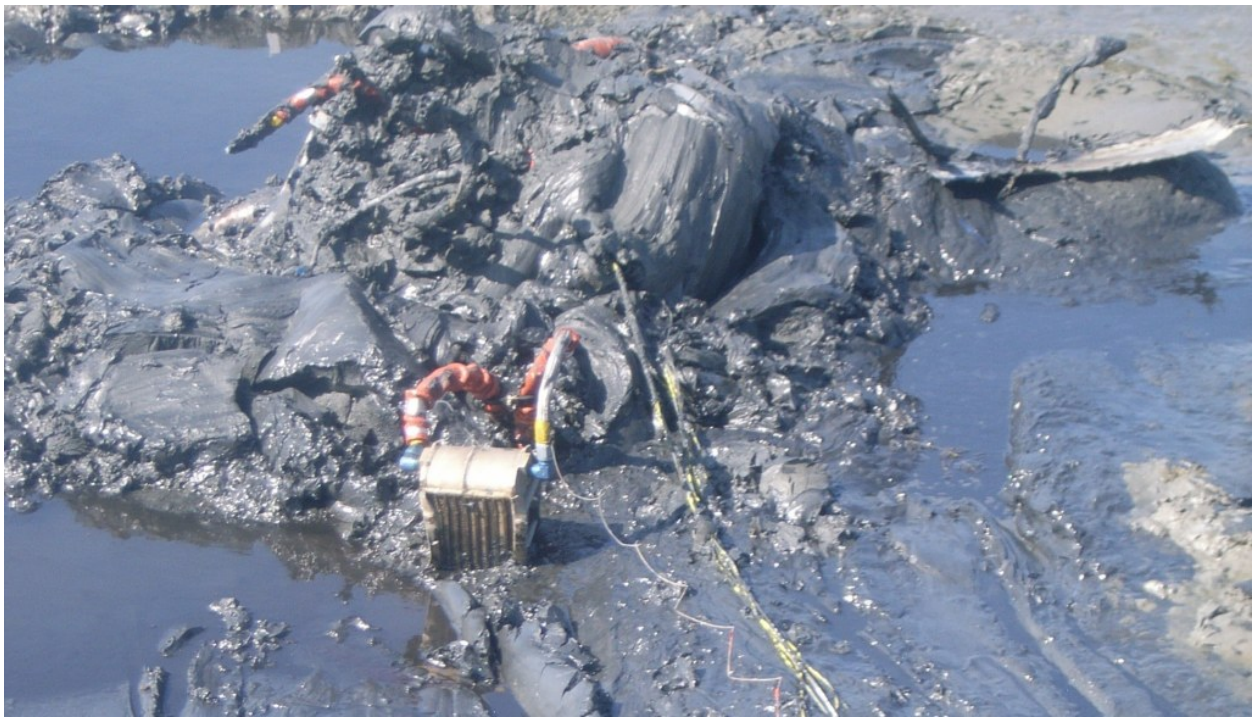
- The leading edges of both wings displayed multiple impacts
- The outboard end of the right wing displayed significant impact damage
- The engine was partially fracture-separated from the fuselage, and buried in the mud

**Figure 16 - Engine Buried in Mud**

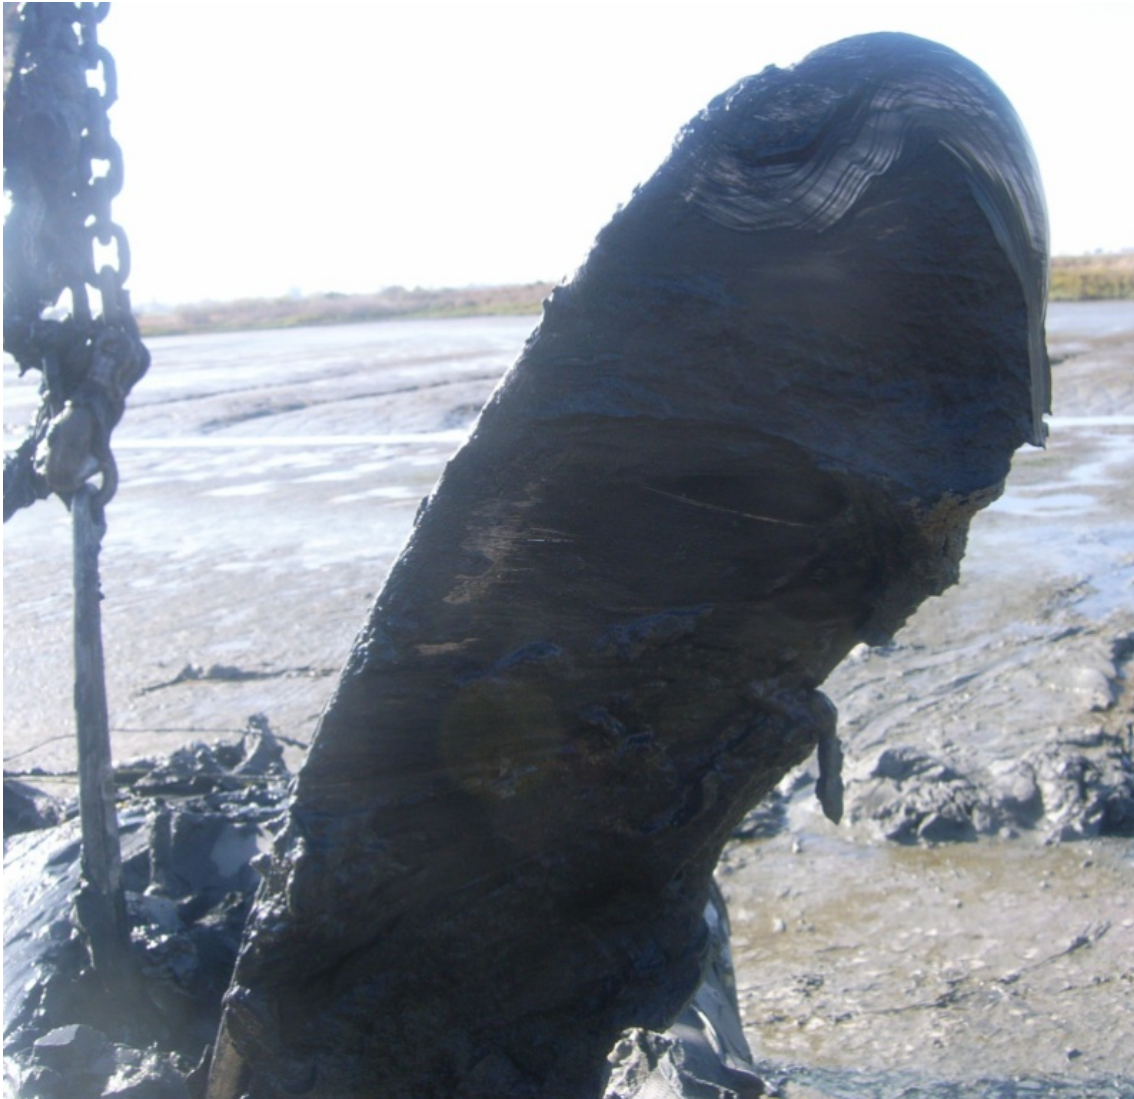
- The 2 blade propeller remained attached to the engine
  - Both blades exhibited moderate deformation
  - Neither blade tip exhibited any damage indicative of a runway strike
  - The propeller blades were caked with mud and were not examined in detail; that will be accomplished at the recovery facility
- The engine was rinsed with water to attempt to remove the mud, but was only partly successful due to a lack of water and the tenacity of the mud
  - The upper right forward portion of the engine was cleansed enough to reveal that that portion of the engine did not exhibit any indications of catastrophic internal failure
  - The remainder of the engine will be examined at the recovery facility
- The aft fuselage and empennage were then cut (as a single unit) from the forward fuselage to facilitate loading and transport

**Figure 17 - Undamaged Propeller Tip**

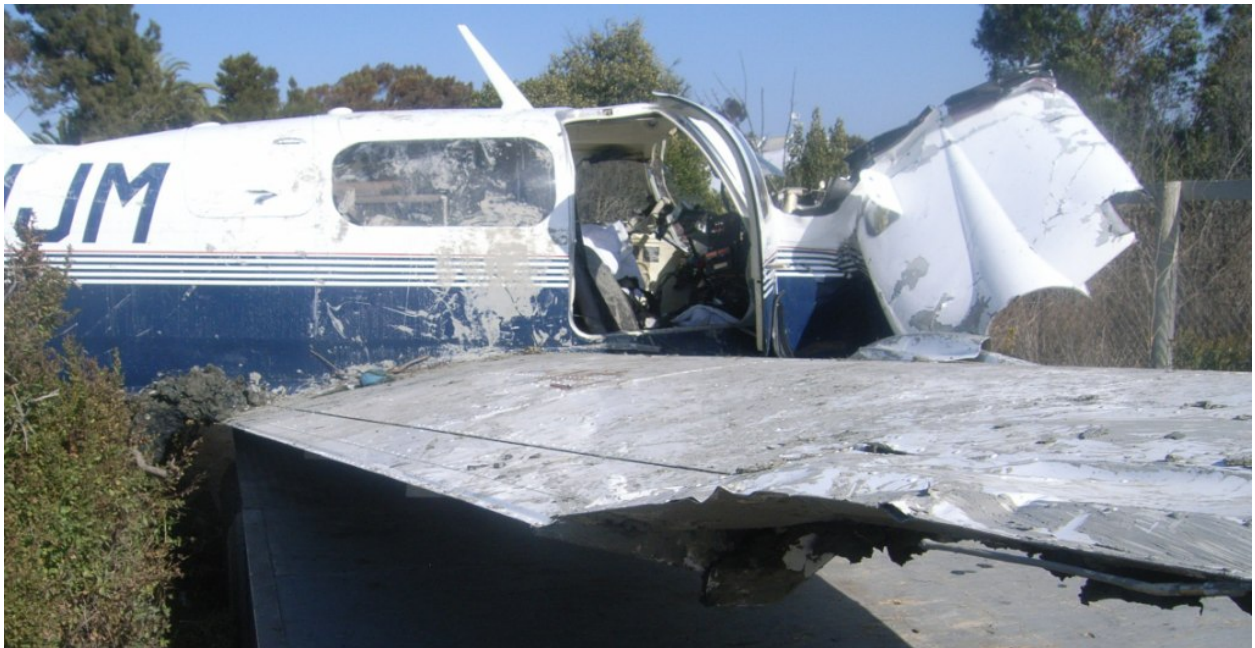
- On the second day the JP Instruments engine monitor was removed from the instrument panel for potential data download
- Later in the day a crane was used to lift the airplane and place it on a flatbed trailer
- While the airplane was suspended from the crane, the underside was examined
  - The left main landing gear was fully retracted
  - The right main landing gear was hanging about 25° into the extended position
  - The nose landing gear was retracted and/or pushed up into the fuselage
  - The underside exhibited minimal other damage
- The right flap was in the fully retracted position
- The left flap appeared to be slightly deflected/extended
- The crane was then used to lift the engine from the mud

**Figure 20 - Right Wing and Flap**
