# NATIONAL TRANSPORTATION SAFETY BOARD

## MATERIALS LABORATORY FACTUAL REPORT

Report No. 19-016

Place : Billings, Montana  
Date : September 12, 2018  
Vehicle : Rotorway RW-1, N166LC  
NTSB No. : WPR18FA260  
Investigator : Thomas Little, AS-WPR

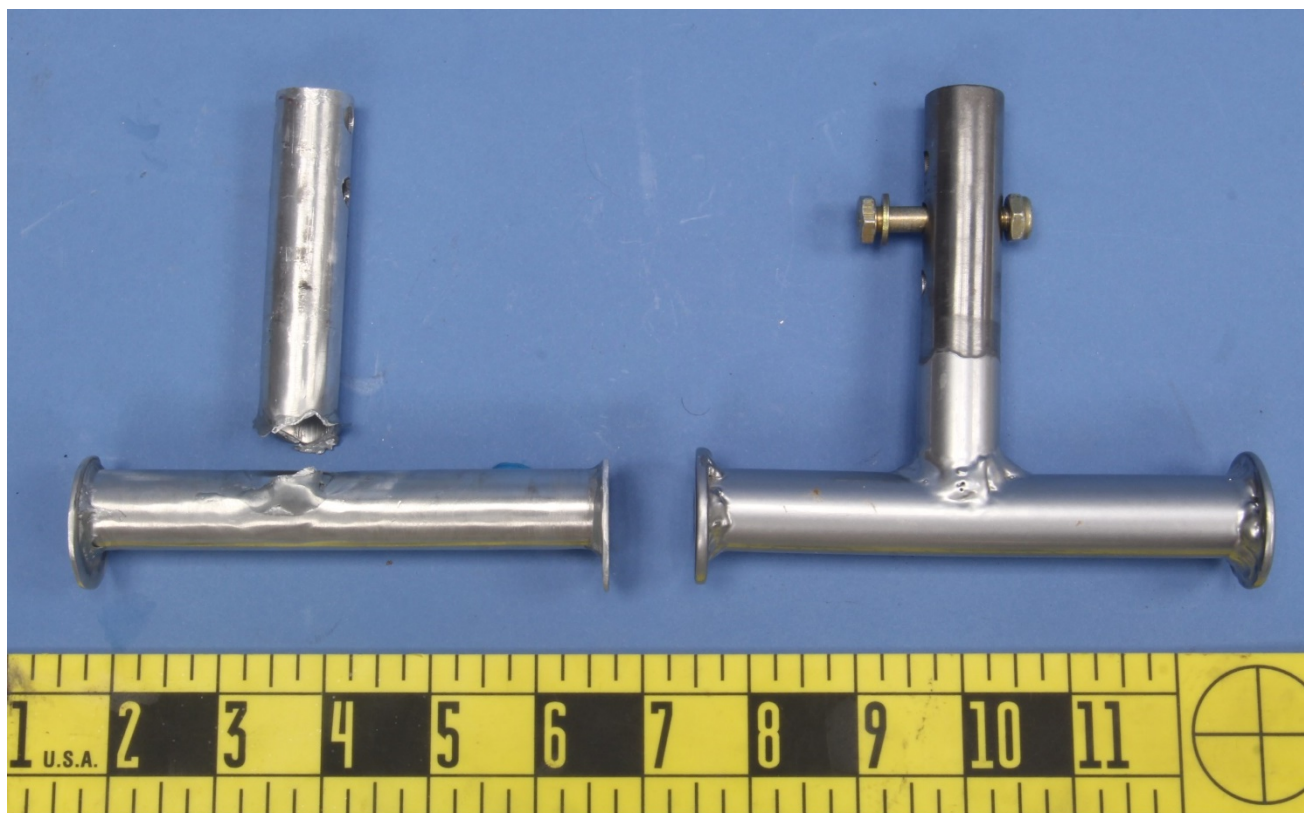
Two pieces of the anti-torque pedal tubes from the right pilot seat position were retained and sent to the NTSB Materials Lab, shown as received in Figure 1. Both anti-torque tube assemblies consisted of a parallel tube with flanges on both ends, joined to a perpendicular tube at the midpoint. The flanged ends of the parallel tube from the fractured assembly were closed, whereas the ends of the intact assembly were open to the interior. Holes had been drilled in the perpendicular tubes oriented parallel to the parallel tube direction.

The left tube assembly in Figure 1 had fractured at the joint. The right tube assembly was intact, and still had a bolt and nut through one of the holes. Figure 2 and Figure 3 show the intact and fractured anti-torque tube assemblies, respectively, annotated to show various dimensions. As demonstrated from the measurements, the two anti-torque tube

Figure 1 – The anti-torque tubes, as received. The tube on the left had fractured at the joint, whereas the assembly on the right was intact.

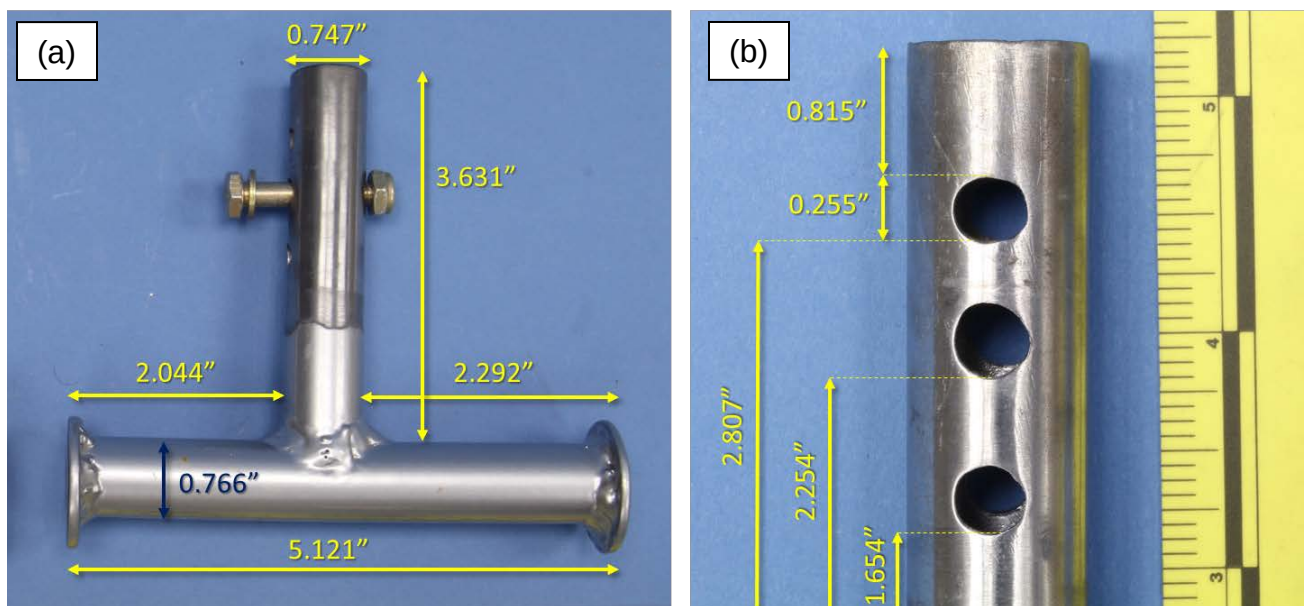
Also different were the number of and quality of the holes drilled in the perpendicular tubes. The perpendicular tube of the intact assembly contained three holes, whereas the corresponding tube of the fractured assembly included two holes. These two holes exhibited elongation and loss of material in the direction of the tube, consistent with wear.

Figure 2 – Annotated various measurements on the intact anti-torque tube assembly showing (a) the entire assembly and (b) the perpendicular tube section with drilled holes. The vertical measurements on the right figure extend to the parallel tube upper surface in the left figure.

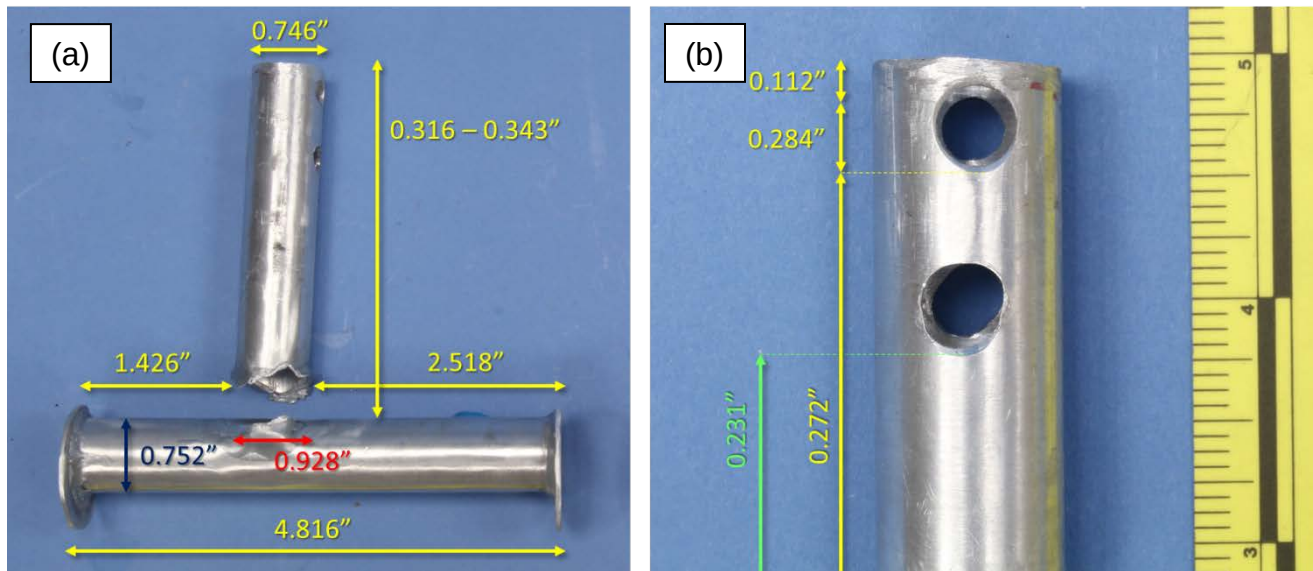
Figure 3 – Annotated various measurements on the fractured anti-torque tube of (a) the entire assembly and (b) the perpendicular tube section with drilled holes. The vertical measurements on the right figure extend to the parallel tube upper surface in the left figure.

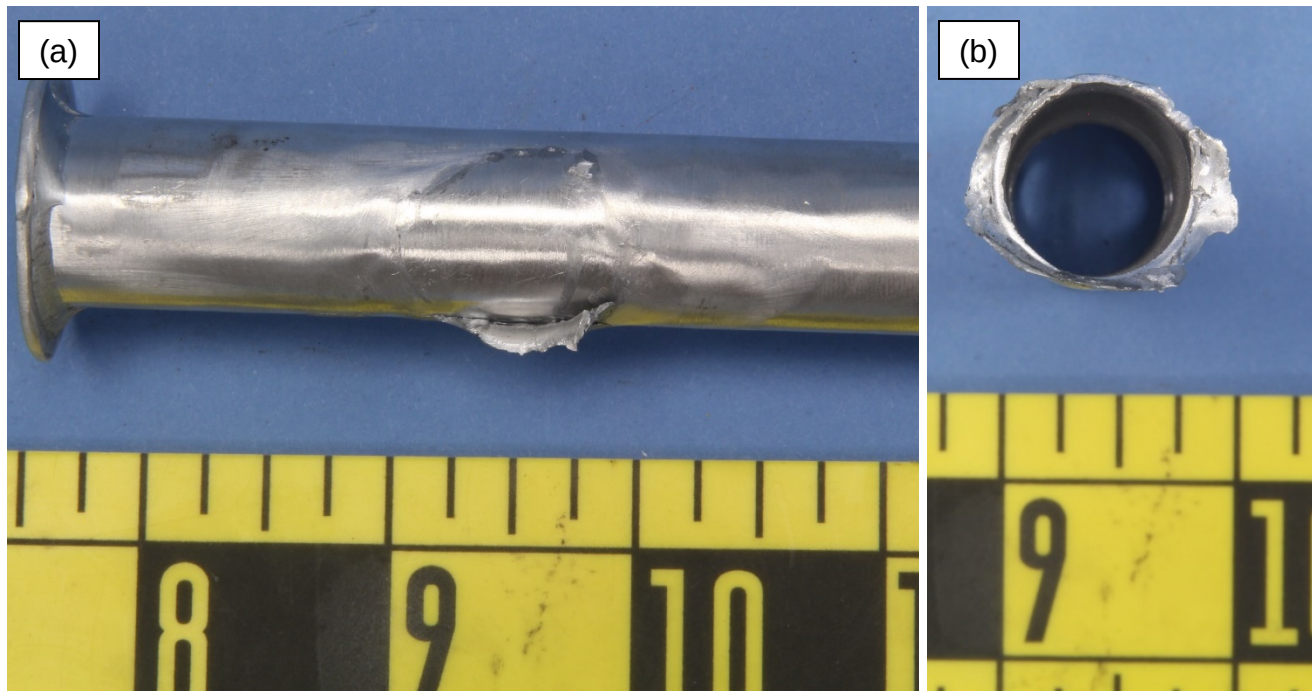
Figure 4 shows the mating fracture surfaces of the left anti-torque tube assembly. As shown in Figure 5, the mating fracture surface from the parallel tube side included remnant filler material on only 0.5 inches on one side and 0.05 inches on the other. The remainder of the fracture surface exhibited features such as mill marks and scratches consistent with as-fabricated exterior tube surface. These exterior features were consistent with those on the tube surface away from the joint location. The fractured joint areas on the parallel tube surface absent any fractured filler metal remnants were consistent with interfacial disbonding, rather than fracture.

Figure 4 – The mating sides of the broken tube fracture surfaces from the (a) parallel tube side and (b) the perpendicular tube side.

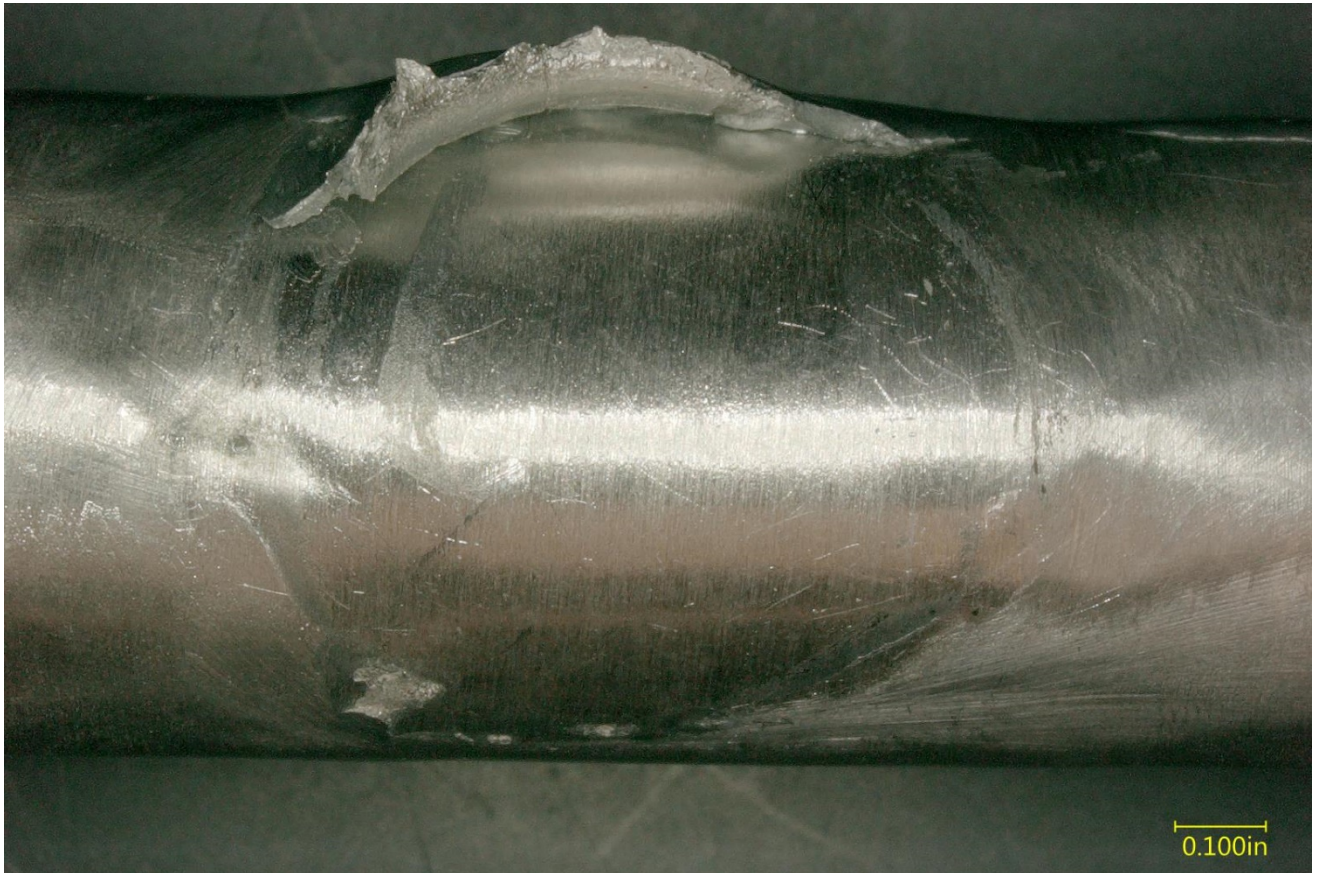
Figure 5 – Closer view of the parallel tube side fracture surface.

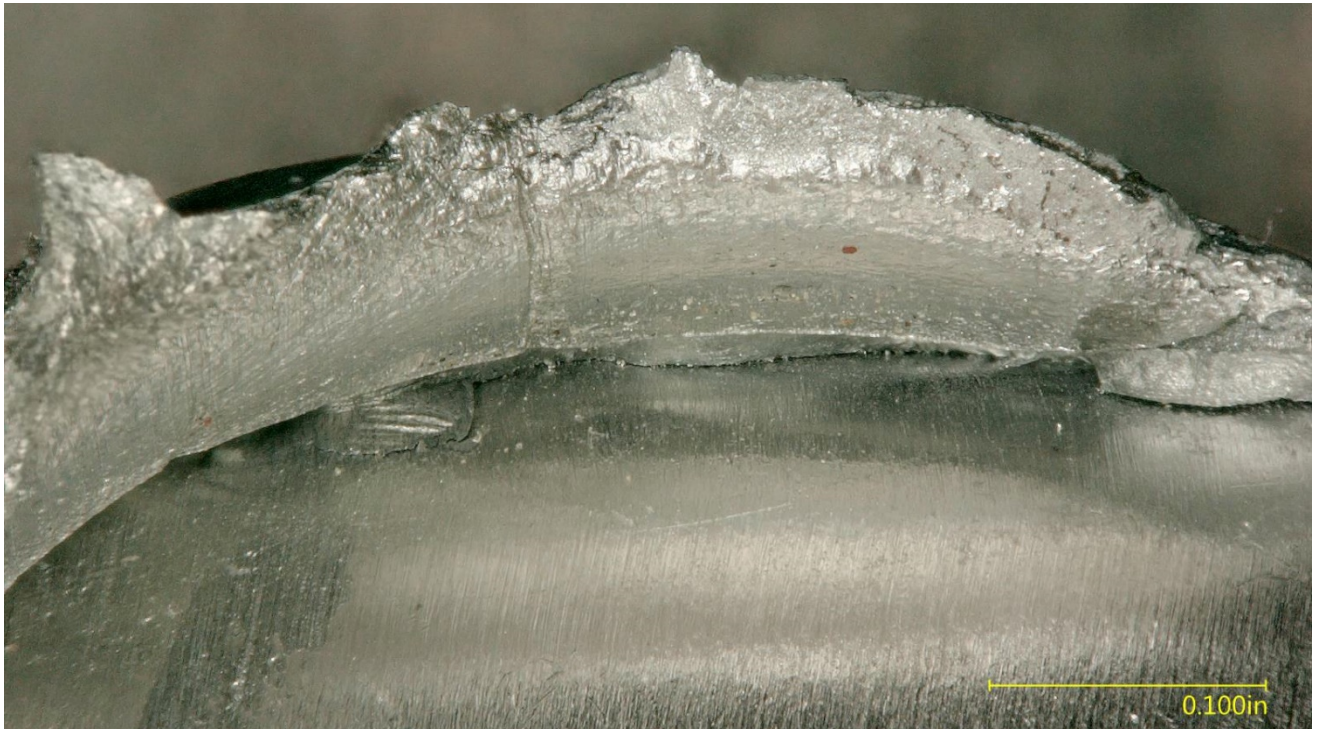
Figure 6 highlights the 0.5 inch fractured remnant on the parallel tube surface. The material appeared as a peeled-lip shape, with a small gap against the tube surface. The fracture surface faced up and away from the tube. The surface was rough and tortuous, with a generally clean appearance and dull luster. The lip material beneath to the fracture surface exhibited localized thinning in the form of necking.

Figure 6 – Closer view of the largest remnant of the fractured joint on the parallel tube.

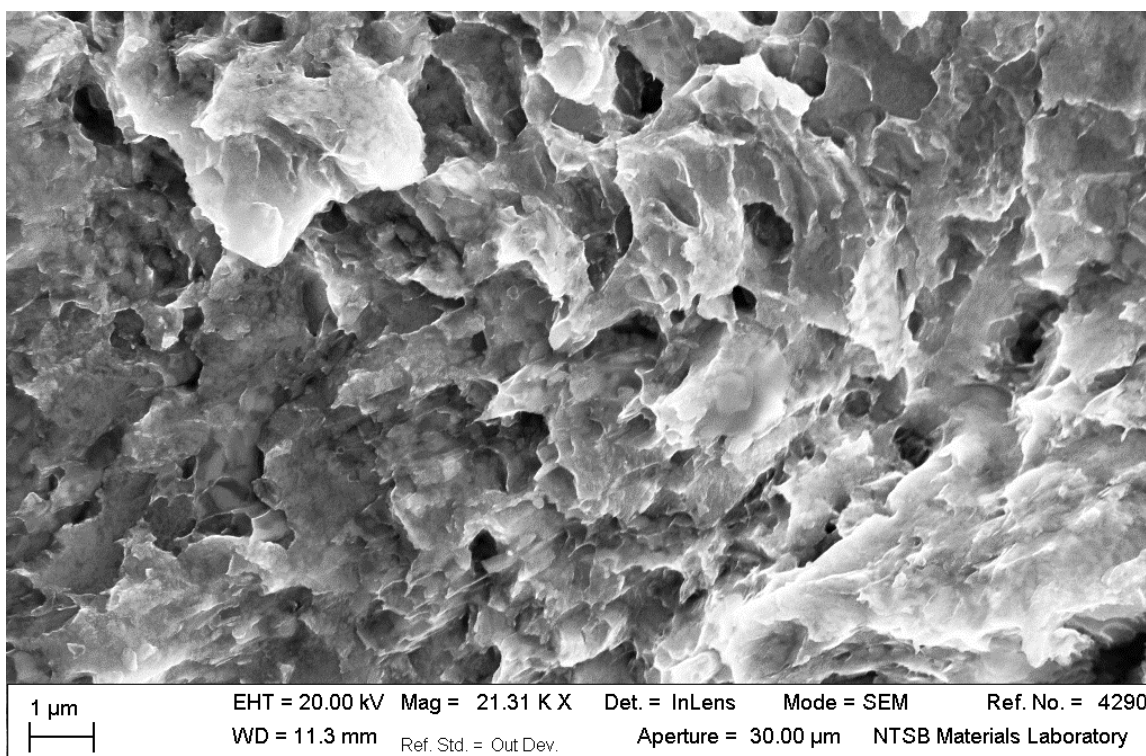
This remnant fracture surface was examined using a scanning electron microscope (SEM). As typified in Figure 7, the fracture surface on the parallel tube side exhibited dimple rupture, consistent with tensile overstress fracture. No other features consistent

Figure 7 – Secondary electron (SE) micrograph of the fracture remnant in Figure 6. The features were consistent with dimple rupture.

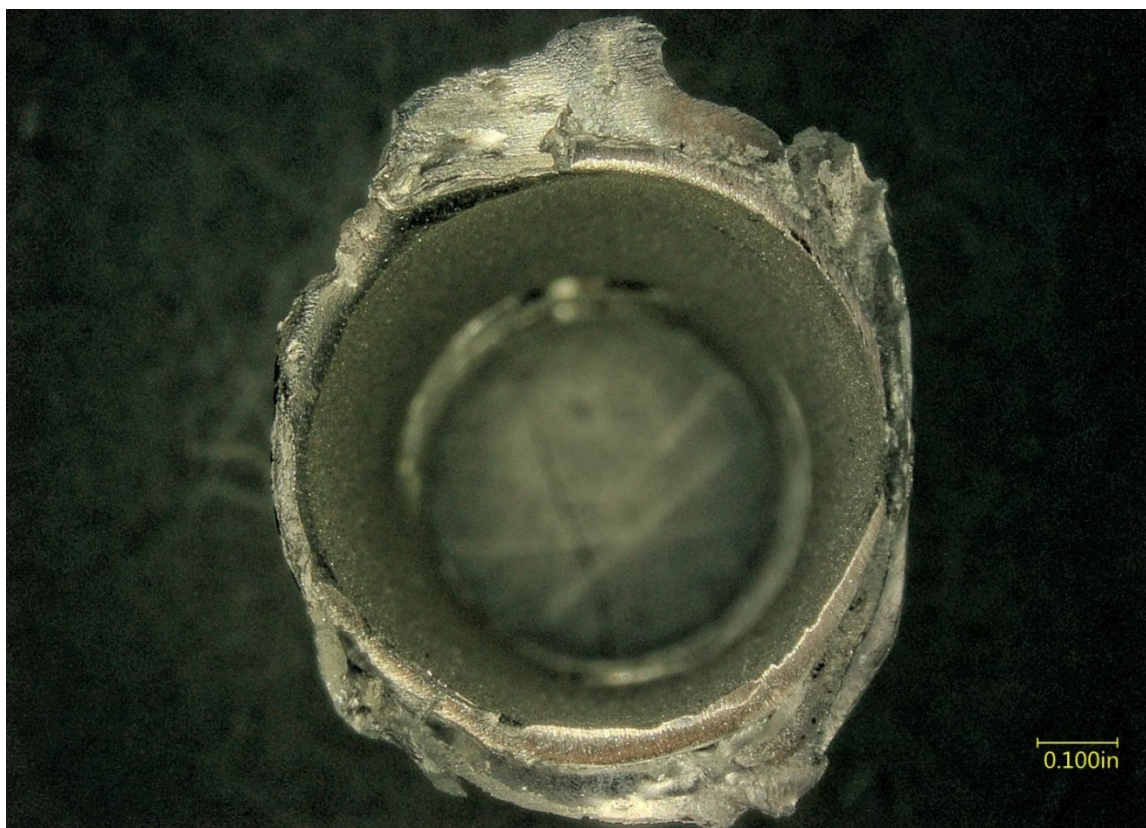
Figure 8 shows the mating fracture surface on the perpendicular tube. This fracture surface consisted of an interior perpendicular tube, surrounded by filler material. Figure 9 and Figure 10 highlight opposite sides of the joint fracture surface. Some portions of this material exhibited parallel transverse marks, consistent with matching surface fabrication marks on the parallel tube. Much of the rest of the joint surface exhibited longitudinal marks, inconsistent with those present on the exterior of the parallel tube surface.

Figure 8 – Closer view of the perpendicular tube side fracture surface.

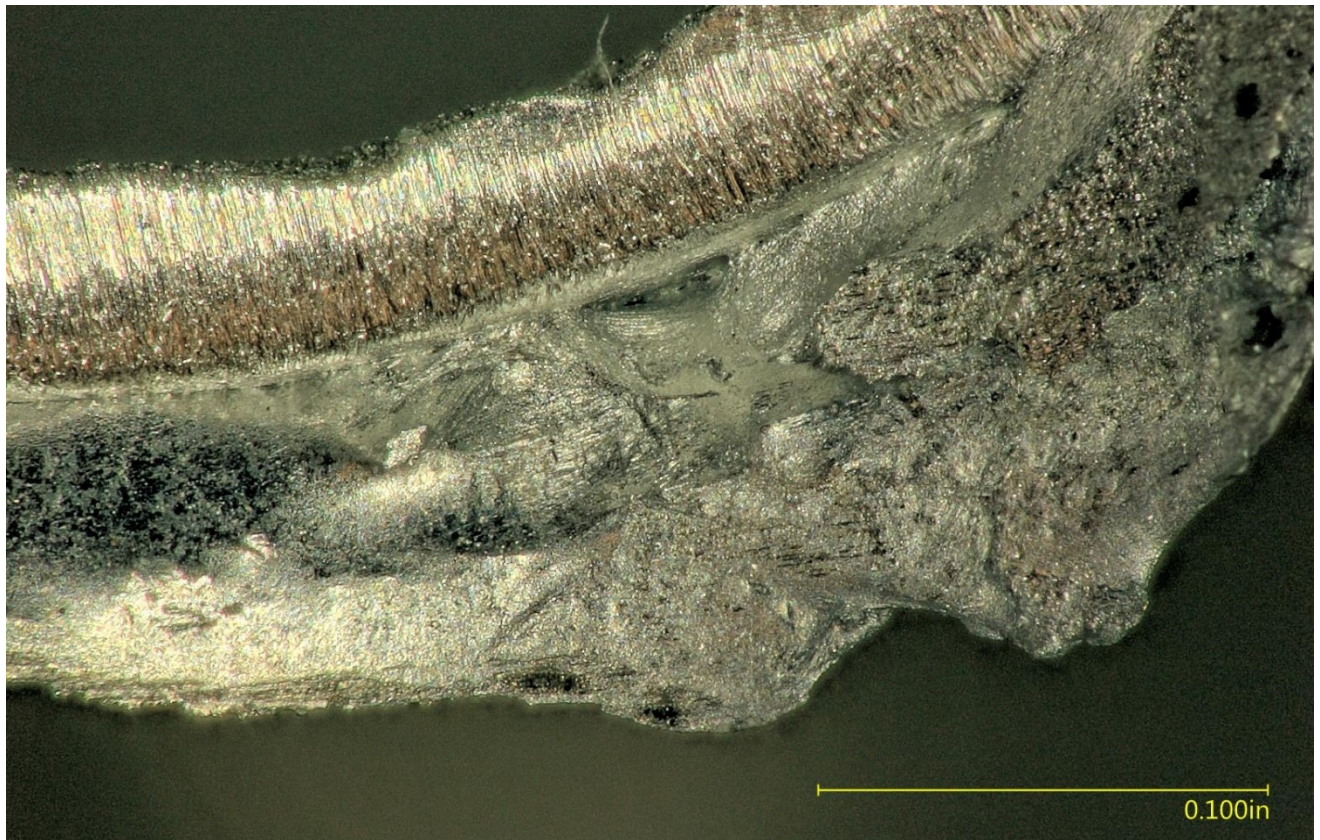
As shown in Figure 9, Figure 10, and Figure 11, much of the filler metal facing the parallel tube was smooth and reflective. Gaps and areas of consistent with lack of seal and penetration were present between the filler metal and the perpendicular tube (see Figure 14). The areas that had been in contact with the mating tube surface were generally flat in orientation. The areas consistent with having not been in contact with another metal surface were rounded. The smooth, rounded areas in Figure 11 were positioned away from the flat areas that had been in contact with the mating tube surface. These exhibited local rumpling consistent a surface oxide wrinkling as the filler alloy cooled and shrank. These portions were consistent with areas that solidified in air without contacting another metal surface.

Figure 9 – View of the largest filler metal remnant on the perpendicular tube fracture surface.

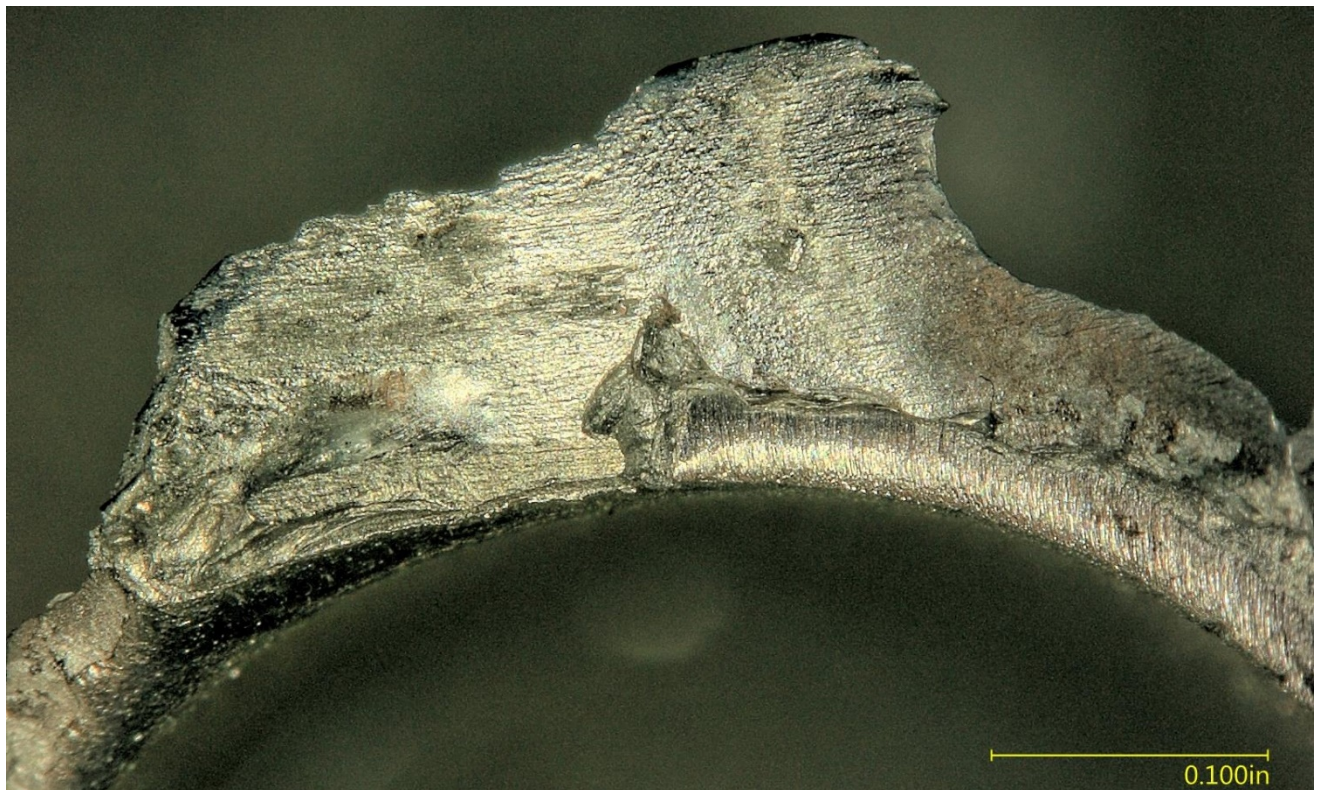
Figure 10 – View of the fracture surface opposite of the portion shown in Figure 9.

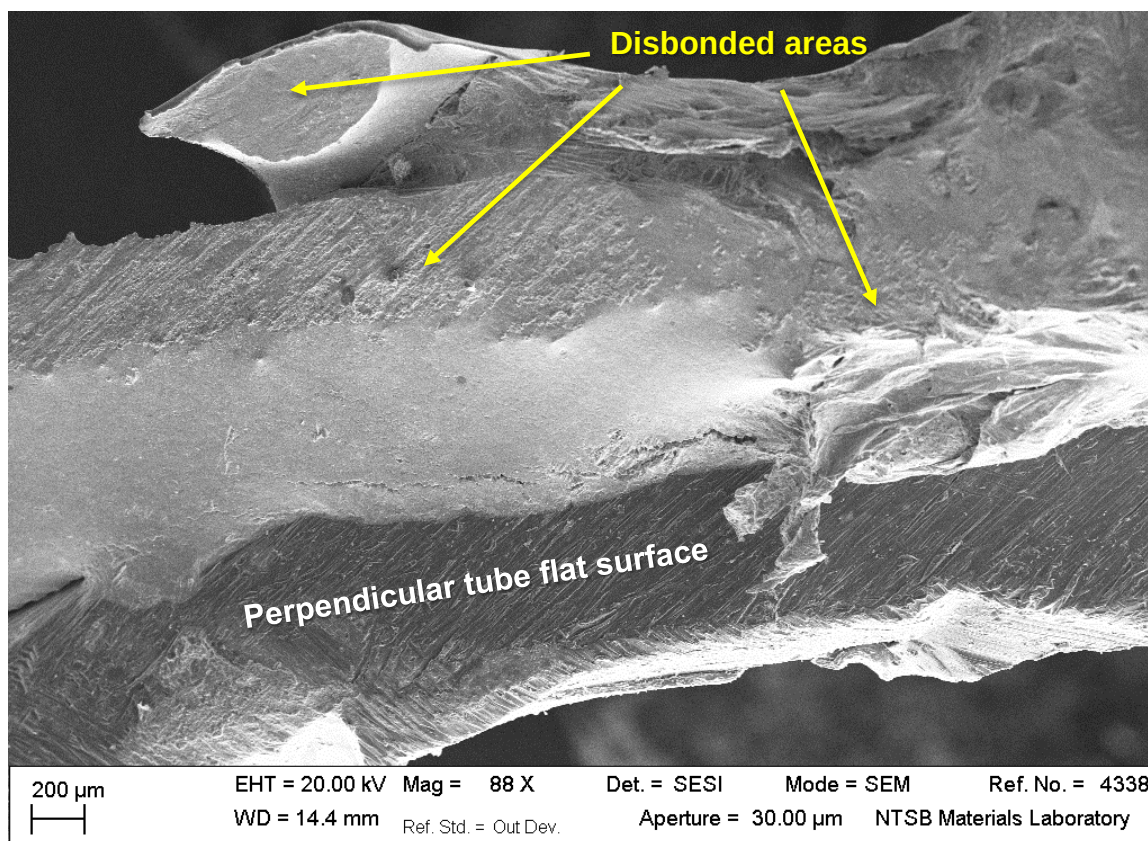
Figure 11 shows another area of the fracture surface on the perpendicular tube, viewed using a SEM. The flat areas shown in Figure 11 were consistent with areas that had been in contact with the mating side of the parallel tube surface. As shown in Figure 12, these areas exhibited a lumpy surface texture, consistent with the underlying dendritic microstructure (indicative of an as-solidified material). Figure 13 shows lamellar surface features, consistent with the eutectic solidification.

In addition, the flat cross-section surface of the perpendicular tube facing the parallel tube was visible in the lower portion of the Figure 11. This surface was recessed from the flat portions of the filler metal, and were fully exposed, consistent with a lack of contact against the mating tube. This surface had not been covered by the filler metal.

Figure 11 – SE micrograph of the joint fracture surface, showing the disbonded areas and the unbonded regions.

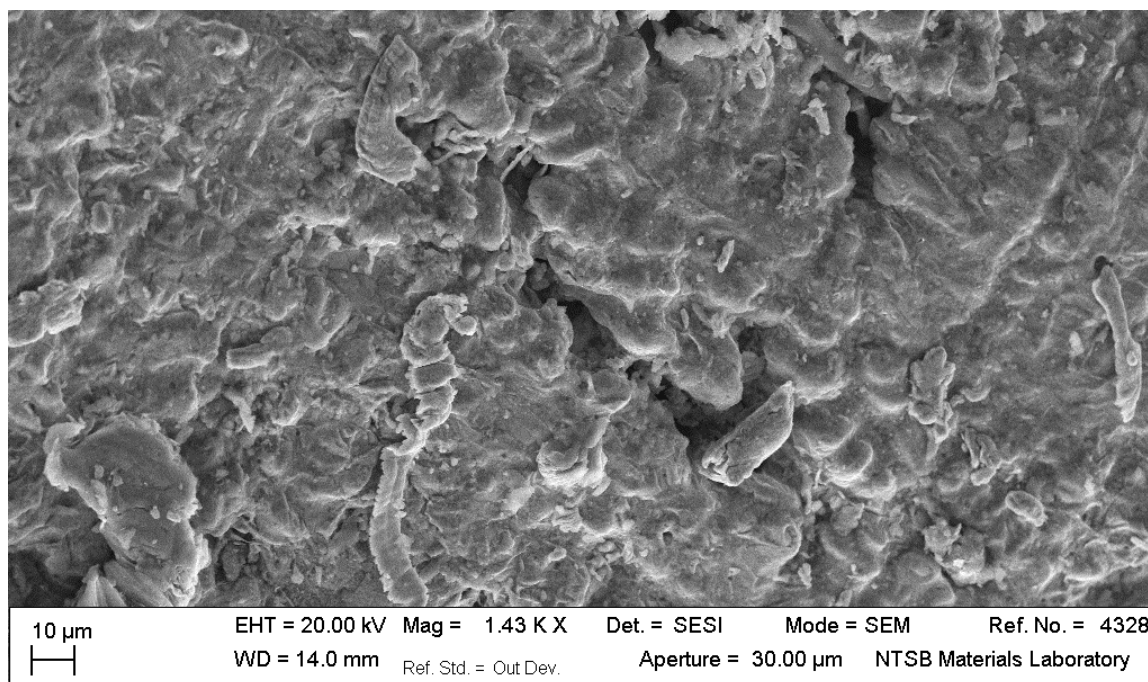
Figure 12 – SE micrograph showing the dendritic structure of a solidified filler metal, with surface wrinkling and oxidation.

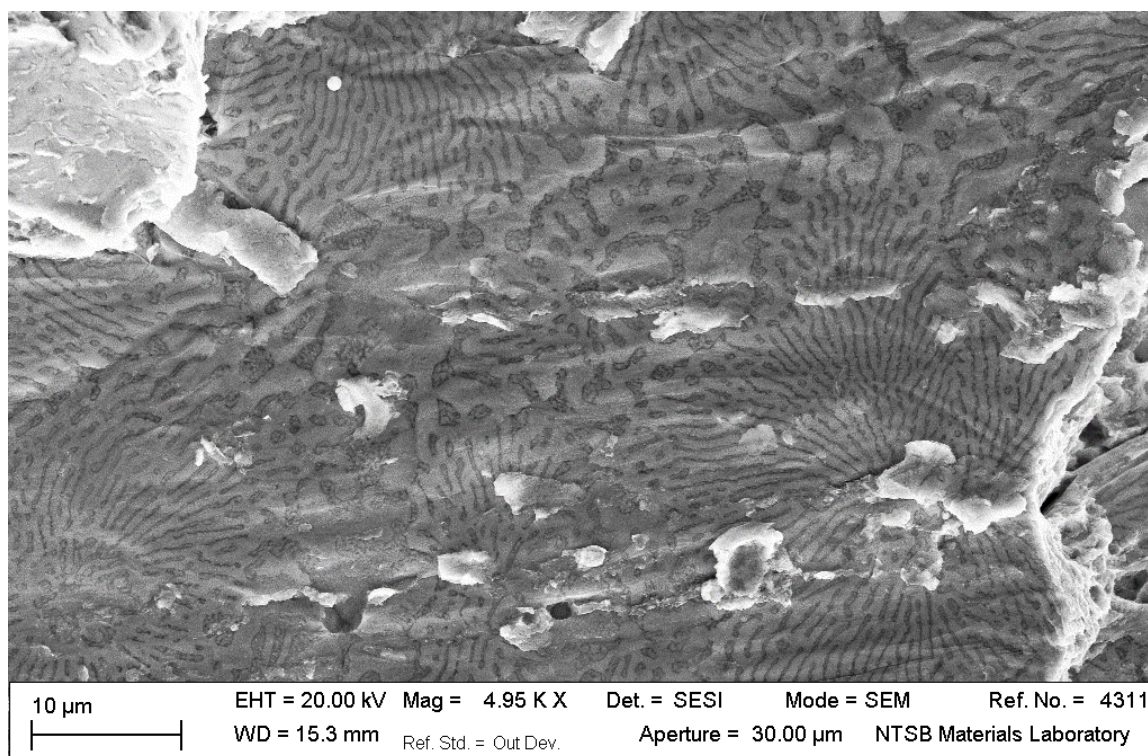
The round areas exhibited wrinkling on their surfaces, as shown in Figure 13 through Figure 15. The wrinkling on the surface was consistent with a thin oxide skin that formed at the beginning of solidification process while the molten filler metal was in contact with air. This skin then buckled as the filler metal cooled and shrank. The surface wrinkled oxide skin was present on much of the filler metal surface, as shown in Figure 16 and Figure 17. Some areas exhibited thicker oxide layers, shown in Figure 18.

Figure 13 – SE micrograph of a closer view of the rounded fracture regions, showing eutectic lamellar features on the surface.

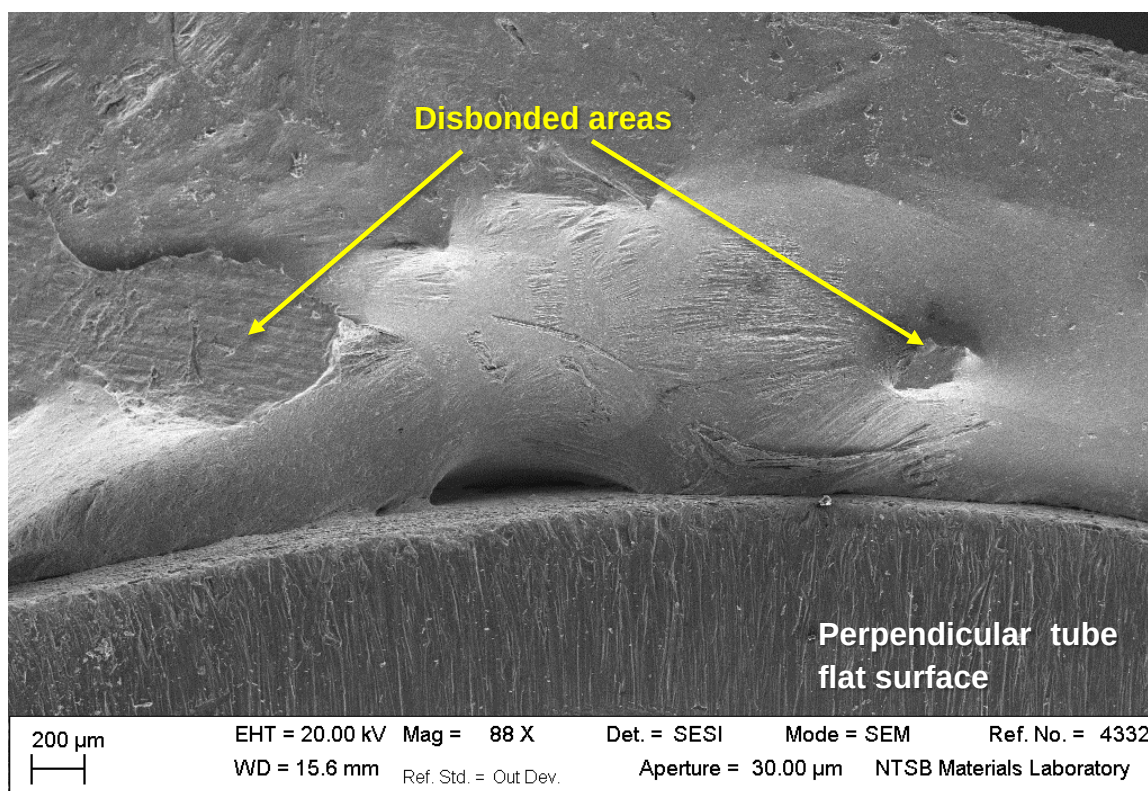
Figure 14 – SE micrograph of the fracture surface from Figure 9.

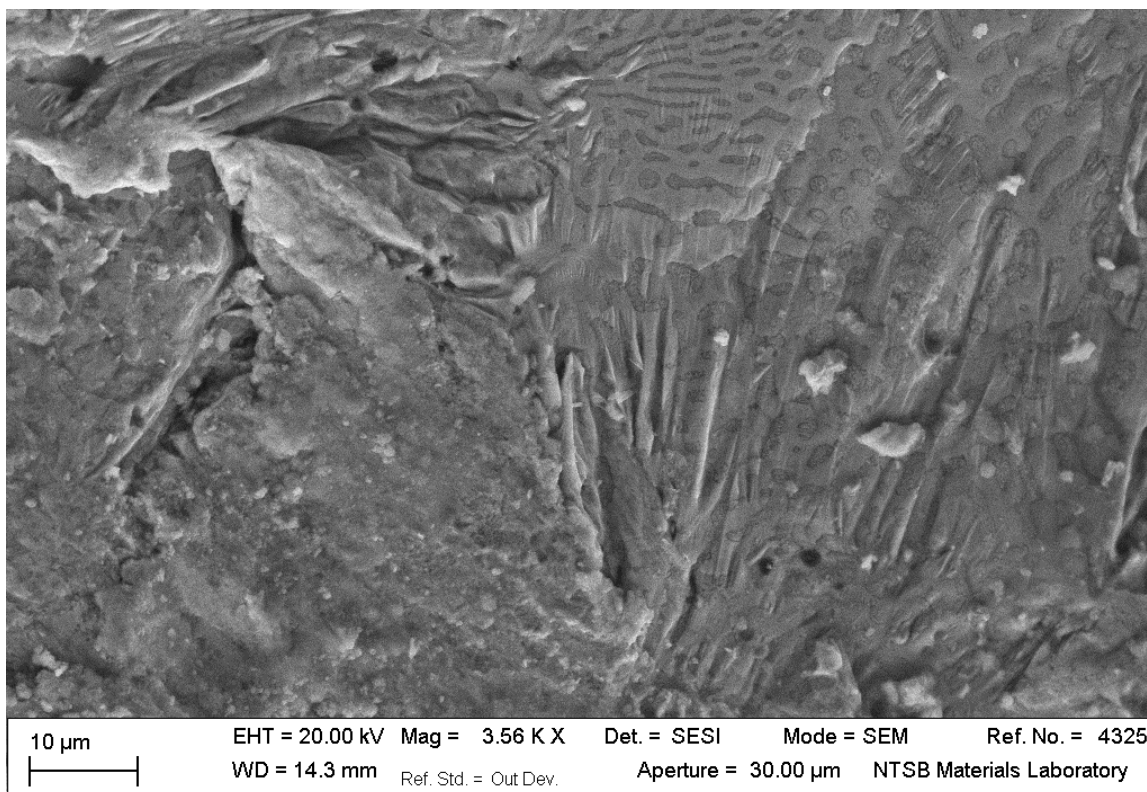
Figure 15 – SE micrograph showing a closer view of Figure 13, highlighting surface wrinkles consistent with solidification shrinkage.

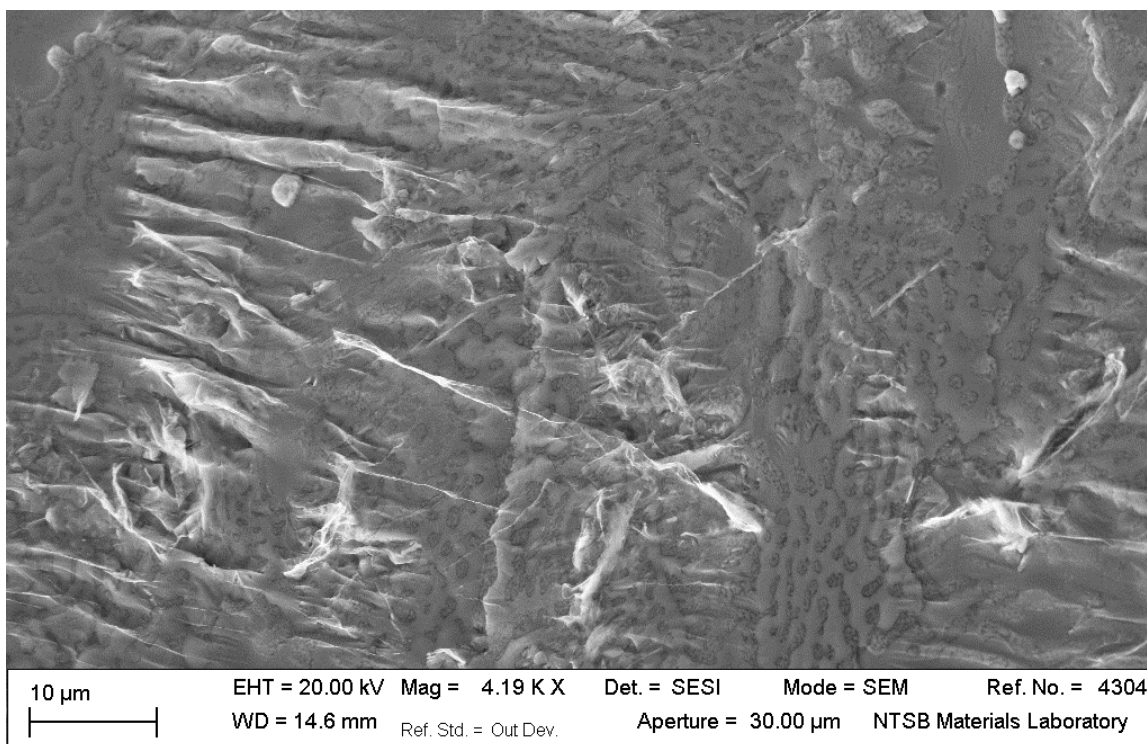
Figure 16 – SE micrograph showing a closer view of Figure 13, highlighting surface wrinkles consistent with solidification shrinkage.

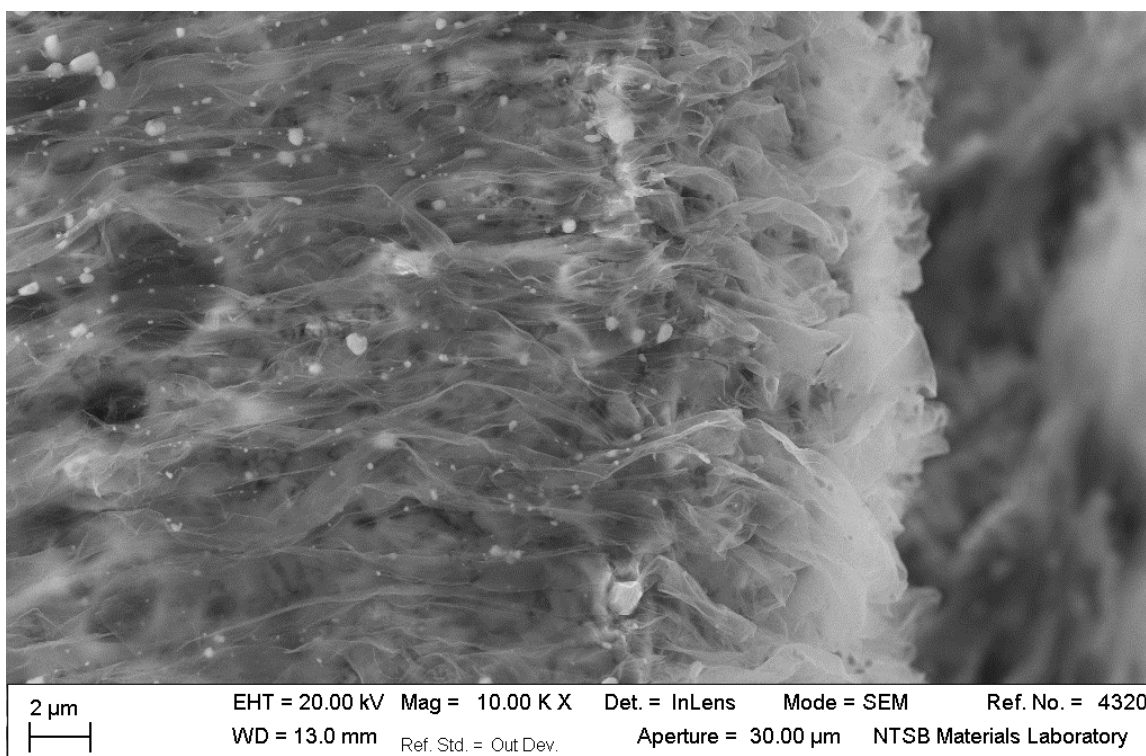
Figure 17 – SE micrograph of another area on the fracture surface, showing a wrinkled oxidation layer.

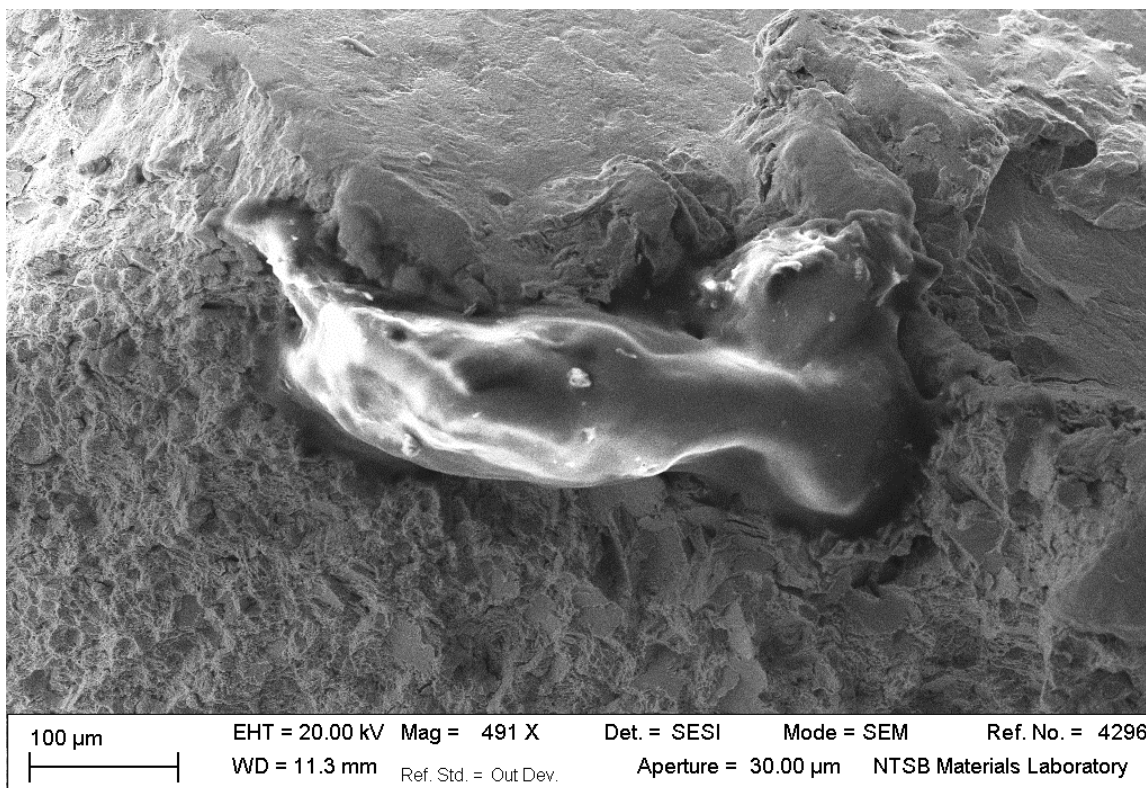
Figure 18 – SE micrograph showing an embedded contamination particle on the filler metal material.

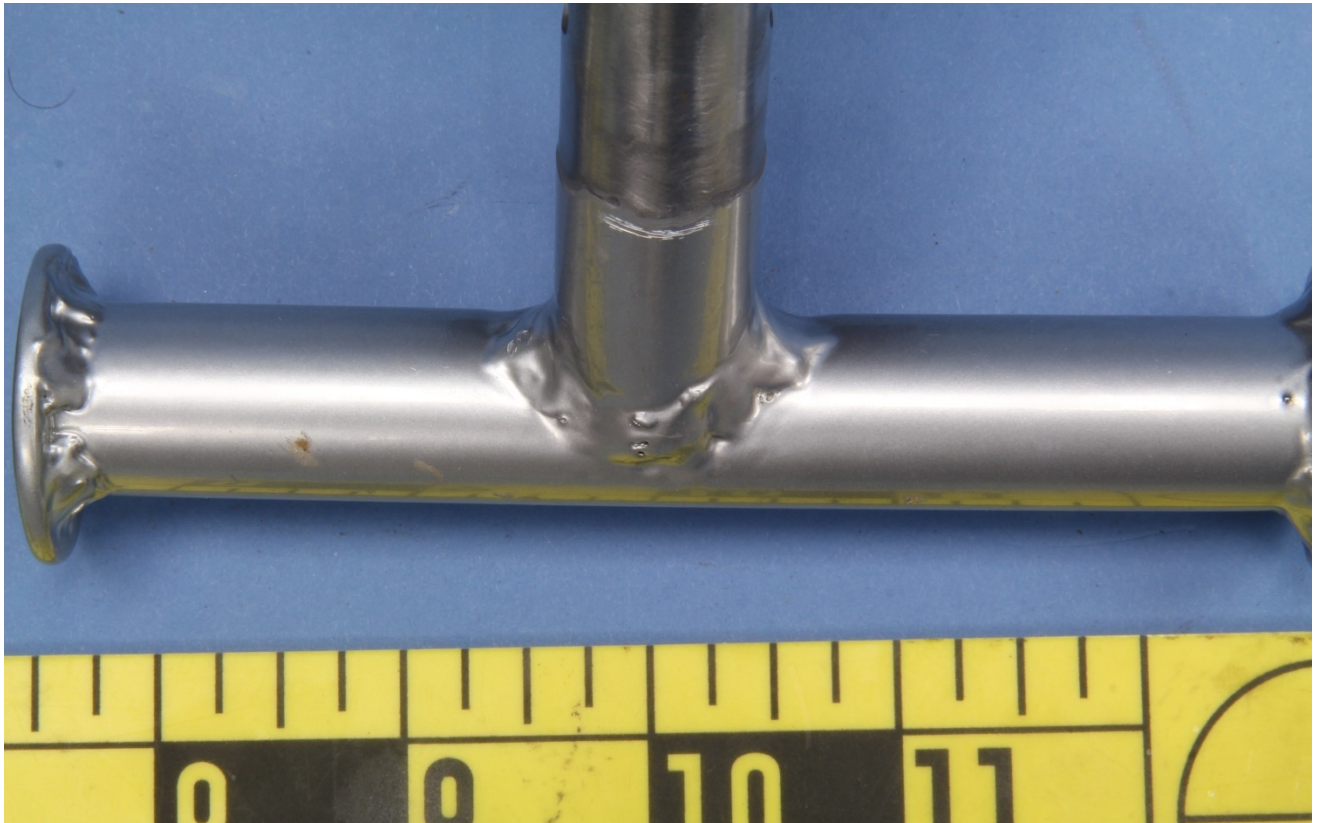
Figure 19 and Figure 20 show the joint between the two tubes of the intact anti-torque tube assembly. The joint was consistent with a welding process, as described below. The weld encompassed the mating surfaces of both tubes, with few external issues. These included pores visible to the exterior surface (as shown in Figure 21) and a small crack approximately 0.05 inches in length (see Figure 22).

Figure 19 – The intact torque tube, highlighting the joint of the two tubes.

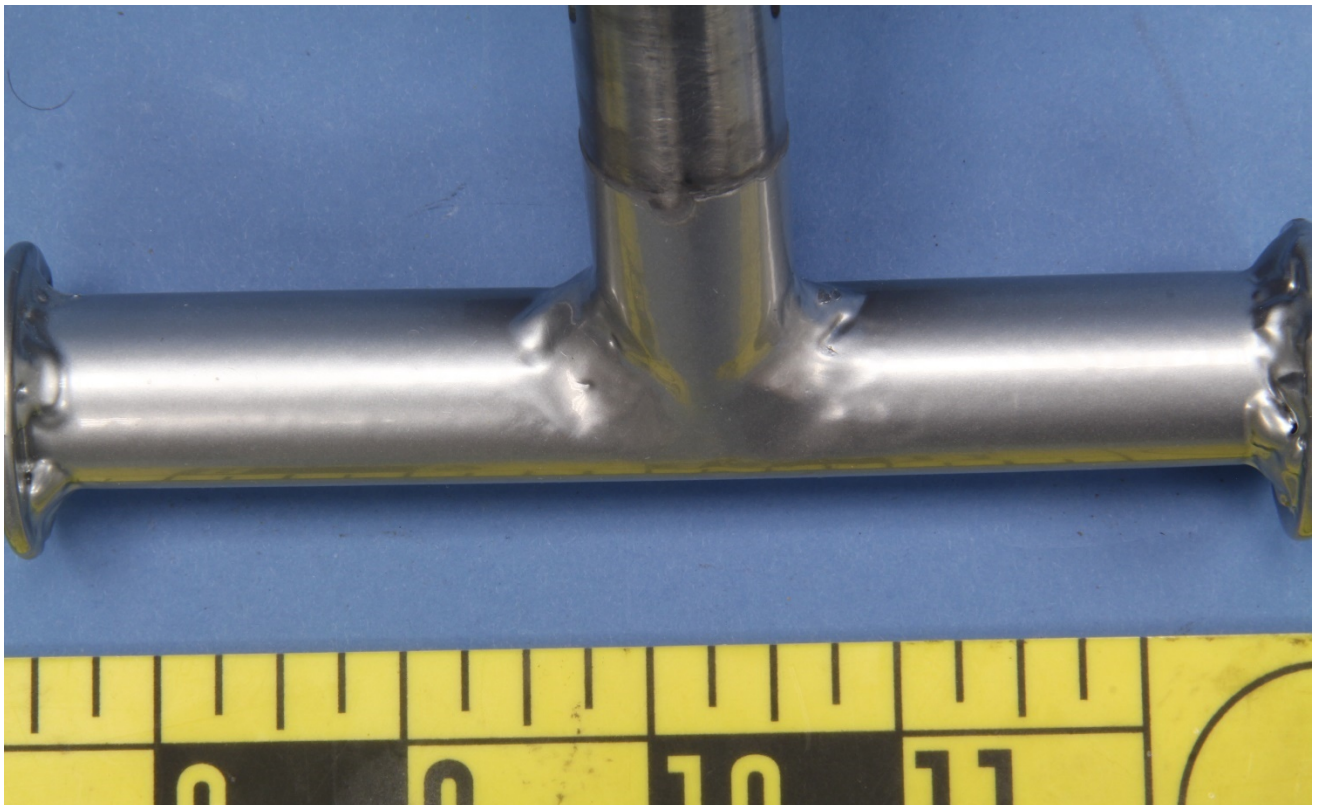
Figure 20 – View of the tube joint from the side opposite Figure 19.

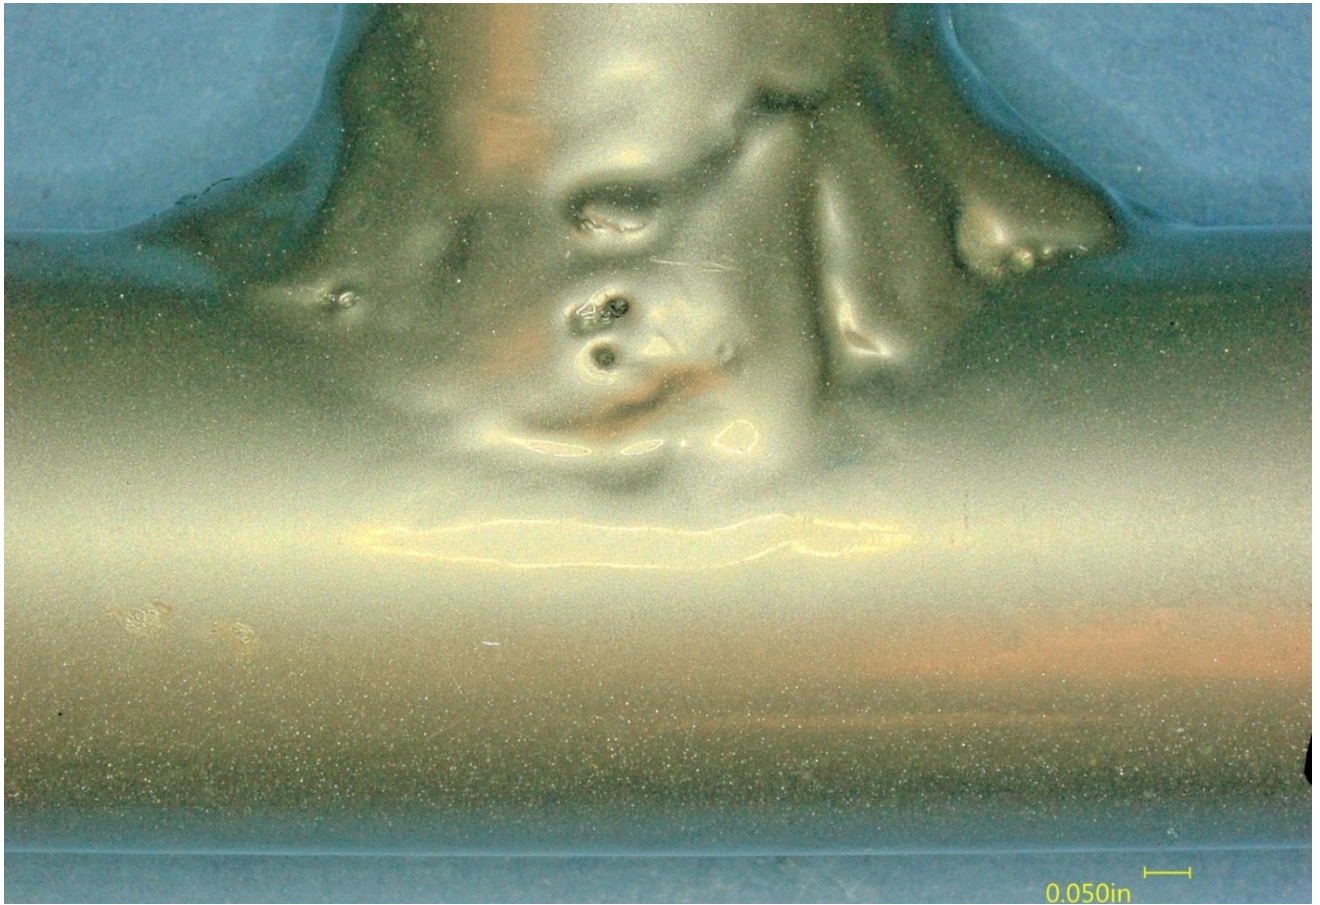
Figure 21 – Closer view of the intact anti-torque tube showing surface porosity.
