# NATIONAL TRANSPORTATION SAFETY BOARD

## MATERIALS LABORATORY FACTUAL REPORT

Report No. 19-016

Place : Billings, Montana  
Date : September 12, 2018  
Vehicle : Rotorway RW-1, N166LC  
NTSB No. : WPR18FA260  
Investigator : Thomas Little, AS-WPR

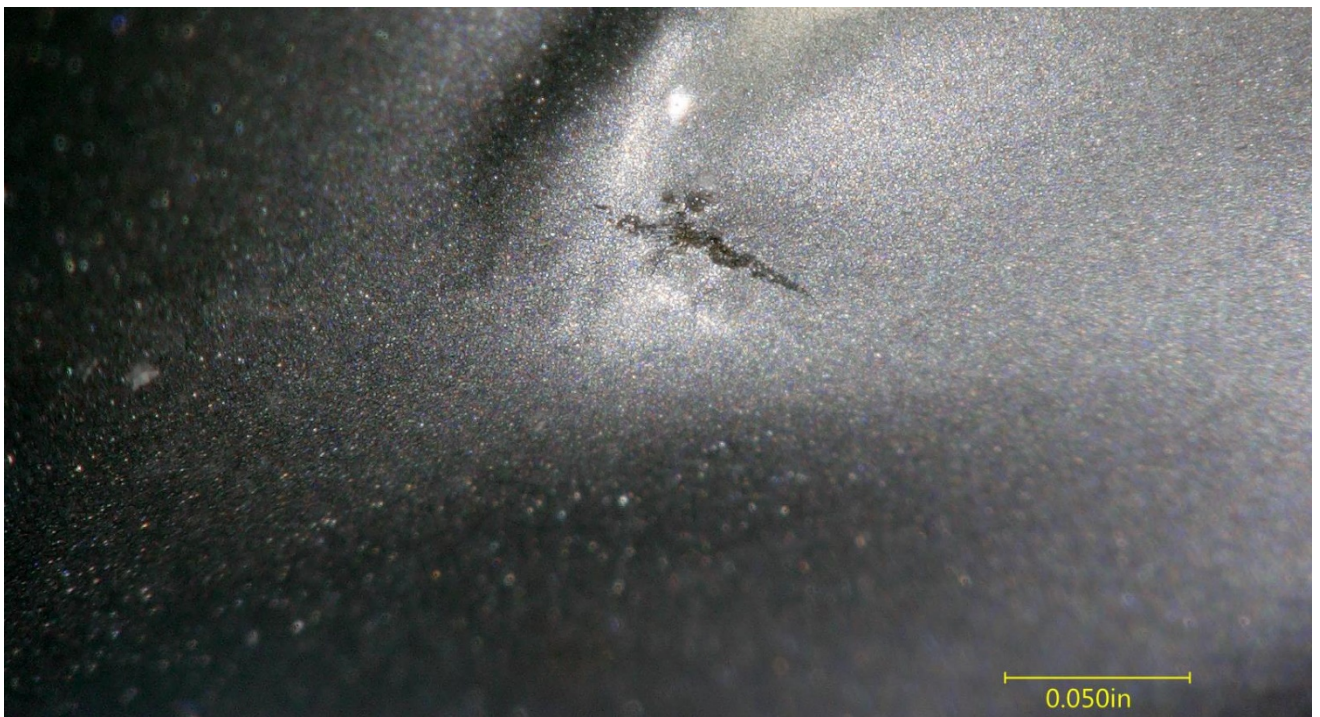
Figure 19 and Figure 20 show the joint between the two tubes of the intact anti-torque tube assembly. The joint was consistent with a welding process, as described below. The weld encompassed the mating surfaces of both tubes, with few external issues. These included pores visible to the exterior surface (as shown in Figure 21) and a small crack approximately 0.05 inches in length (see Figure 22).

Figure 22 – Closer view of a surface crack on the intact tube joint.

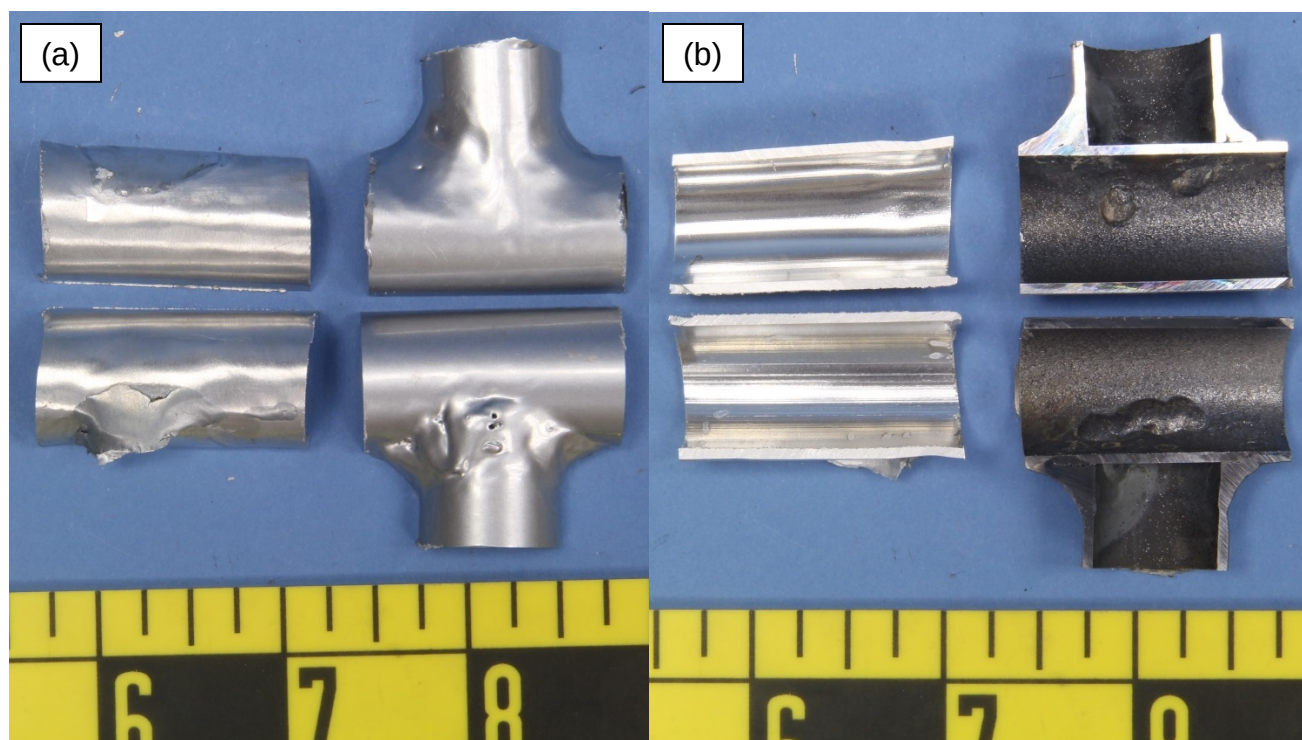
The parallel tubes of both assemblies were sectioned longitudinally through the respective joints. The exterior and interior of both tube joints are illustrated in Figure 23. The intact assembly is shown on the right in both figures. The interior surface of the intact joint exhibited penetration consistent with a welding operation performed about the melting temperature of the alloy. The interior of this tube also exhibited the darker complexion typical of steel tubes. The interior of the parallel tube of the fractured anti-torque tube assembly exhibited no indications consistent with penetration by a second filler material.

Figure 23 – Cross sections of the anti-torque tubes from the (a) exterior surfaces and (b) the interior surfaces. The aluminum, fractured tube is positioned on the left and the intact tube was on the right.

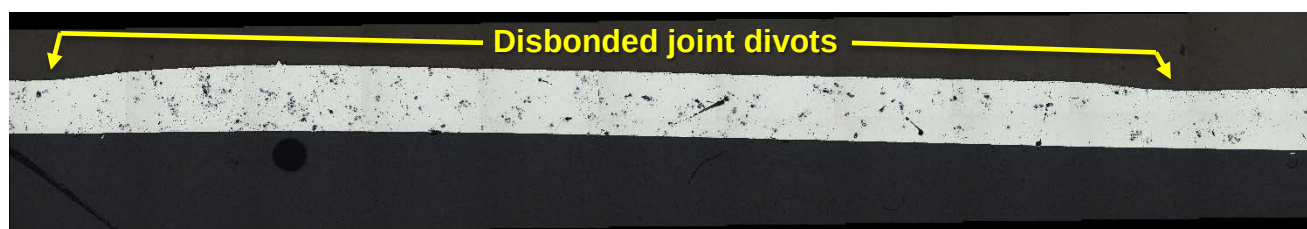
The cross-sections were vacuum-mounted in epoxy and polished. As shown in a closer view montage of the fractured assembly parallel tube surface, no indications of penetration or fusion with the perpendicular tube were present (Figure 24). The surface of the tube facing the fracture in this cross-section exhibited two divot marks, consistent with where the perpendicular tube was seated (Figure 25). The interior of this tube exhibited porosity as demonstrated by the dark spots on Figure 25. There were some subsurface second phases near the location of the divots of this tube (Figure 26). These second phases were not found elsewhere on the tube.

Figure 24 – Bright-field optical micrograph montage of the cross section of the parallel aluminum tube through the fractured joint. Those divots where the filler metal had disbonded from the joint are annotated (~25X, as polished).

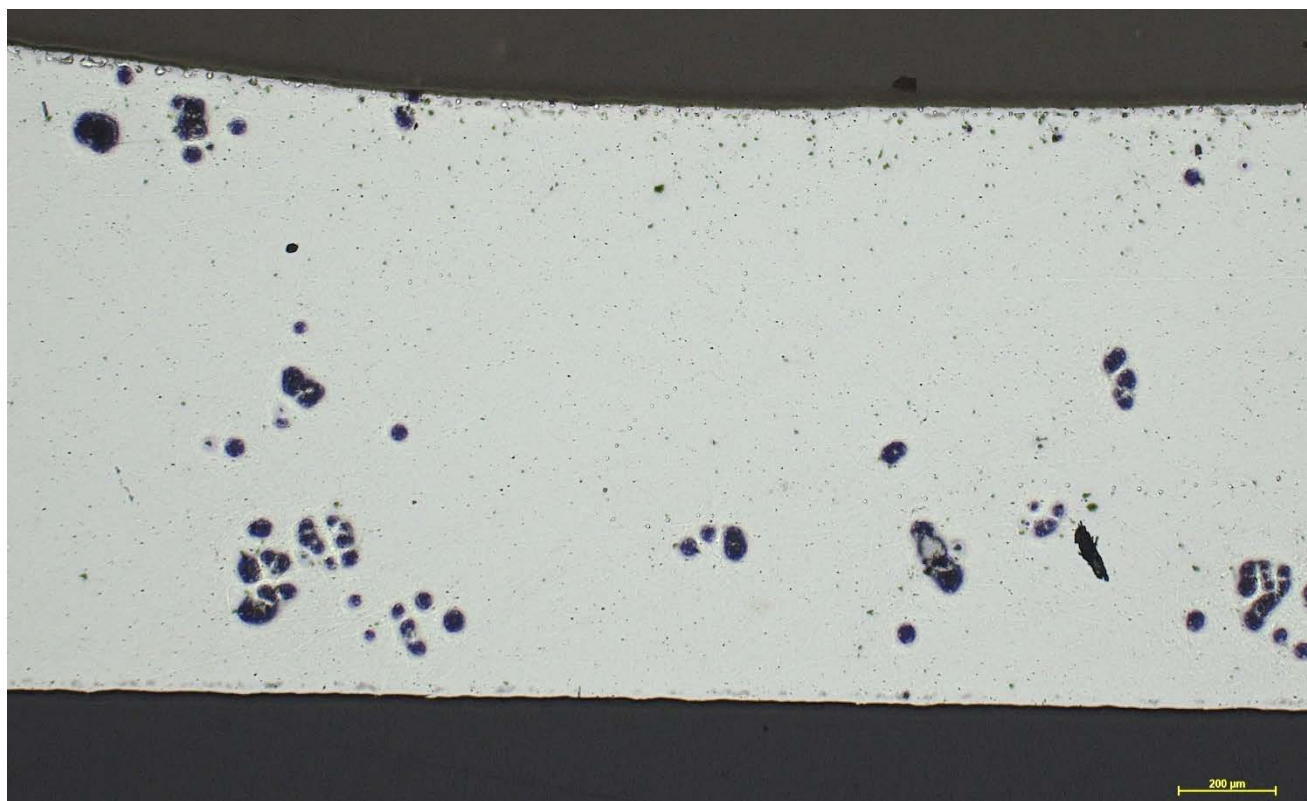
Figure 25 – BF optical micrograph at one of the aluminum tube fracture sites, showing a lack of material at the divot and internal porosity (~50X, as polished).

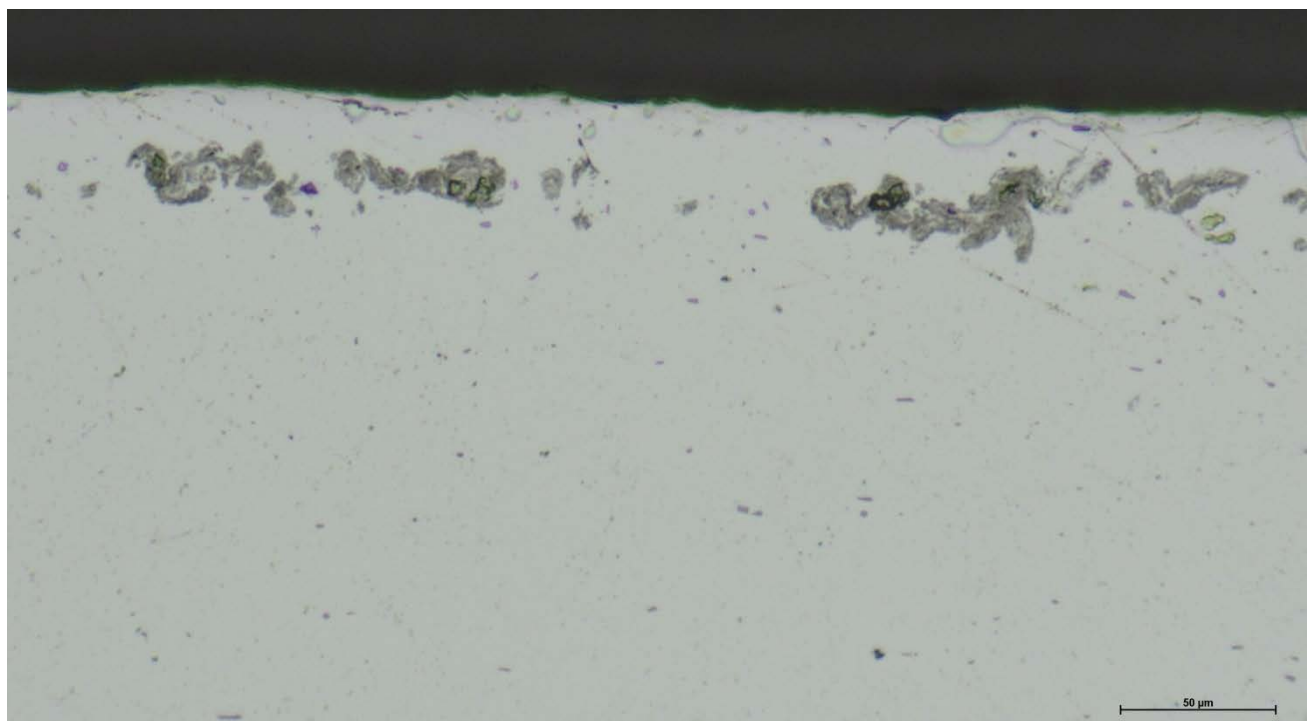
Figure 26 – BF optical micrograph of the aluminum tube divot (~200X, as polished).

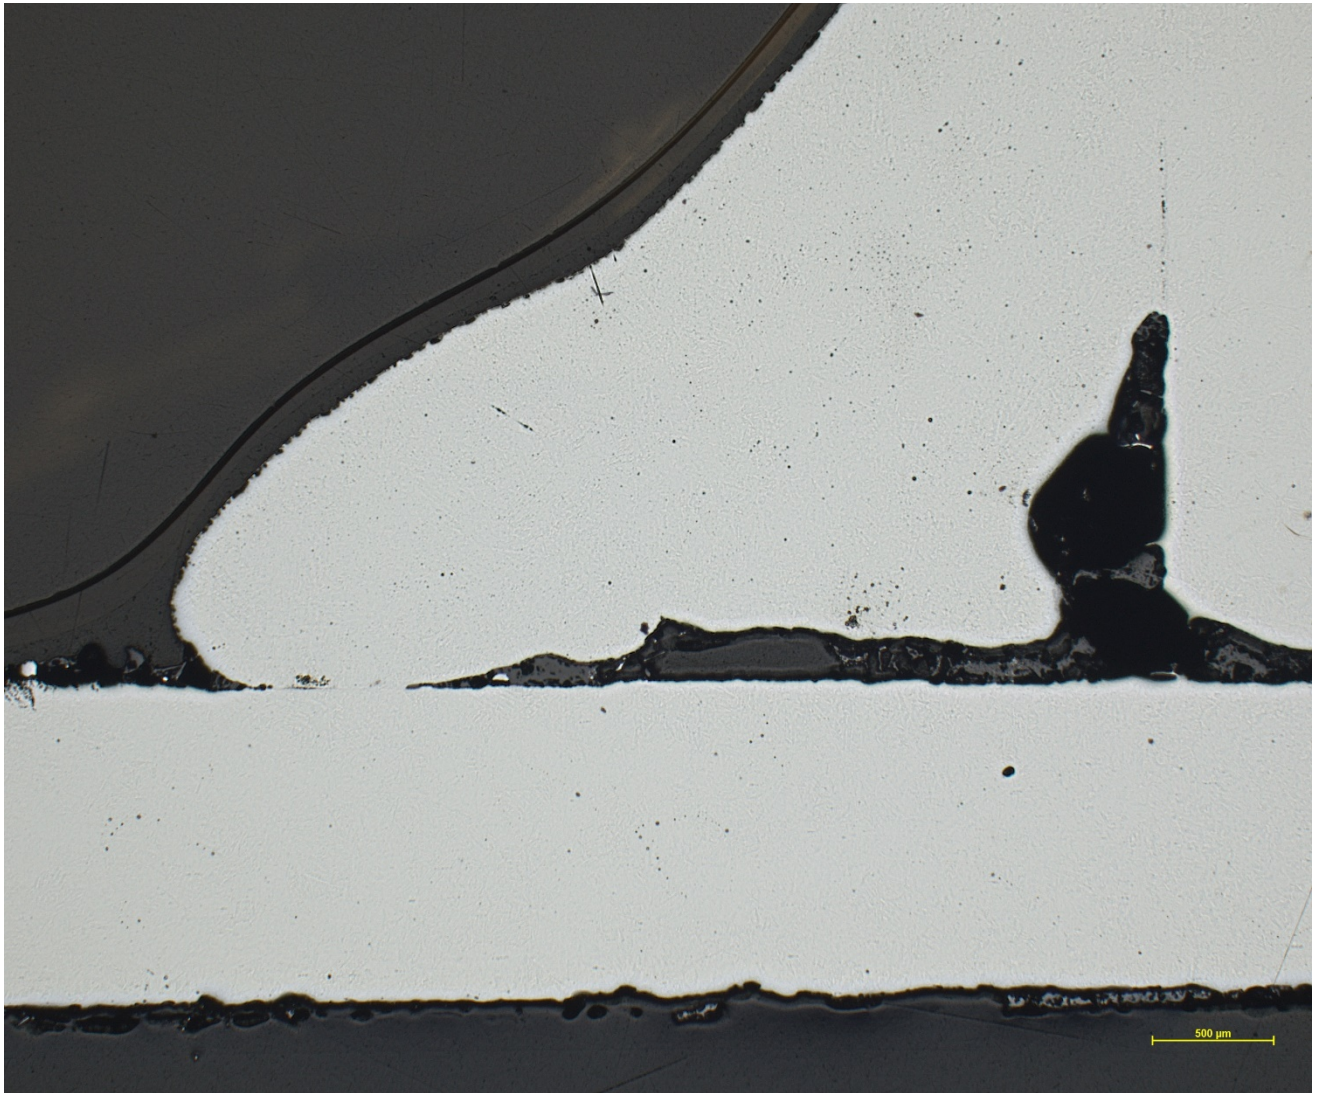
Figure 27 shows a section of the intact weld joint, as polished. While there were areas with gaps between the tubes and weld filler, the joint was intact with some fusion and penetration. A typical area of the microstructure of the parallel tube and the perpendicular tube are illustrated in Figure 28 and Figure 29 respectively. Both tubes exhibited microstructures consistent with a worked material, exhibiting longitudinal-oriented mixture of ferrite and pearlite. The microstructure of the weld filler exhibited a martensite, consistent with more rapid cooling of the material in this region (Figure 30). There were no noted issues with the microstructures of the intact tube assembly.

Figure 27 – BF micrograph of a cross section of the steel tube weld from the intact anti-torque tube assembly (~25X, as polished).

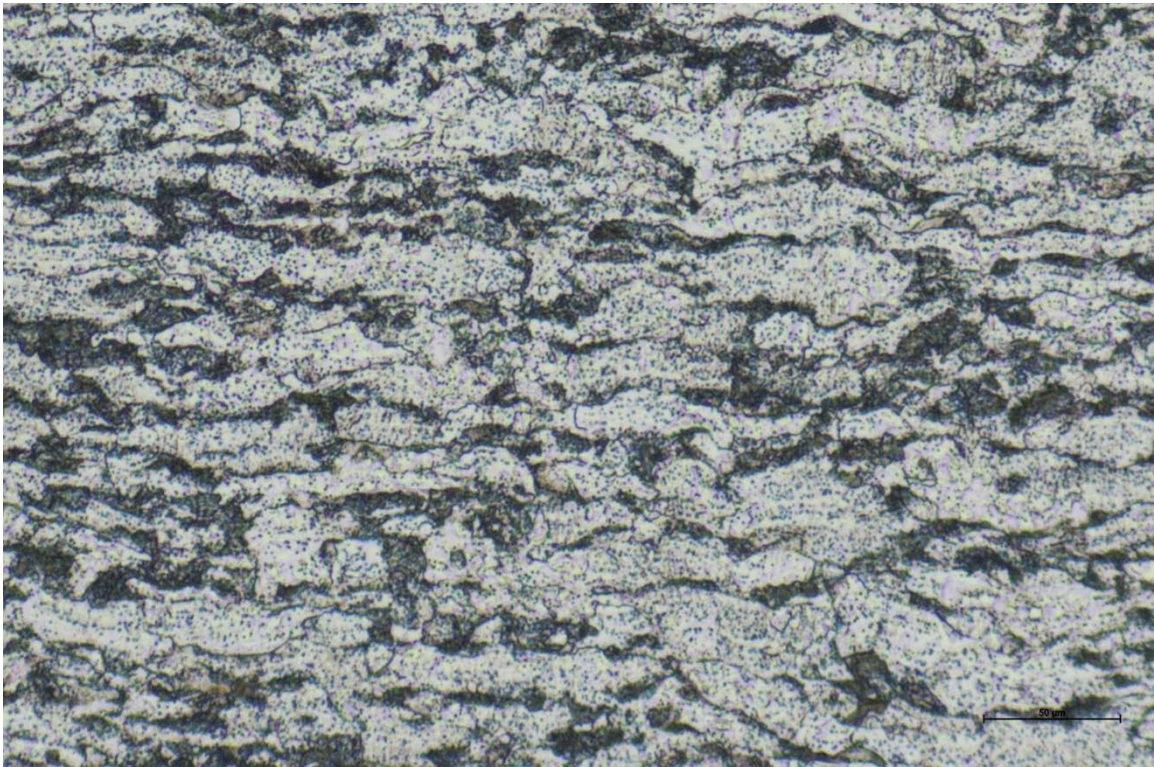
Figure 28 – BF micrograph of the parallel tube microstructure from the intact anti-torque tube assembly (~500X, etched 2% Nital).

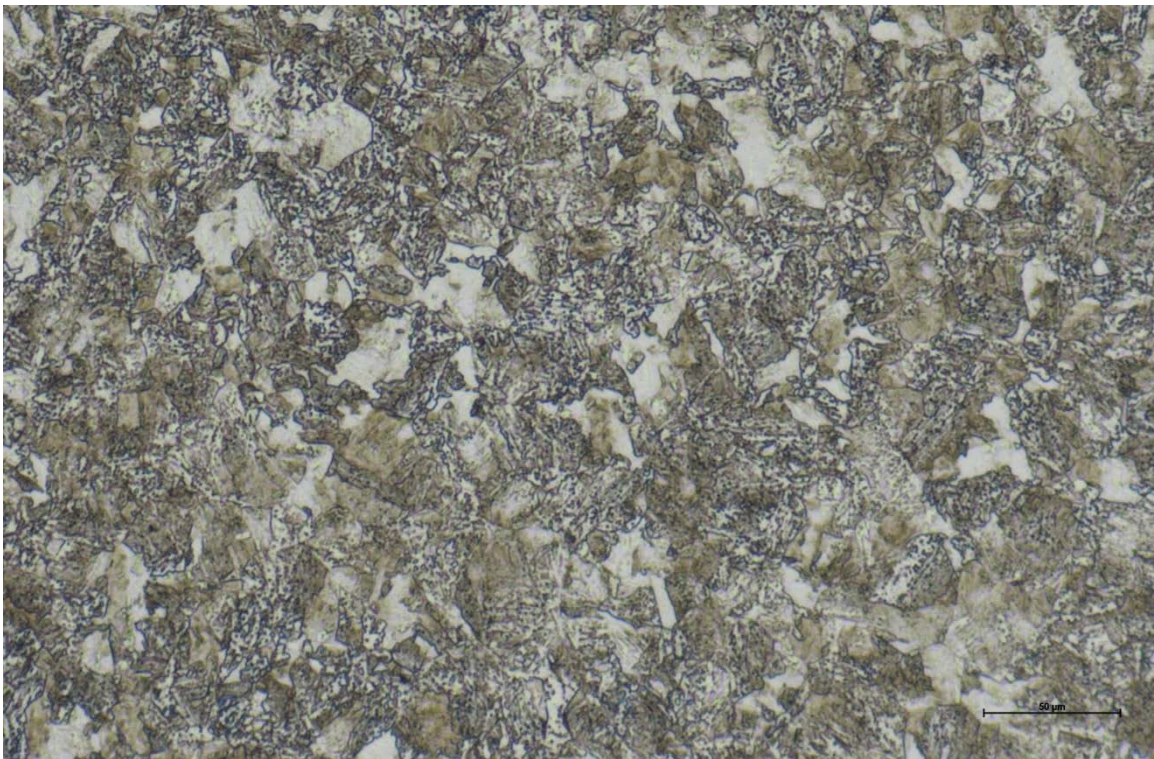
Figure 29 – BF micrograph of the perpendicular tube microstructure from the intact anti-torque tube assembly (~500X, etched 2% Nital).

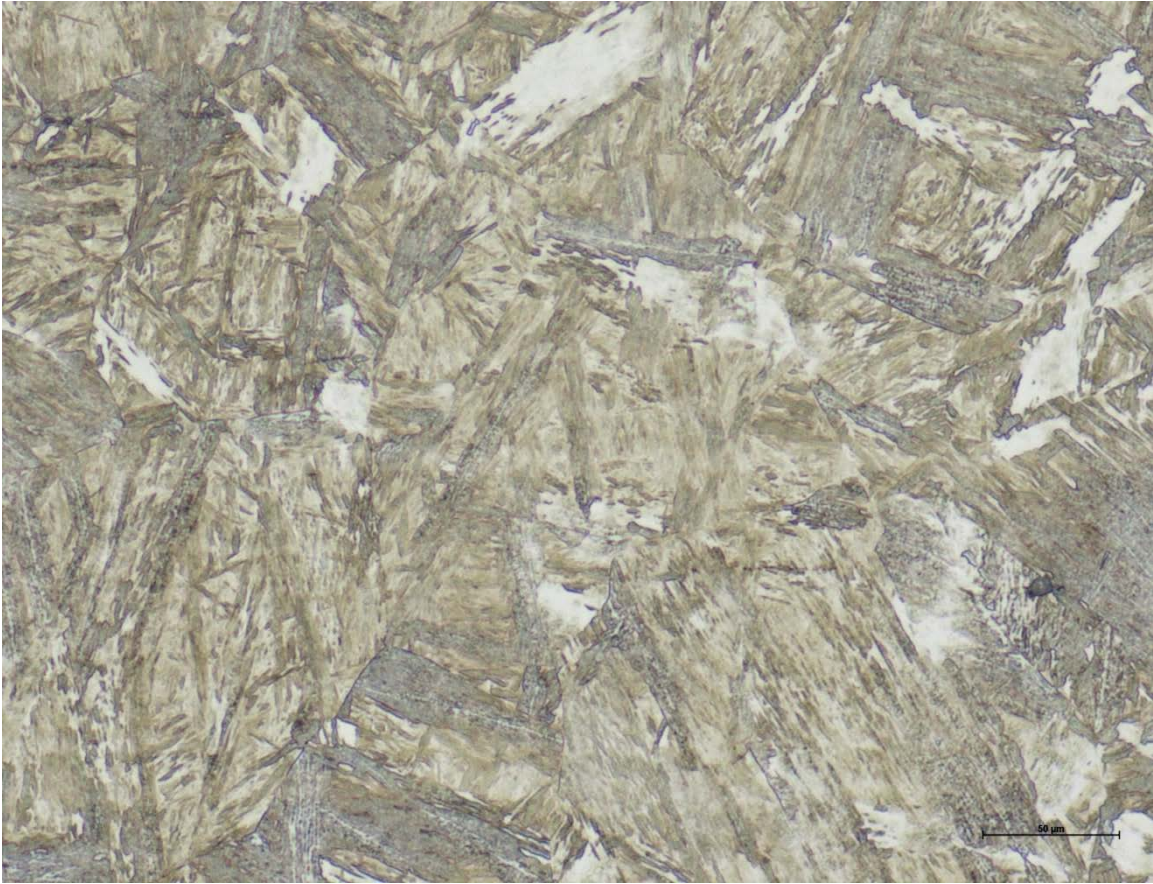
Figure 30 – BF micrograph of the weld filler metal microstructure from the intact anti-torque tube assembly (~500X, etched 2% Nital).
