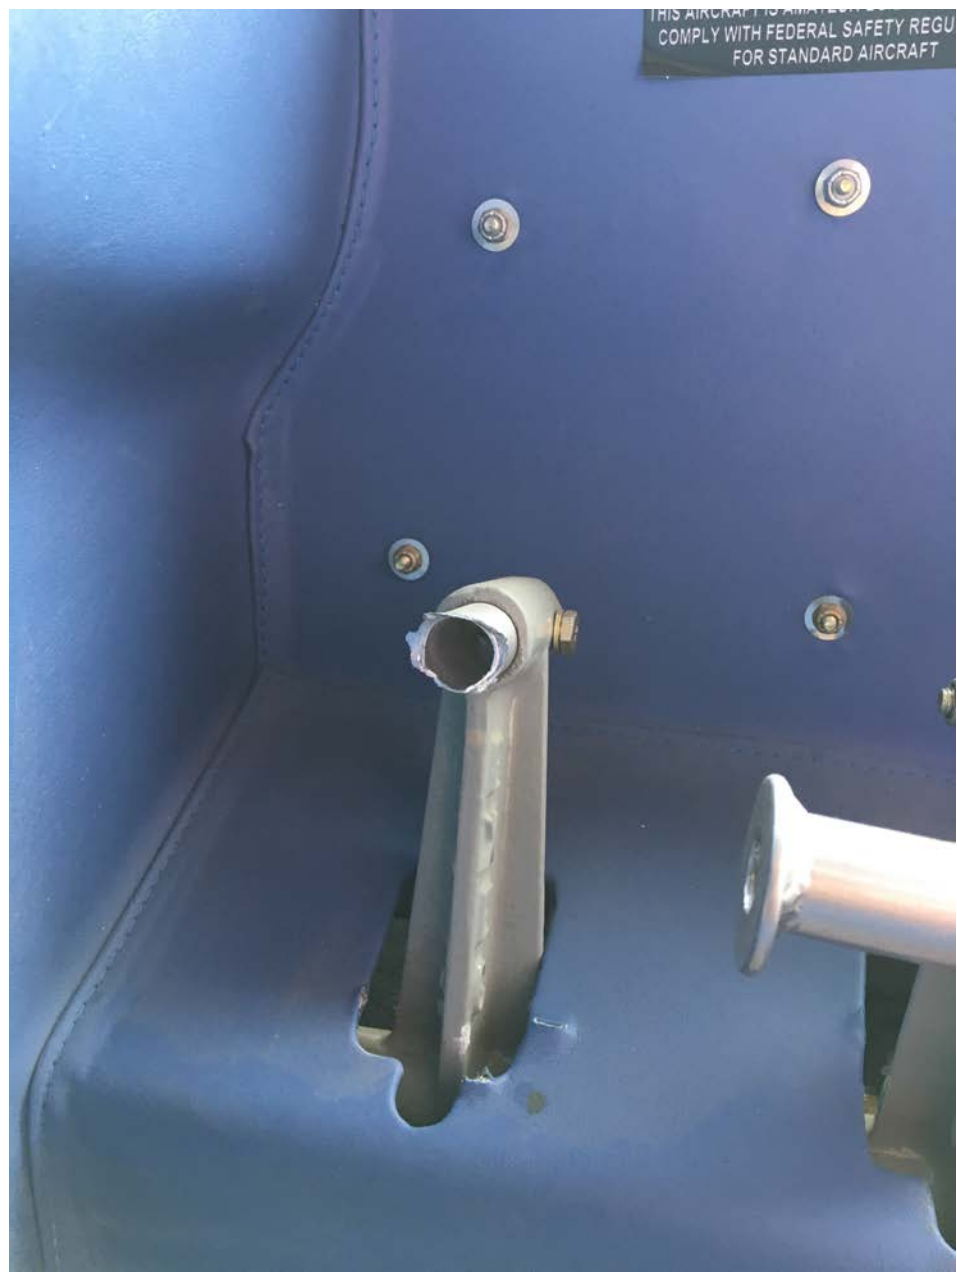
**Photo 5 – photo of failed vertical anti-torque pedal**
