## **NATIONAL TRANSPORTATION SAFETY BOARD**

### **Field Notes**

**WPR18F276**

Aircraft: Cessna 210M, Registration Number: N732MN, Serial #: 21061628

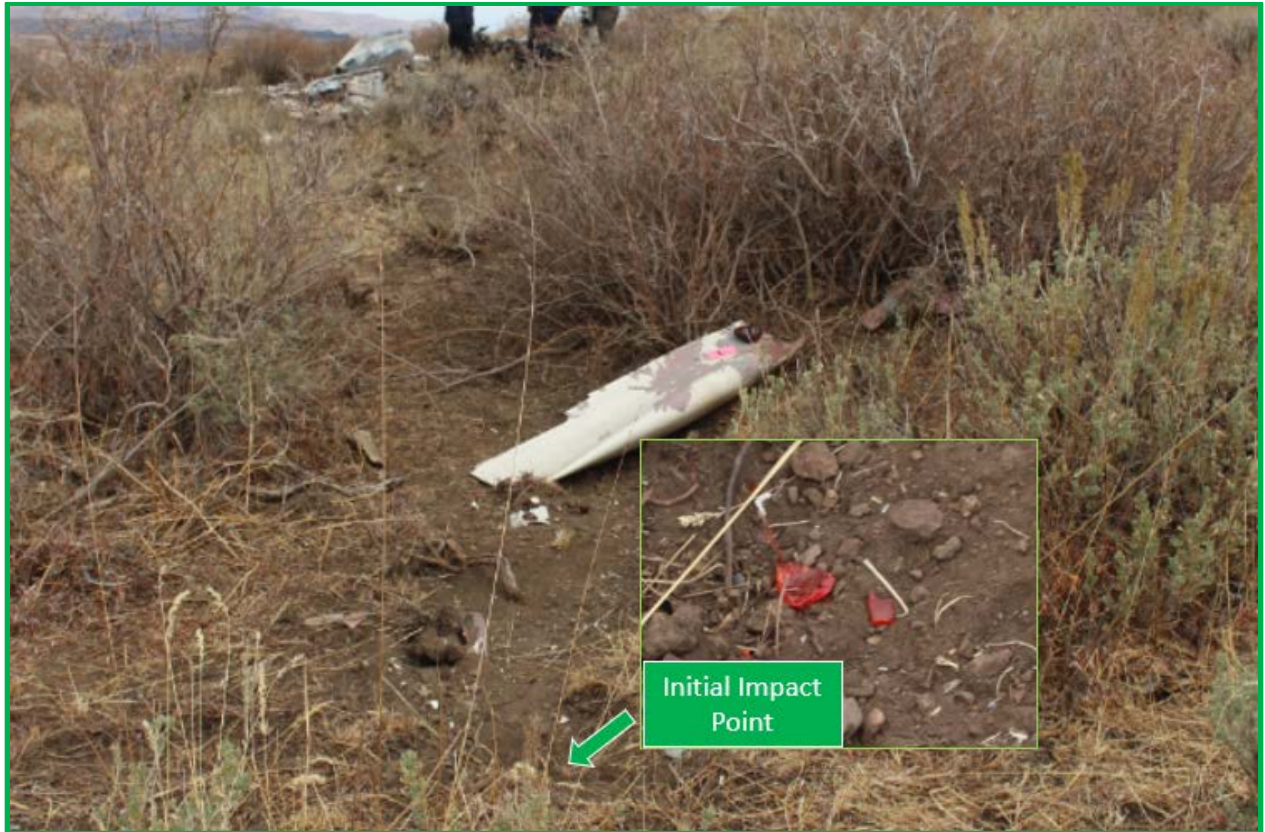
Investigators from the NTSB, FAA, Textron Aviation, and Continental Motors accessed the wreckage on October 1 thru October 2, 2018. The wreckage was located in a valley that gradually sloped downward in a East to West direction. The wreckage debris field from initial impact to the last found piece of wreckage was approximately 379 feet in an overall South to North orientation. The main wreckage was located at GPS N43.07521 and W116.77118, approximately 6,656 ft elevation. The first identified point of contact with terrain was located at GPS N43.07504 and W116.77114, which contained ground scarring and a fragment of the left wing red navigation light lens. The last piece of debris was a propeller located at GPS N43.076075 and W116.771025.

Figure 5: View of the Initial Impact Point (IIP).

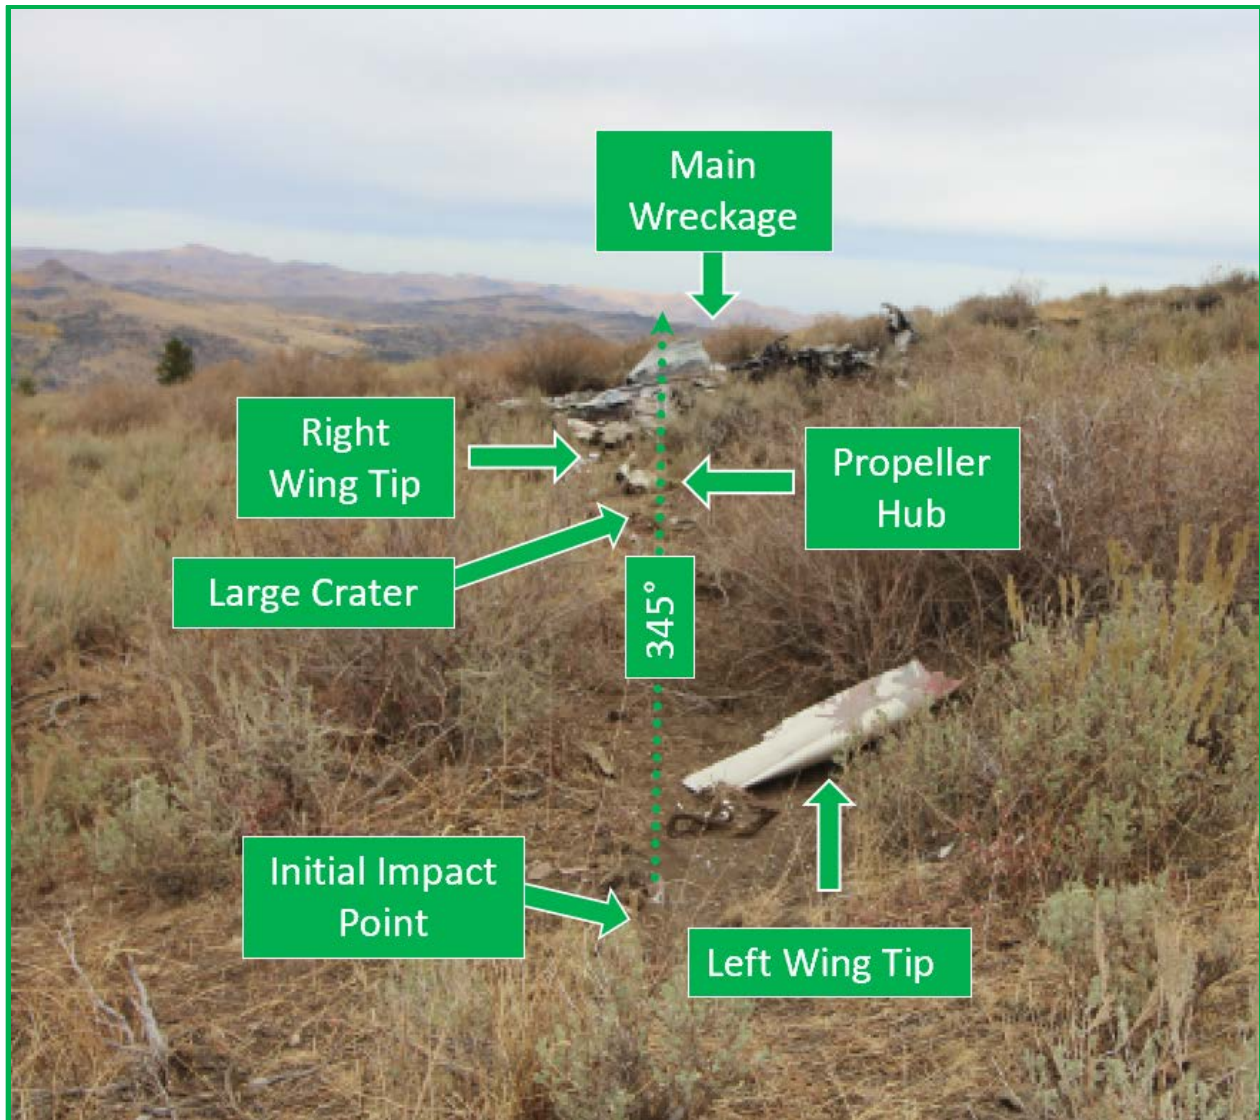
Figure 6: View of Debris Path.

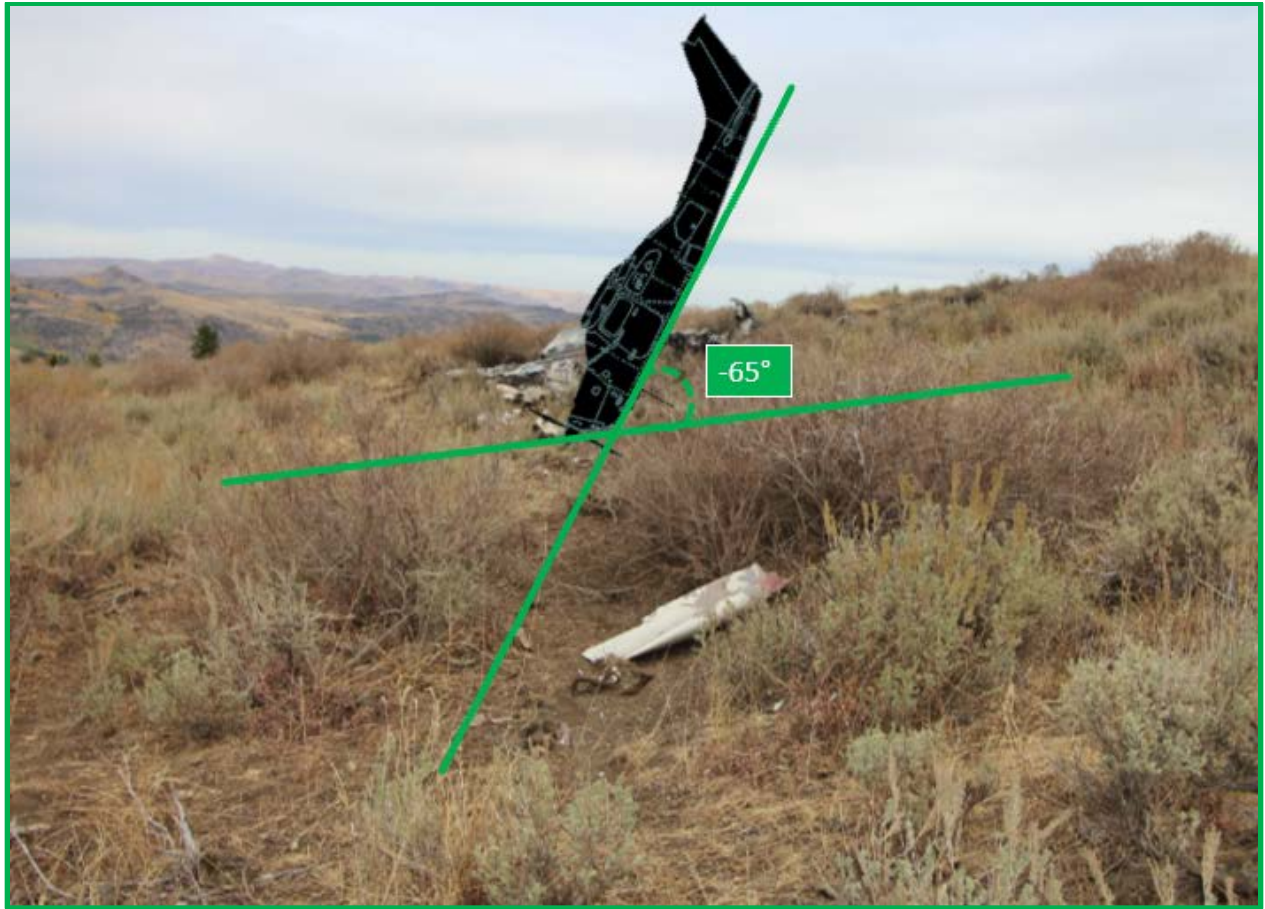
Figure 2: View of Approximant impact angle.

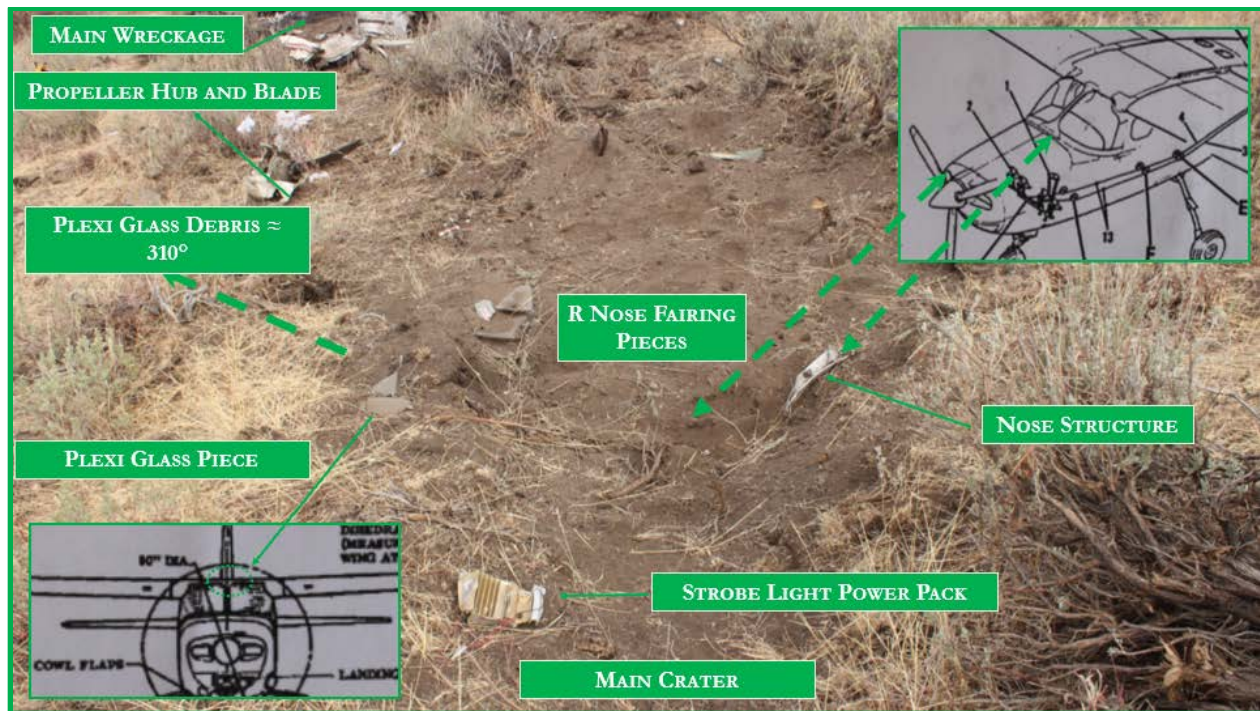
Figure 3: View of Large Impact Crater.

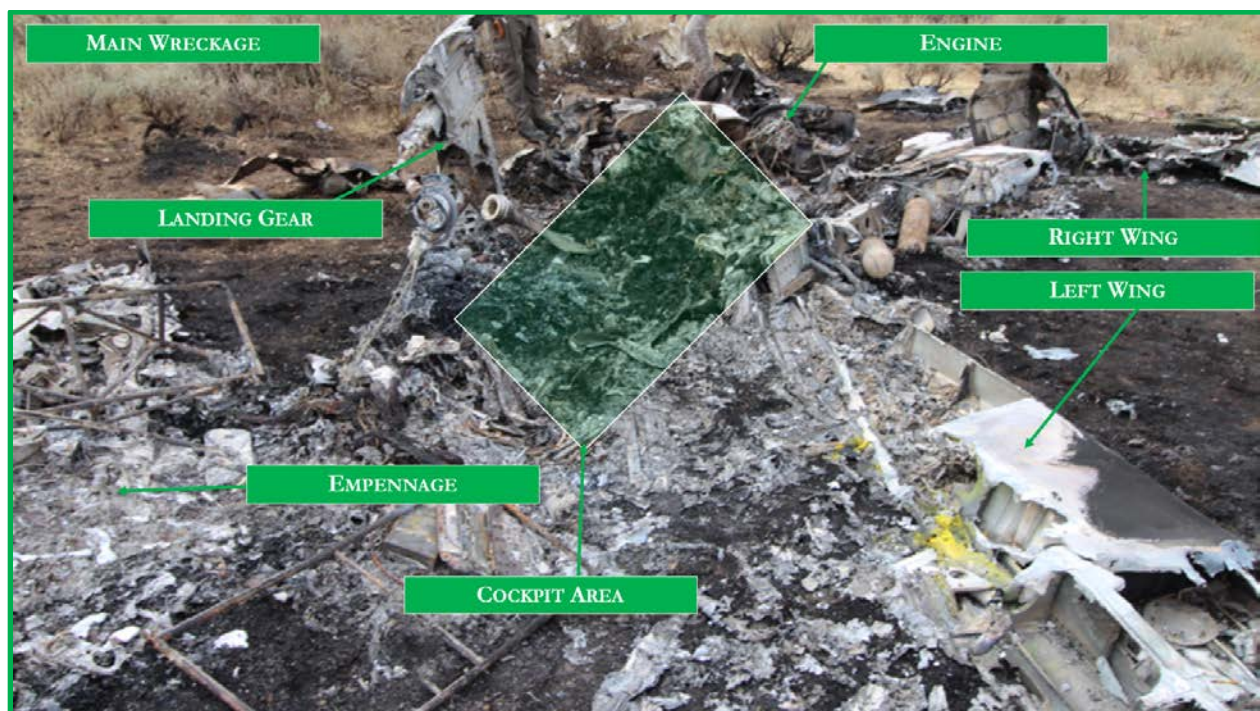
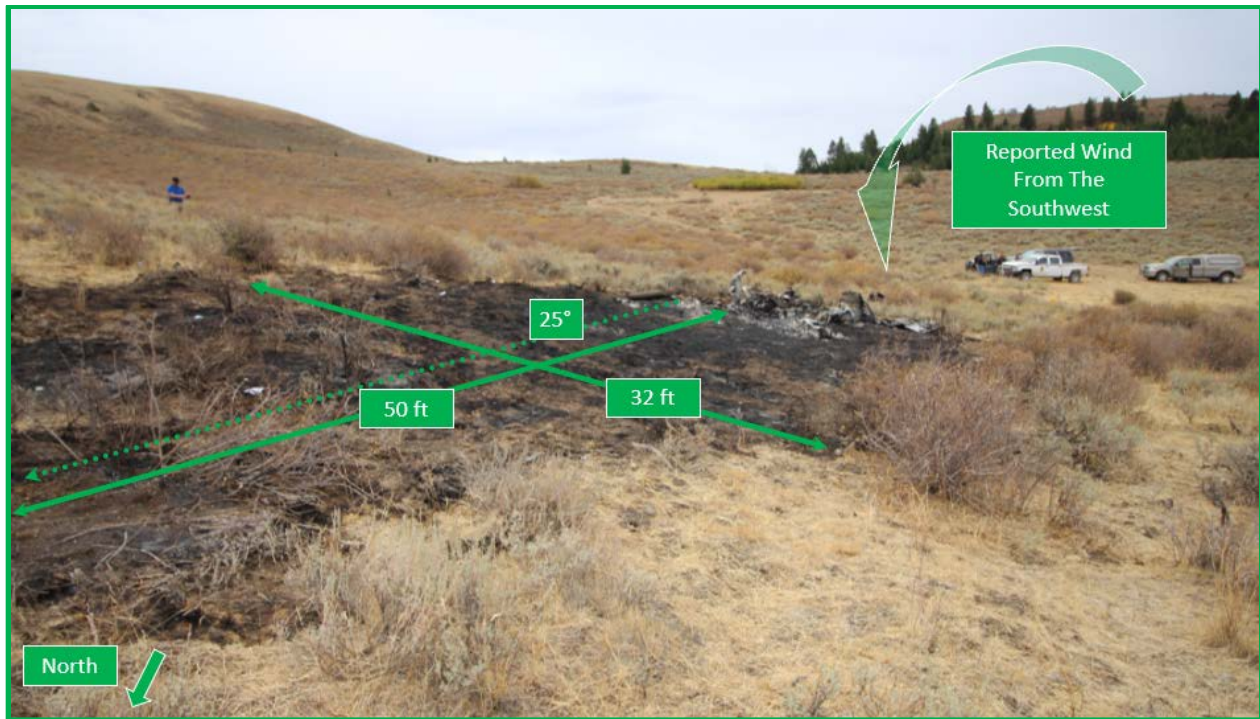
The main wreckage was located between the first point of impact and the last piece of debris. The main wreckage consisted of the fuselage, engine, both wings, and empennage. The fuselage, both wings, and empennage were mostly thermally destroyed during the post impact fire.

Figure 09: View of Main Wreckage.

Figure 10: View of Main Wreckage.

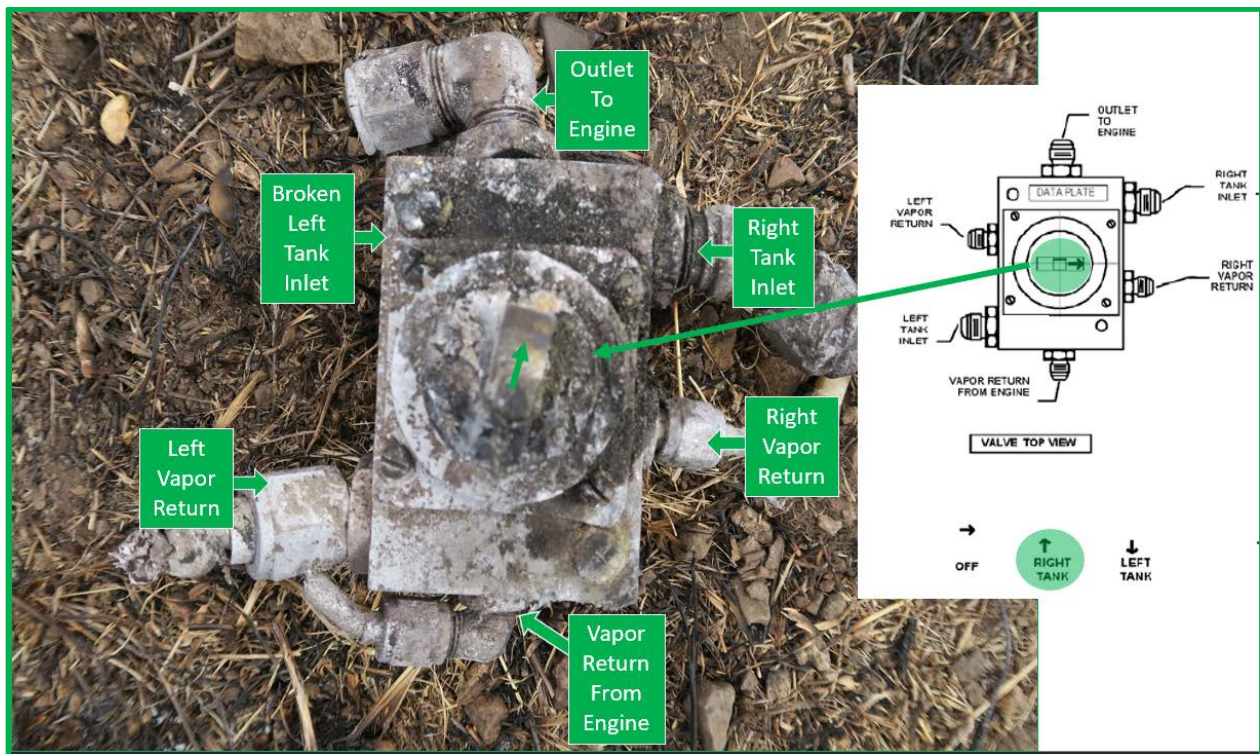
The fuel selector was found in the right tank position.

Figure 4: View of Fuel Selector

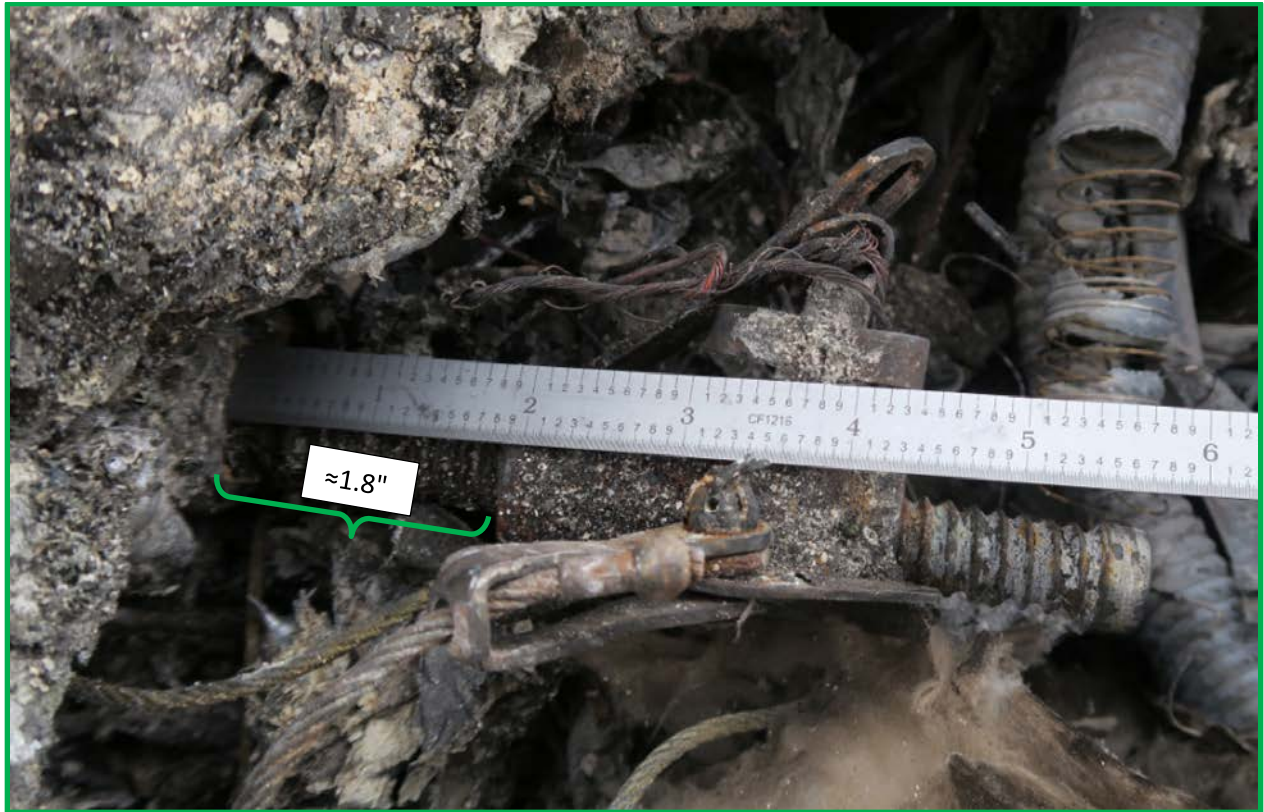
The landing gear was in the up position. The flap jack actuator was measured approximately 1.8 inches (10° of Flap).

Figure 5: View of flap jack screw.

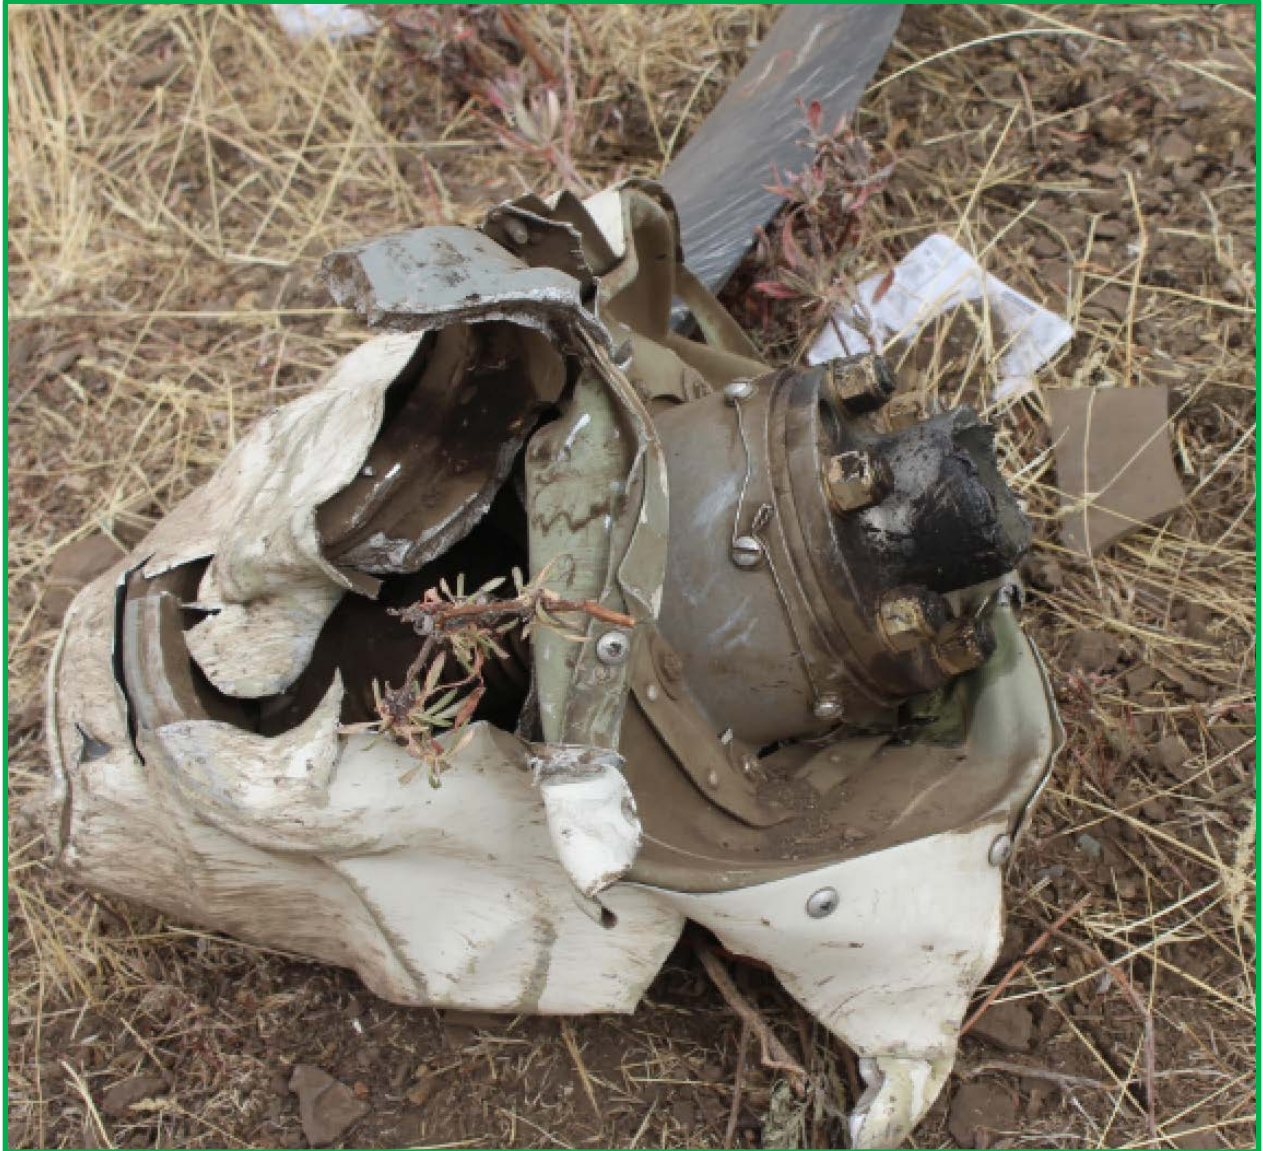
The propeller was separated from the crankshaft propeller flange. Blades B and C separated from the propeller hub and were located within the debris field (Blades were labeled A, B, and C for photographic purposes).

Figure 7: View of Propeller Hub

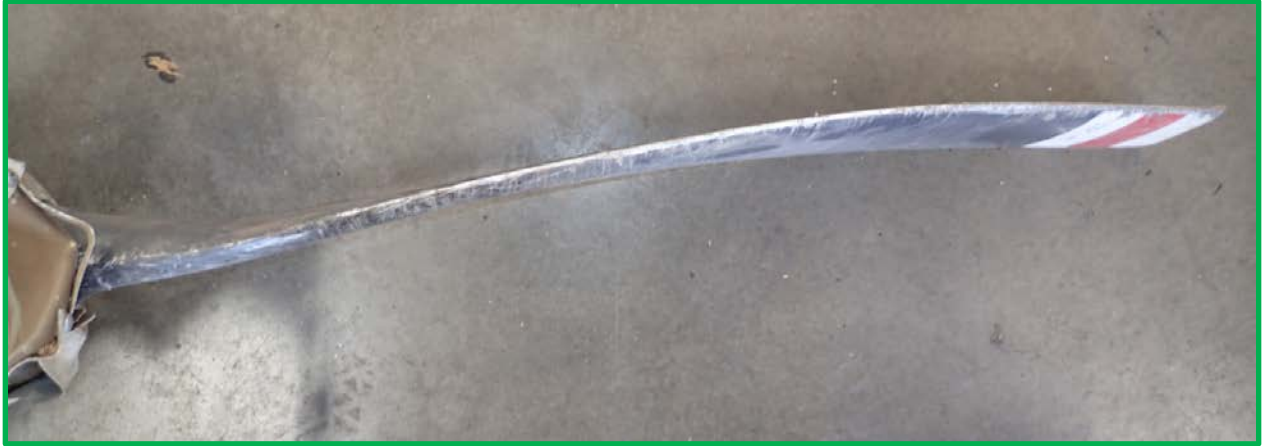
Blade A

Figure 8: View of Blade A.

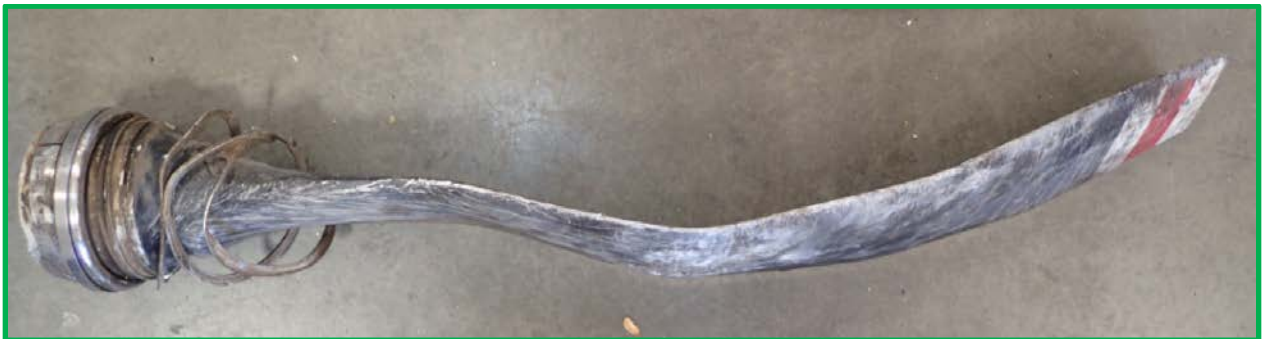
Blade B

Figure 9: View of Blade B.

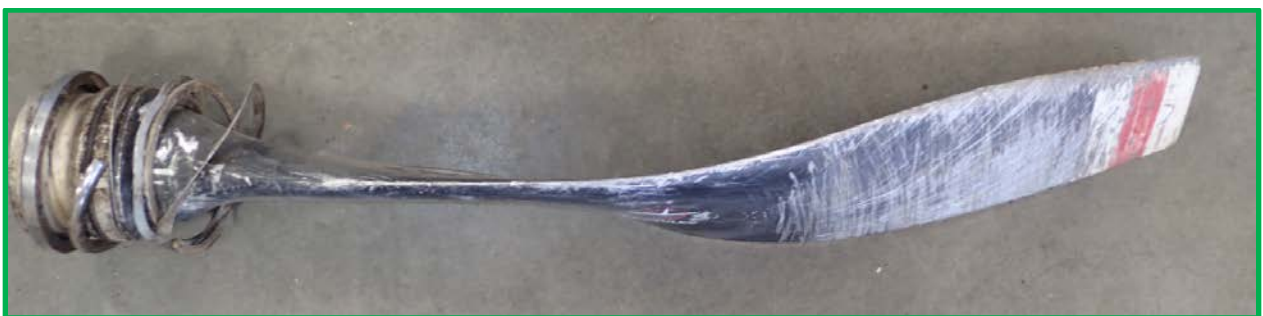
Blade C

Figure 10: View of Blade C.
