# **National Transportation Safety Board**

## **Performance Study**

### **Specialist Report**

| Airplane: | Cessna T210M, N732MV |

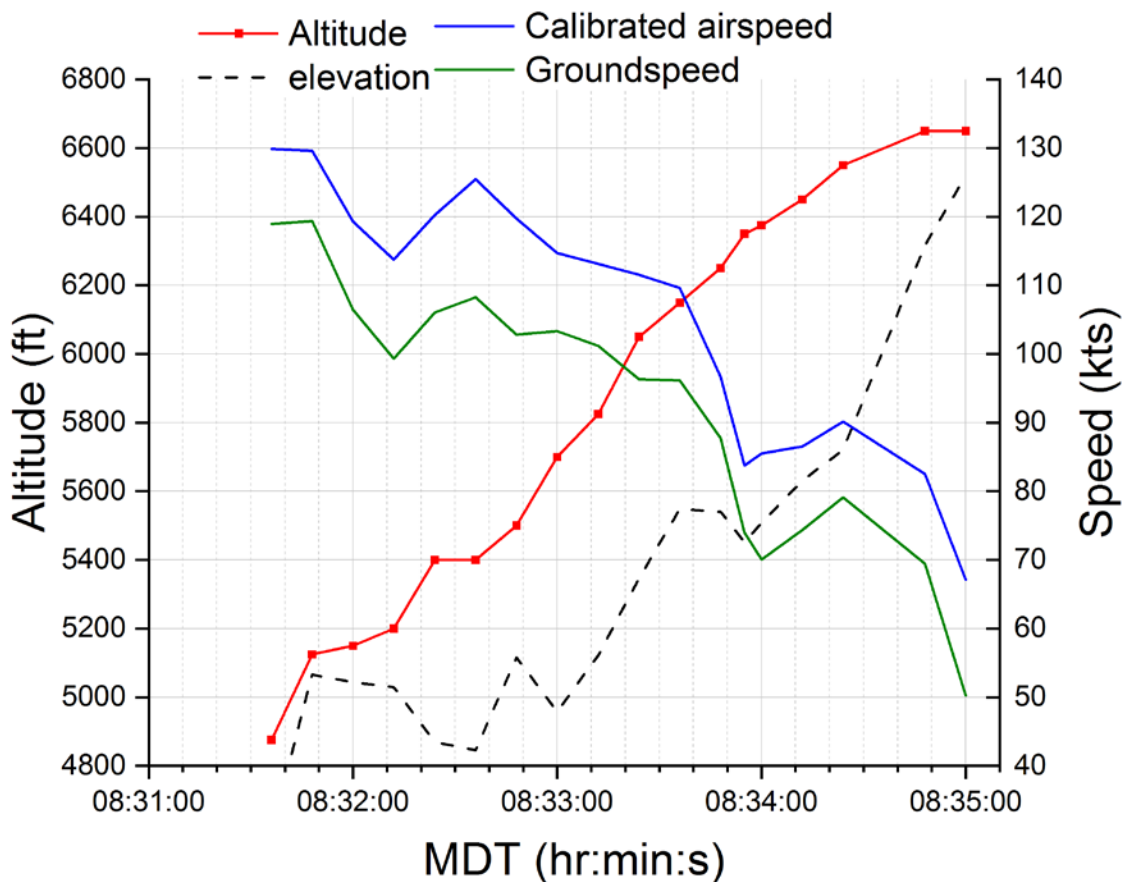
Radar was provided from 08:31:36 to 08:35 which recorded latitude, longitude, and altitude about every 12 seconds. This data corresponded with the airplane's final climb with increasing mountain elevation (Figure 1 and Figure 2). As the airplane climbed, its speed decreased from about 130 kts of calibrated airspeed to below 70 kts at the end of the data. Calibrated airspeeds are an estimate since the winds in the high-elevation, mountainous area at the time of the accident are not known. However, the slowing trend throughout the climb is apparent.

**Figure 1.** Recorded altitude (msl), terrain elevation, and calculated groundspeed and calibrated airspeed.

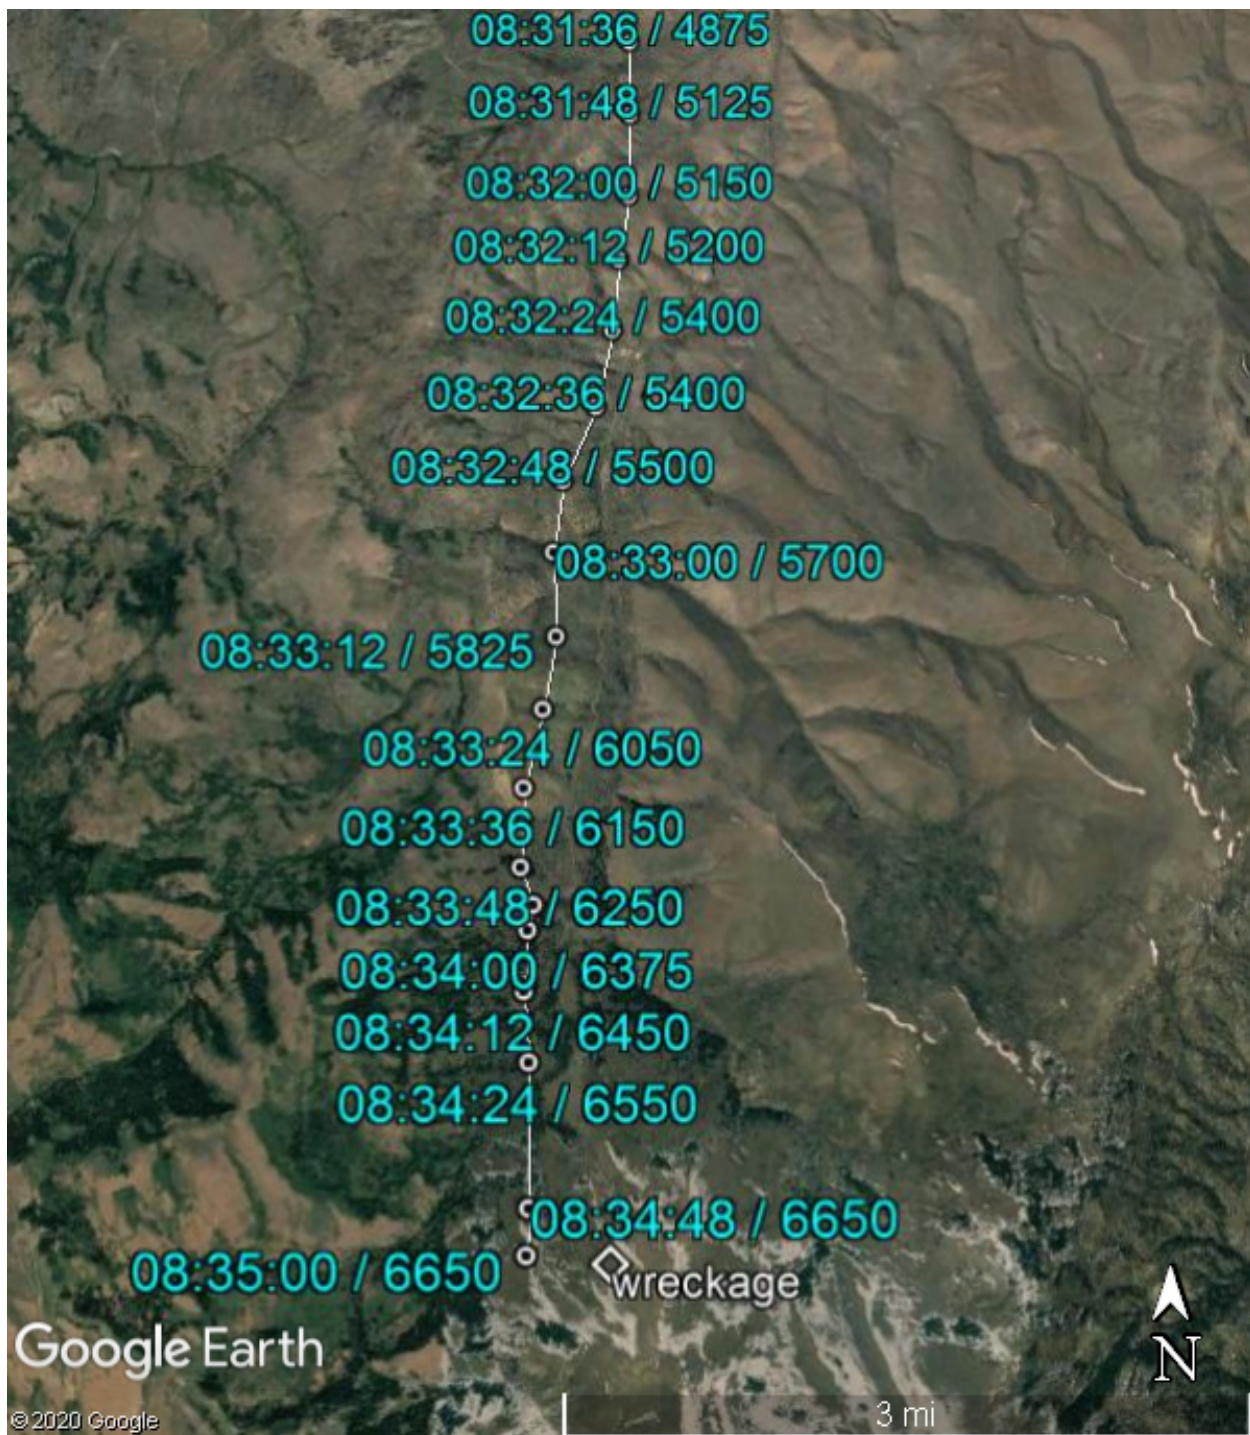
**Figure 2.** Accident flight in blue with select times and altitudes (msl) annotated in blue.

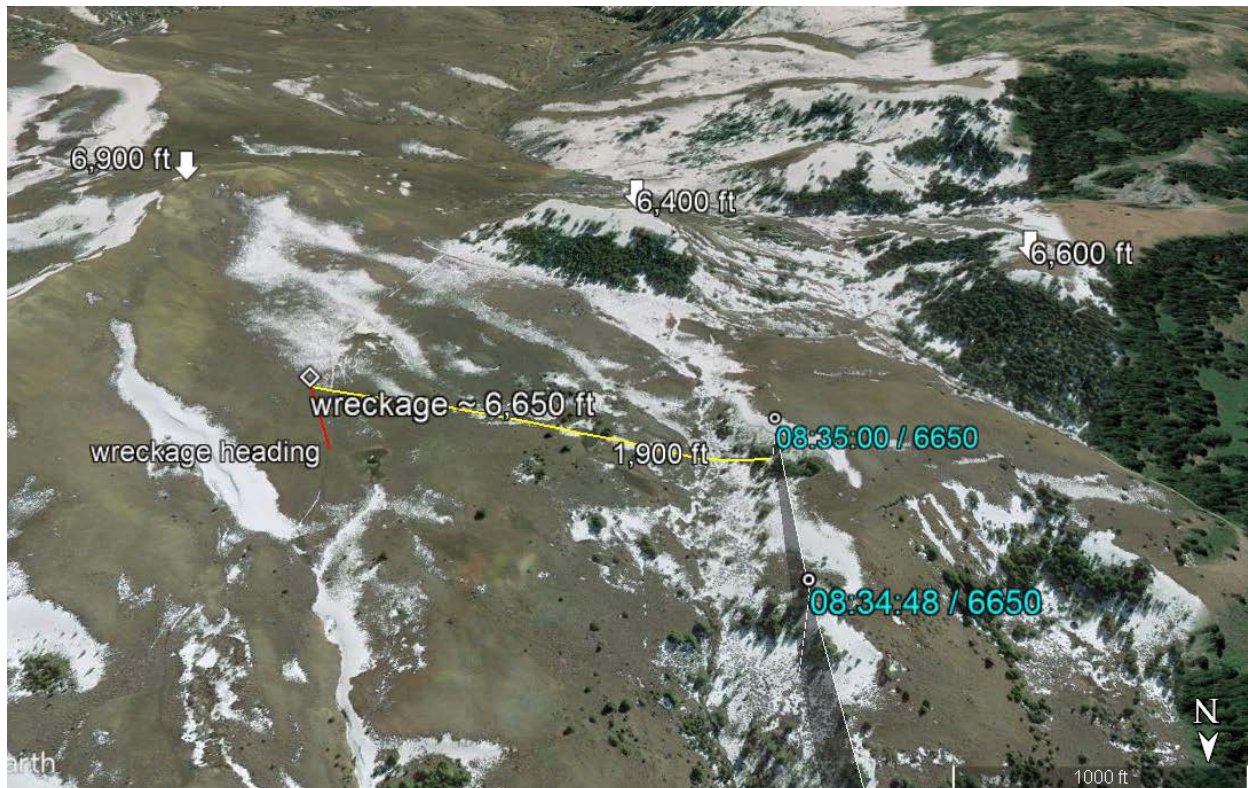
Figure 3 shows the terrain near the end of the accident flight. The wreckage location was about 1,900 ft from the final radar location at an elevation of about 6,650 ft, which was level with the final recorded altitude. The wreckage lay along a heading of 345°, a 200° left turn from the final flight heading.

**Figure 3.** Accident flight in blue with select times and altitudes annotated in blue, wreckage location, and local elevation features.

Assuming a 1,900 ft diameter turn from the final radar location to the wreckage site at a speed of 70 kts, the equation results in a necessary bank angle of nearly 90°, which would not be reasonable for coordinated flight.
