# NATIONAL TRANSPORTATION SAFETY BOARD

## MATERIALS LABORATORY FACTUAL REPORT

Report No. 20-021

Place : La Verne, CA  
Date : September 30, 2018  
Vehicle : Cessna 177RG, N46321  
NTSB No. : WPR18FA279  
Investigator : Fabian Salazar (AS-WPR)

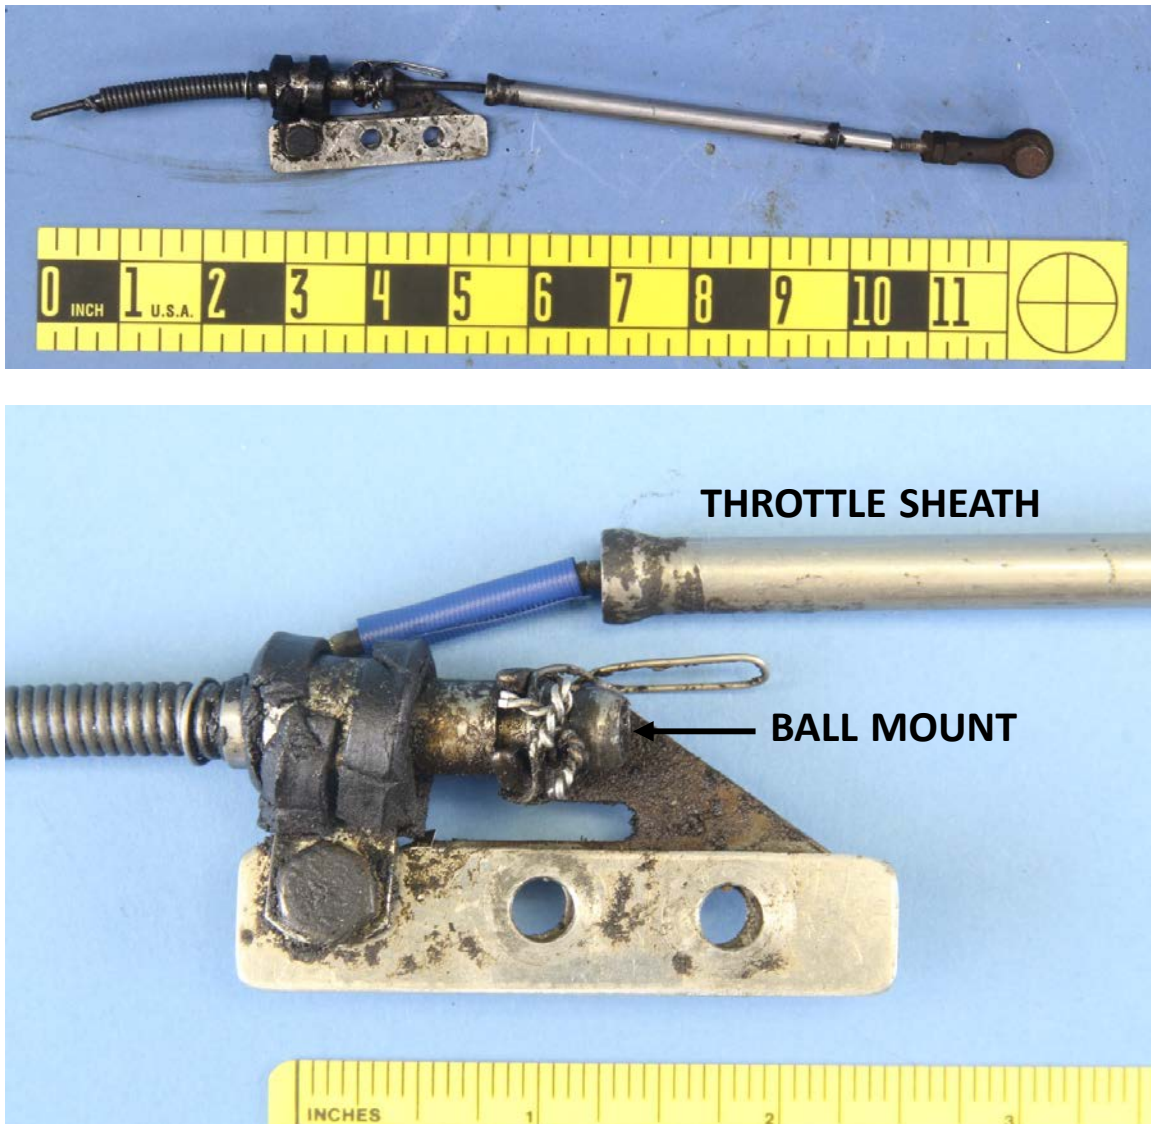
A portion of the throttle cable assembly from the accident aircraft was submitted for evaluation. The throttle sheath had detached from the mating ball mount, as shown in Figure 1.

Figure 1: Overall (top) and close-up (bottom) photos of the submitted throttle cable assembly. The bottom photo shows the throttle sheath detached from the ball mount.

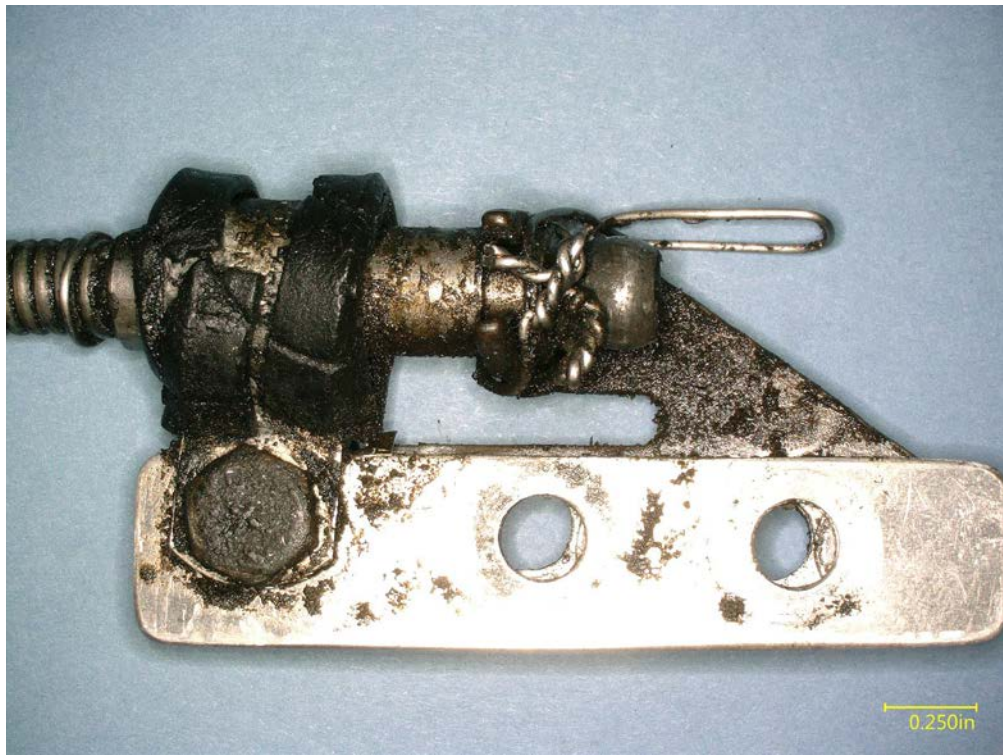
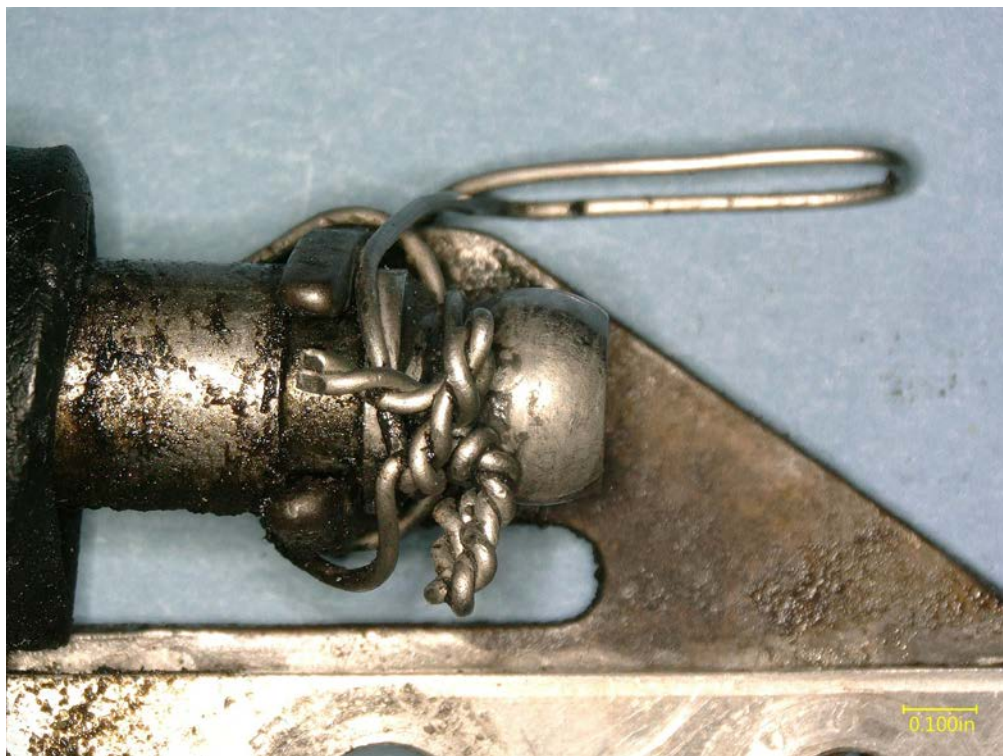
Close-up images of the ball mount before and after light cleaning are shown in Figure 2. The surfaces of the ball mount had light scoring consistent with movement against the mating throttle sheath. Safety wire was observed wrapped around the base of the ball mount. A portion of the safety wire was tucked against the side of the ball mount that mated to the throttle sheath. The yellow double-sided arrow in Figure 3 indicates the radial distance along the ball mount that had safety wire against it.

Figure 2: Digital microscope images of the detached ball mount before (top) and after (bottom) cleaning. Safety wire was observed wrapped around the base of the ball mount.

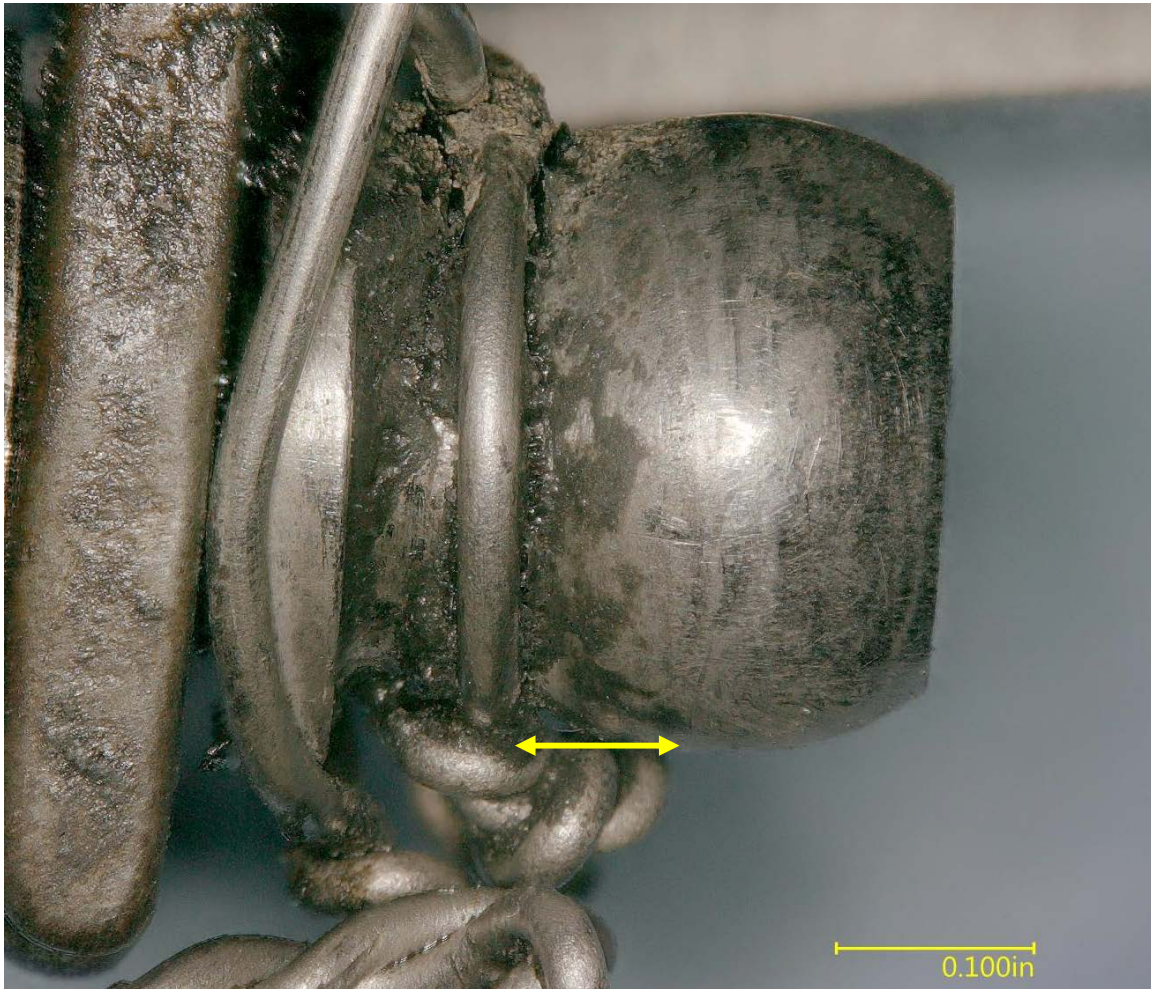
Figure 3: Digital microscope image showing close-up of the cleaned ball mount. The yellow double-sided arrow indicates the radial distance along the ball mount that had safety wire against it.

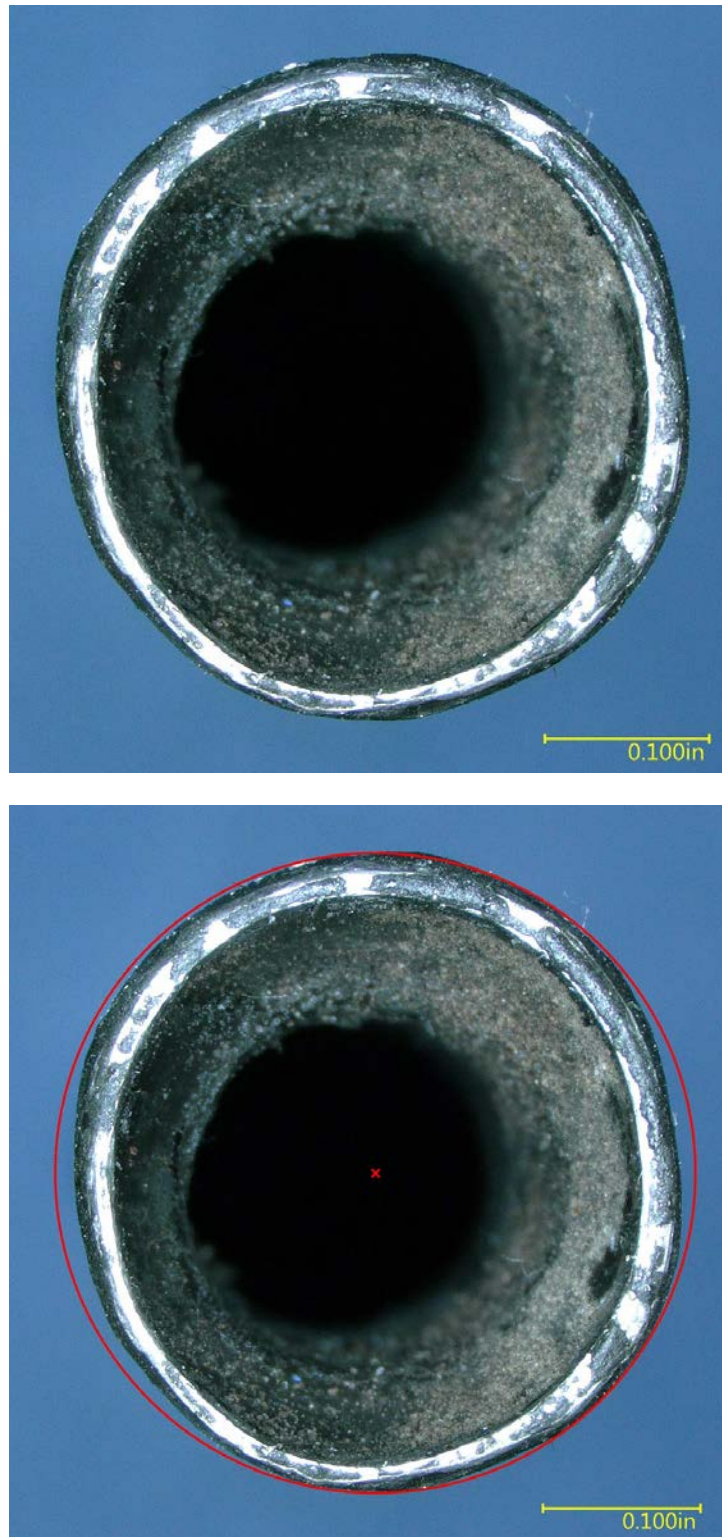
The end of the throttle sheath that mated to the ball mount is shown in Figure 4. The end was slightly out of round, as indicated by the red circle. No distinct damage consistent with pinching that would have resulted in the out of round condition was observed on the flared end.

Figure 4: Digital microscope images showing the flared end of the throttle sheath. The end was slightly out of round, as indicated by the red circle in the bottom image.
