**NATIONAL TRANSPORTATION SAFETY BOARD**

**AIRPLANE & ENGINE EXAMINATION**

**WPR18LA002**

**WPR18LA002**  
**Tonopah, Nevada**  
**October 2, 2017**  
**1230 PDT**  
**Cessna 172SP – N5311H**

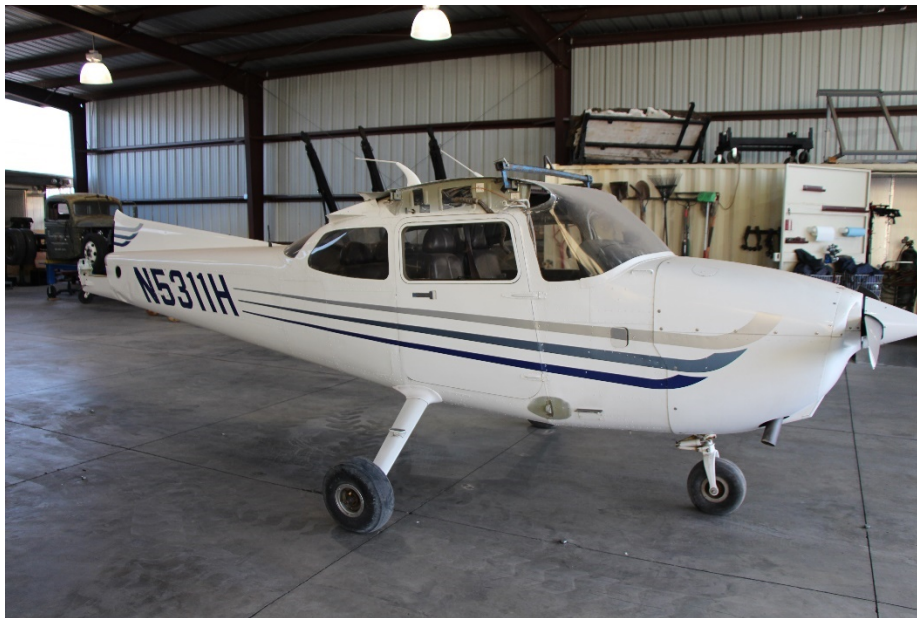
Photograph 1: Airplane Fuselage Prior to Examination

The airplane was photographed in its post-recovery condition with the wings and tail, which had been removed by the recovery team. Buckling was observed on the rudder skin and dents were found on the aft fuselage and wings. Once the airplane's external condition was documented, the engine cowling was removed.

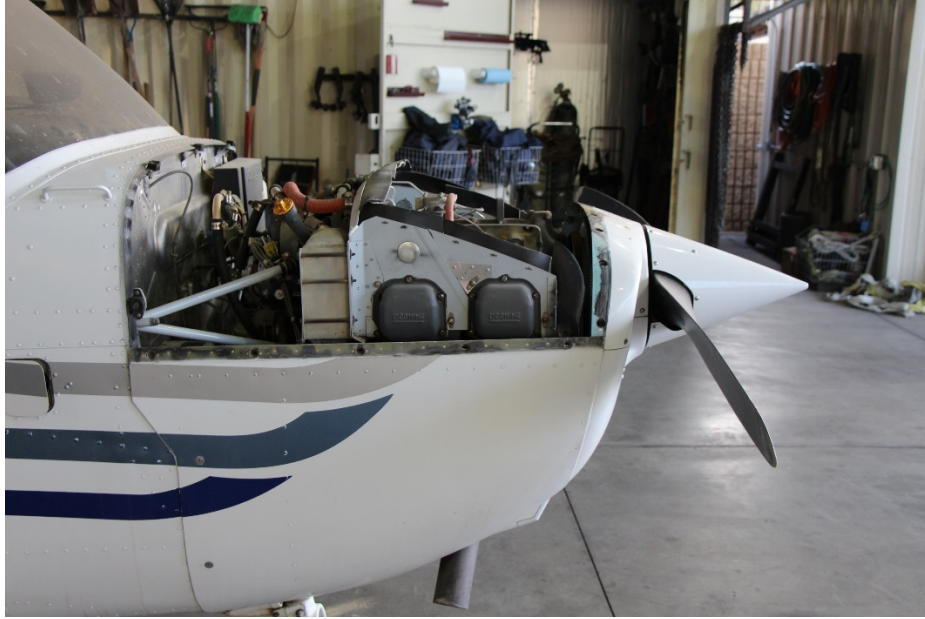
Photograph 2: Airplane Engine Prior to Examination

The engine mounts were unremarkable and the engine case was intact. Loose sand and debris from the accident site were found on the battery case and engine case.

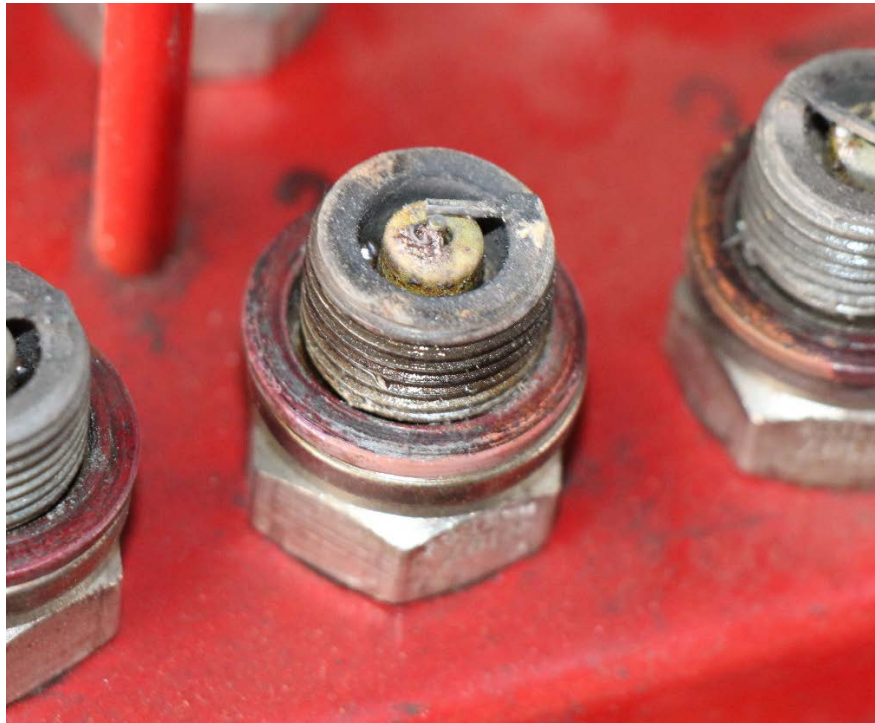
Photograph 3: Cylinder No. 2 Bottom Spark Plug

Most of the Champion 38S fine wire bottom spark plugs showed normal wear when compared to the Champion Aerospace Aviation Safety Manual. The bottom spark plug to cylinder no. 2 displayed evidence of lead bromide on the cone adjacent to the ground electrode and the bottom plug to cylinder no. 3 exhibited bridging between the cone and ground electrode. However, neither plug displayed any bridging or debris between the ground electrode and post.
