# **AIRFRAME AND ENGINE EXAMINATION**

**WPR18LA006**

Location: Buckeye, AZ  
Date: October 9, 2017  
Aircraft: Nanchang CJ-6 Registration Number: N8NW  
NTSB IIC: Albert Nixon

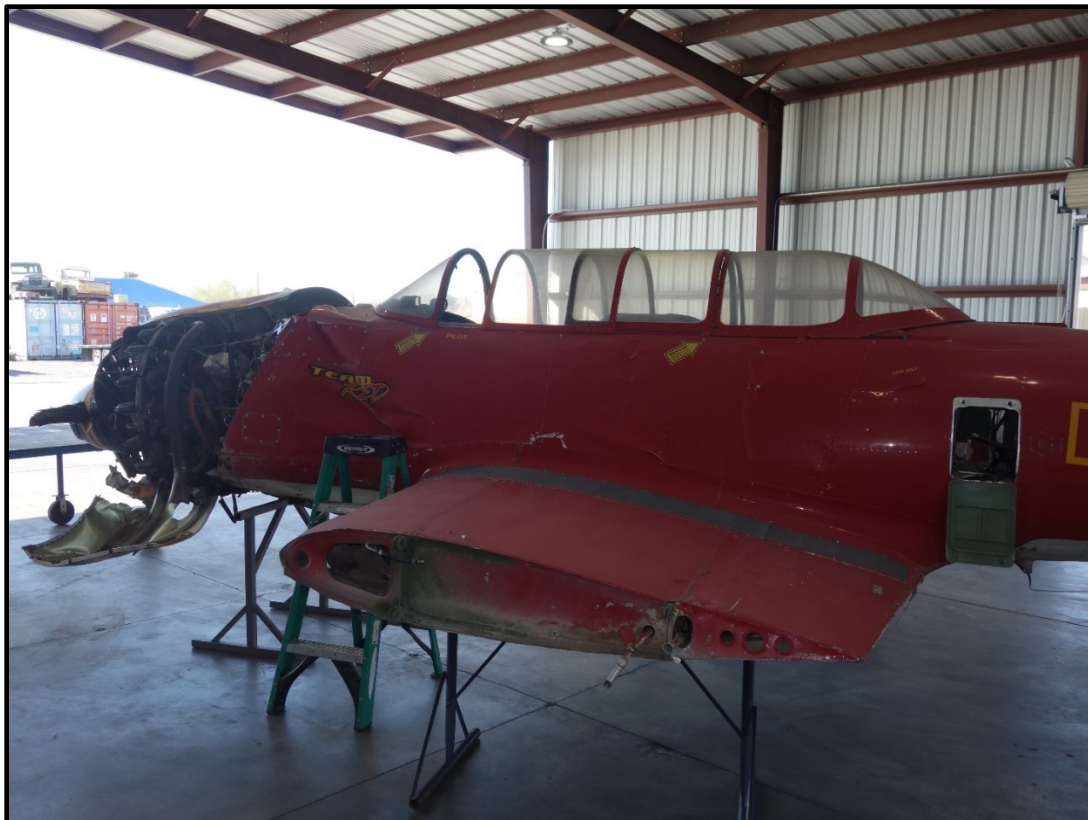
Examination of the airplane revealed that the outboard portion of the wings were removed for recovery. The fuselage sustained several dents and buckling throughout. The bottom portion of the empennage was crushed.

Figure 1: Airplane set up for Examination as viewed from the left side.

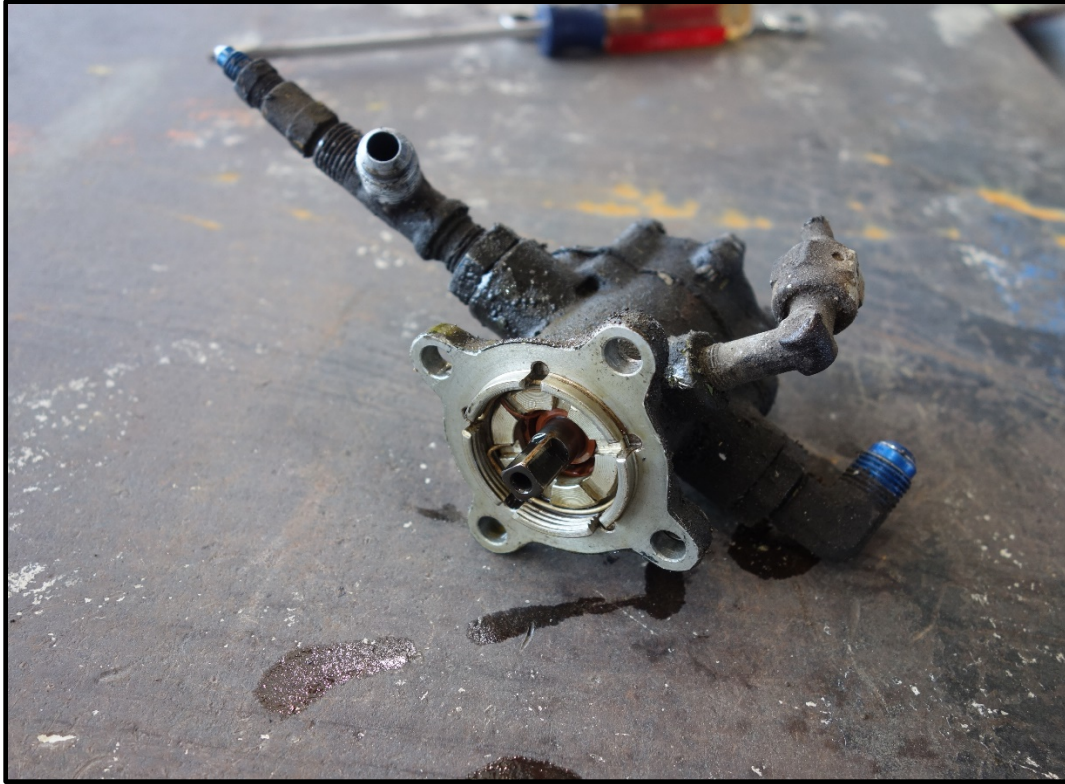
**Figure 2: Fuel Pump removed for examination.**

The engine driven rotary gear type fuel pump was removed and examined. Examination of the pump's vanes and drive shaft revealed no anomalies. The pump's drive shaft rotated freely by hand; however, fuel was noted on the accessory side of the pump. Further examination revealed that the pump's diaphragm which is located on the drive shaft was ruptured. Remnants of the diaphragm were observed on the accessory side of the pump and the diaphragm was located inward from its original position on the drive shaft. The fuel header tank in the belly of the aircraft was empty. The fuel line from the gascolator to the engine was intact. The fuel lines were removed, and none had any obstruction to prevent flow.
