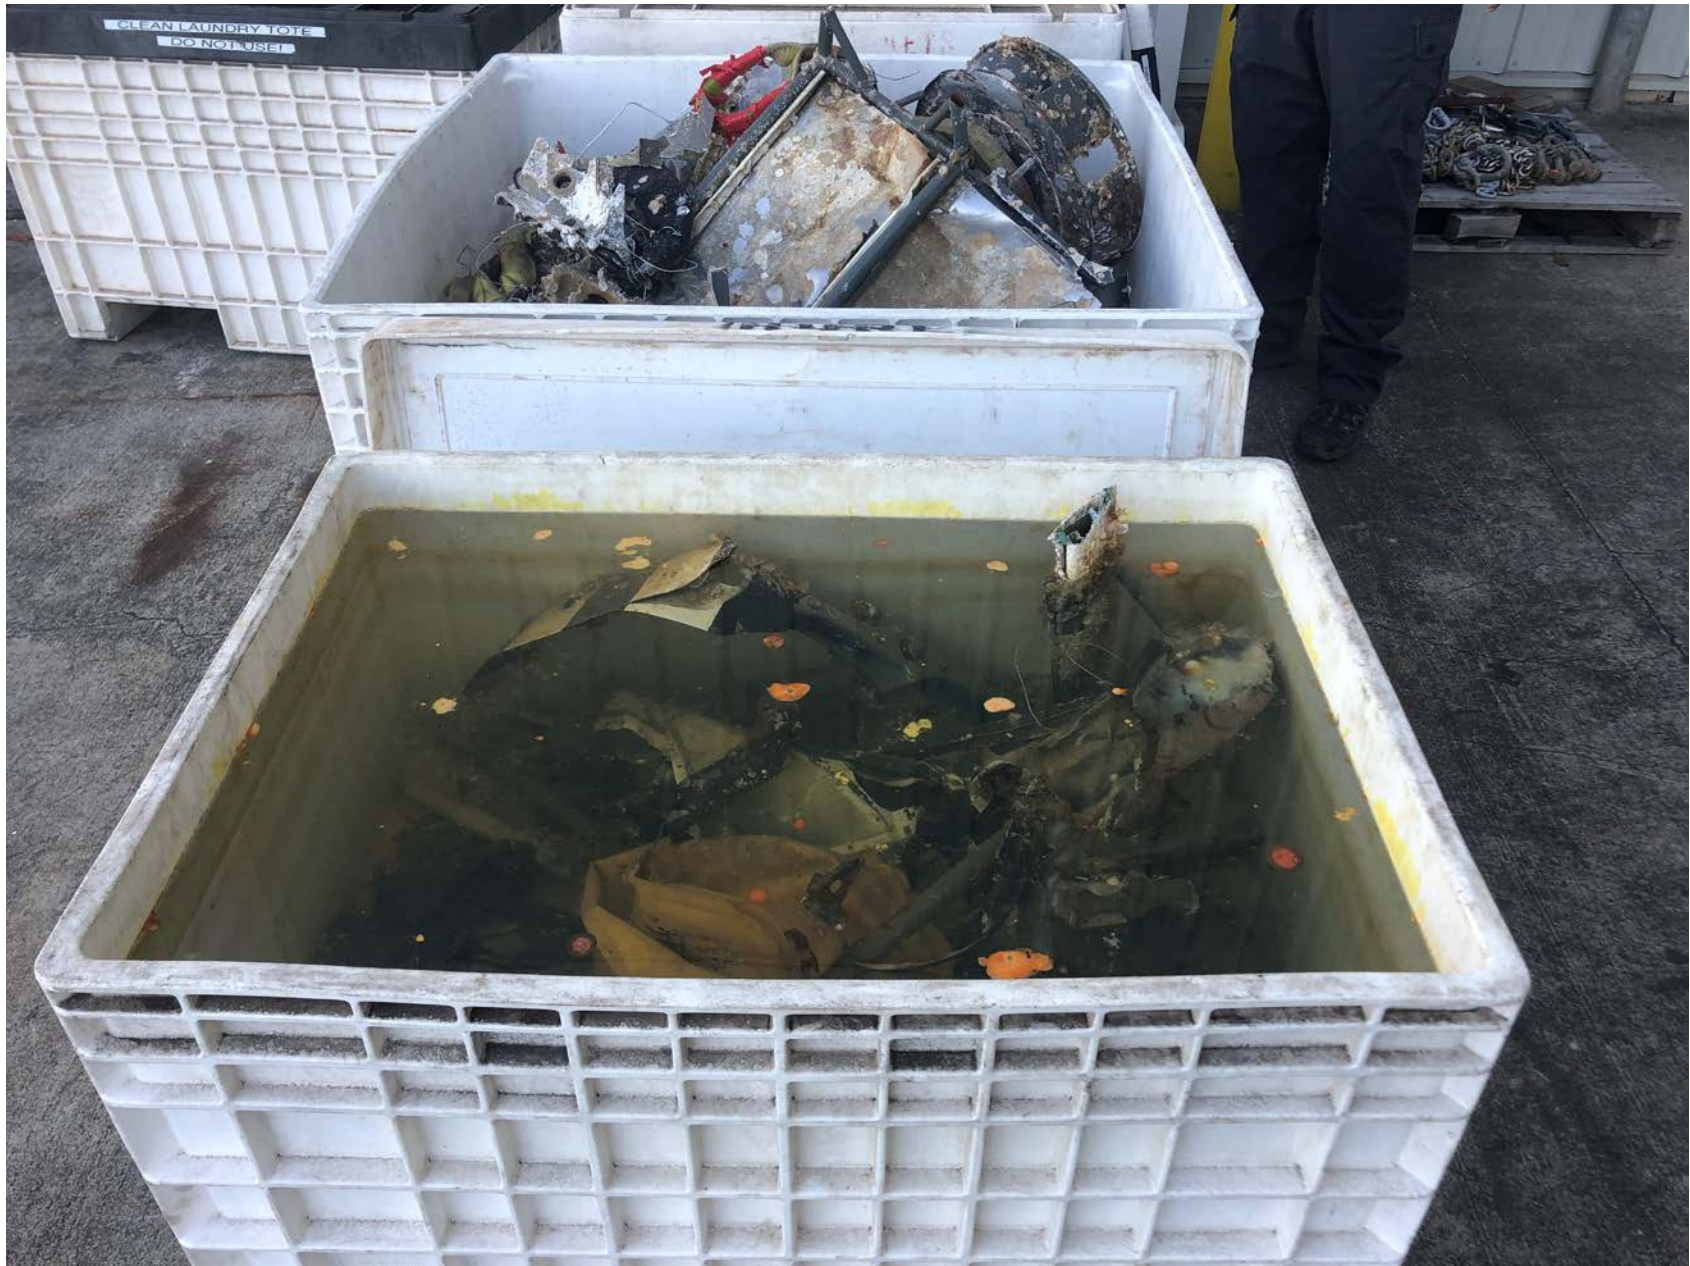
**Photo 1 – Recovered Wreckage Debris**

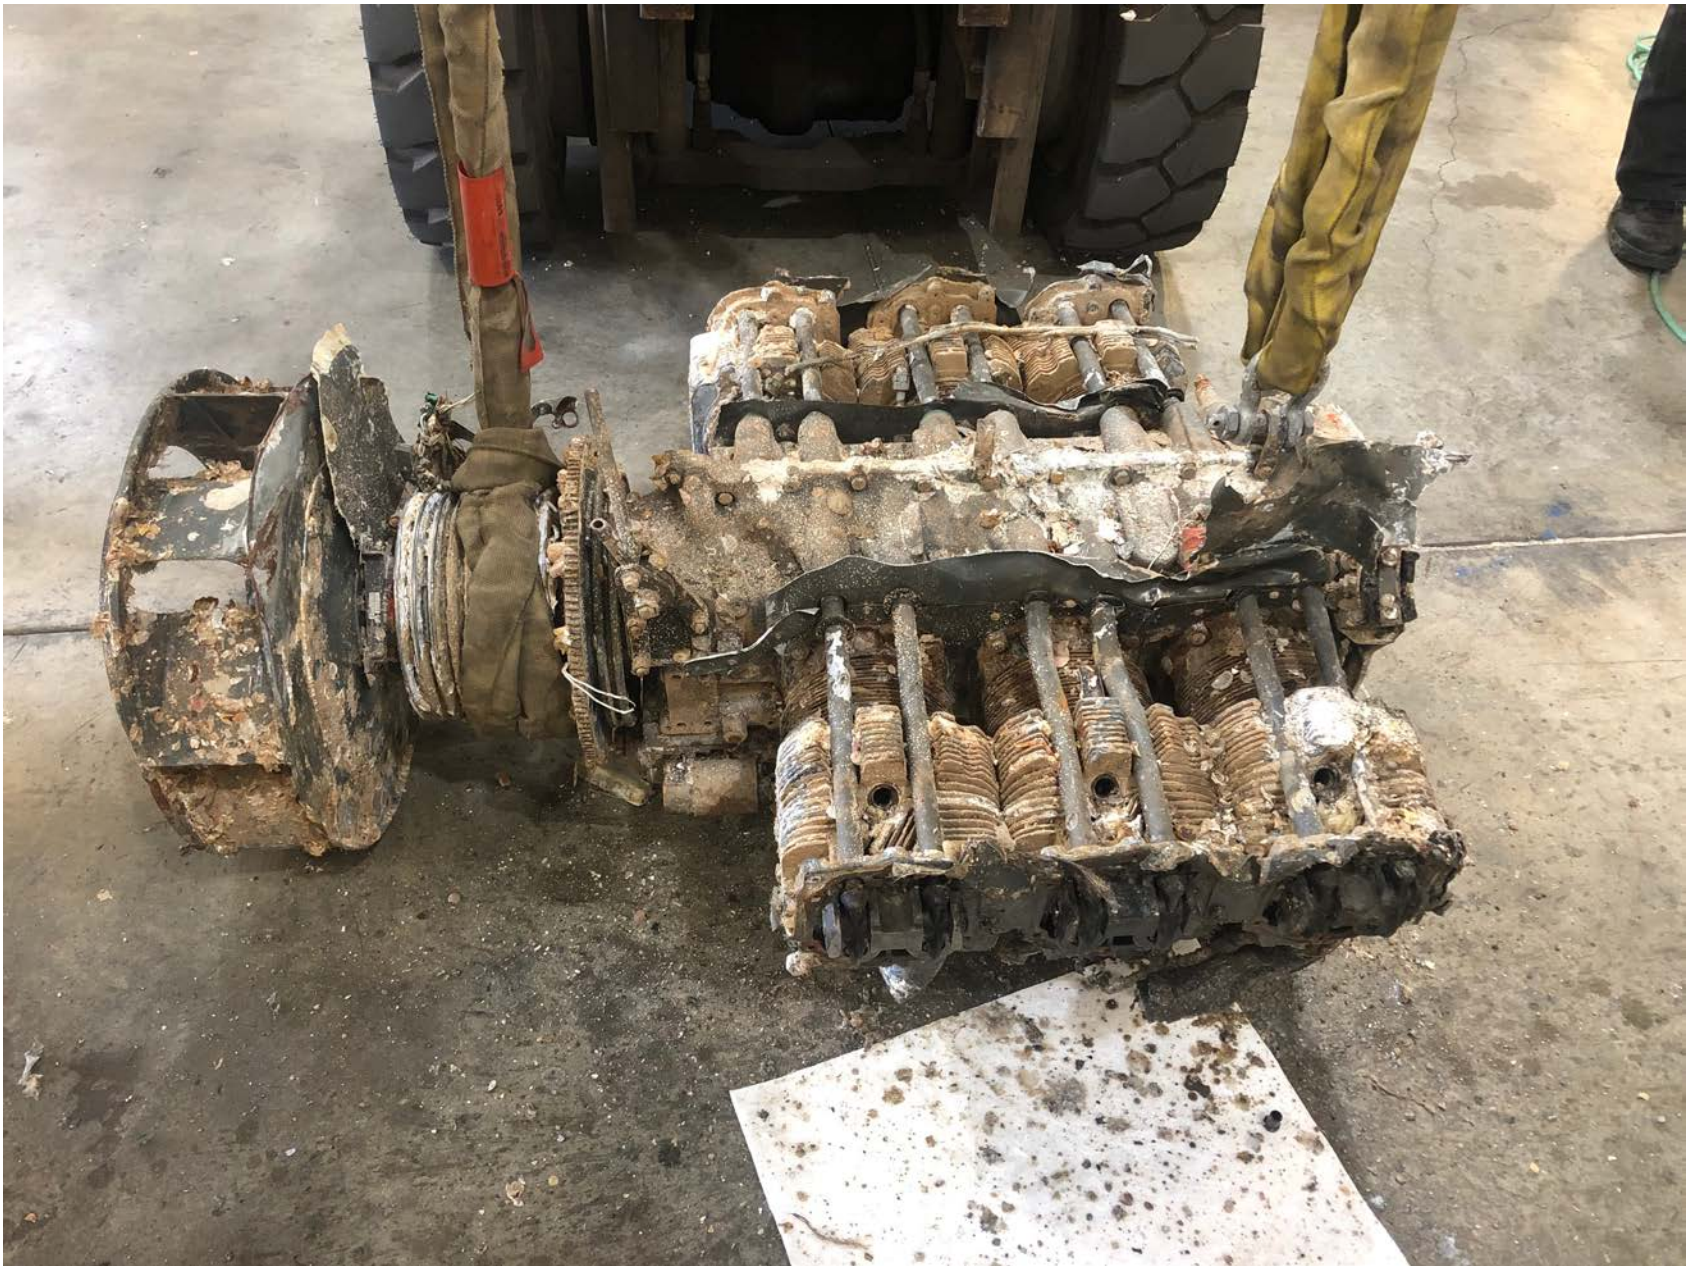
**Photo 2 - Recovered engine**
