## On Scene Photos

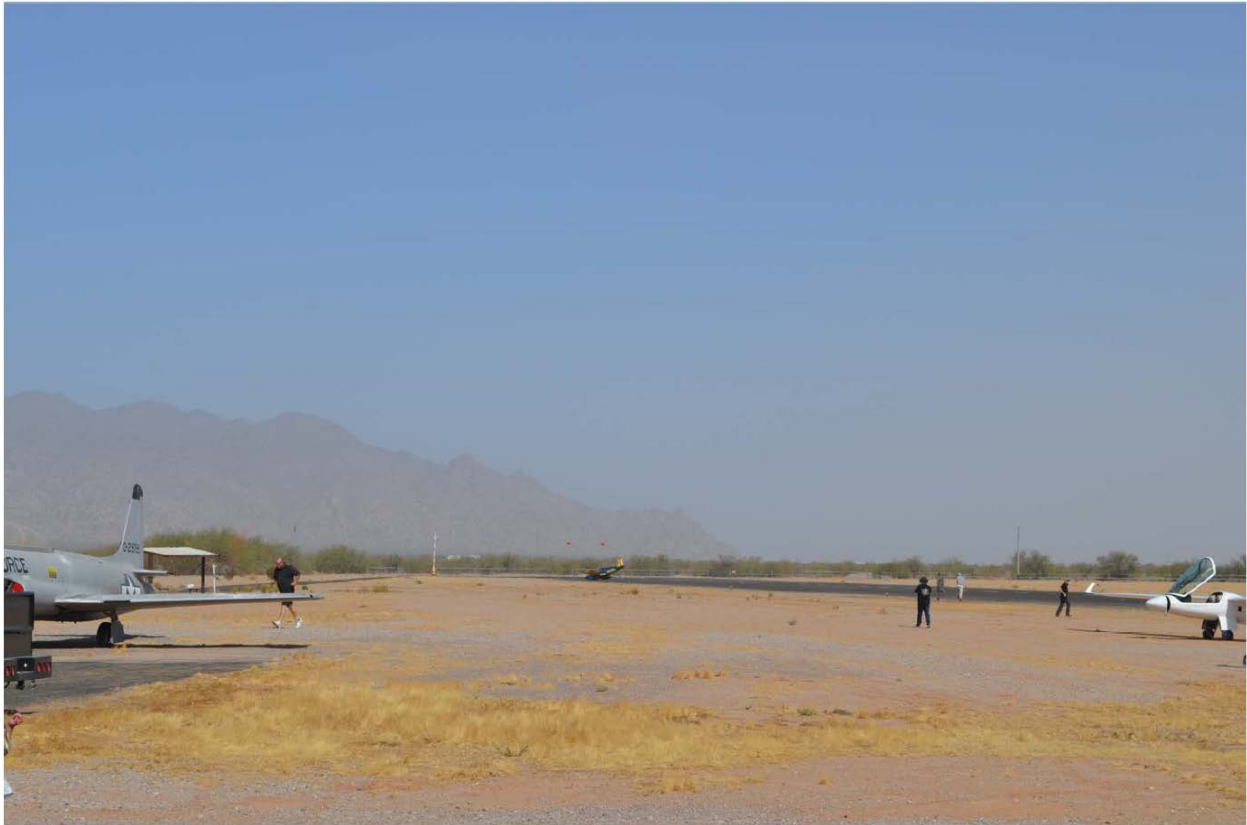
*Figure 1: Overview of Accident Site*

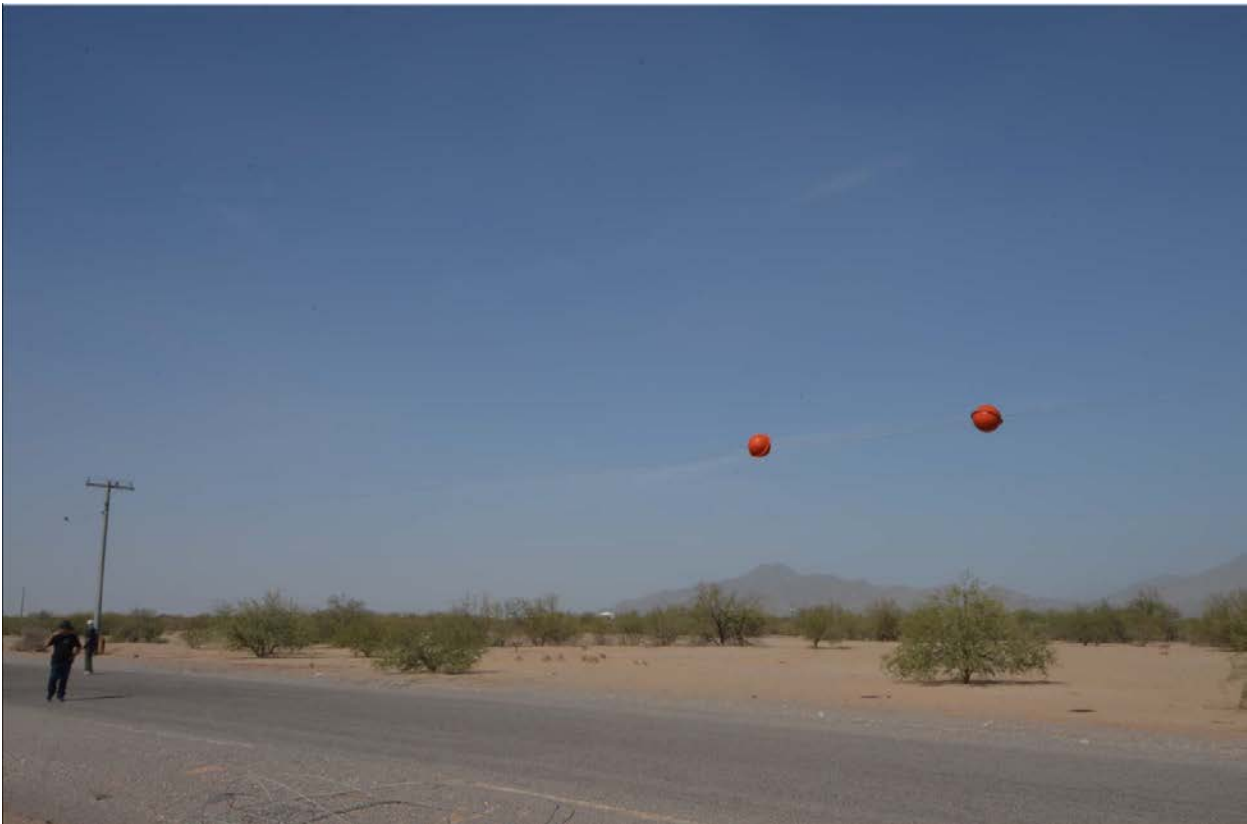
*Figure 2: Remaining Powerlines*

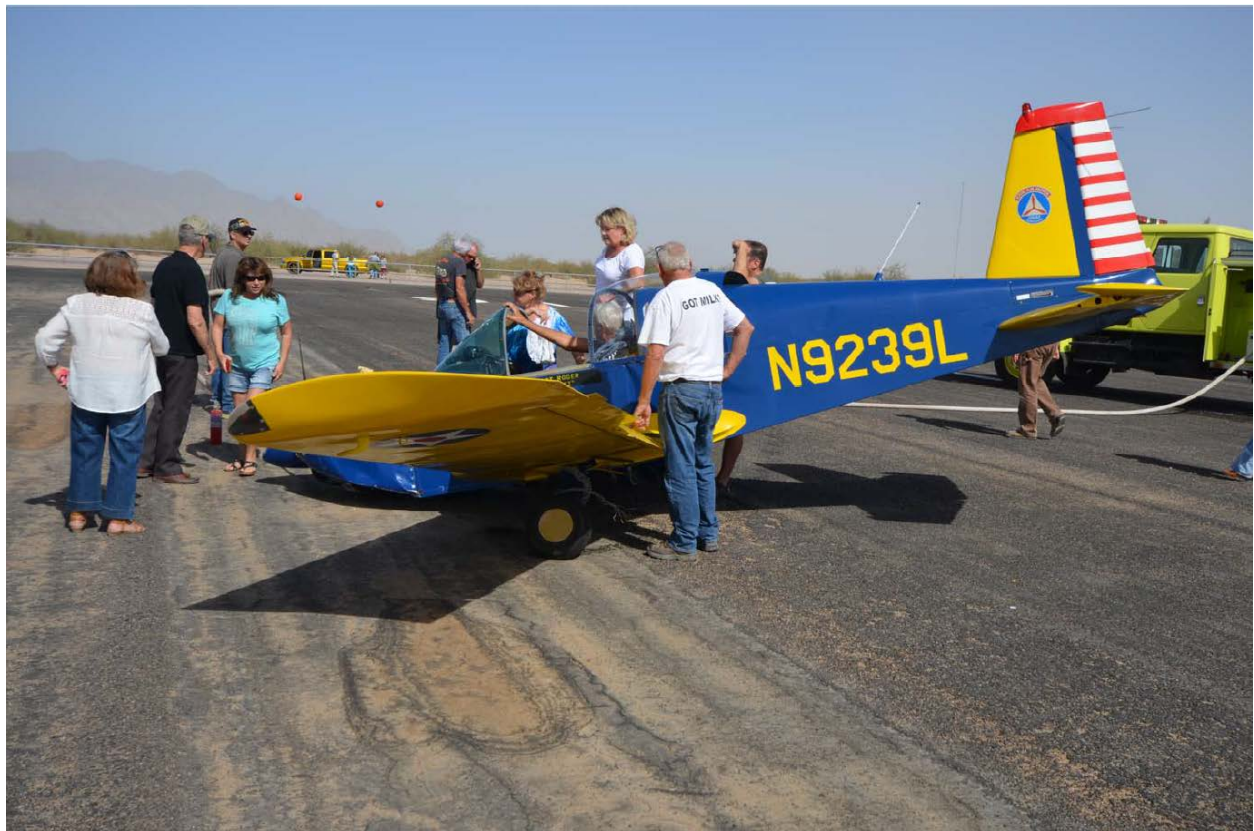
*Figure 3: Overall View of Damage*

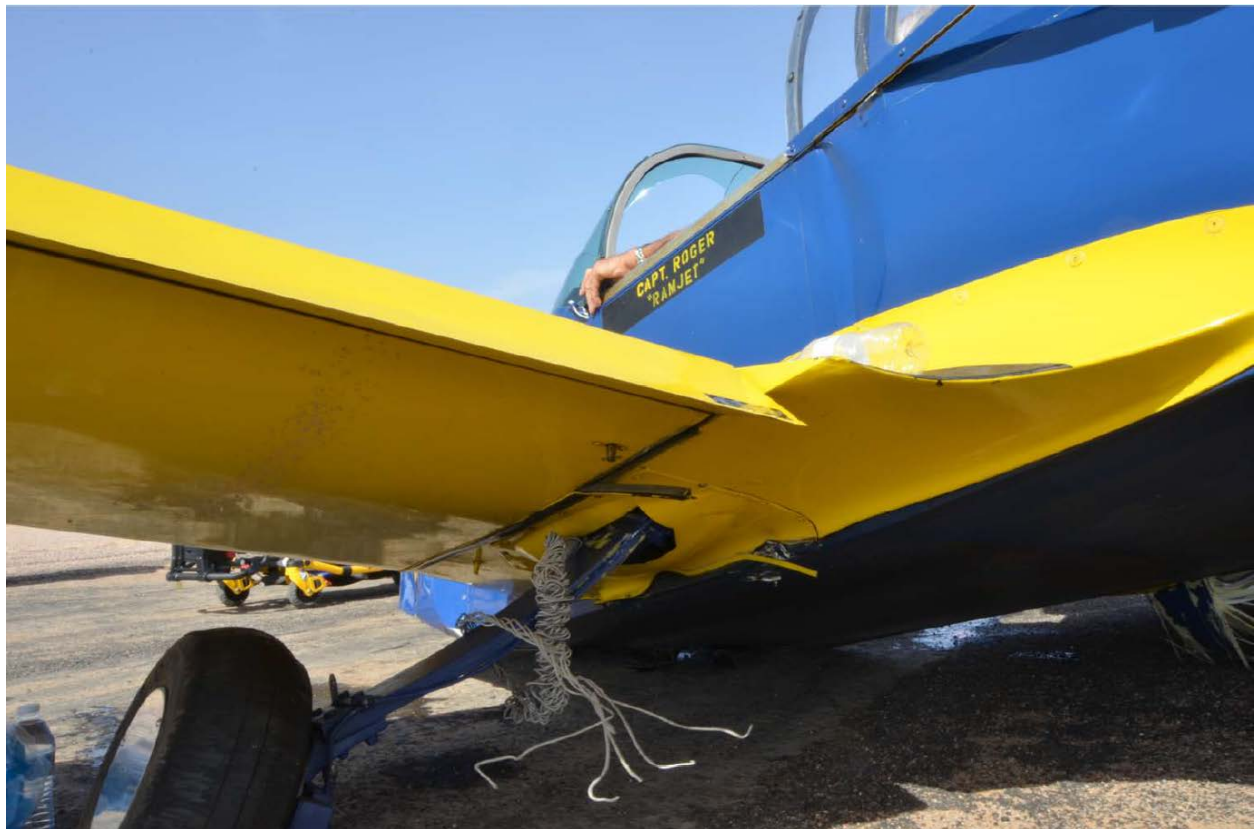
*Figure 4: Electrical Wire was found Wrapped around the Main Landing Gear*

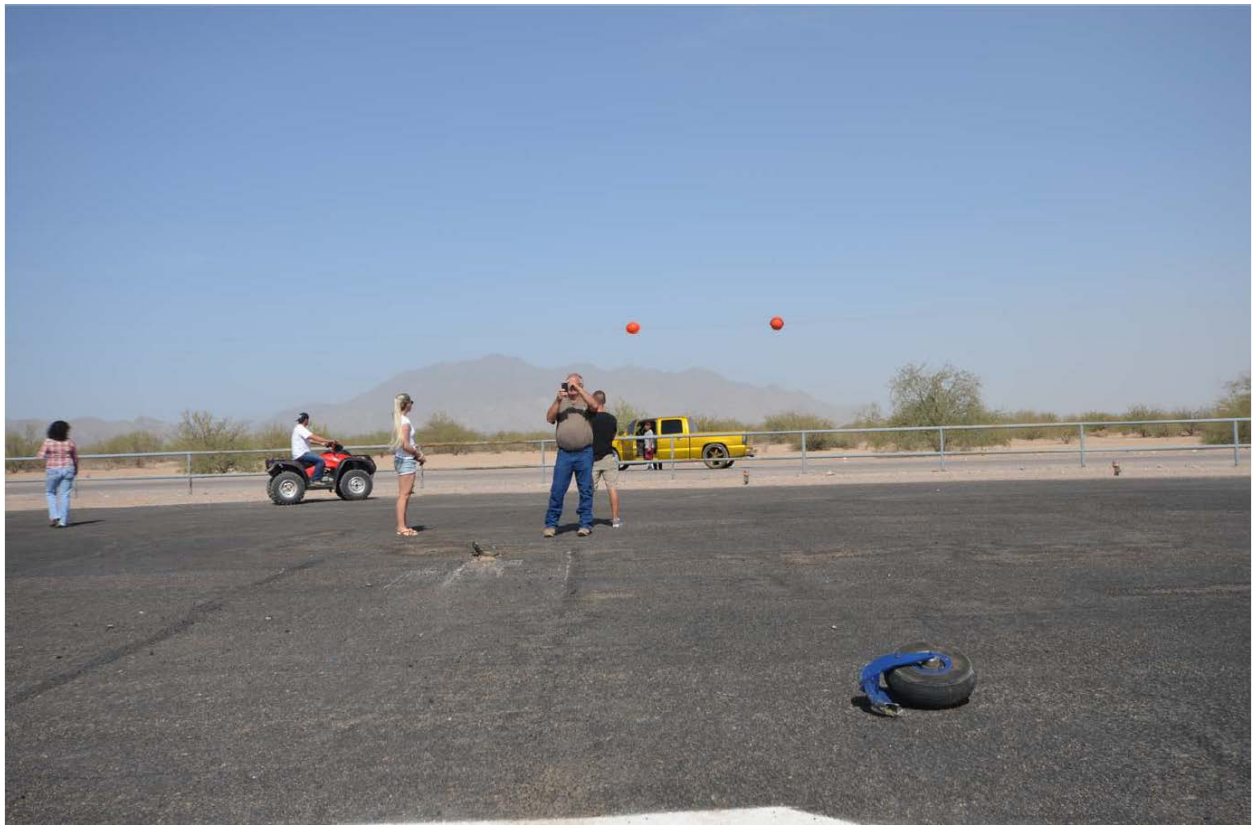
*Figure 5: Powerlines in relation to Approach end of Runway*
