## **NATIONAL TRANSPORTATION SAFETY BOARD**

### **ENGINE EXAMINATION REPORT**

**WPR18LA018**

Location: Blythe, California  
Date: October 3, 2017  
Aircraft: Cirrus SR22, N418CP, Serial #: 3262  
NTSB IIC: Albert Nixon

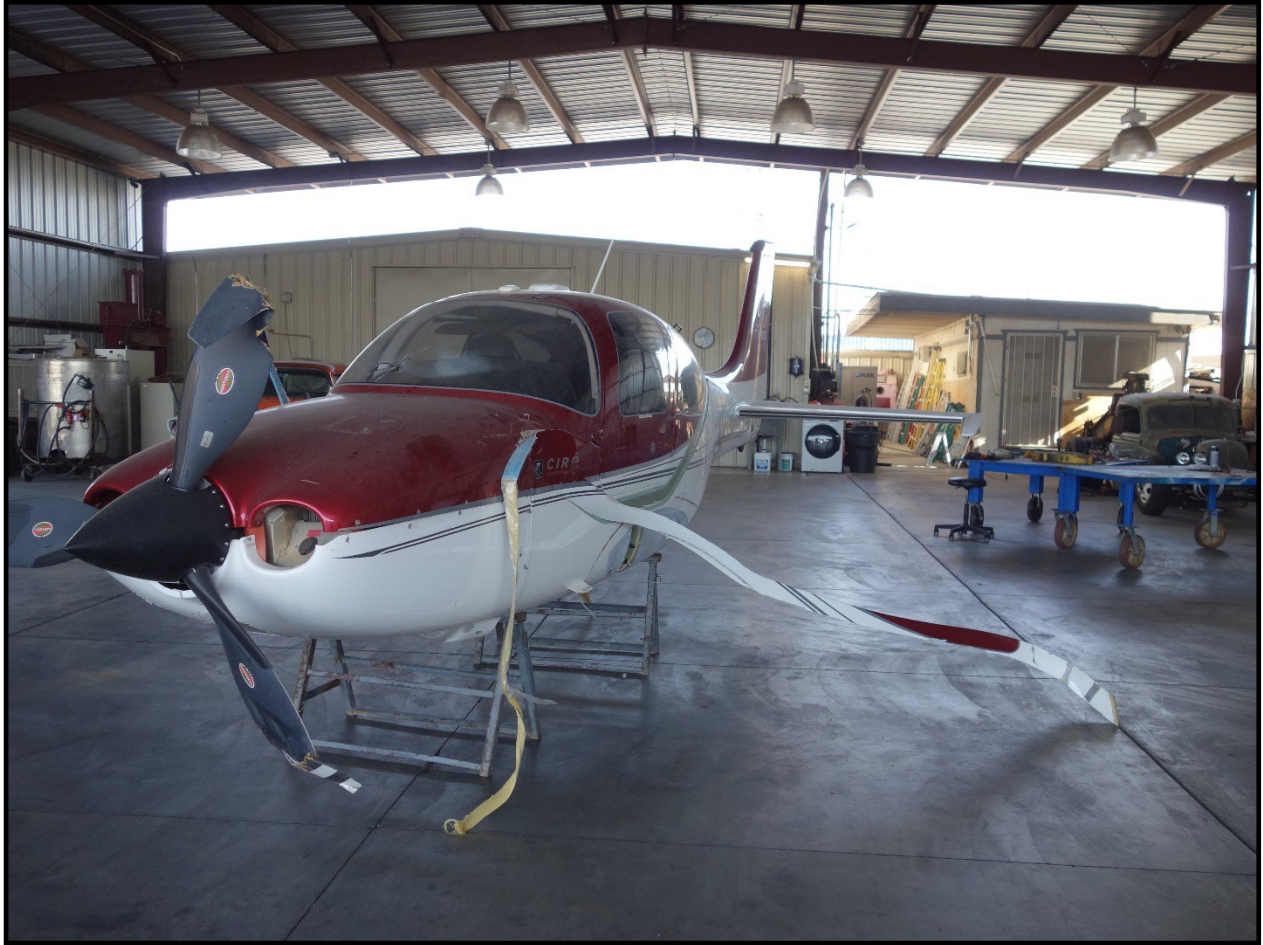
Examination of the Continental IO-550N engine, serial number 691904, revealed that it remained attached to the airframe by the engine mounts and no external damage was observed to the cylinders. The engine accessories remained attached to the engine via their respective mounts. A small hole was observed at the topside of the engine crankcase that was consistent with an internal engine failure.

**Figure 1: Airplane set up for examination (left front side).**

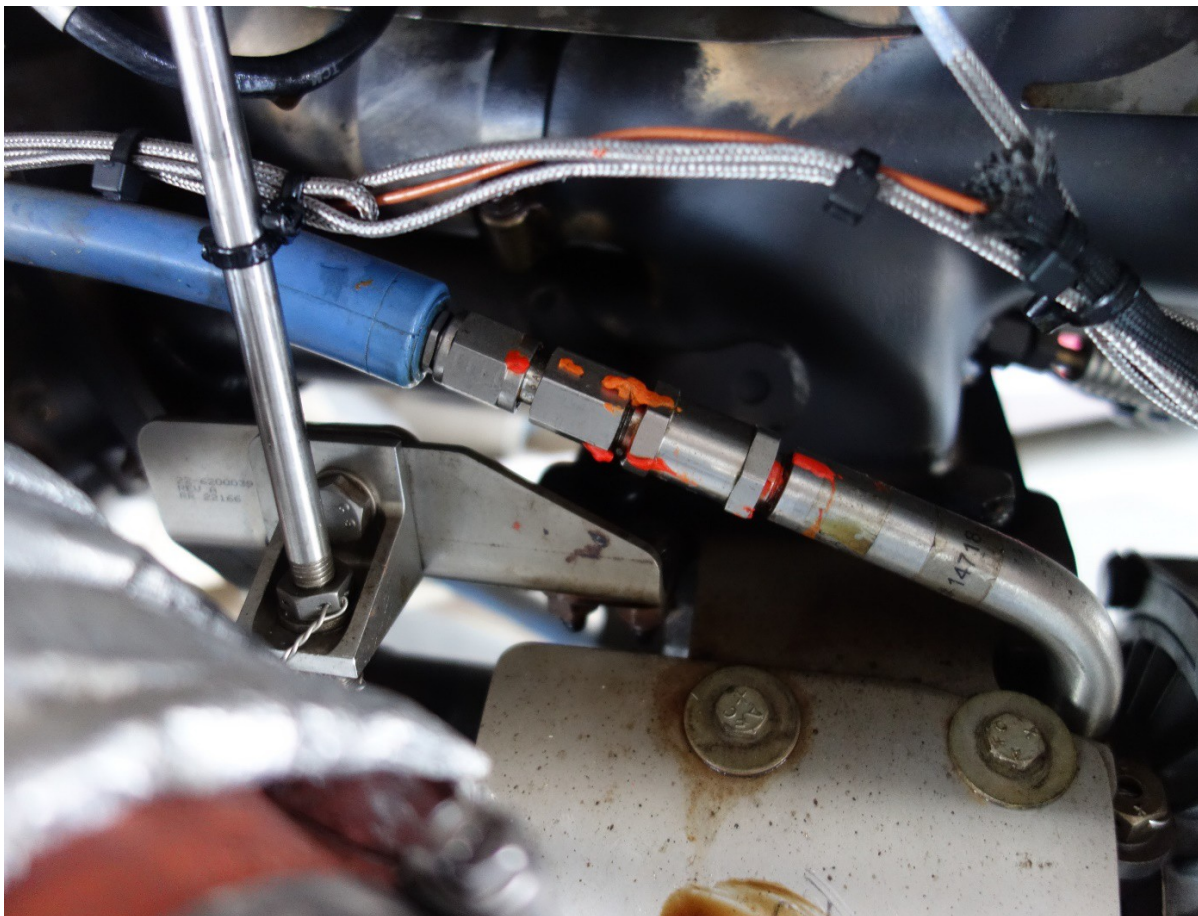
The right turbocharger remained attached to the engine. The turbocharger compressor section was examined; the blades rotated freely by hand, and no anomalies were noted. The b-nut fitting on the inlet oil line to the right turbocharger check valve was loose and was able to be manually rotated. A large amount of oil residue was noted in the vicinity of the loose b-nut fitting. Additionally, the right side of the bottom of the engine cowling displayed significantly more oil residue staining than the left side. The b-nut fitting was removed for examination. The examination of the b-nut threads revealed no anomalies. No other noticeable oil leaks were noted on the engine. Examination of the left turbocharger revealed no anomalies.

Figure 2: Loose b-nut fitting (right side).

The examination revealed that the engine exhibited damage that was consistent with lubrication distress. The examination of the engine revealed no additional evidence of mechanical malfunctions or failures that would have precluded normal operation.
