# Continental Motors

## ENGINE EXAMINATION REPORT

| ENGINE MODEL | IO-550-N (Turbo normalized by Tornado Alley) |
| FILE NUMBER | 17-227 |

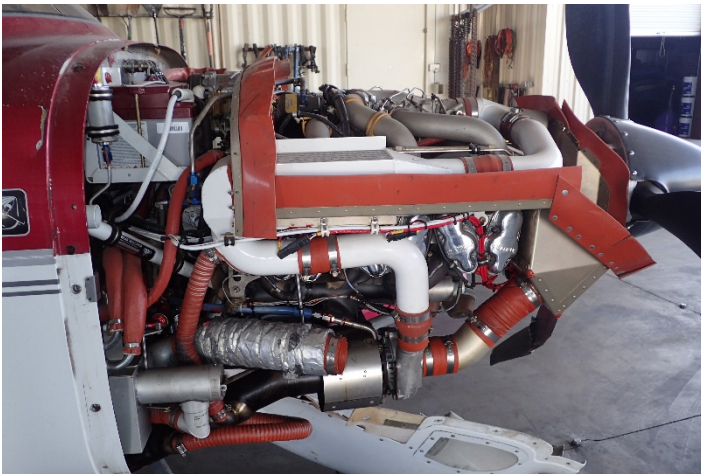
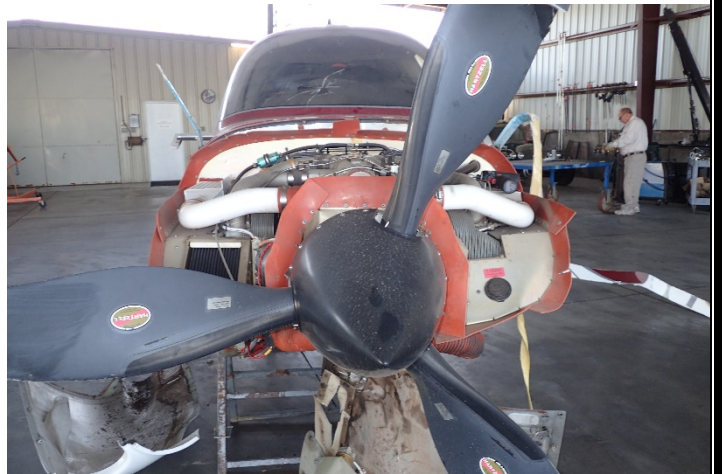
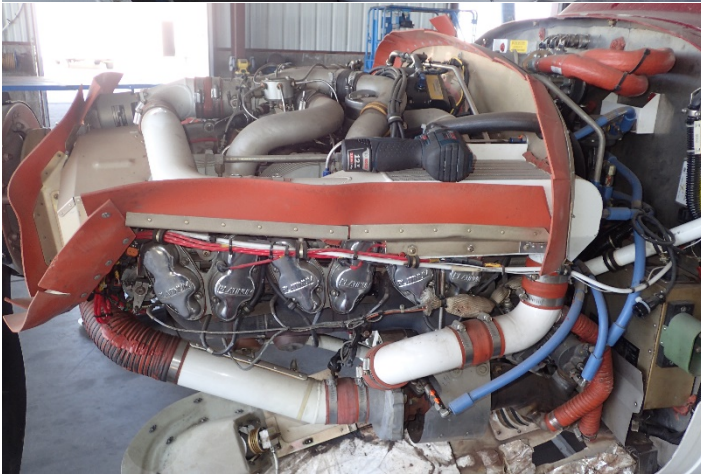
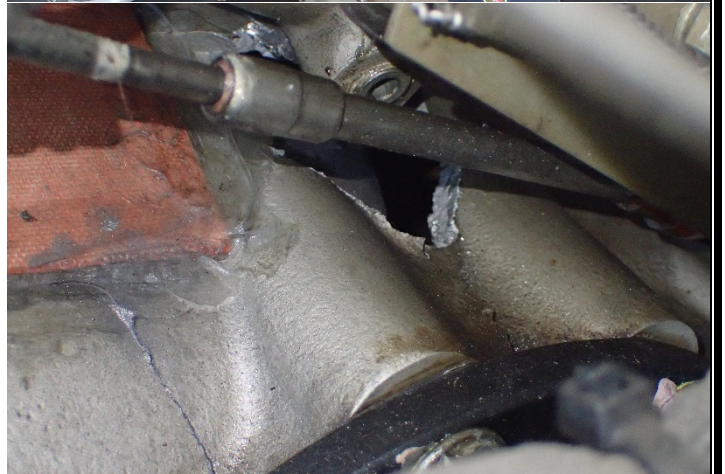
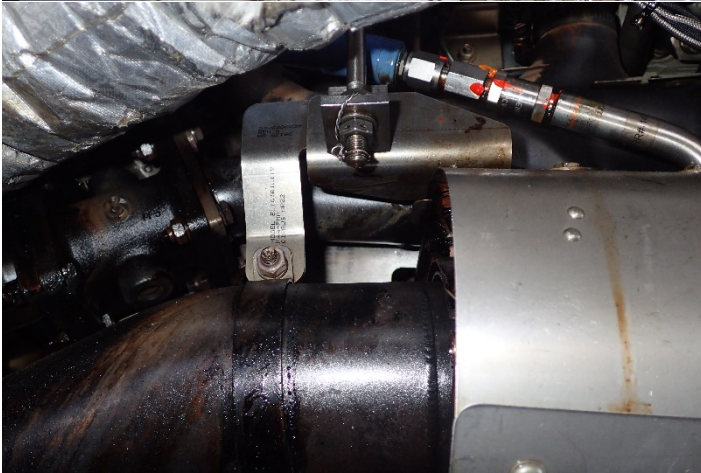
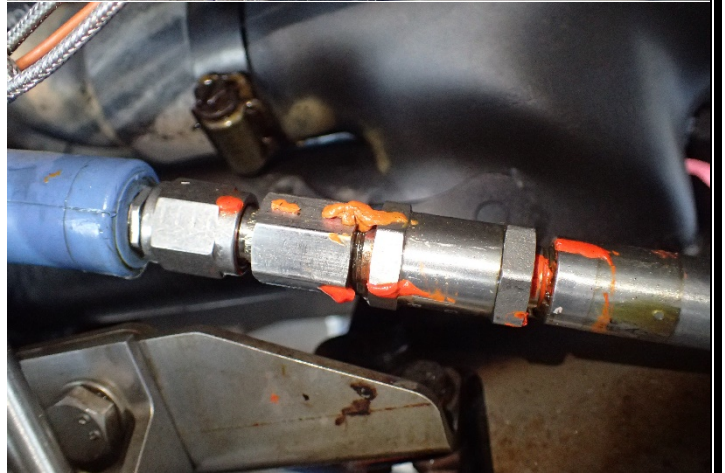
The engine remained attached to the airframe through the engine mounts, cables, hoses, and wires. There was a small hole noted at the top of the engine crankcase consistent with an internal engine failure. The propeller remained attached to the crankshaft and displayed impact damage signatures to the propeller blades. All six cylinders remained attached to their cylinder bays and there was no external damage noted to the cylinders.

The oil pump, oil filter, and oil sump were attached to their installation points and were undamaged; there were no signs of oil leaks around the components. There was a significant amount of oil noted on the right side of the engine near the turbocharger. The B-nut going to the turbocharger inlet check valve was noted to be loose and was able to be moved by hand; there was fresh oil around the B-nut.

The exhaust system remained attached to the engine and displayed impact damage signatures in the forms of bending and crushing to the tail pipes and mufflers. The turbocharger remained attached to the exhaust system and the V-band clamp was noted to be intact.

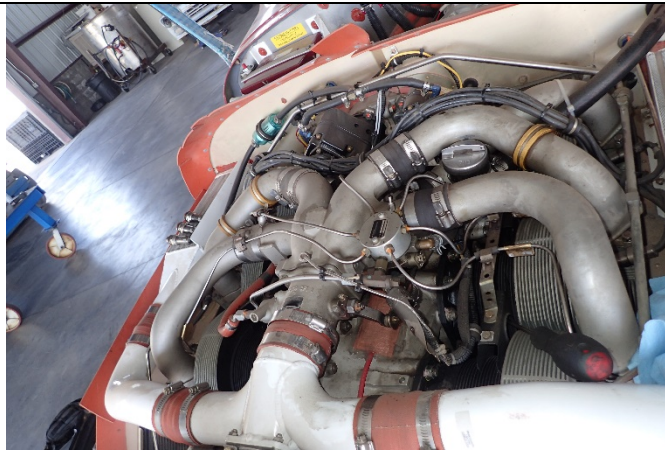
The exhaust system remained attached to the engine and displayed impact damage signatures to the tail pipes; the damage consisted of bending and crushing. The V-band clamp attaching the turbocharger to the exhaust system was noted to be intact.

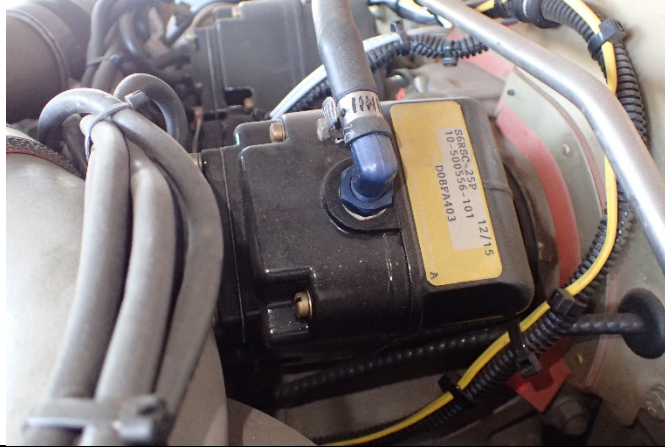
The magneto remained attached to its installation point and was undamaged. There were no signs of oil leaks around the magneto installation flange. There were no anomalies noted with the magneto.

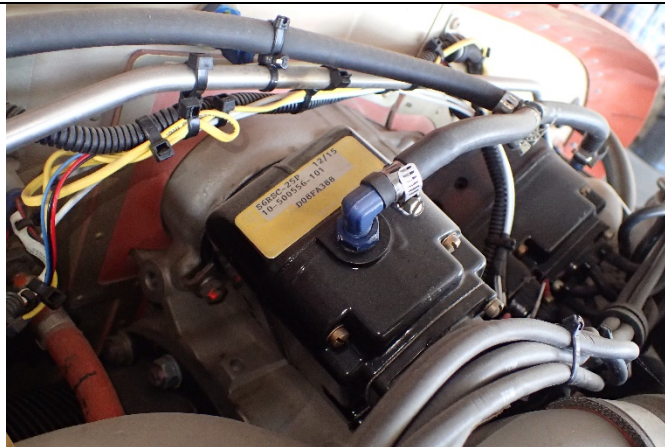
The magneto remained attached to its installation point and was undamaged. There were no signs of oil leaks around the magneto installation flange. There were no anomalies noted with the magneto.

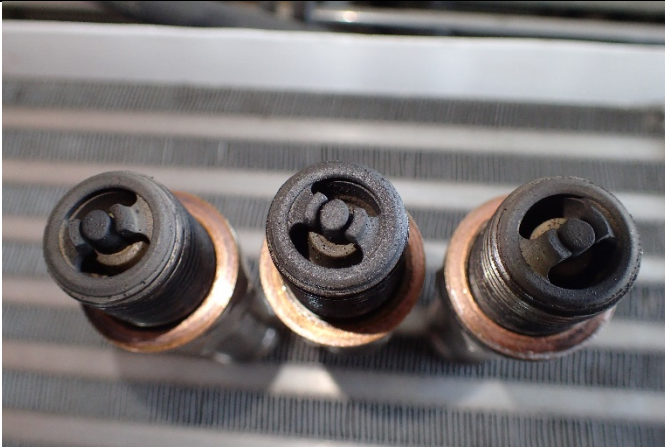
#1, #3, #5 Bottom Spark Plugs

All of the spark plugs remained installed in their cylinders and were undamaged. The bottom spark plugs were removed and the electrodes were visually inspected; the electrodes displayed normal wear and operating signatures. It was noted that in order to remove the #1 bottom spark plug, the turbocharger inlet check valve oil line was needed to be disconnected and moved to the side.

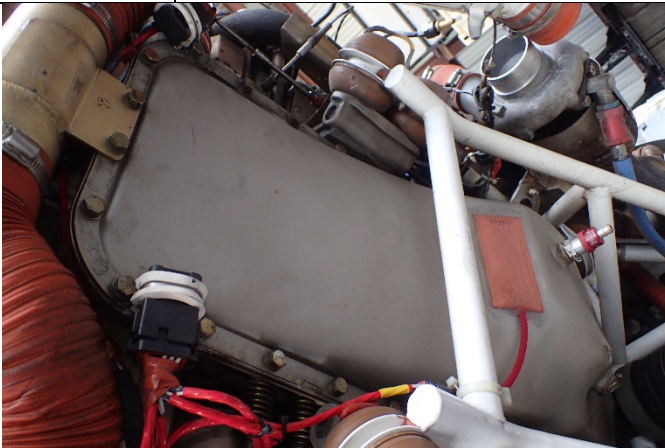
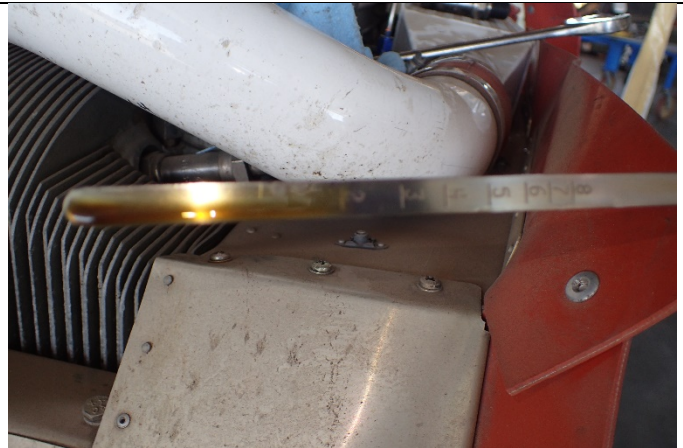
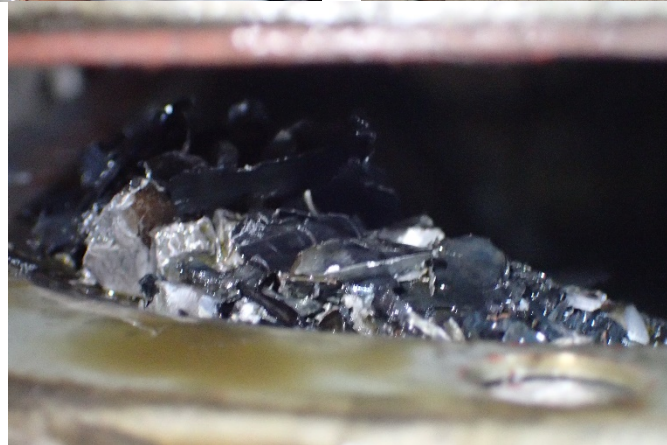
The oil sump remained intact and was undamaged; it was noted that the quick drain remained secured and was in the closed position. The oil gage was checked for the oil quantity; the gage indicated there was 2 quarts of oil within the sump. The oil sump was partially drained and then partially removed from the engine. There was a significant amount of metallic material within the oil sump; the material was consistent with bearing material, piston material, and crankcase material.

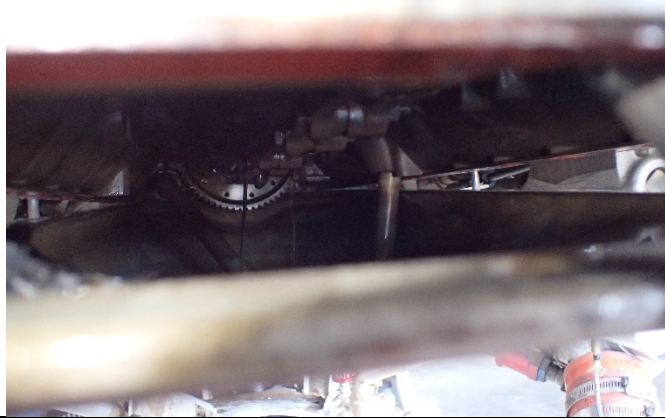
The oil pick-up screen was not observed due to the fact that the oil sump could not be completely removed. The pick-up tube was partially visible; there were no anomalies noted with the visible portion of the tube.

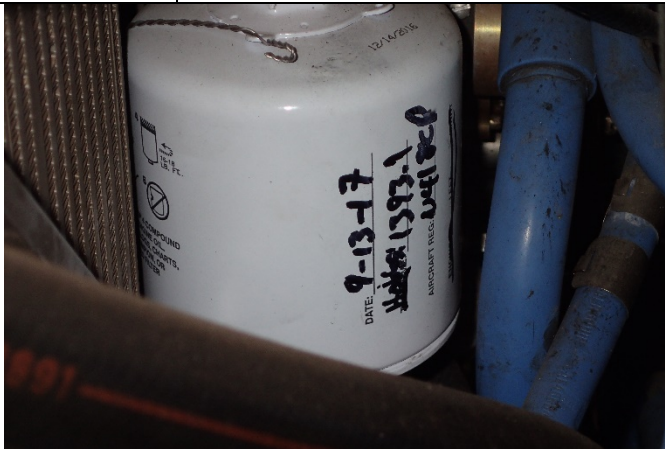
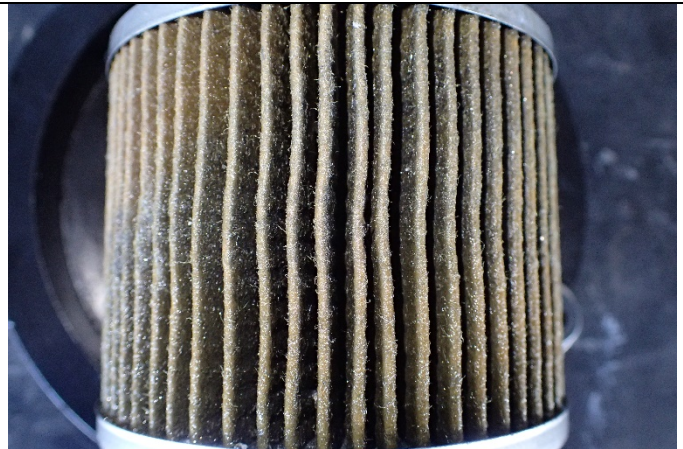
The oil filter remained secured to the oil filter adapter; there were no signs of oil leaks around the oil filter. The oil filter was removed and the housing was cut open. The filter pleats were visually inspected; there was several pieces of metallic material noted within the filter pleats. It was noted that there was very little residual oil within the filter and filter pleats.

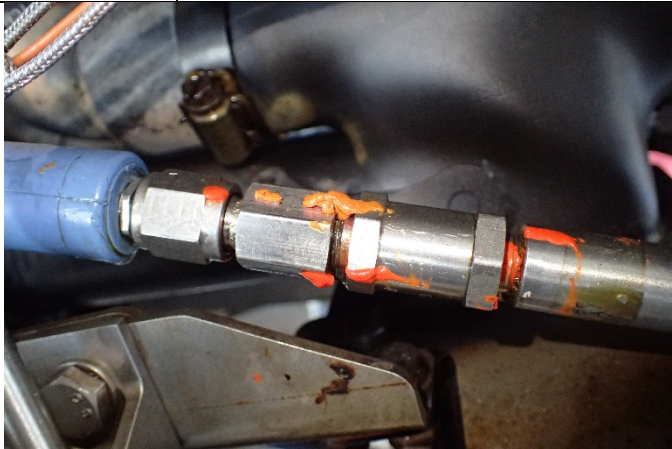
| Condition: | The oil lines were checked for security and signs of oil leaks. It was noted that the B-nut for the oil line going into the right turbocharger inlet check valve was loose and was able to be removed by hand. There was a significant amount of oil located in the vicinity of the loose B-nut and the right side of the bottom cowling displayed significantly more oil staining than the left side bottom cowling. The B-nut was removed and the threads were visually inspected; there were no signs of damage to the B-nut or the check valve threads. There was a small amount of fresh oil around the wastegate drain port; however, there was not a significant amount of oil located around the drain port or on the left bottom cowling (the wastegate is located on the left side of the engine). There were no further oil leaks noted and all of the other oil lines remained secure. |

Right turbocharger check valve with loose B-nut

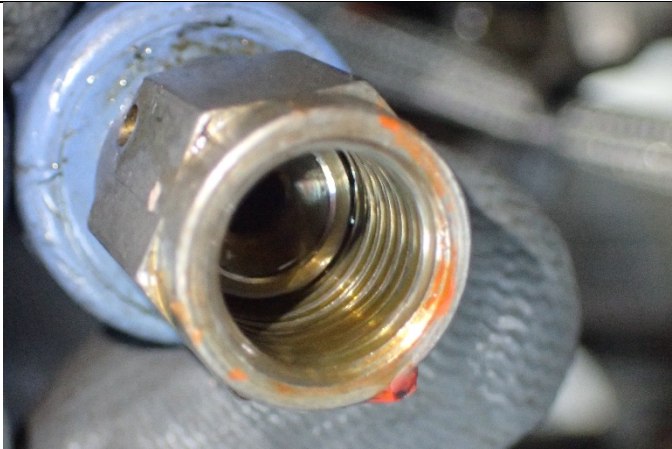
Loose B-nut threads

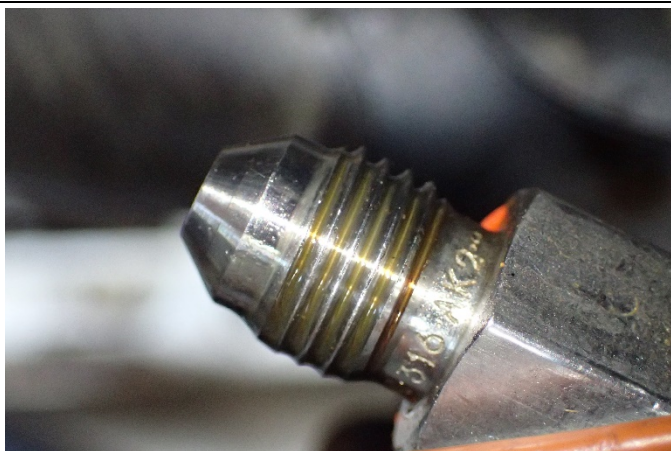
Check valve inlet fitting threads

The turbocharger remained attached to its installation point and was undamaged. IT was noted that there was a significant amount of oil around the turbocharger. The B-nut going to the right turbocharger inlet check valve was noted to be loose and was able to be removed by hand. The threads were visually inspected on the B-nut and the attachment fitting and there was no damage noted to the threads. The compressor was visually inspected and displayed normal operating signatures; the compressor was capable of normal rotation.

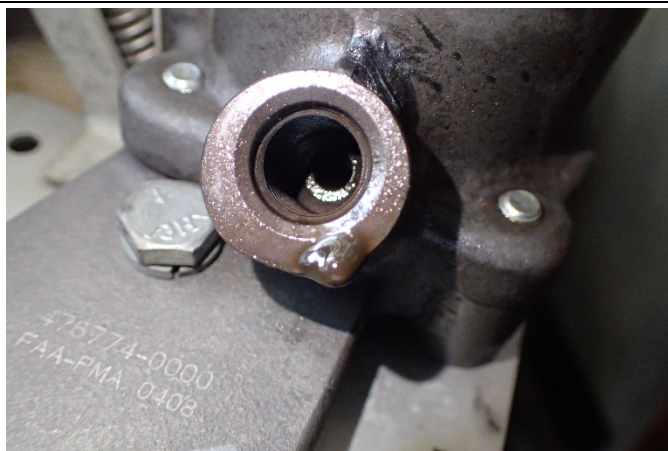
Wastegate drain port

The wastegate remained attached to its installation point and was undamaged. The inlet and outlet oil lines were noted to be secure. It was noted that there was no drain line attached to the drain port; there was a small amount of oil noted around the drain port; however, there was no significant oil staining or spray around the port or on the cowling directly below the wastegate.

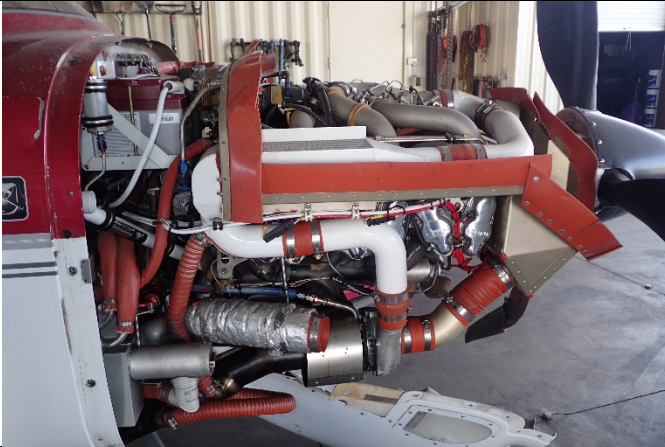
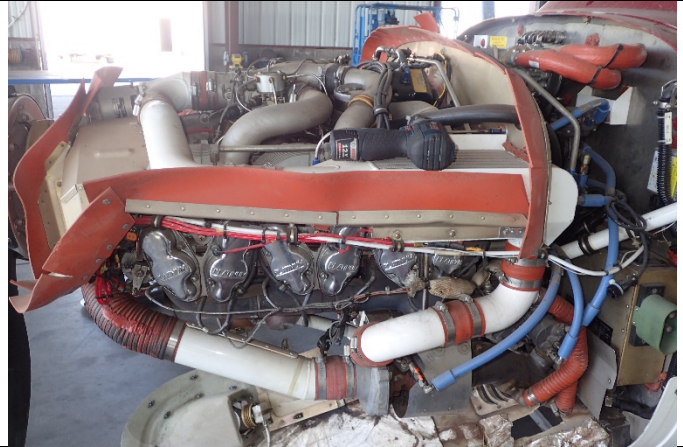
**Condition:** All of the cylinders remained attached to their cylinder bays and there were no signs of external damage to any of the cylinders. The cylinders were inspected using a lighted borescope; the #3 connecting rod had released from the crankshaft and the piston was near the top dead center position which restricted the #3 cylinder inspection. It was also noted that the #4 connecting rod had released from the crankshaft; however, the piston was up far enough in the cylinder to facilitate a borescope inspection. The visible cylinder bore, valves heads, and piston faces displayed normal operating and combustion signatures.

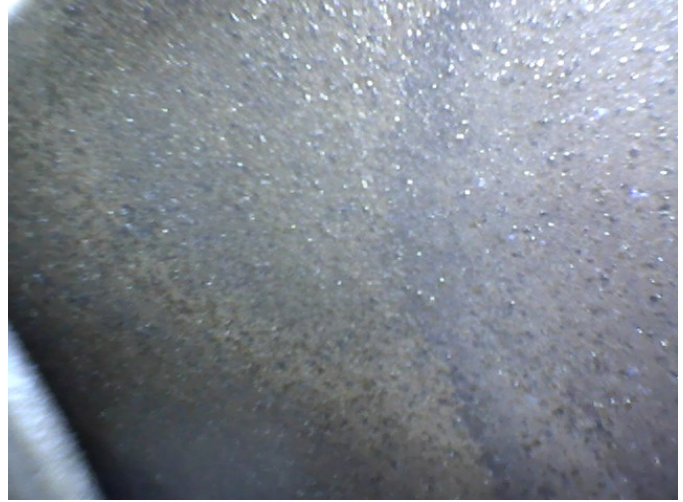
#3 Piston

The piston faces were inspected using a lighted borescope. The piston faces displayed normal operating and combustion signatures; there were no signs of detonation noted. It was noted that during crankshaft rotation the #3 and the #4 pistons would not move consistent with the #3 and #4 connecting rods releasing from the crankshaft. The rest of the pistons moved normally during crankshaft rotation.

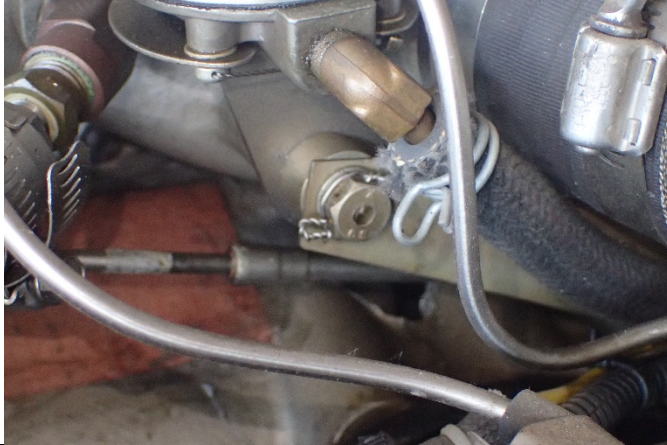
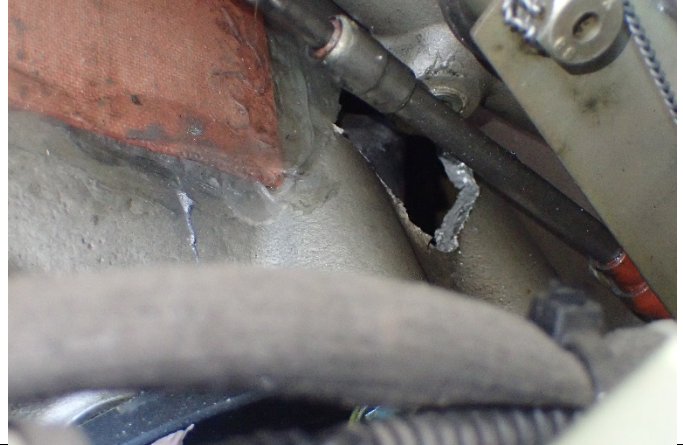
The crankcase was noted to have a small hole at the top of the crankcase consistent with an internal engine failure. There were no further anomalies noted with the crankcase.

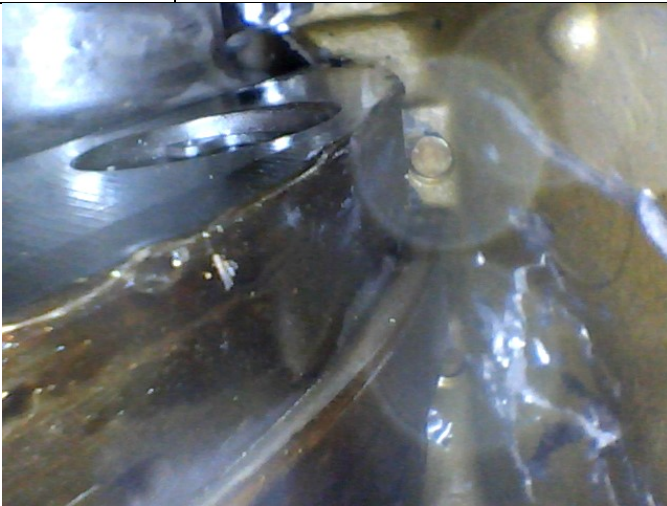
Counterweight observed during borescope

| CRANKSHAFT | Forging Number:<br>Inaccessible | S/N: Not observed | Heat code: Inaccessible |
|---|---|---|---|
| Condition: | The propeller flange remained attached to the crankshaft and there were no signs of cracks in the external portion of the crankshaft. The crankshaft was capable of rotation with noticeable resistance; continuity was established between the crankshaft and the camshaft. It was discovered during crankshaft rotation that the #3 and the #4 connecting rods had released from the crankshaft. A lighted borescope was inserted into the hole in the top of the crankcase; the journal for one of the released connecting rods was visible during the inspection. The journal displayed thermal damage consistent with lubrication distress. | | |

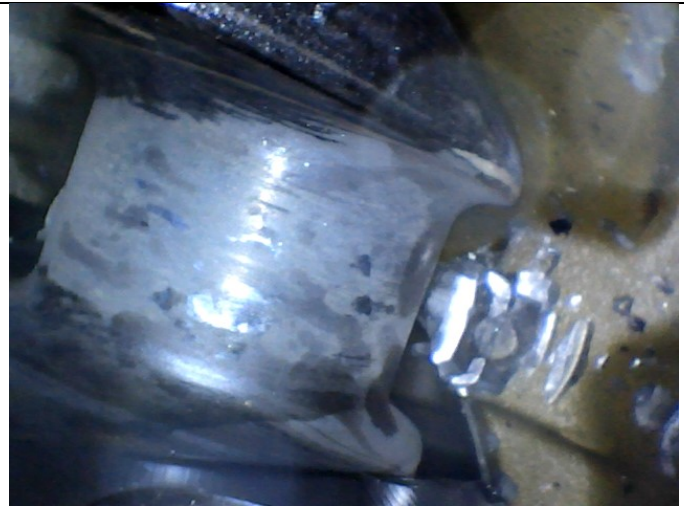
Either the #3 or the #4 connecting rod journal  
(unable to determine which due to difficult access)

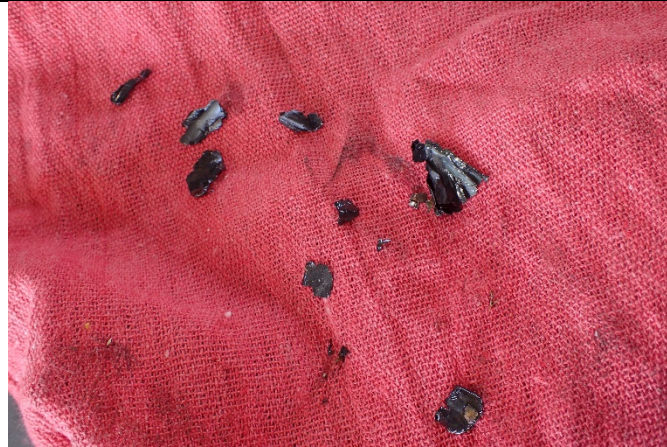
Several pieces of bearing material were located in the oil sump. The bearing displayed thermal damage signatures consistent with lubrication distress.

Bearing material found in oil sump

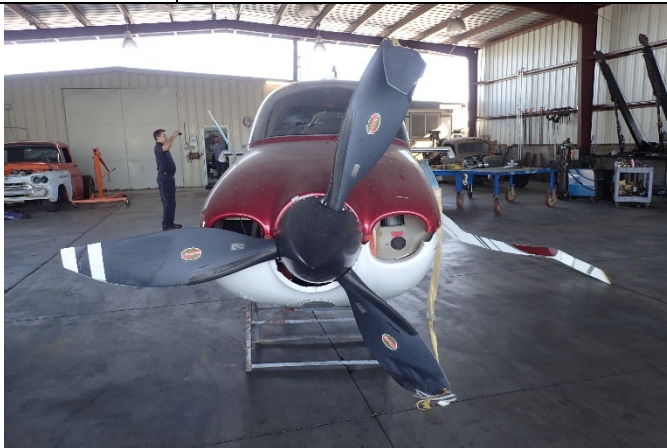
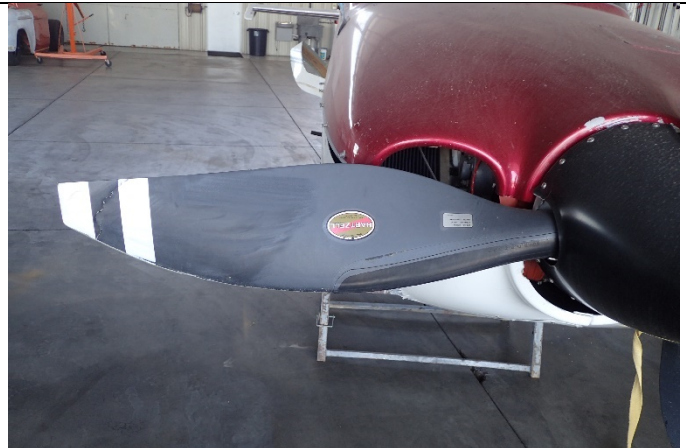
The three blade, variable pitch, composite propeller remained attached to the crankshaft and displayed impact damage to all three propeller blade tips. There were no leaks noted around the propeller hub/propeller flange. There were no anomalies noted with the propeller.
