## RECORD OF CONVERSATION

**Date: December 1, 2017**  
**Person Contacted: Mr. Ed Aycock (Federal Aviation Administration Inspector)**  
**NTSB Accident Number: WPR18LA029**

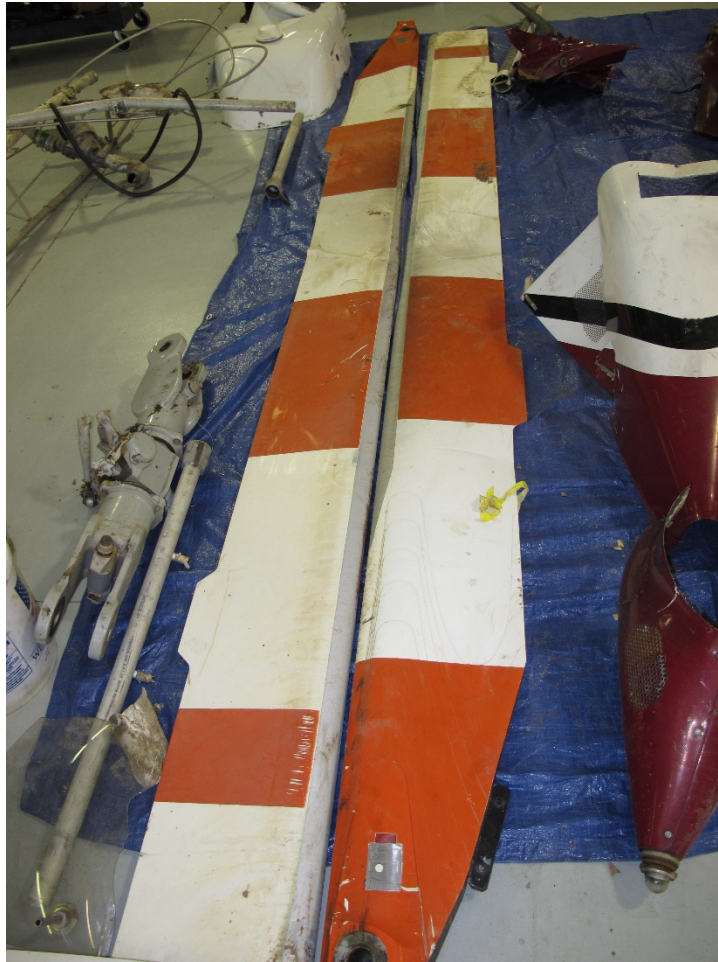
*Figure 5: Main Rotor Blades*

- The tail boom was fracture separated consistent with main rotor blade contact.
- Both main rotor blades showed impact related damage
  - In addition, the blades exhibited warping due to slight spanwise deflection opposite of the direction of rotation, but with low inertia.

- One blade was found cracked chordwise in the center section.
- Flight control continuity was established throughout the airframe.
  - There were several brakes throughout the drive train, however, all components were present.

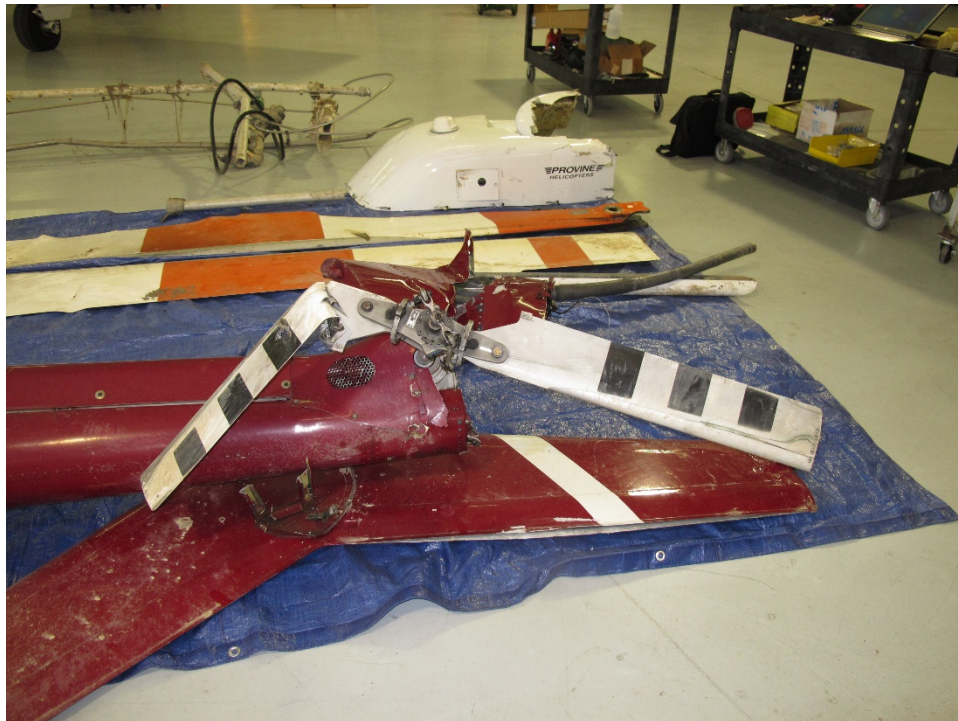
*Figure 6: Tail Rotor Blades*

- The transmission rotated freely by hand with no binding or abnormal sounds.
  - The chip detectors were clear of debris.
- The tail rotor hub and blades were still attached to the tail rotor gearbox on the tail boom.

- One blade was intact while the other was broken chordwise at the doubler.
  - The tail rotor hub rotated freely by hand with no binding or abnormal sounds.

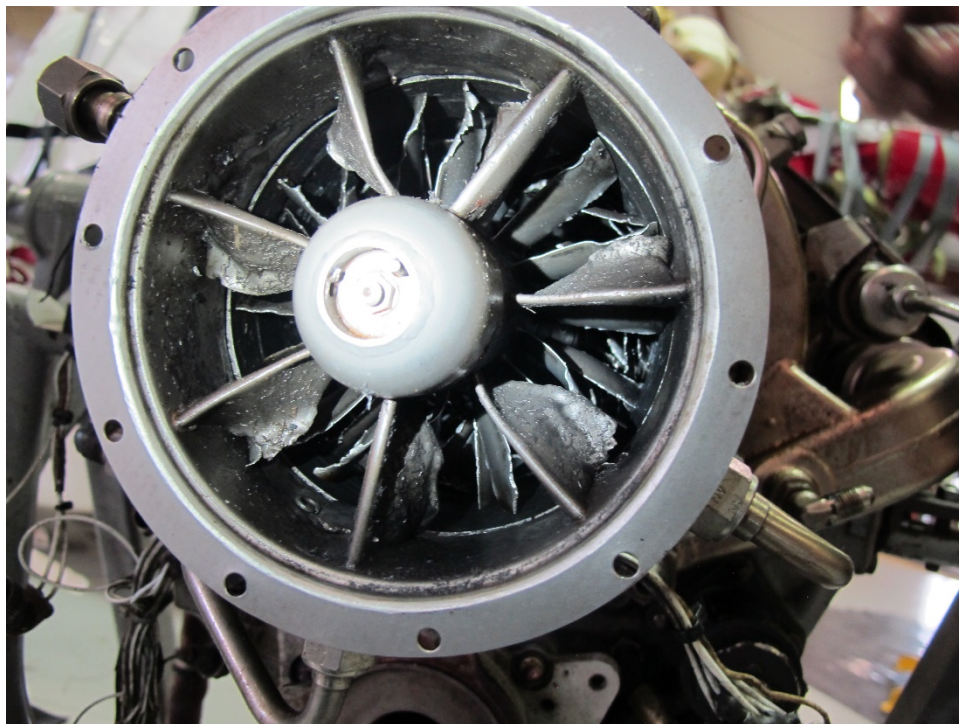
*Figure 8: Compressor Inlet*

- A washer, consistent with the one missing from the barrier filter pressure switch was found in the compressor inlet.
- The first stage compressor blades and compressor inlet exhibited damage consistent with foreign object ingestion.

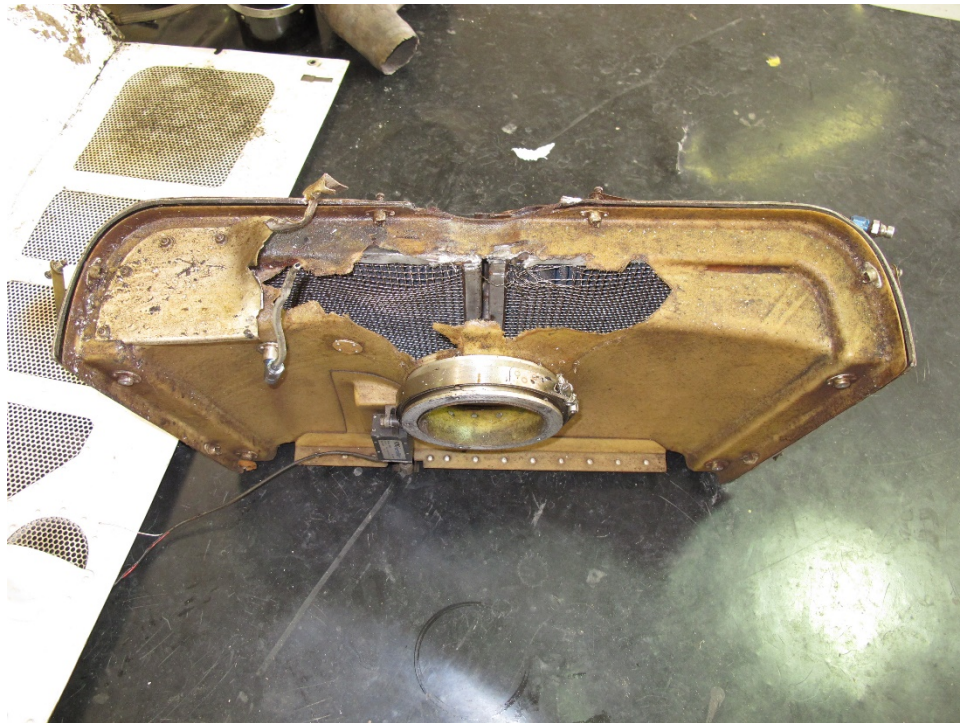
*Figure 9: Barrier Filter Assembly*

- All external air, fuel, and oil line connections were at least finger tight.
- The inlet barrier filter was dirty, but not obstructed
  - The bottom portion of the barrier filter assembly was fracture separated presumably during the accident sequence.

- The barrier filter pressure switch was dislodged and loose within the assembly.
    - It displayed damage consistent with being ingested by the compressor.

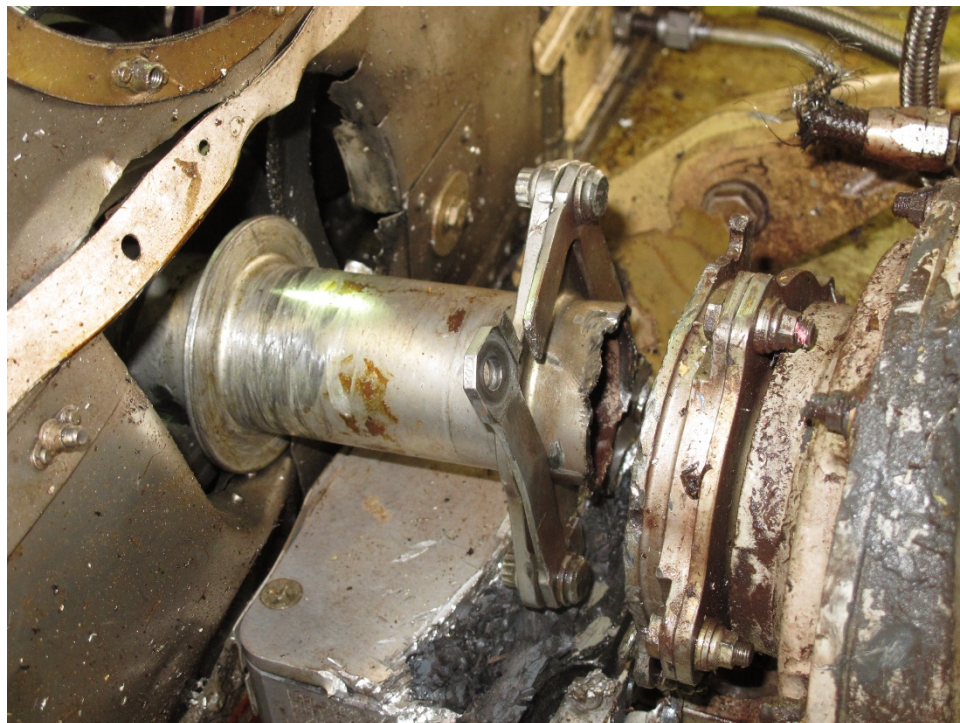
*Figure 10: The Main Transmission Input Shaft*

- Foreign object damage was also noted within the compressor, and the case halves were pierced in several areas.
- The main transmission input shaft was fractured from the main transmission and displayed evidence of rotation after separation.

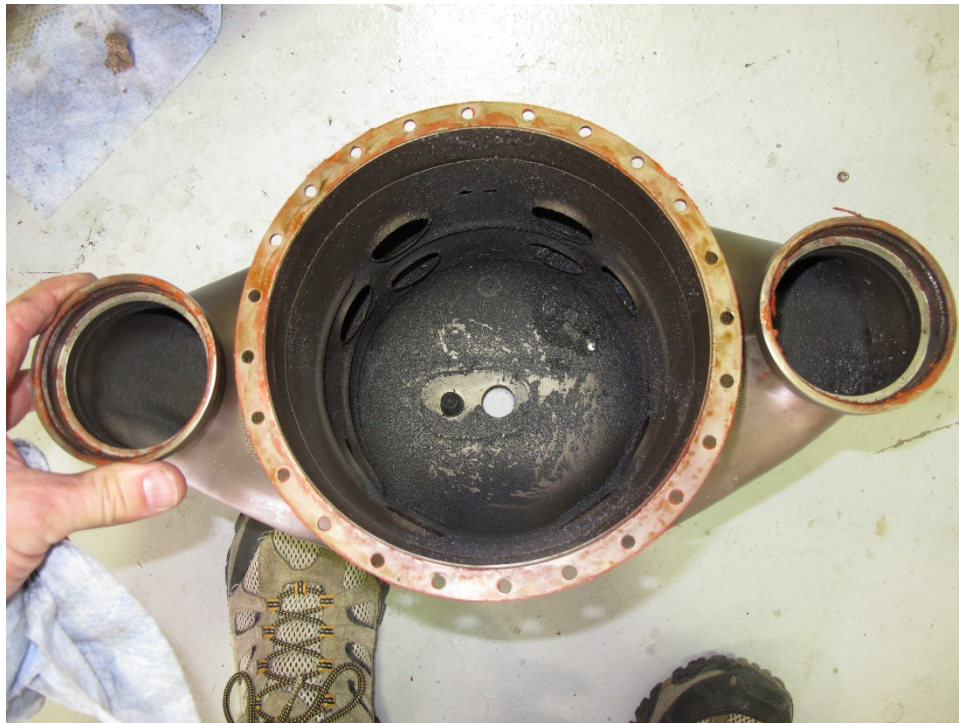
- The N1 rotated freely once the compressor module was removed.
- The fourth stage and first stage turbine wheels did not exhibit damage.
- Black debris with a sludge-like consistency was noted throughout the gas path from the compressor to the combustor and turbine inlet.

- It was mostly on the inner surface of the outer combustion case consistent with rotation of the N1 system.
- Both the upper and lower chip detectors were removed, and minor debris was noted.

*Figure 11: Black debris in Outer Combustion Case*

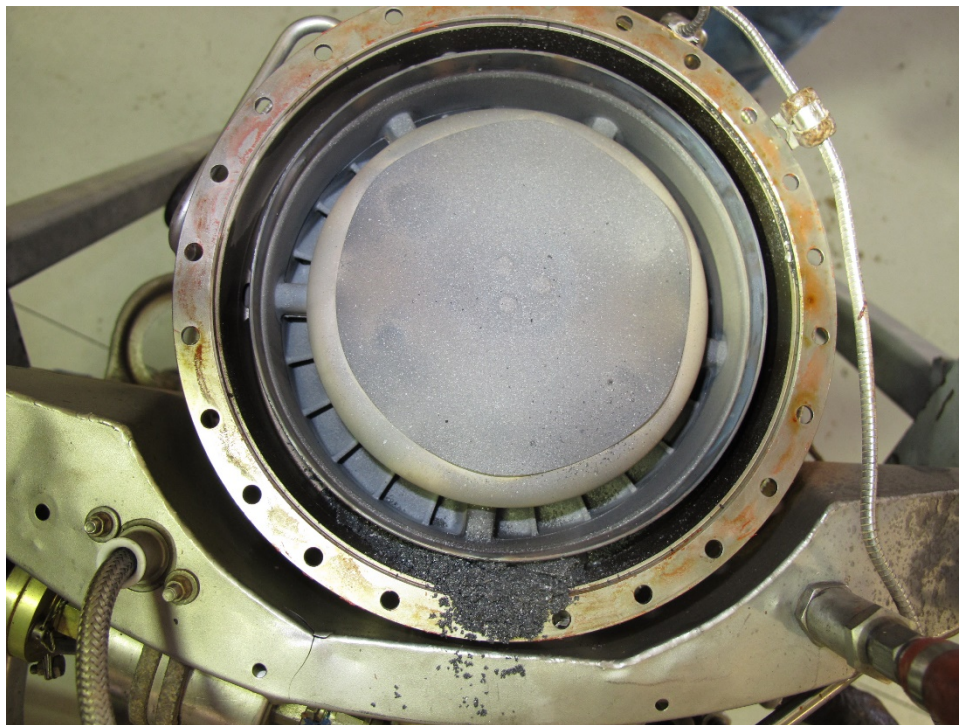
*Figure 12: Black Debris in First Stage Turbine*
