## **NATIONAL TRANSPORTATION SAFETY BOARD**

# **POWER TURBINE GOVERNOR EXAMINATION**

**WPR18LA029**

Location: Rolling Fork, Mississippi  
Date: November 7, 2017  
Aircraft: Bell 206B, Registration N93PH, Serial #788  
NTSB IIC: Samantha Link

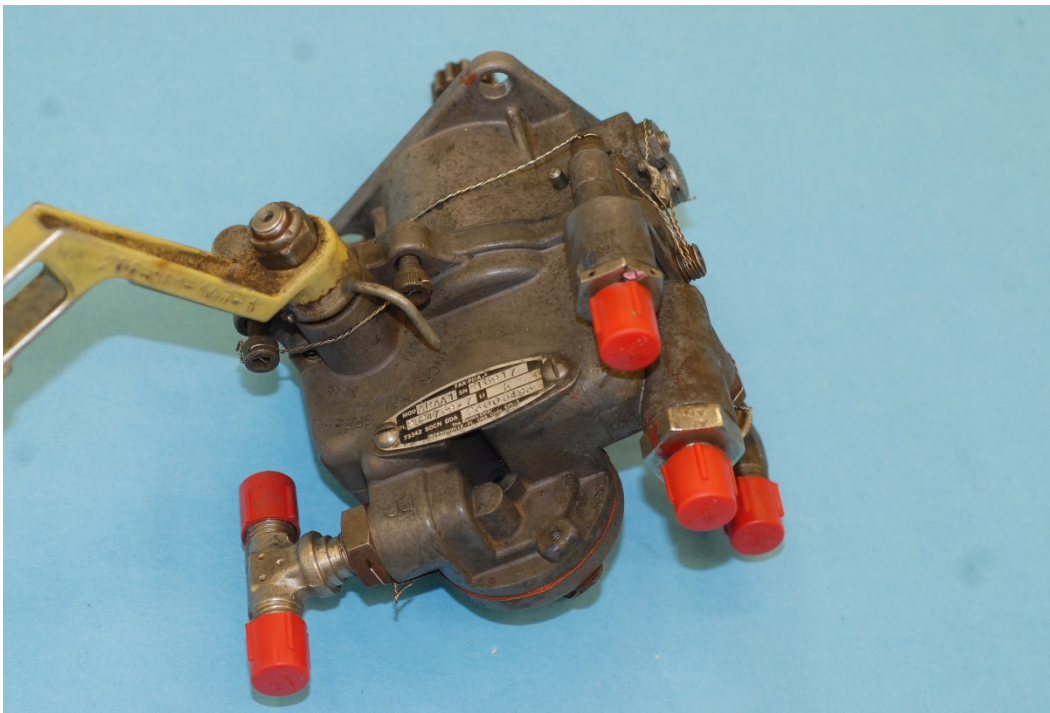
Figure 1: Power Turbine Governor

- Power turbine governor Serial #16917
  - This particular unit was about 35 years old. It has no evidence of maintenance configuration improvements or an overhaul
    - Overhaul occurs at 2,000 hours
  - Maintenance log revealed the unit was installed onto the helicopter on September 13, 2017 with a total of about 627 hours.
    - The unit flew about 161 hours while installed onto the accident helicopter
- An initial visual inspection was conducted on the unit and no anomalies were noted

- The collective lever moved smoothly from stop to stop, however, it did have a very small friction area at about the 74-degree mark.
- The unit was prepped for an operational run on a test bench before it was installed onto the test bench.
- The power turbine governor was tested to full ATP specifications
  - It ran normally with no anomalies noted
- The power turbine governor was removed for teardown.

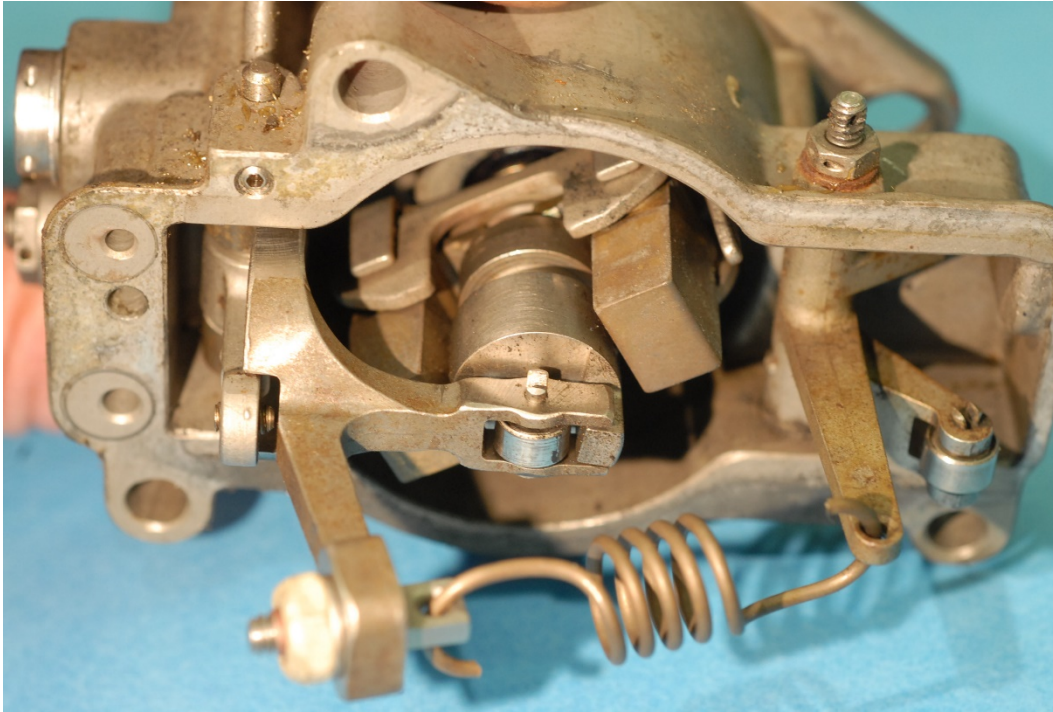
Figure 2: Drive Body

- The drive body cover was removed
  - The fly weight was manipulated by hand it rotated smoothly with no binding.
- The throttle shaft rotated smoothly
- The speed spool bearing rotated normally and the bearing movement over the Teflon post was consistent with normal.
  - The Teflon tube exhibited some signs of wear.
- The cam follower lever rotated freely with the exception of a slight bind.
  - Not enough of a bind for the pilot to feel in the collective control
- The flyweight shoes exhibited some wear and corrosion on the flyweight shoes, which is considered normal wear.
