## **NATIONAL TRANSPORTATION SAFETY BOARD**

### **SUMMARY OF ENGINE EXAMINATION**

**(WPR18LA033)**

| Aircraft: | Piper PA-28-201T |

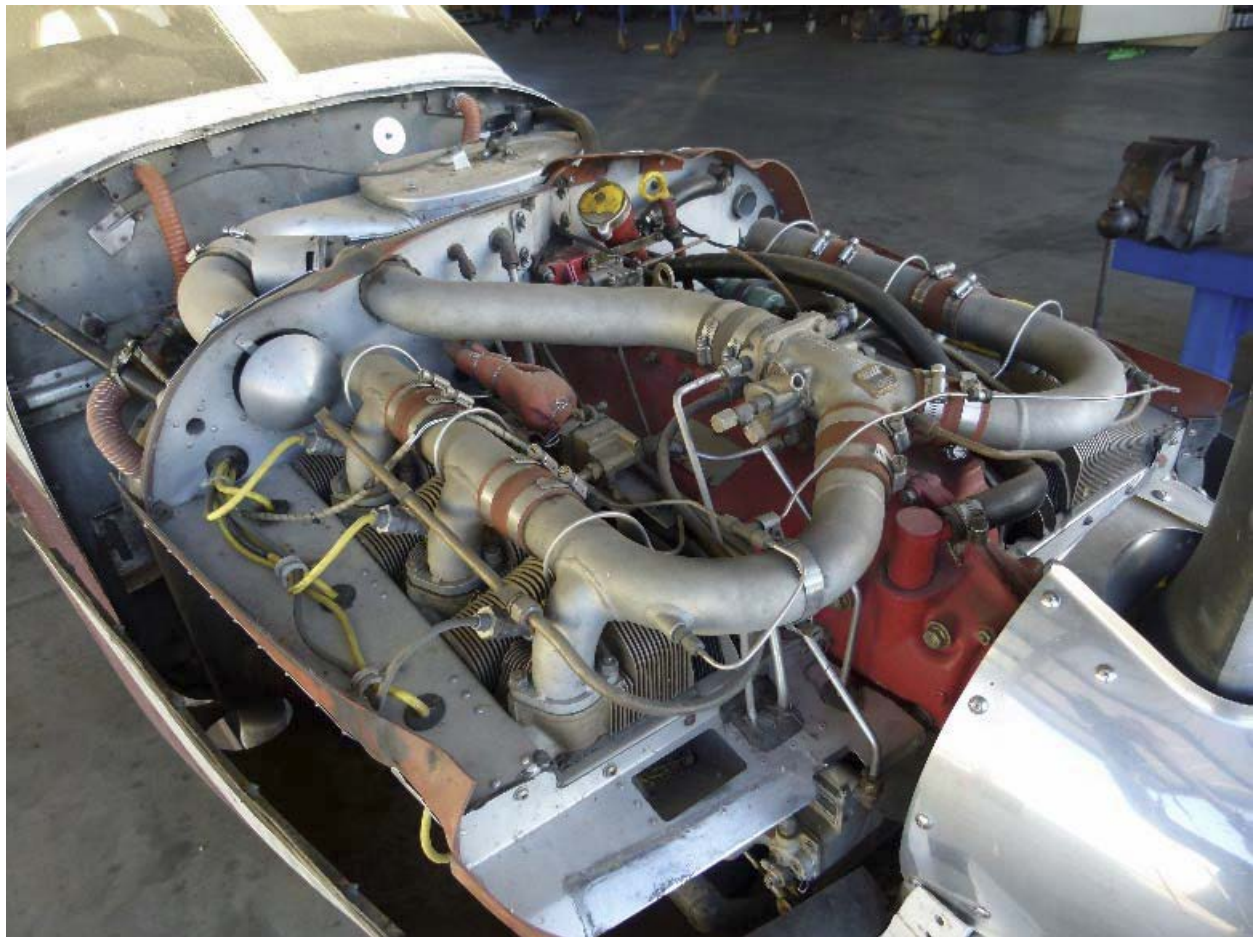
The engine remained attached to the airframe and did not exhibit any damage. The propeller remained attached to the crankshaft propeller flange. All three blades were bent aft at mid-span and exhibited chordwise scratches.

Figure 1 -overhead view of engine as received

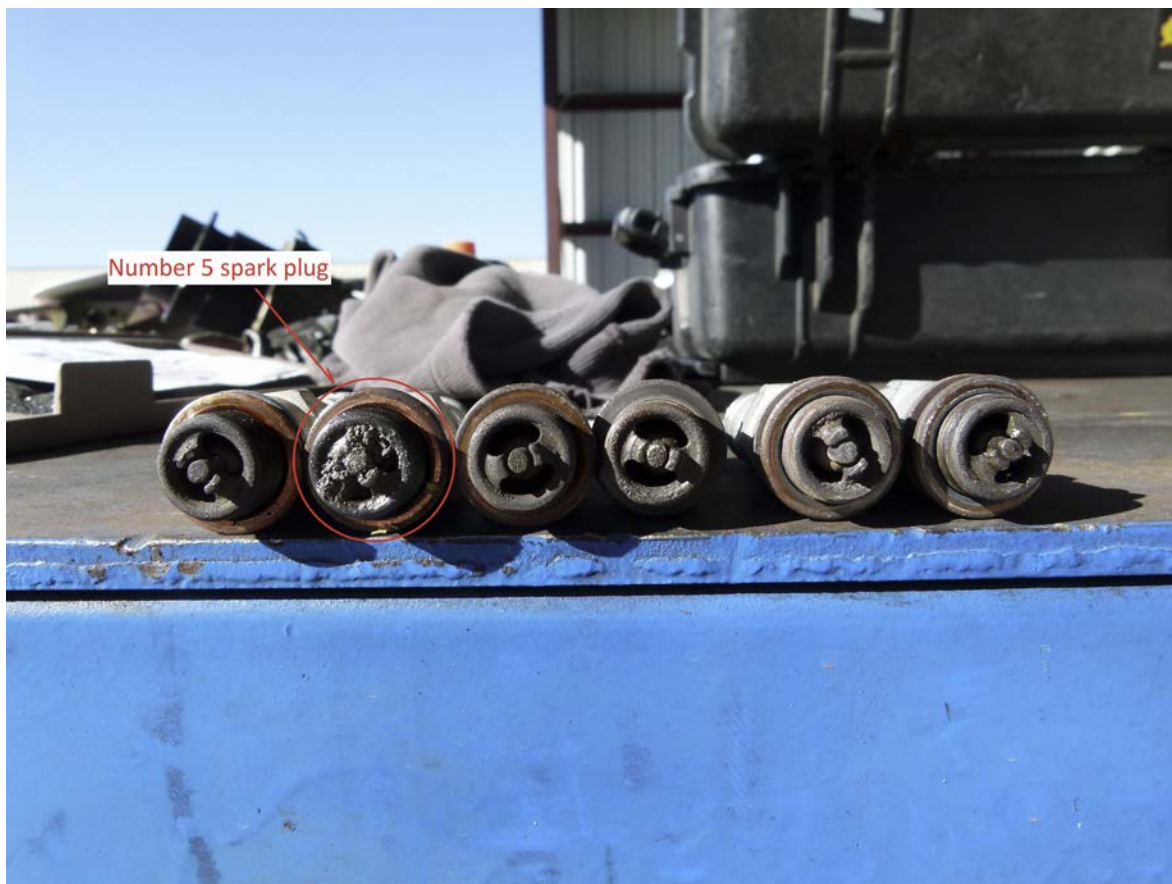
The top spark plugs were removed and all except the number 5 spark plug exhibited dark colored combustion deposits. The number five spark plug exhibited a molten metal like substance around the electrode.

Figure 2 - top spark plugs

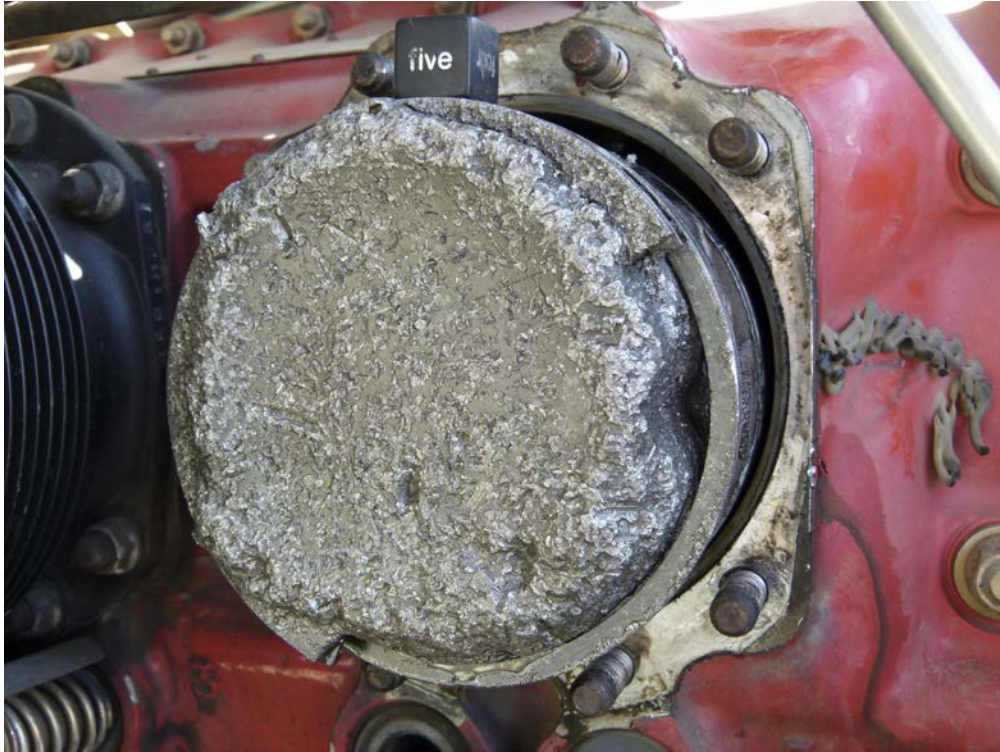
Detonation in the cylinder combustion chambers was noted in cylinders 1, 3 and 5. Cylinder 5 displayed the most significant signs of detonation and mechanical damage.

The cylinders were examined with a lighted bore scope. The number 2-4-6-cylinder combustion chambers exhibited normal operating signatures. Cylinder 5 exhibited signs of detonation / preignition with material missing from around the circumference of the piston face. The number 5 cylinder exhaust and intake valves also showed signs of mechanical damage. Cylinders 1 and 3 exhibited minor signs of detonation.

Figure 3 - number 5 cylinder piston

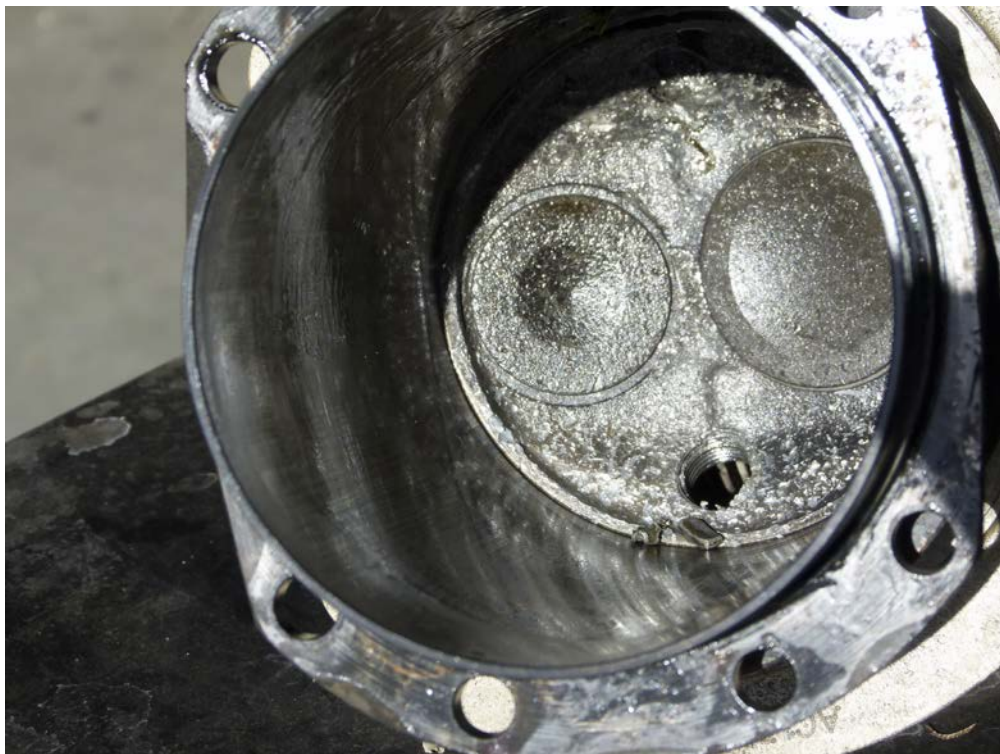
Figure 4 - number 5 cylinder intake and exhaust valves
