**NATIONAL TRANSPORTATION SAFETY BOARD**

**AIRPLANE & ENGINE EXAMINATION**

**WPR18LA034**

**Cessna 172P – N52492**

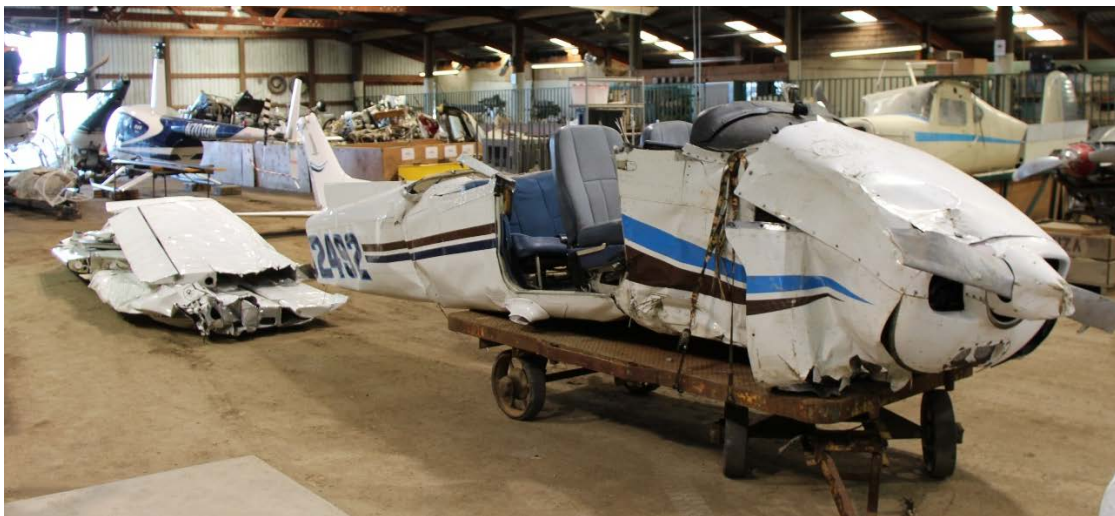
The airplane came impacted a trailer and a several small trees before it collided with the front of a residence and came to rest in the front yard. All three landing gear had collapsed or separated from the fuselage, which was resting flush against the ground. The outboard portion of the left wing was separated and the right wing was partially separated about mid-span. The empennage displayed some buckling at the aft fuselage.

Photograph 1: Airplane Fuselage & Wings Prior to Examination

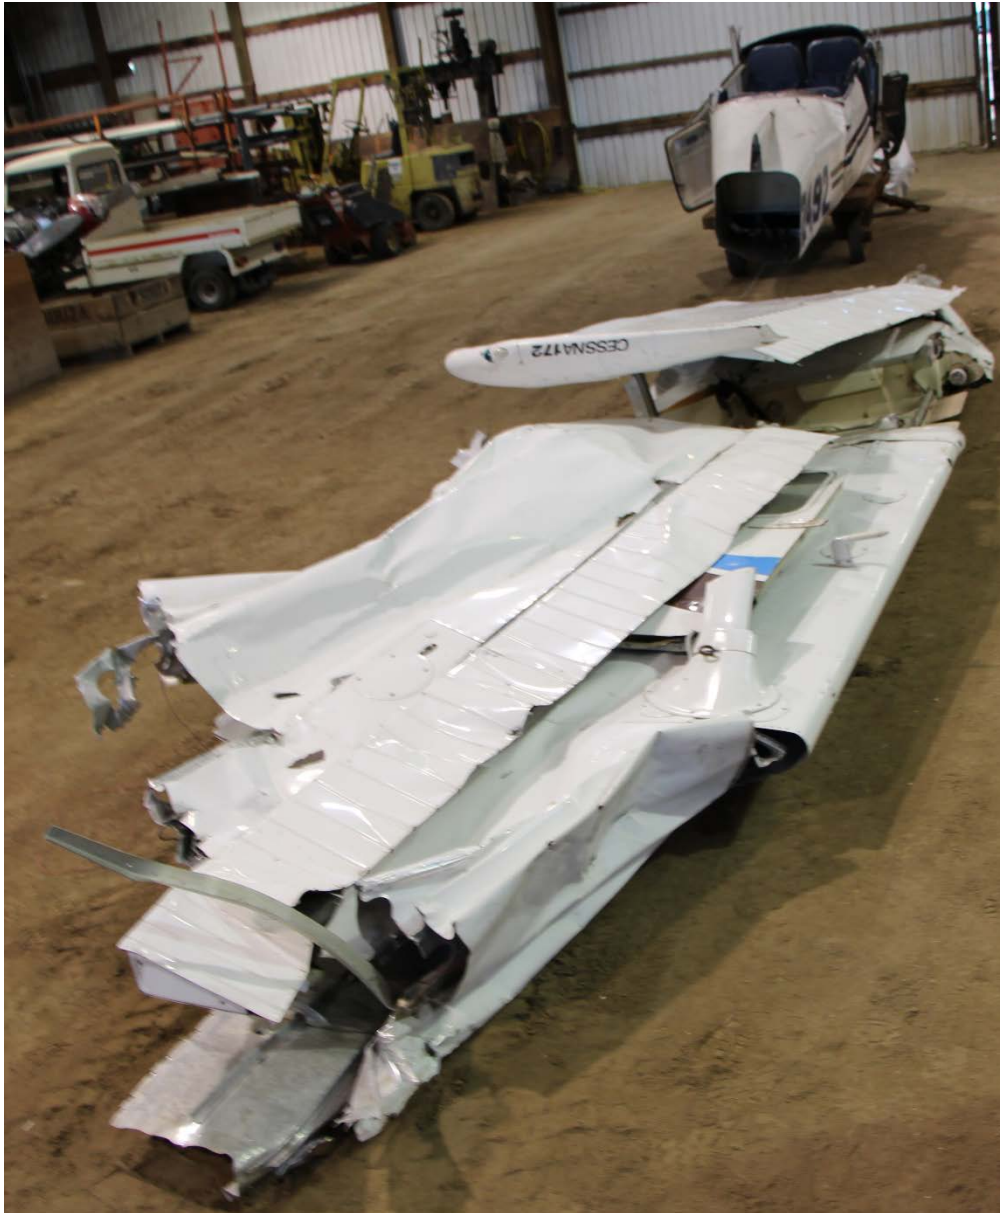
Photograph 2: Airplane Wings and Aft Fuselages Prior to Examination

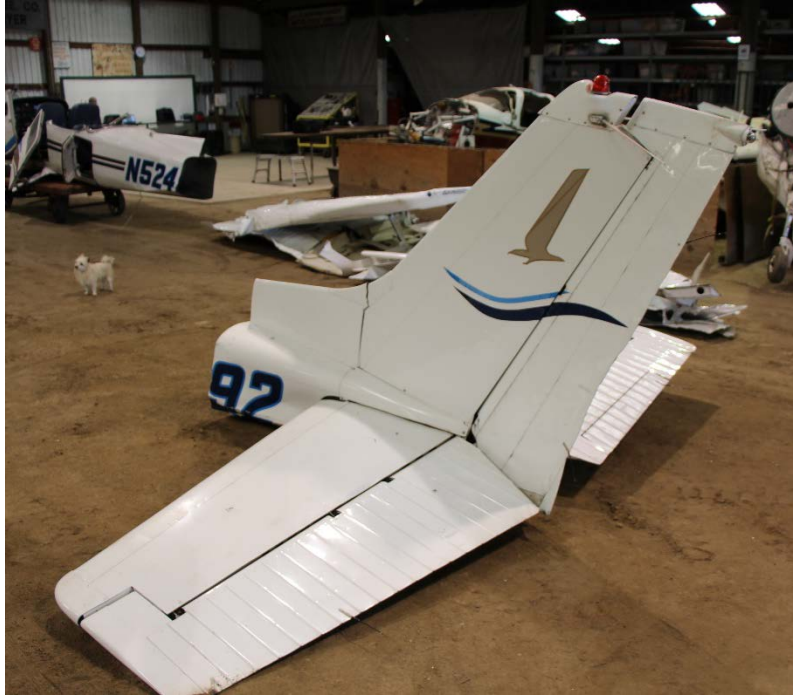
Photograph 3: View of Empennage

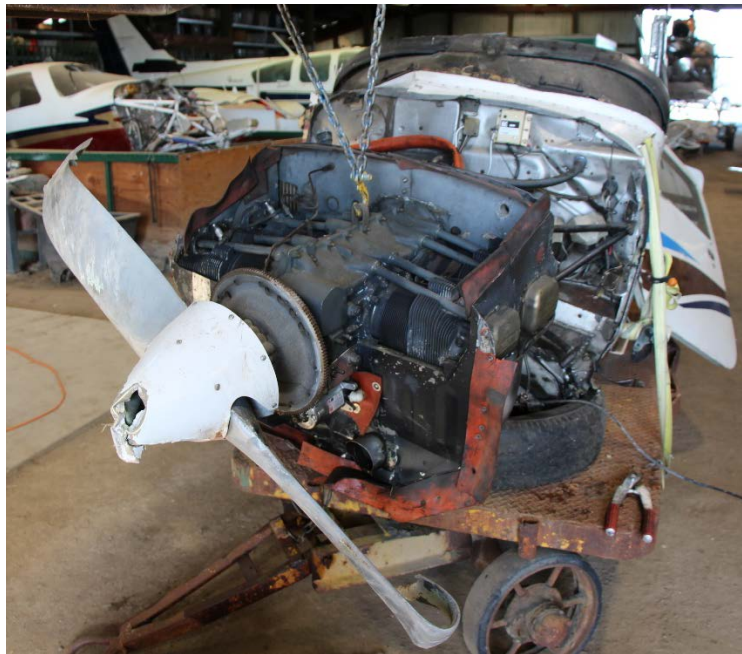
The engine case and accessories were not damaged with the exception of the carburetor, which had broken off at the flange. The forward baffling showed normal wear and was removed from the engine case during disassembly. The propeller spinner was fractured and the extension was cracked.

Photograph 4: View of engine without cowling

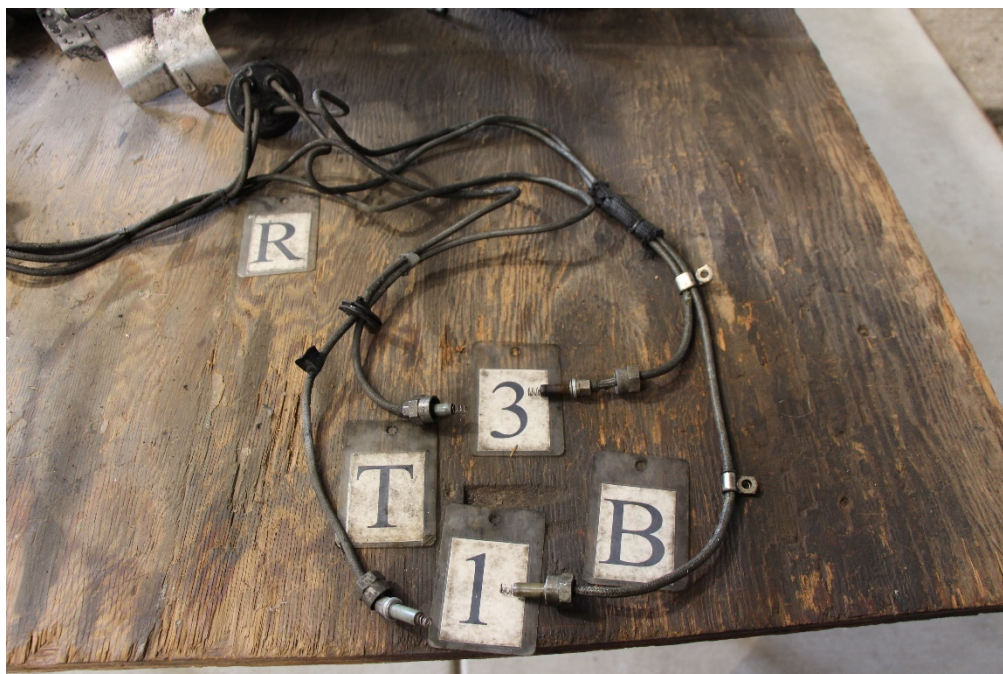
Each of the engine's 8 Champion 40E spark plugs were removed and were gray in appearance, consistent with normal wear when compared to the Champion Aerospace Aviation Service Manual. A thumb compression test revealed intake and exhaust pressure for each cylinder. The left magneto, a Slick model 4371, serial number 02050059, and the right magneto, a Slick model 4371, serial number 02052067, remained attached to the engine accessory case. Each ignition harness lead displayed normal wear and exhibited spark when the propeller was rotated by hand.

Photograph 5: Top and Bottom Ignition Leads for Cylinder Nos. 1 and 3

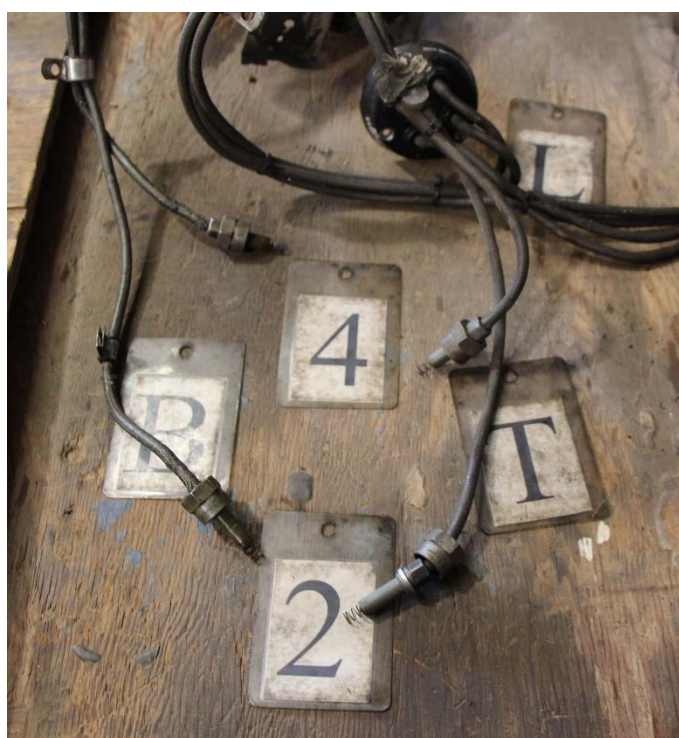
Photograph 6: Top and Bottom Ignition Leads for Cylinder Nos. 2 and 4

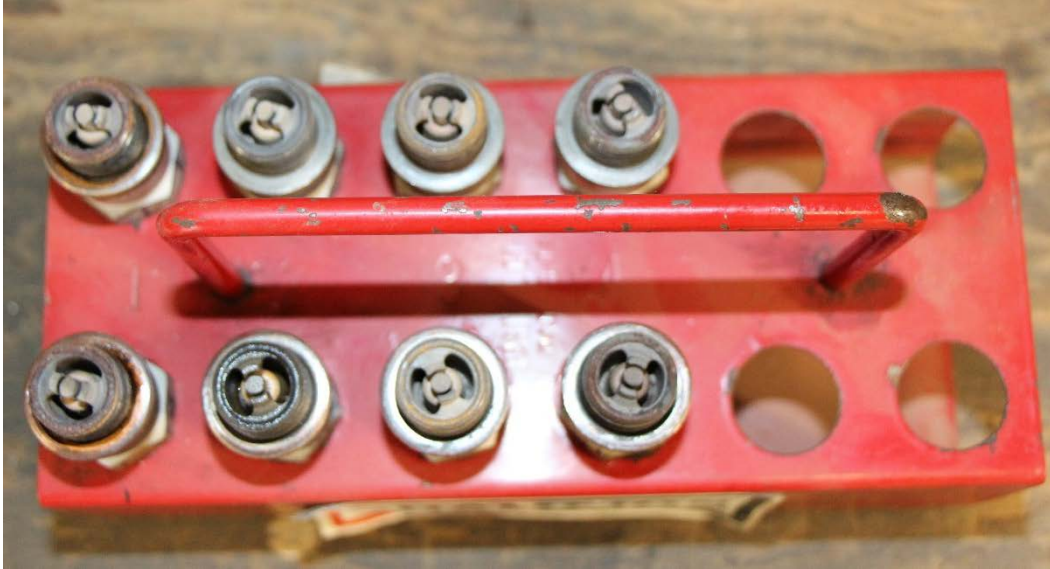
Photograph 7: Top and Bottom Spark Plugs for Cylinder Nos. 1-4

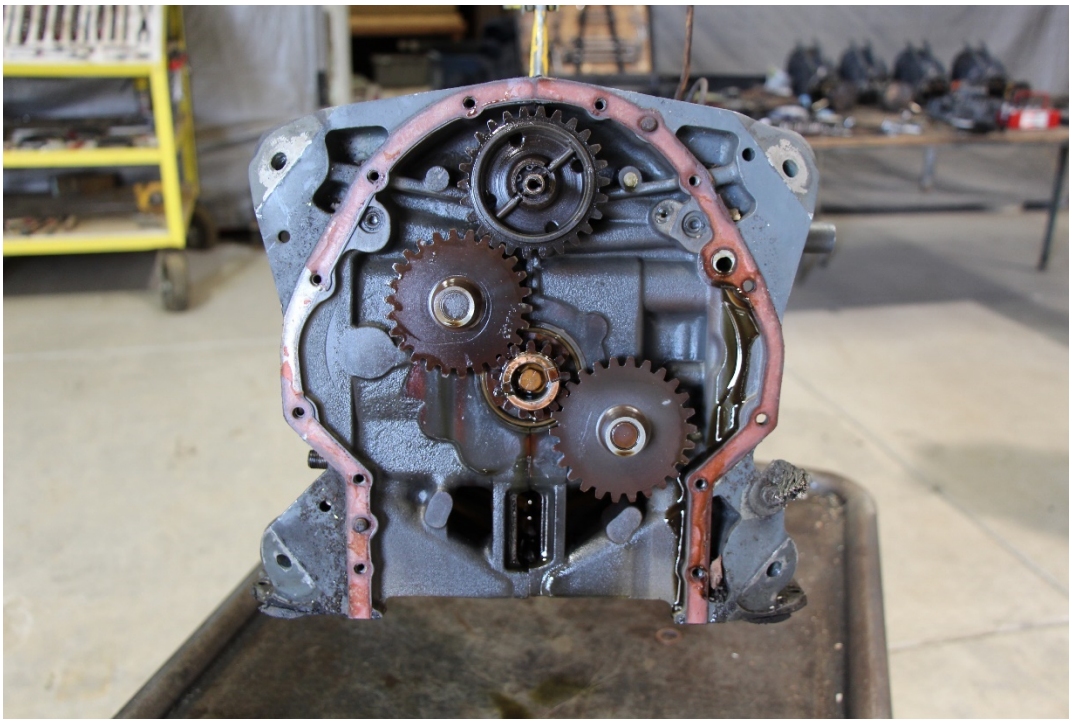
The crankcase halves were unremarkable and the bearing races appeared normal. The accessory gear were coupled together and the teeth were normal in appearance.

Photograph 8: Accessory Gears with Accessories Removed

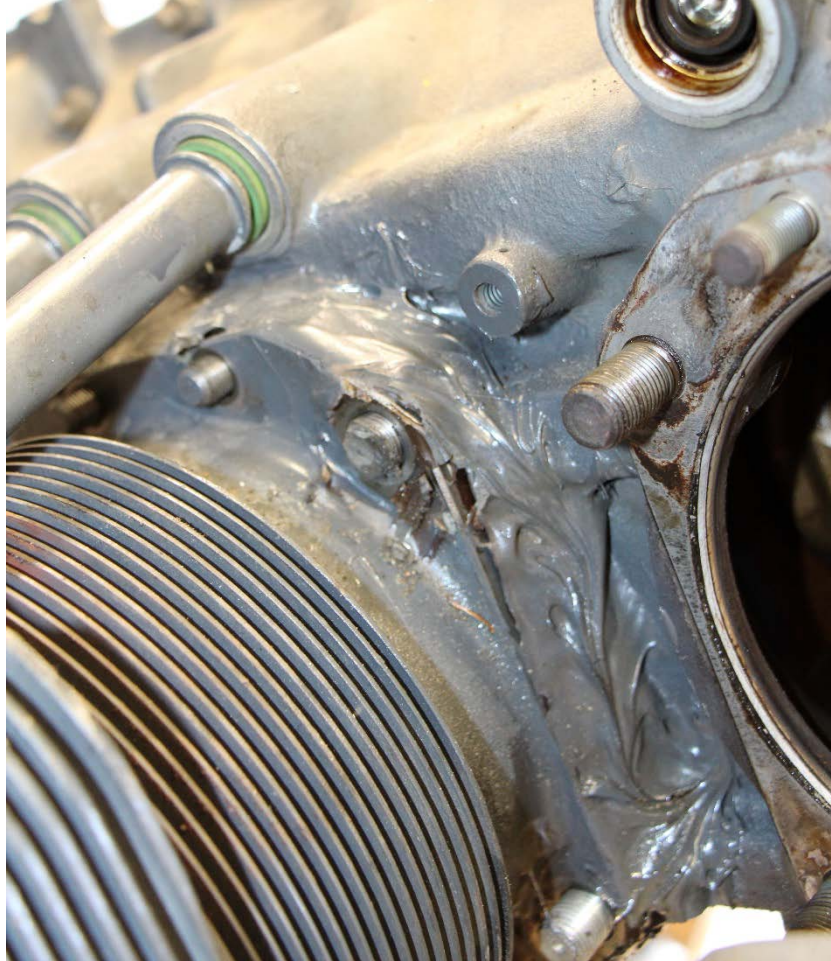
Each of the four cylinders walls, valves, pistons and connecting rods displayed normal wear with the exception of the exhaust valves to cylinder nos. 1 and 2, which displayed carbon deposits that were affixed to each valve. Cylinder no. 2 was sealed with PRC along the circumference of the outside diameter of the cylinder at the crankcase. The push rods were straight and unremarkable.

Photograph 9: PRC on Cylinder No. 2

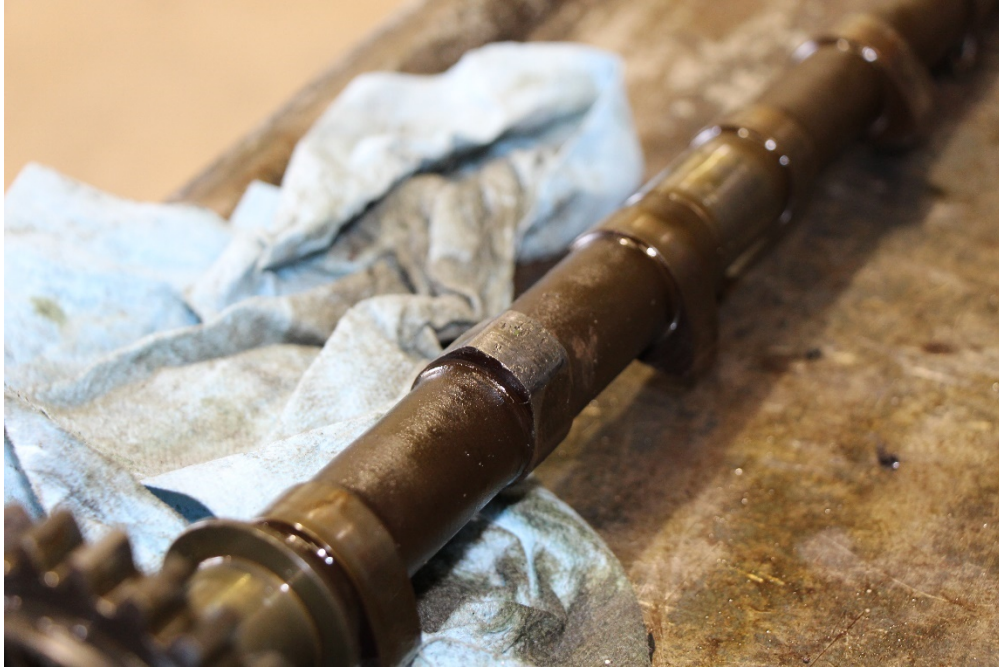
Rocker arm movement for each cylinder exhaust valve was smooth and unremarkable. The intake valve movement for cylinder nos. 1 and 2 were normal, but the intake valves to cylinder nos. 3 and 4 did not make full travel. The camlobe that support the intake valves to cylinder nos. 3 and 4 was severely worn with extensive pitting. The respective lifter for both intake valves was extensively spalled. Additionally, the cam lobe that supports the intake valves for cylinder nos. 1 and 2 exhibited some wear and the lifters were spalled.

Photograph 10: View of Camshaft and Intake Valve Cam Lobe to Cylinder No. 3 and 4 (note pitting and wear)

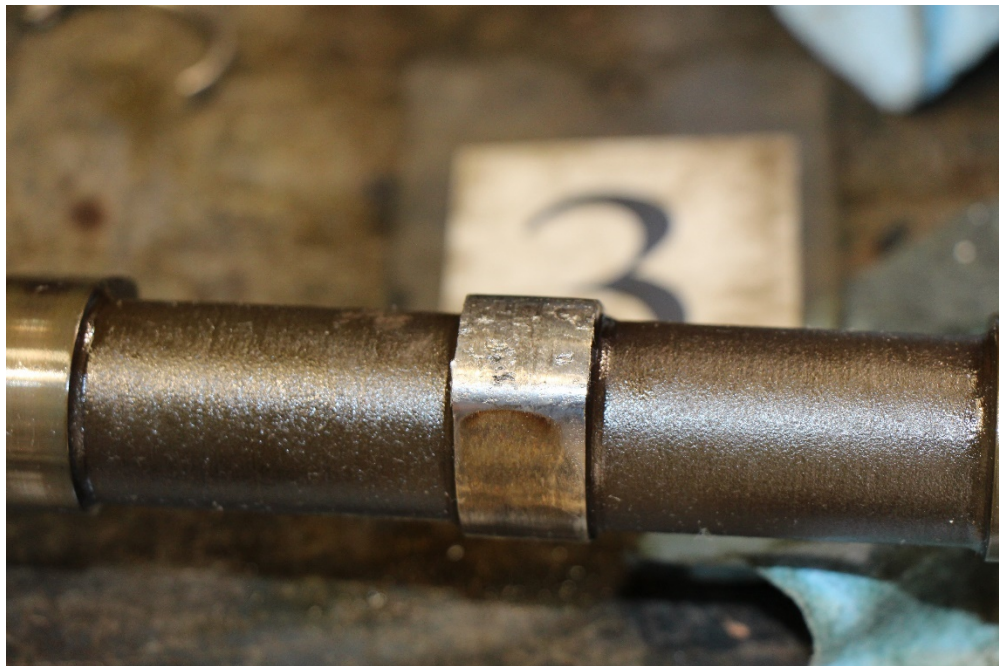
Photograph 11: View of Intake Valve Cam Lobe to Cylinder No. 3 and 4 (note pitting and wear)

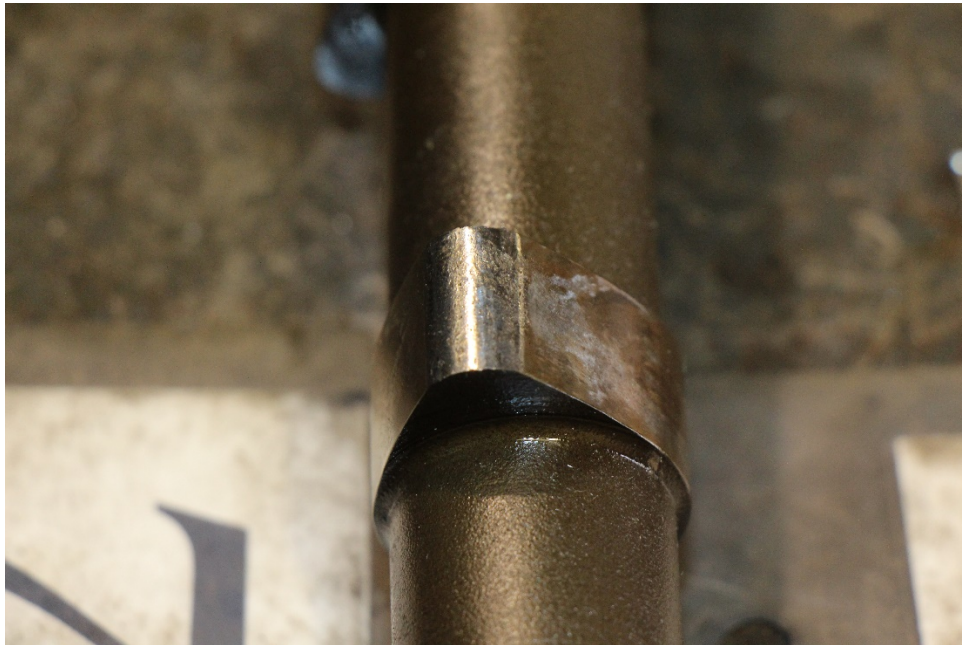
Photograph 12: View of Intake Valve Cam Lobe to Cylinder No. 3 and 4 (note some pitting and wear)

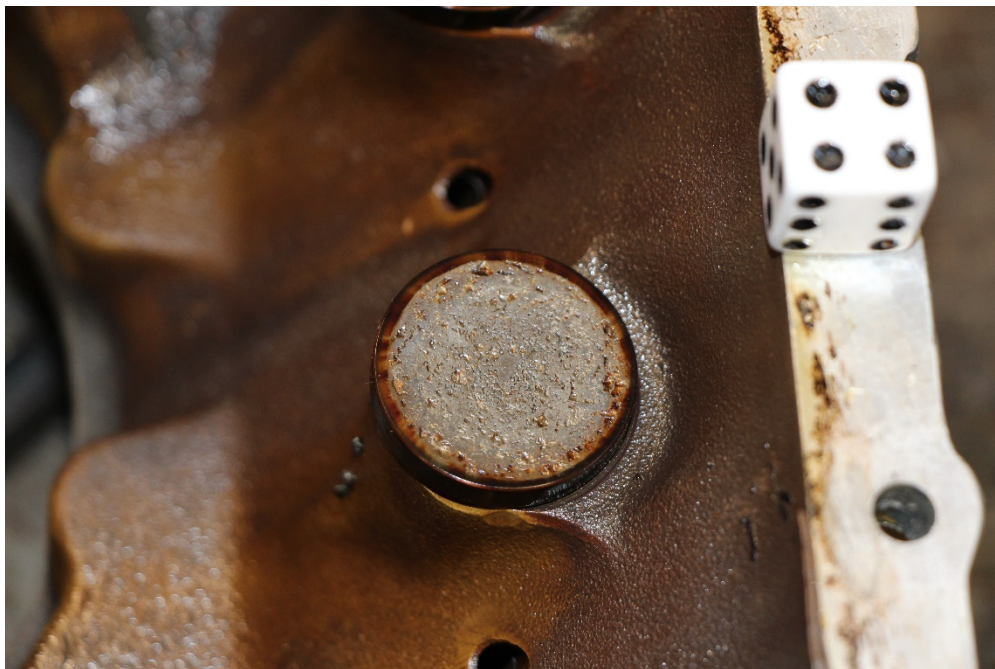
Photograph 13: View of Cam Lifter to Cylinder No. 4 Intake Valve (note spalling)

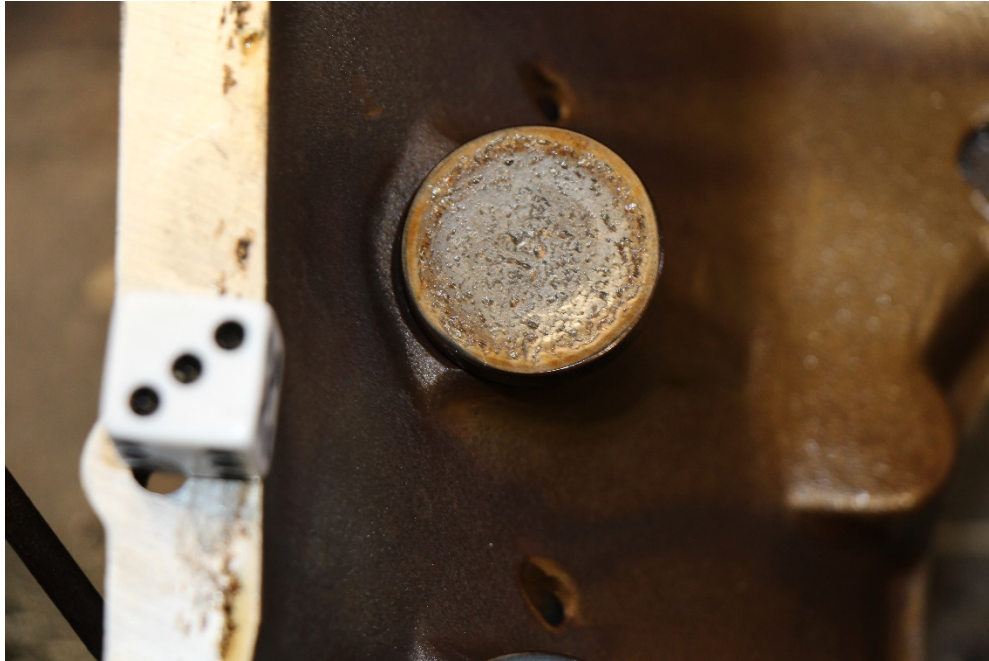
Photograph 14: View of Cam Lifter to Cylinder No. 3 Intake Valve (note spalling and wear)
