## ***Quicksilver GT-500 Preliminary Engine Tear-down Inspection Summary***

Date of accident: 11-25-2017

N Number: N599RA

Engine: Type Rotax 582 Blue Head (2 cylinder water cooled two stroke)

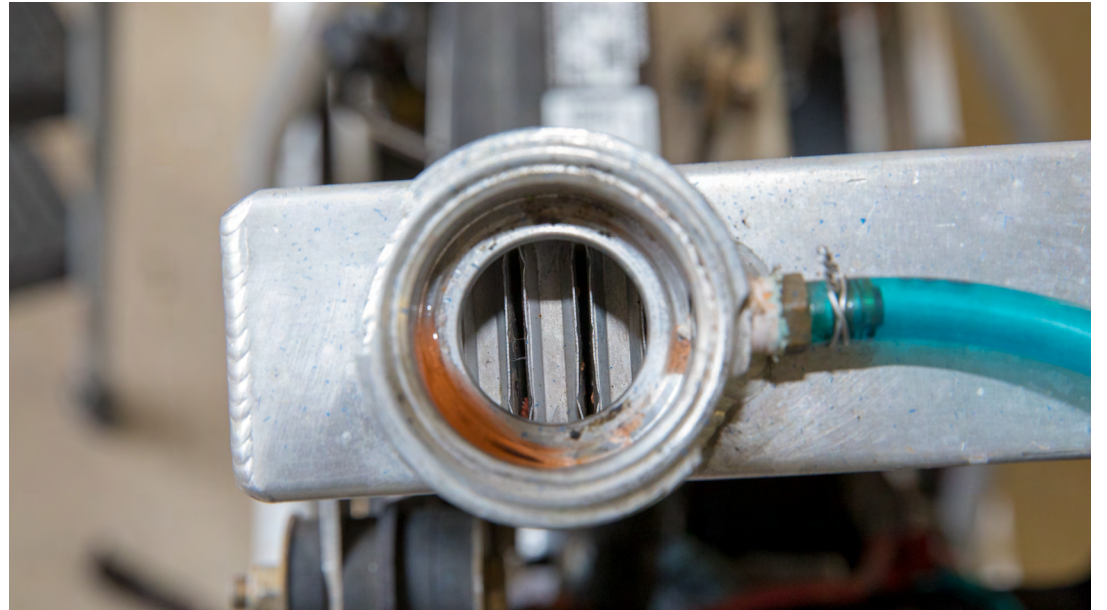
*Figure: 1 Radiator*

1. Radiator: Radiator coolant level was found to be low enough that the fluid was not be visible through the radiator cap. (Figure: 1) There was antifreeze in the system. After draining the remaining coolant from the system, it is estimated that approximately 1/4 of the antifreeze was missing from the cooling system.
2. Coolant recovery bottle: The radiator overflow and recovery bottle had fluid in the bottle. The amount of

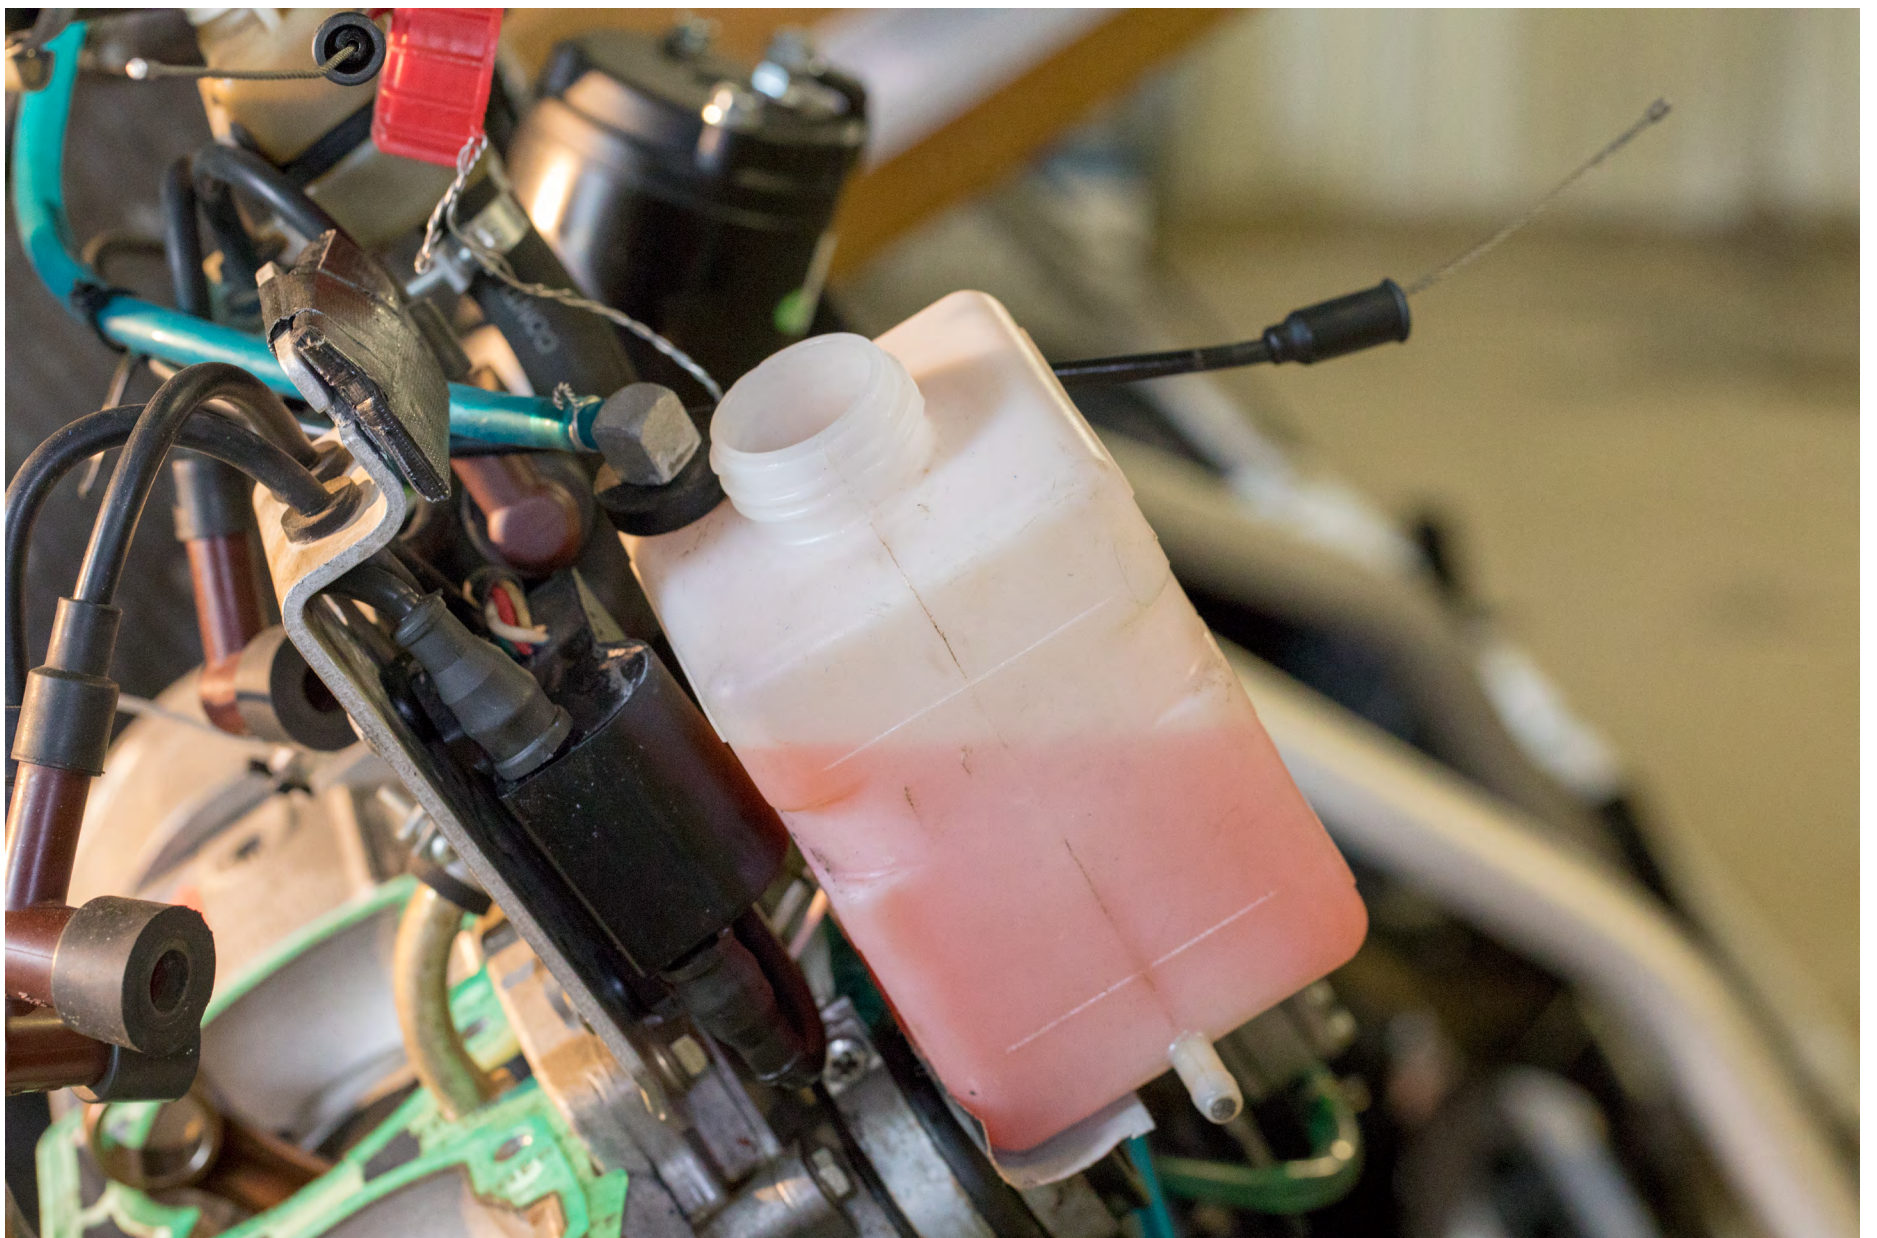
*Figure: 2 Radiator Overflow and Recovery Bottle*

coolant in the bottle was within normal servicing limits.(Figure: 2) However, the recovery bottle was rendered nonfunctional by the improper installation. The hose from the radiator is attached to the top of the recovery bottle rather than its proper location which would be at the bottom of the recovery bottle. The 90° fitting installed into the top of the recovery bottle extends into the bottle less than 1 inch. Any loss of fluid in between any flights could not be replenished during the cool-down cycle. The normal nipple used for installation has been plugged.

3. Radiator Recovery Bottle: Proper installation of the radiator recovery and overflow bottle would likely have refilled the radiator. Based on the observed amount of leak, proper installation of the recovery bottle would likely have prevented the engine failure. In addition, the diminishing quantity of coolant in the recovery bottle would have reinforced and identified the significance of the existing leak.

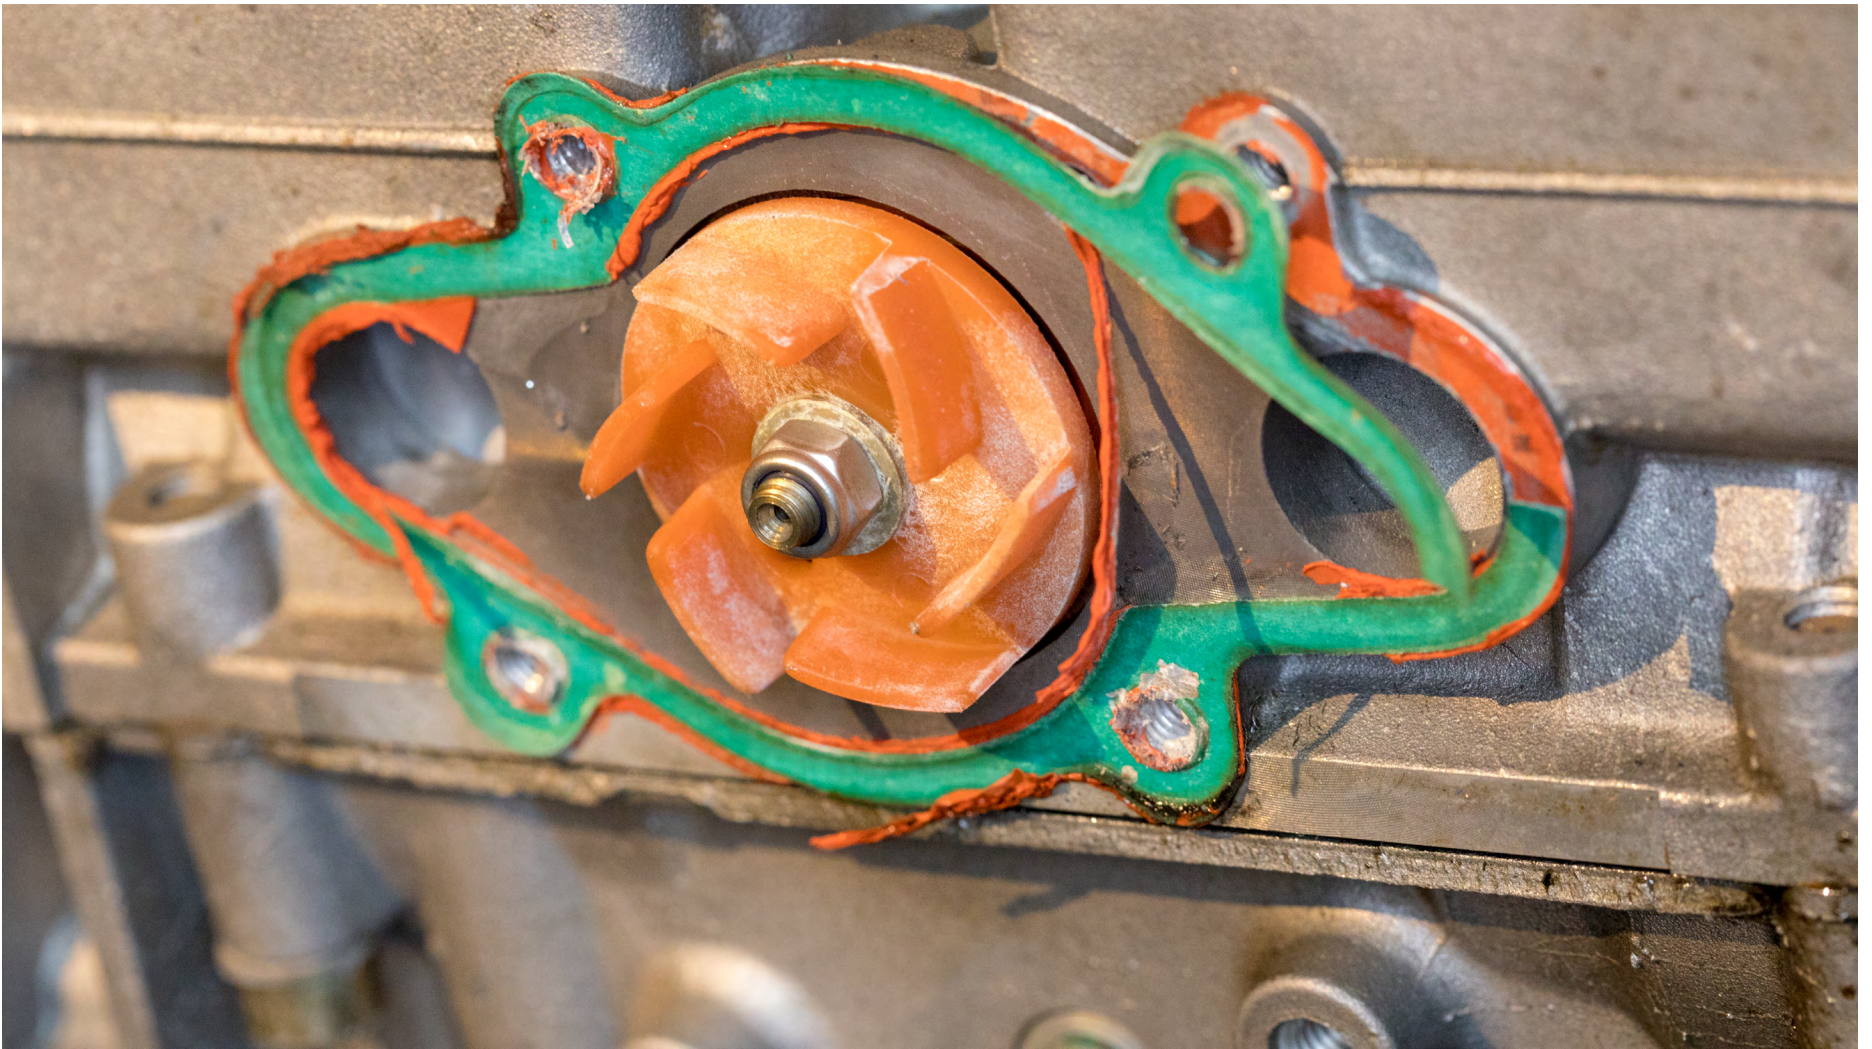
*Figure: 3 Water Pump*

3. Water pump: The water pump system was intact and operating correctly. No physical signs of looseness or play in the water pump shaft. (Figure: 3)
4. Coolant Leak: A small, but visible, leak was found on the water pump inlet hose, (Figure: 4) water pump housing, case halves, and motor mount plate on the exhaust side of the engine. The exhaust side is also the side that the water pump and coolant hoses are mounted on. No leaks or discharge from the radiator were evident. One of the more common sources of leaks on this side of the engine is at the case half location directly underneath the water pump. (Figure: 5) There is a witness hole that will drain coolant if the Rotary intake valve shaft seal leaks coolant. The Rotary intake valve shaft is also the shaft that drives the water pump. On earlier versions of the Rotax 582 this was a common problem area with frequent leaks, however, on the blue head 582, the problems were addressed in a design change and the number of shaft seal leaks have now diminished and this problem is now considered rare. Close examination of this area between the case halves and underneath the water pump revealed that there is coolant in this area. However, there is a strong possibility that the fluid leak around the water pump housing nipple, Located directly above, is the source of this fluid. Because of the relatively small amounts of fluid that leak through this shaft seal, past experience has shown that visual inspection of the seals when removed from the engine is not an adequate method of determining whether or not the seals are functioning properly. A visual indication of fluid leaking or not leaking at the weep hole is the best indication of the seals condition. And because we cannot run the engine after repairing the hose leak without first repairing the engine, the possibility of the shaft seals contribution to the leak remains unknown.

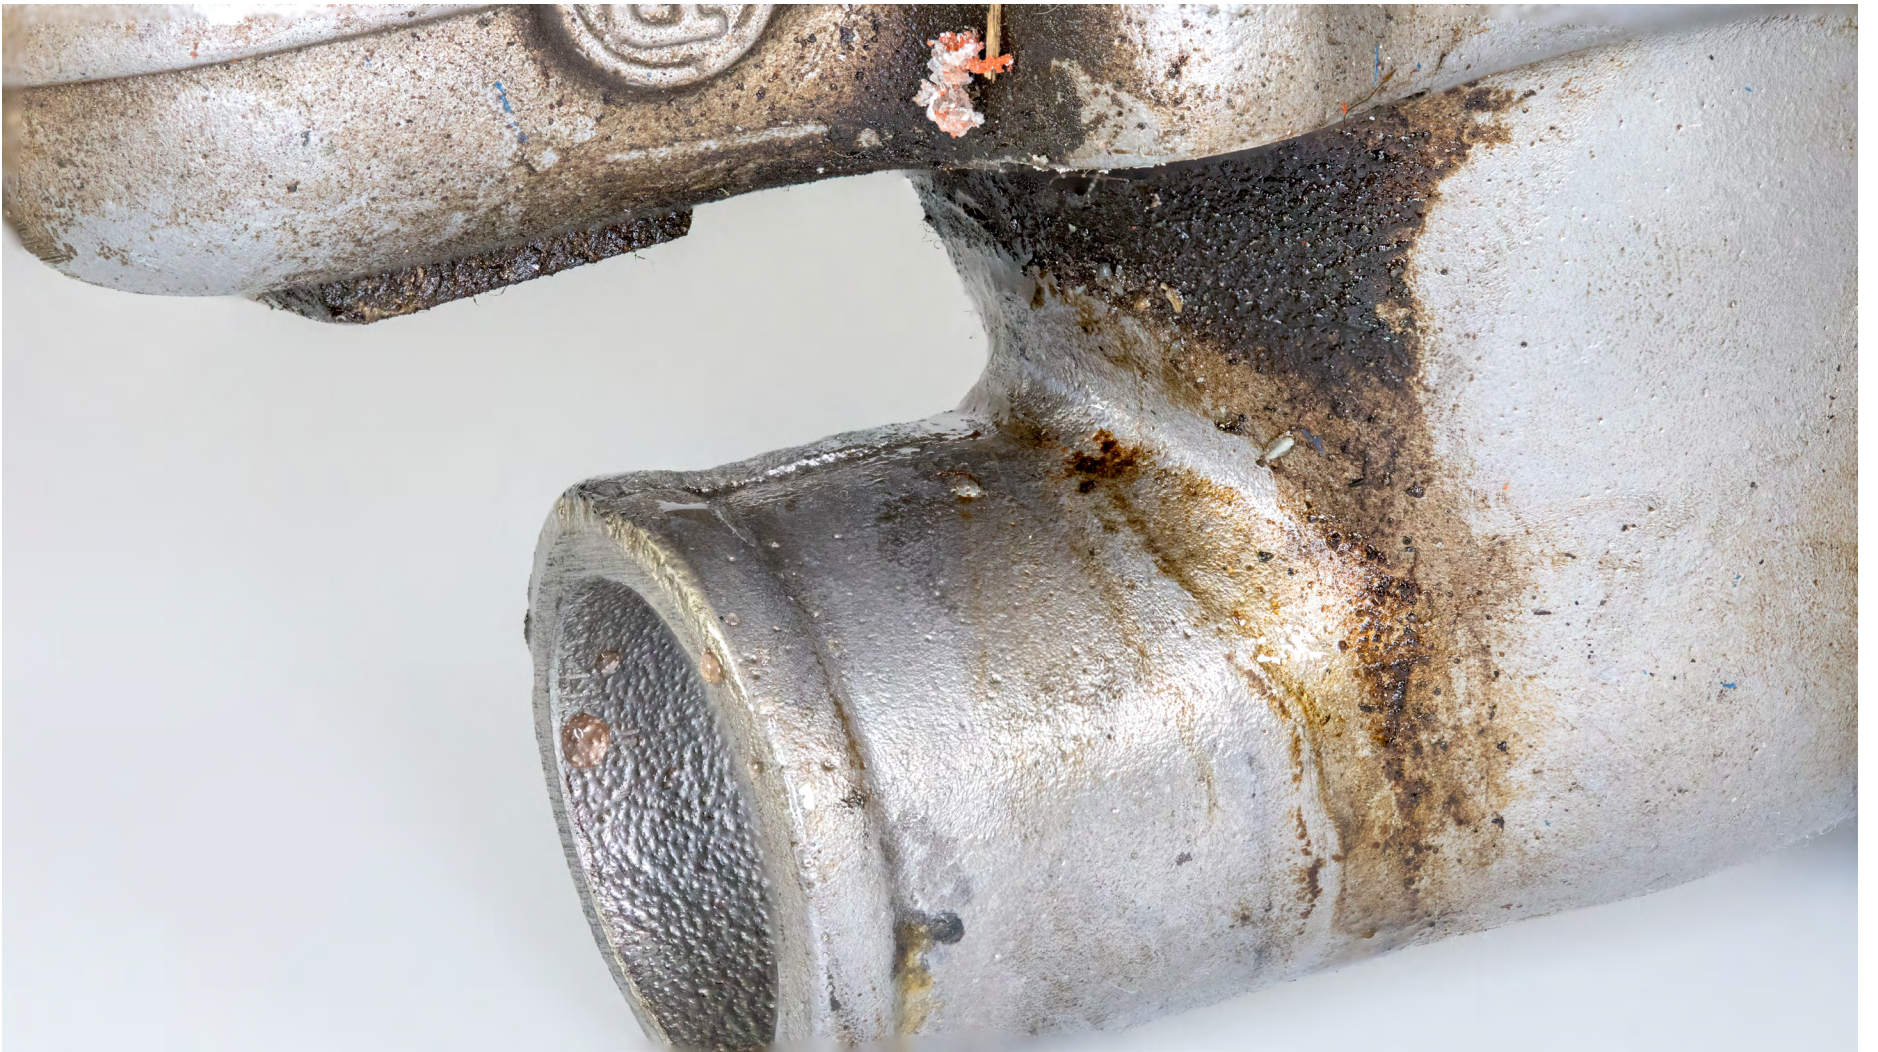
5. Water pump housing nipple: Looking at the water pump housing nipple (Figure: 6) We can see coolant, mixed with caked on debris, that has obviously accumulated over a period of time. The majority of this

accumulation is on the top of the water pump housing nipple. And the water pump housing is located above the case halves. Because there are no other sources for coolant in this general vicinity the most likely source of the leak are these hoses and nipples on the water pump housing. Upon closer examination of the water pump housing nipple we can see that the casting has some anomalies. (Figure: 6) we can see a step in the casting. We find this typical of other 582 engines as well and the normal remedy would be to simply rework this area to create a smooth surface for hose installation. However, in (Figure: 7) we see an example on the outside casting seam with a more extreme step. In this case, it appears as though this would be rather difficult to completely eliminate a leak without a significant degree of rework or replacement of the housing. Based on the evidence of excessive tightening of both hose clamps in this location, it would be reasonable to suspect that previous evidence of leakage was identified and attempts made to remedy the situation with ex-

*Figure: 6* Water Pump Housing Nipple (Inner)

cessive tightening of the hose clamps. The hose was removed and measured at 1 inch ID and the water pump housing nipple (not concentric) was measured at .904 inches at its smallest dimension and .978 at its largest dimension. Based on these anomalies, it is likely that this is at least, the primary source of fluid loss within the coolant system.

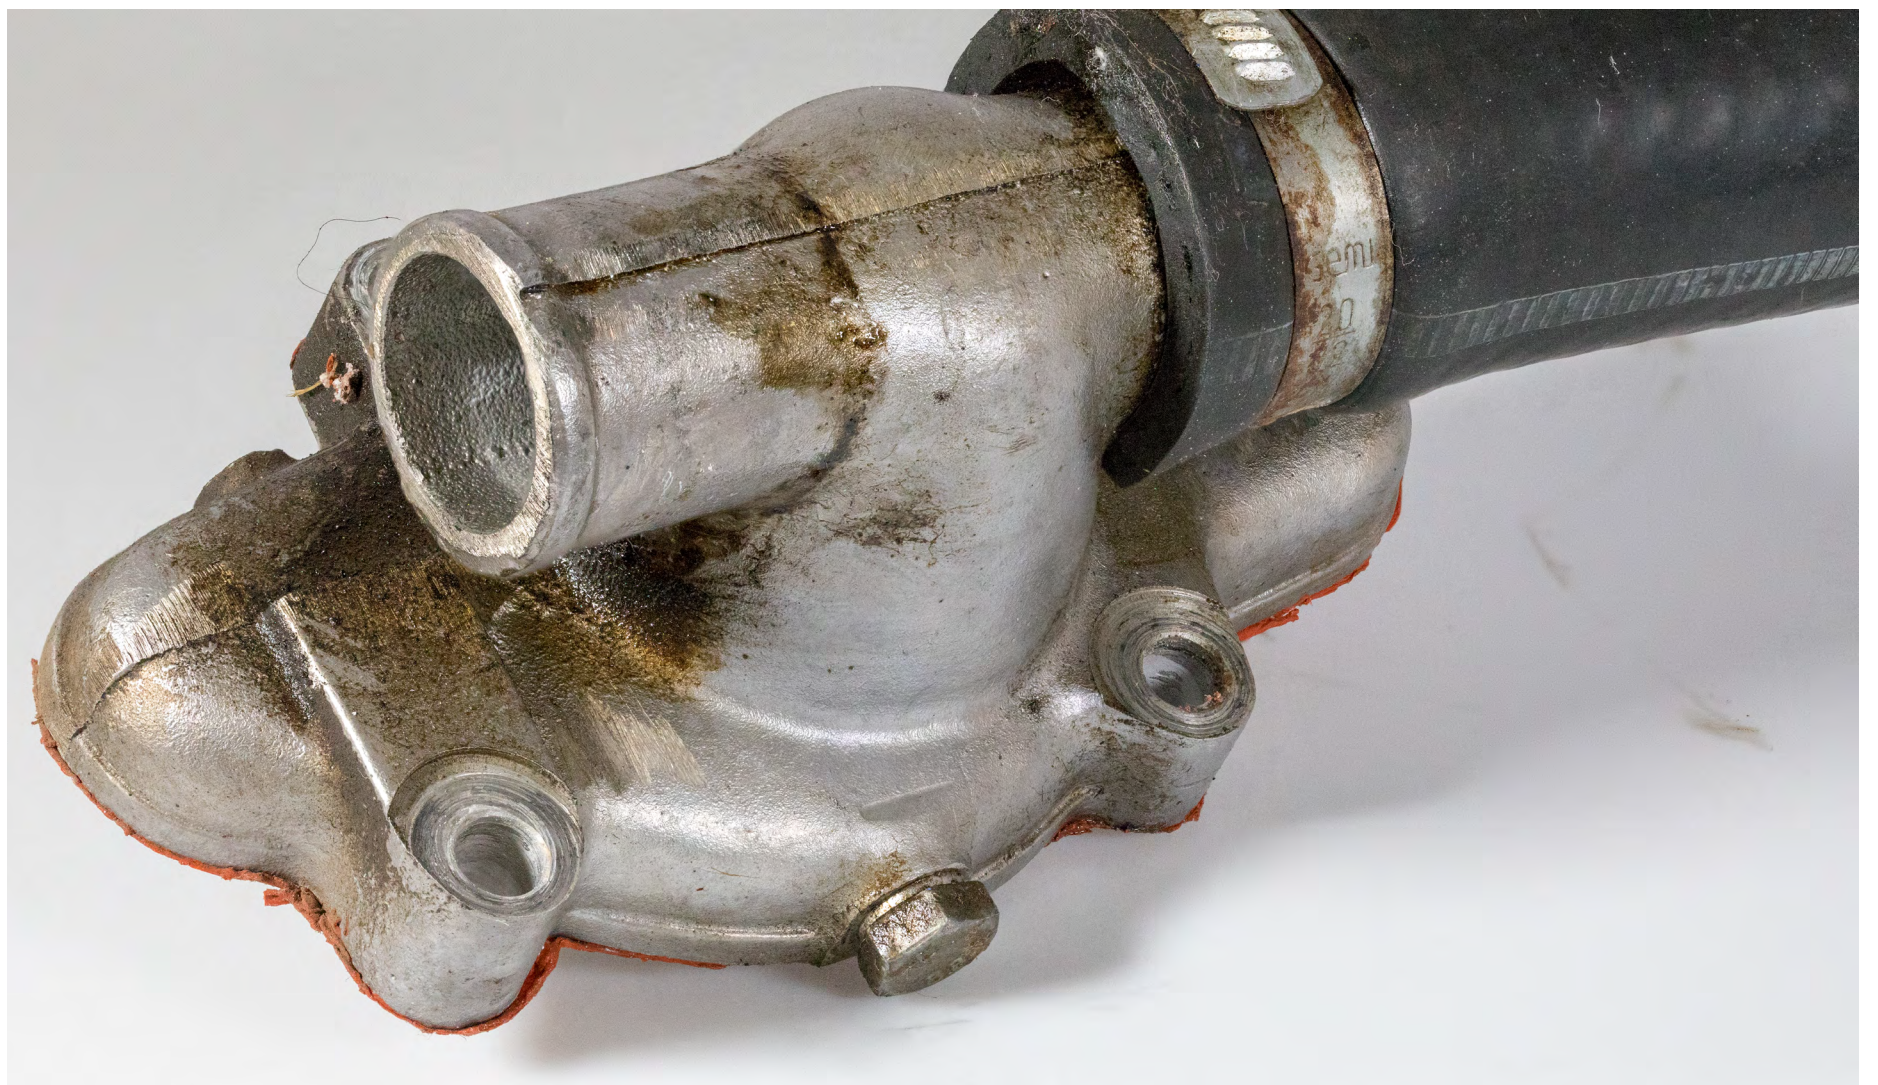
*Figure: 7* Water Pump Housing Nipple (Outer)

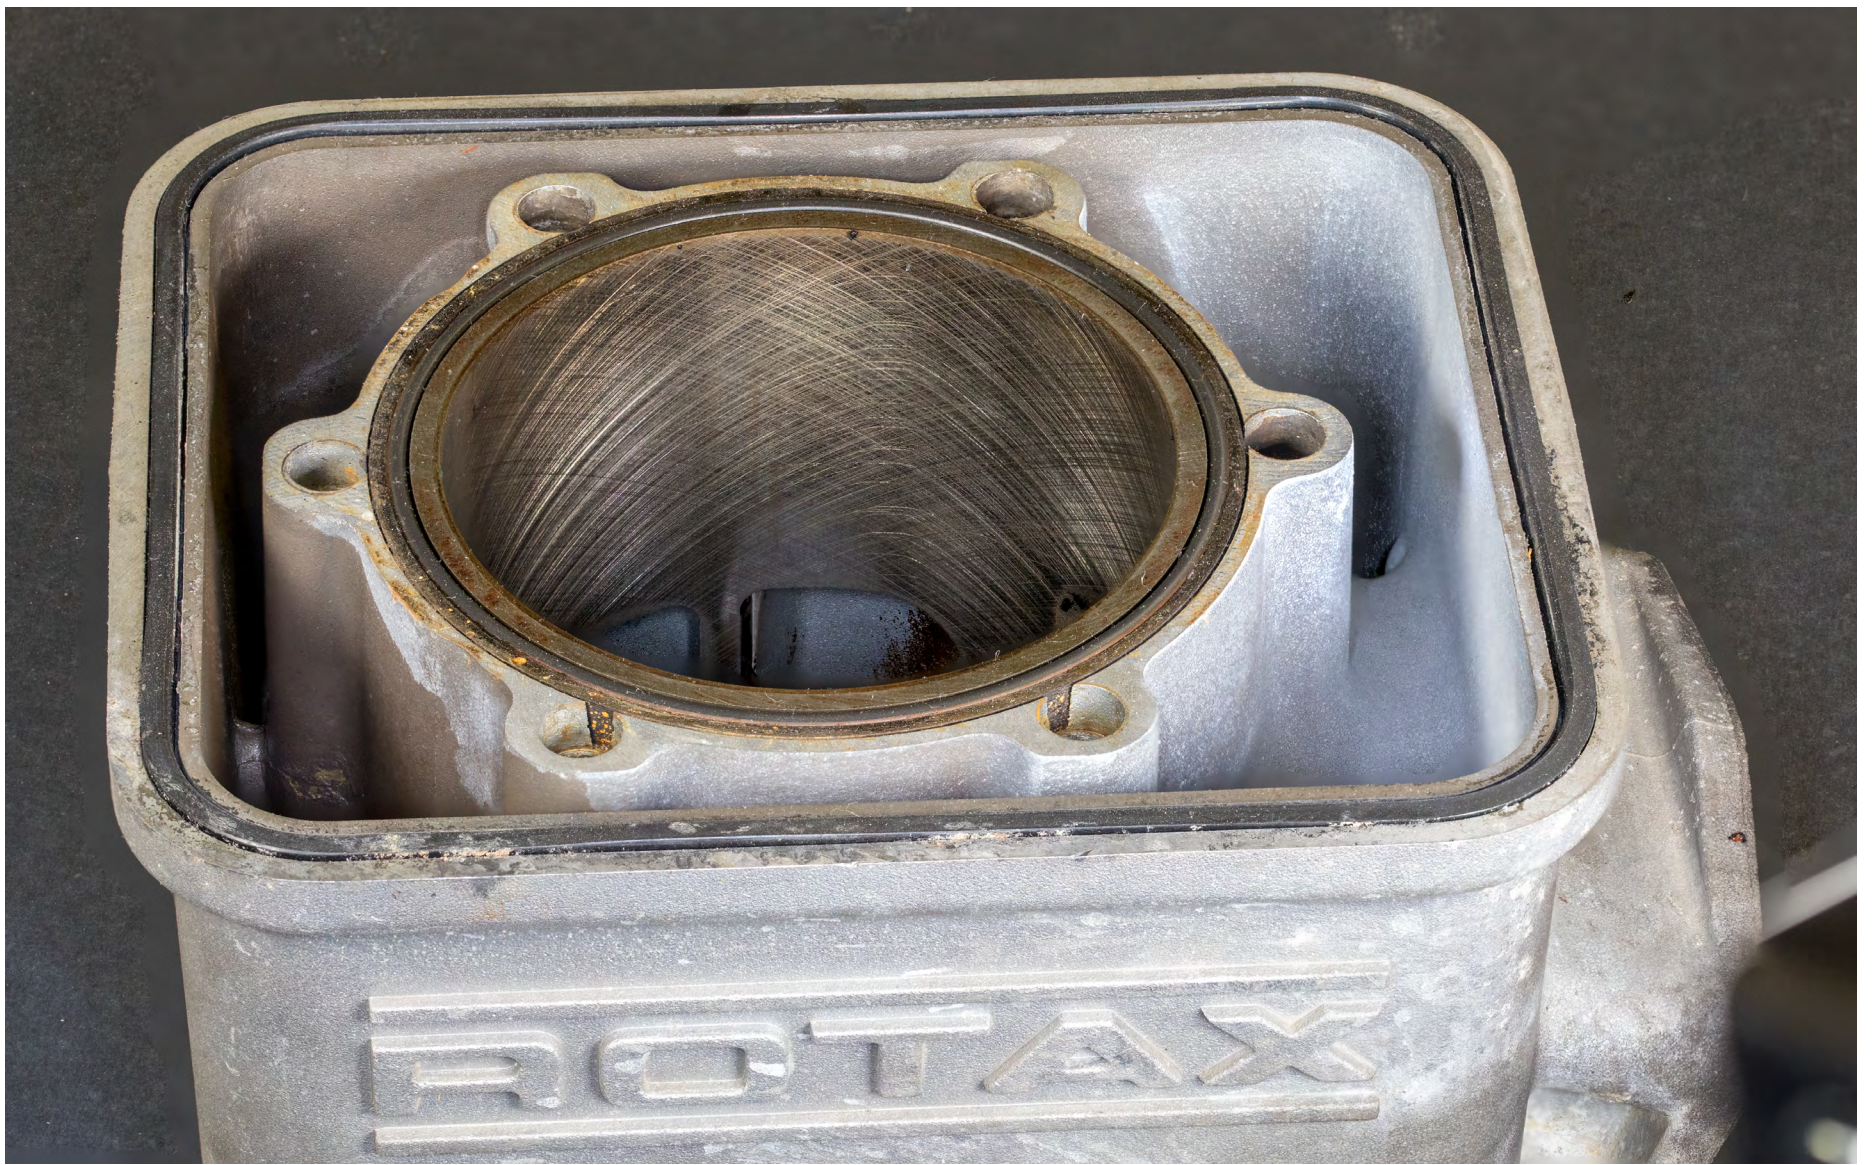
*Figure: 8* PTO Clyinder

6. Inspection of both cylinders show signs of lack of coolant. In (Figure: 8) you can see the walls of the water jacket on the exhaust port side are dry. Whereas, on the intake port side (cool side of the cylinder), there are signs of anti-freeze still embedded into the surface of the aluminum cylinders. This over heating indication is evident on both the PTO and the Magneto cylinders. The PTO cylinder shows the same symptoms as the magneto cylinder which suffered the seizure. However, this cylinder did not suffer any catastrophic failure.
7. Spark plugs (magneto side): Melting of both spark plug electrodes on the magneto cylinder is an indication of pre-ignition and subsequent detonation within that cylinder. (Figure: 9) shown is the plug closest to the magneto with the greatest amount of degradation.

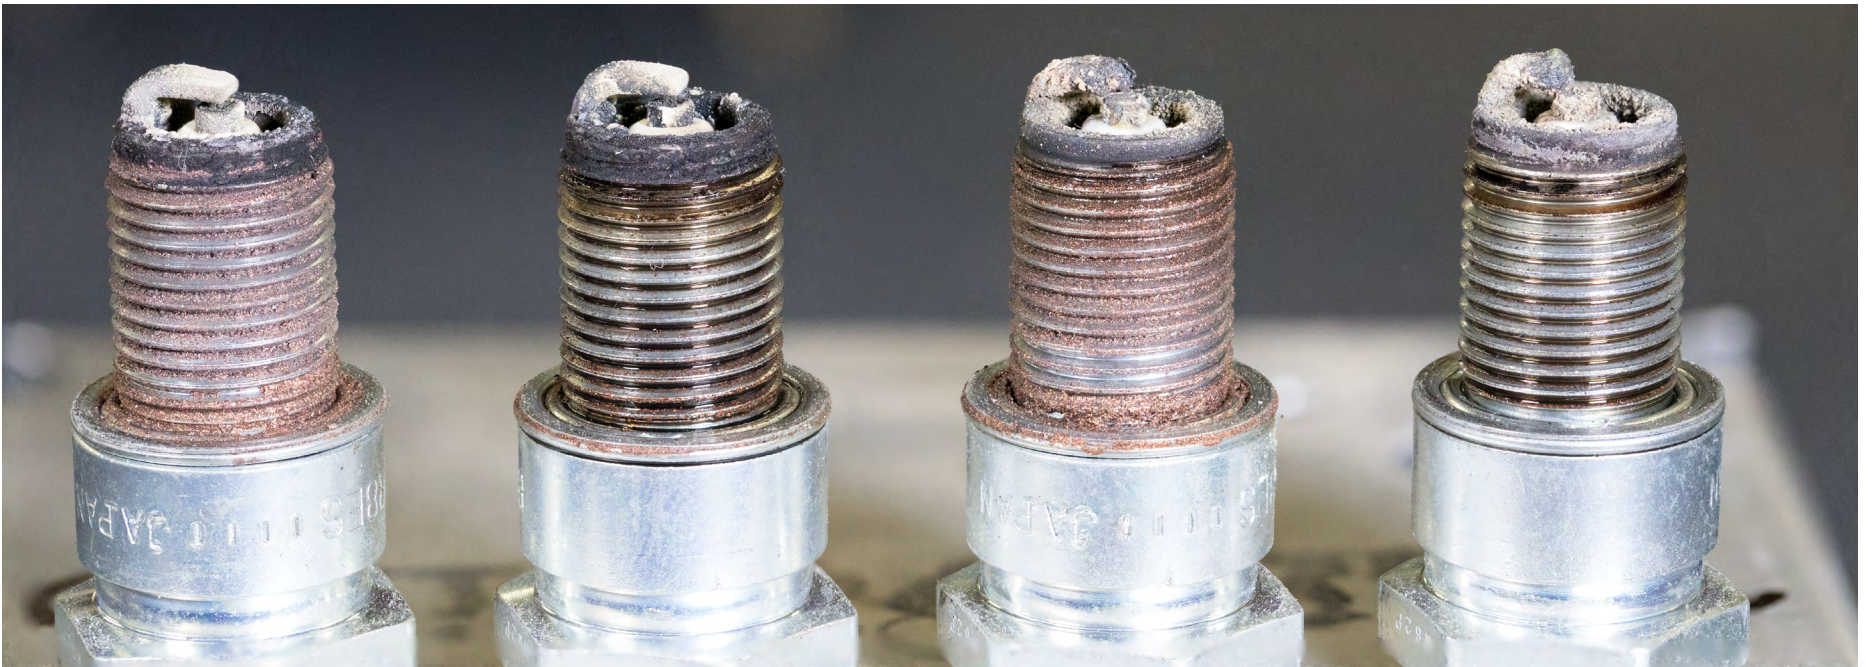
*Figure: 10 Spark Plugs In Order PTO on Left Mag on Right*

8. Spark plugs (PTO side): Both spark plugs from the PTO cylinder show signs of overheating of the ceramic insulator as indicated by the white color and lack of carbon or any other combustion deposits on the ceramic insulator. However, looking at the rest of the spark plug indicates that the engine had been running rich shown by the indication of black carbon deposits around the perimeter of the spark plug body. This corresponds with an indication of having an overheated cylinder head and not being able to dissipate the heat from both the head and the spark plug.(Figure: 10)

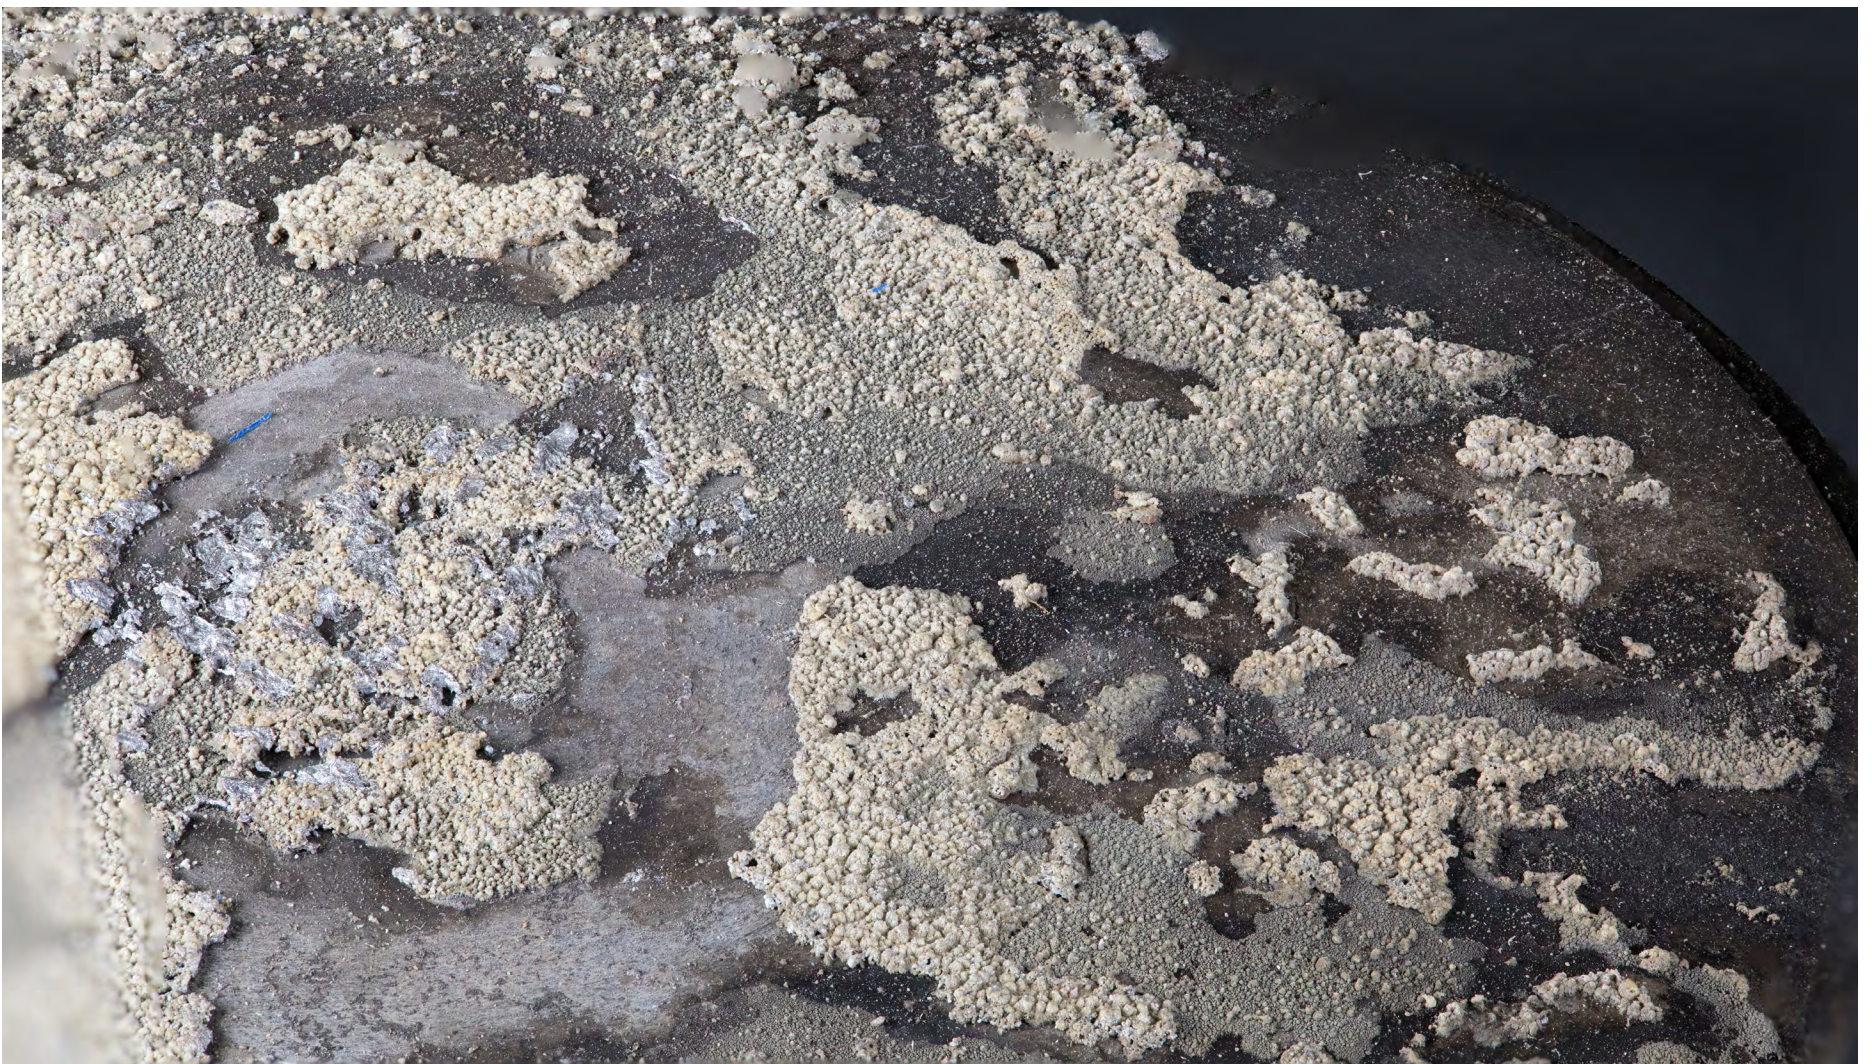
*Figure: 11 Metal Deposits*

9. Magneto Side Piston: The piston from the magneto cylinder also shows signs of pre-ignition and detonation. Melted metal deposits (from the spark plug electrodes ) on top of the piston in the center of the cylinder is an indication of pre-ignition (Figure: 11). Having detonation only would be indicated by the end gas explosions occurring at the perimeter of the piston rather than the center. The most likely source of pre-ignition would be either carbon deposits or spark plug electrodes. On the Rotax 582, ignition from car-

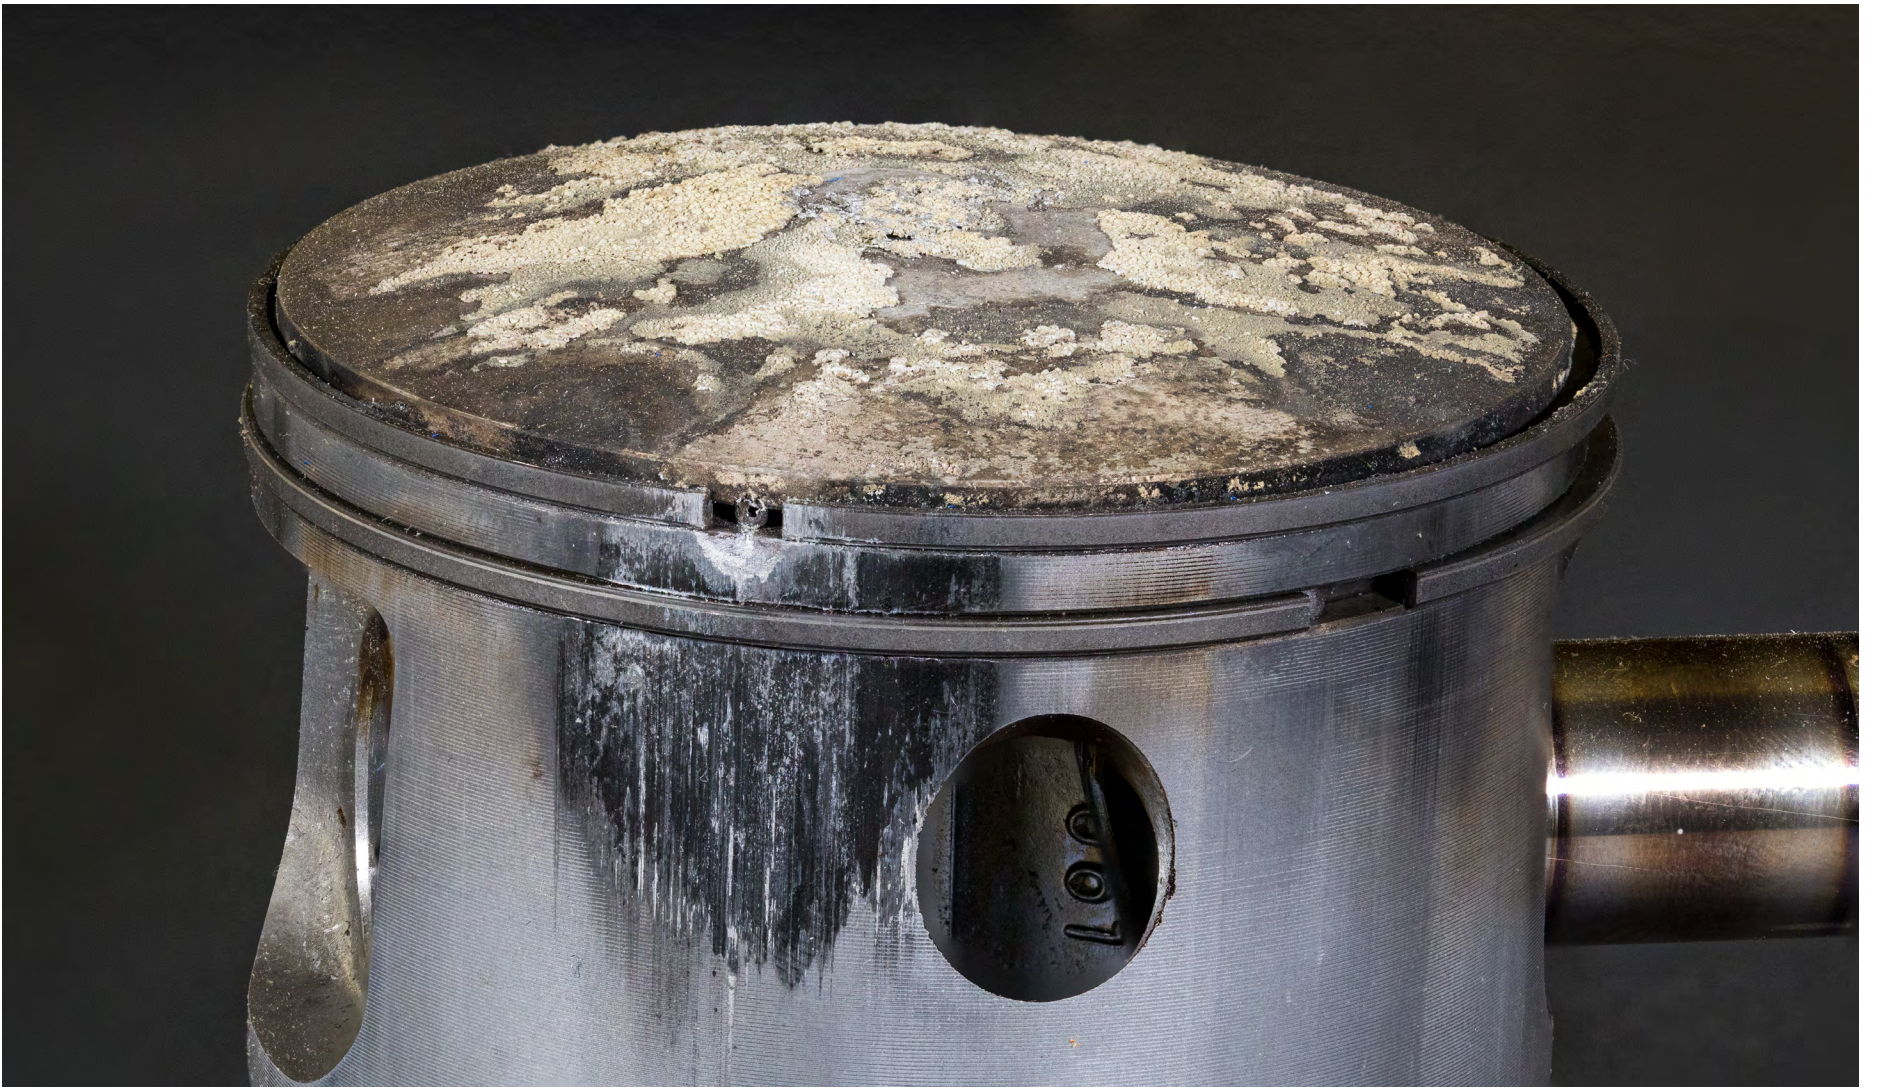
*Figure: 12 Magneto Side Piston (Intake Side)*

bon deposits most often occurs at the hottest spot on the piston which would be the exhaust side. Based on the shock-wave disruption of the carbon deposits on the top of the piston, they appear to be fairly well distributed and originating from the center of the piston outward. In addition, the burning away of the cylinder head in the area of the upper ring (Dykes ring) (Figure: 12) at the pin and ring end gap is consistent

with pre-ignition/detonation high-pressure/temperature gases escaping between the ring end gap and burning away the aluminum portion of the piston. It appears as though this area was most likely subject to secondary end gas detonation. This can be identified by the area of clean metal exposed as a result of the localized shock-wave pattern that removed the combustion deposits from this area. As this localized area of extremely high temperature/pressure exits between the ring end gap the velocity and temperature act much like a cutting torch. This melts away the aluminum and the embedding of the aluminum into the cylinder wall begins the cascading effect which results in seizure of the piston. If we compare the discoloration around the perimeter of the PTO side piston with the discoloration around the perimeter of the magneto (failed side) piston, you can see that the discoloration has been worn away by the tight piston to cylinder wall clearances. Both pistons, most likely, looked identical just prior to the engine failure. If we look at the bottom side of the piston, (Figure: 13) we can see the signs of overheating. The discoloration in the aluminum is a sign that the piston has been running at excessive temperatures. The indication of discoloration on the wrist pin is also another indication that the piston has been exposed to excessive temperatures for longer than just the period of time from the last takeoff power application to engine failure. This supports the hypothesis that the engine may have been losing coolant prior to the landing at the Willows airport. In addition, the carbon buildup on the bottom of the piston is also an indication of prolonged operation at above normal temperatures. On a normally operating engine no discoloration or carbon deposits will be evident.

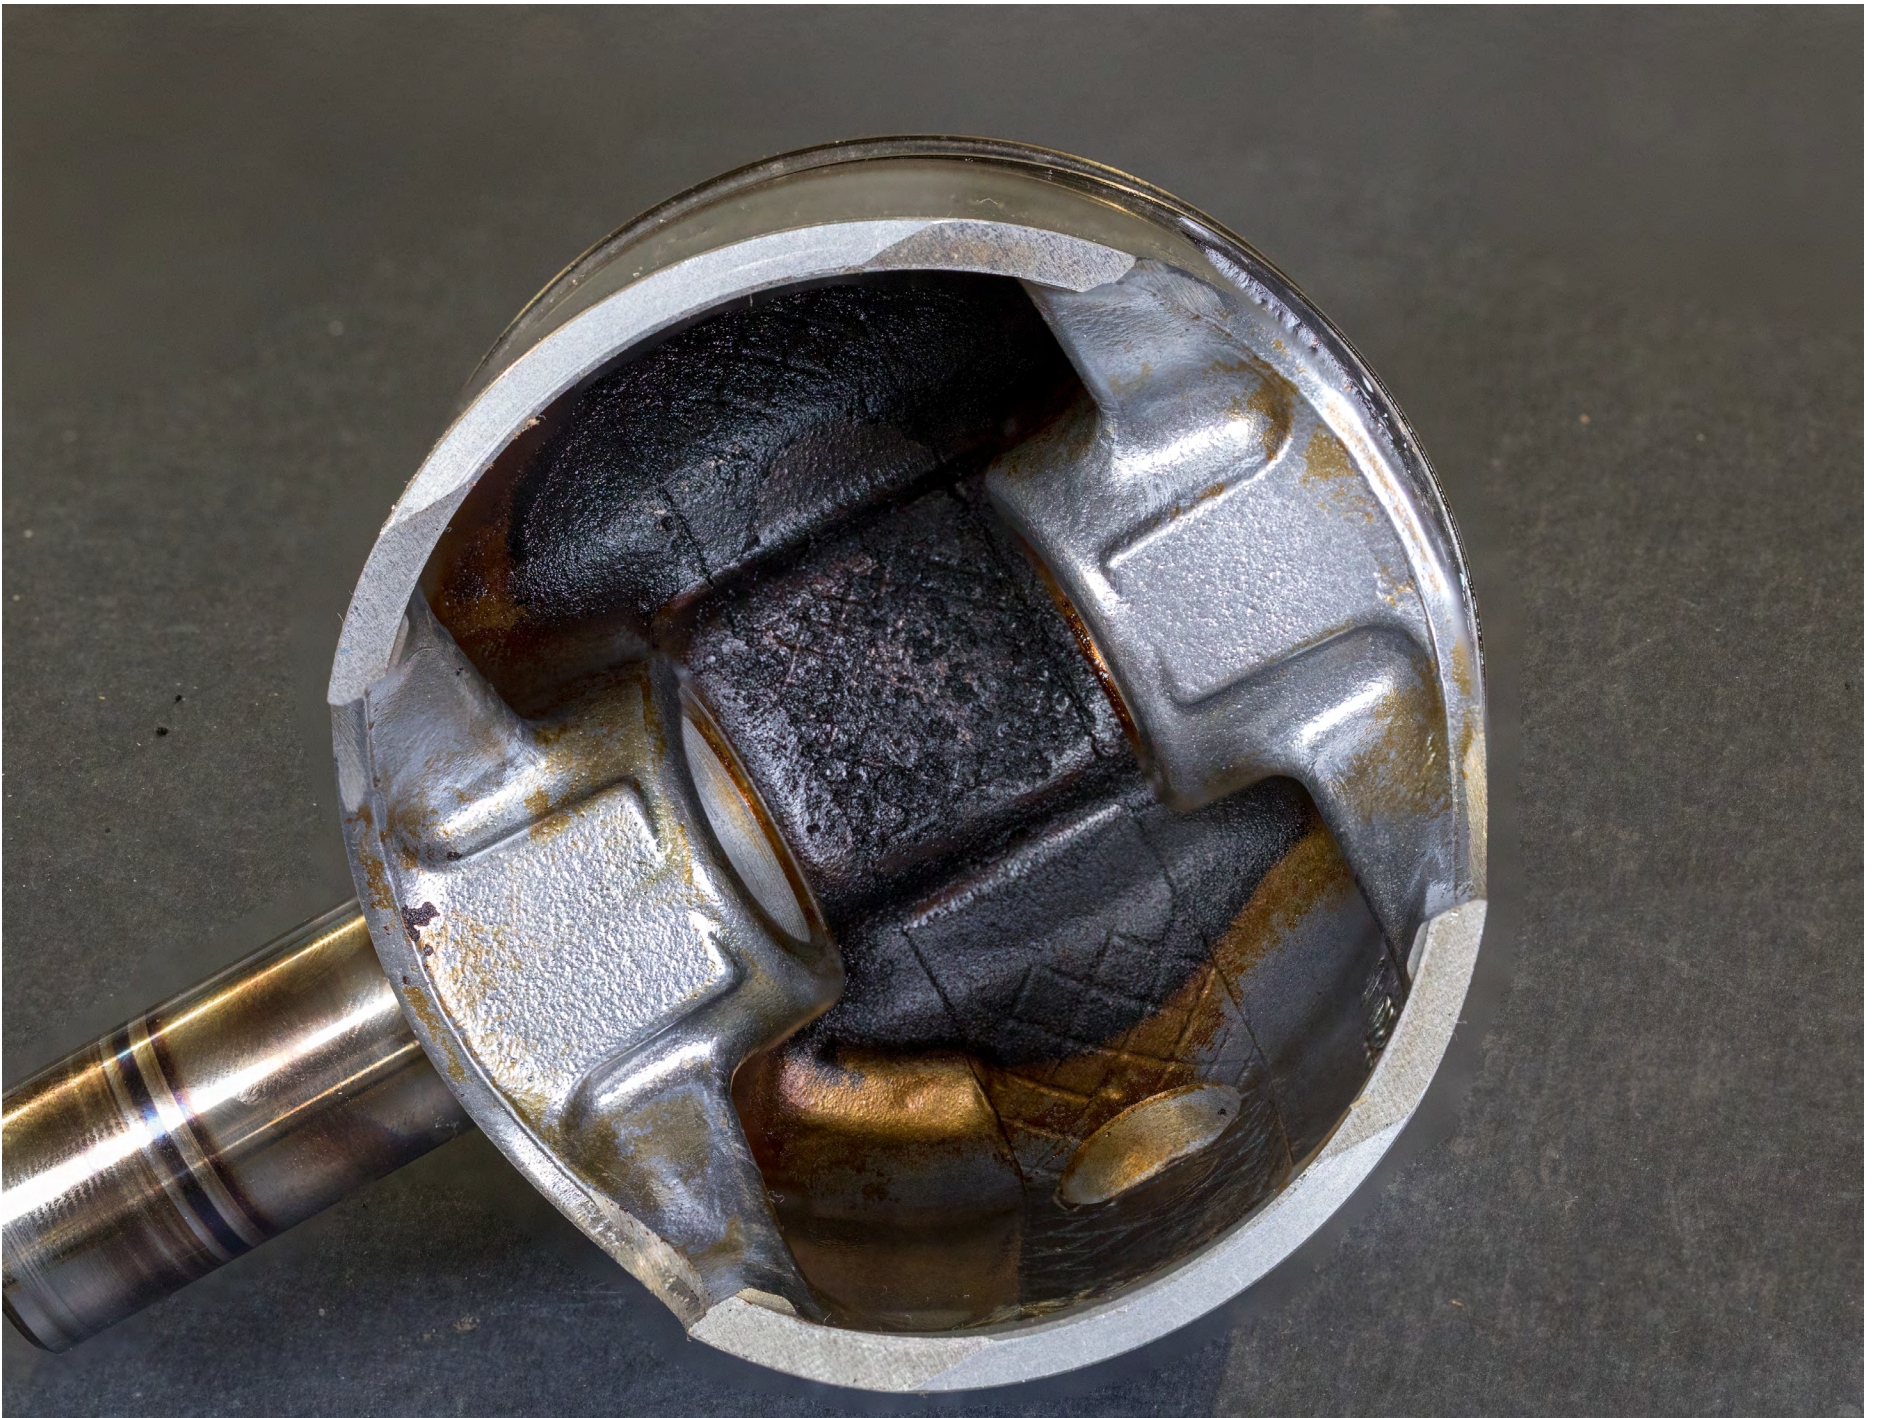
*Figure: 15 PTO Side Piston (Bottom)*

10. PTO side Piston: (Figure: 15) The PTO side piston also shows signs that the cylinder/piston had been overheating for some period of time. Both the discoloration and the presence of burnt on carbon deposits are evidentiary of this phenomenon. Both rings are floating and free from sticking. This would indicate that the overheating was a fairly recent event. Engines that run at a higher than normal temperature have a tendency to build these carbon deposits also within the ring groove causing the rings to “stick”. At the Dykes ring (top ring) end gap location, there is evidence of the very first signs of melting of the piston. (Figure: 16) On the intake side of the piston there are two vertical striations showing not a visible seizure, but an area of extremely high pressure very similar to what we would refer to as “sympathetic seizure marks” that we would see on the exhaust side of an engine suffering from lubrication injection pump failure, or even as a result of conditions similar to that related to a cold seizure. These are indications that the piston is overheating and has expanded to reduce the cylinder to piston wall clearance to below tolerances. This pressure was sufficient enough to burnish away the machining marks which are normally visible around the perimeter of the entire piston. On the opposite side of the piston there are also two points of high-pressure opposing the pressure points on the intake side of the piston. These will invariably be the first points of failure on the piston and cylinder wall if the engine continued to run in this configuration. The discoloration that encompasses the circumference of the top portion of the piston has been worn away in the high pressure area of the striations. This indicates that the discoloration and overheating occurred prior to the actual failure of the engine. The machining marks around the perimeter of the piston, which we mentioned previously, are one of the most useful tools in determining the quality of the engine overhaul and the subsequent operating conditions. Both of the pistons show extremely low wear. And indicates that the engine was operating correctly up until the subsequent incident.
