## ***Quicksilver GT-500 Preliminary Engine Tear-down Inspection Summary***

Date of accident: 11-25-2017

N Number: N599RA

Engine: Type Rotax 582 Blue Head (2 cylinder water cooled two stroke)

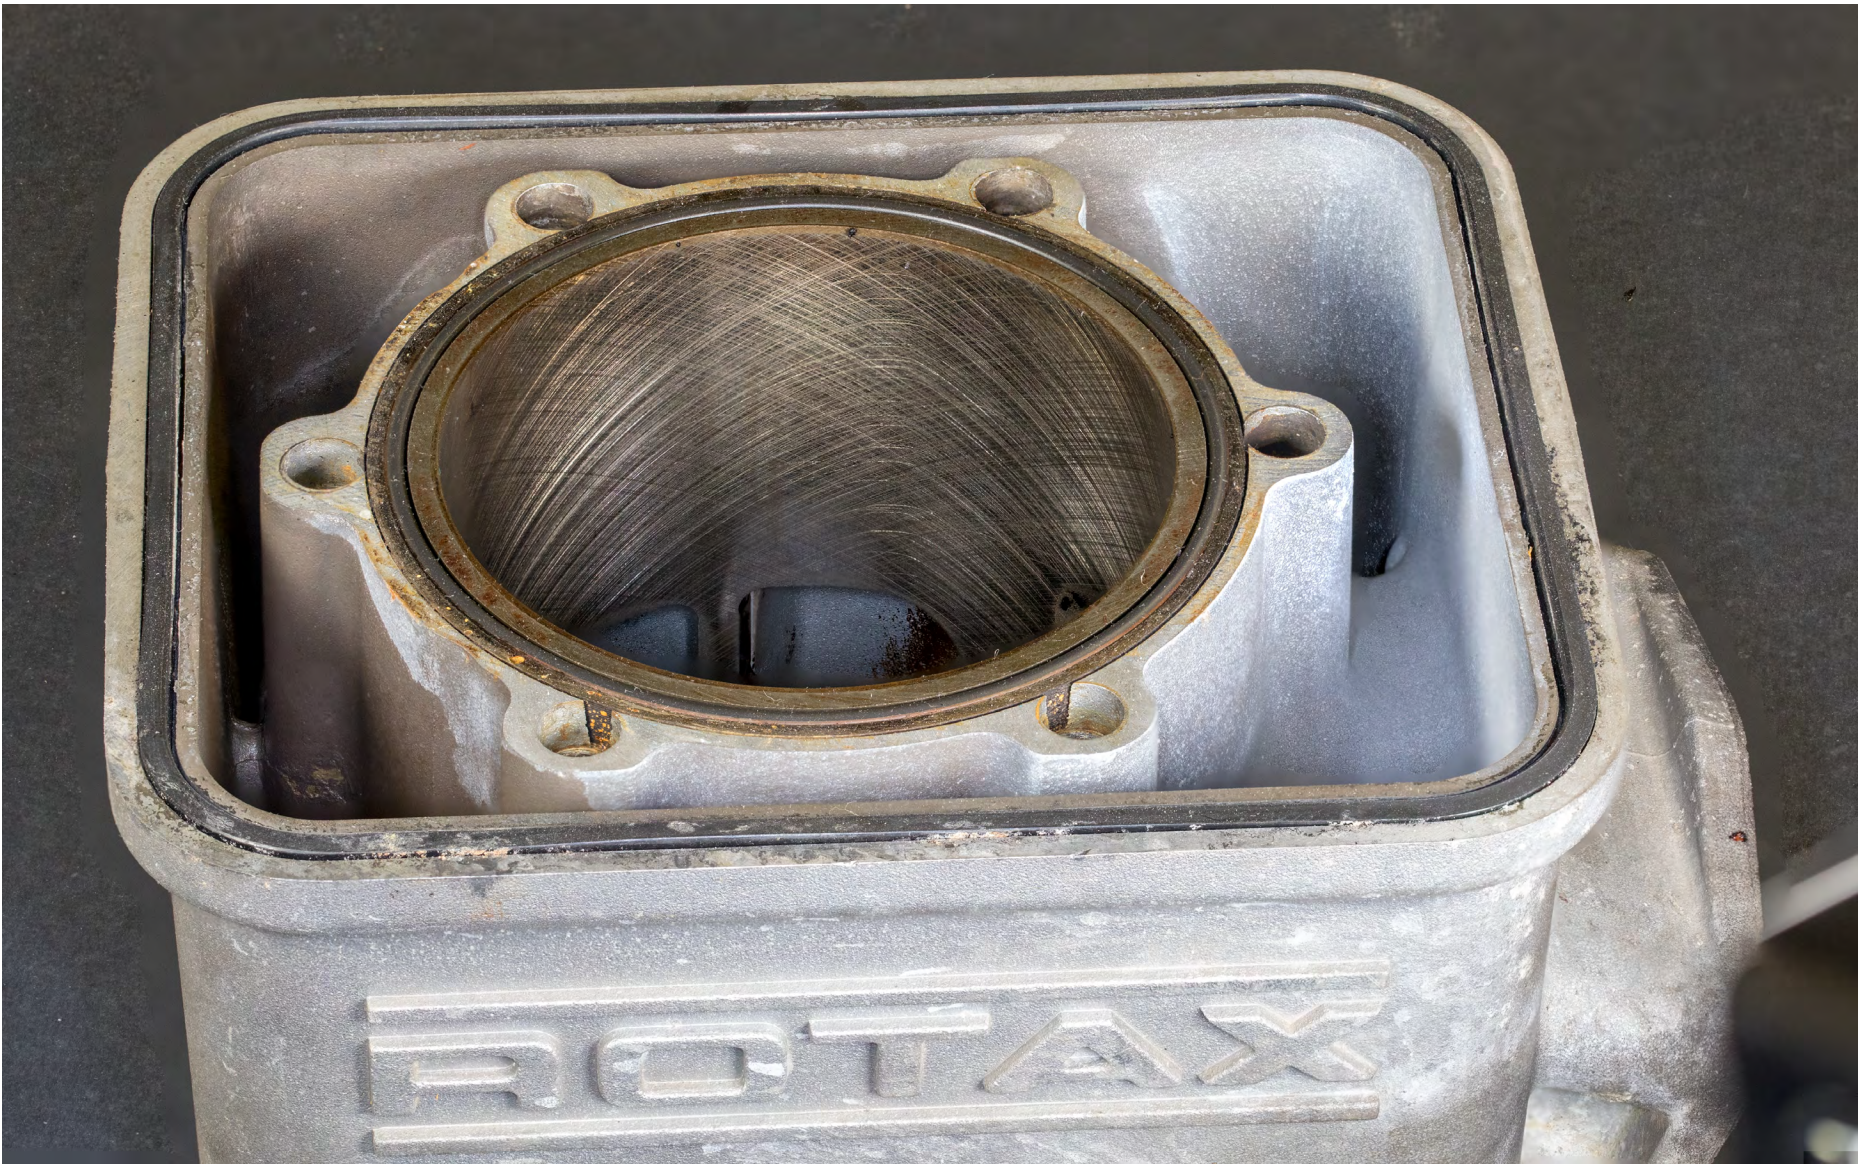
*Figure: 18 PTO Side Piston (Exhaust Side)*

11. PTO side cylinder: (Figure: 18) Like the pistons, the crosshatch in the cylinder walls and its condition are one of the prime indicators of proper overhaul and subsequent operating conditions. The quality of the crosshatch within both cylinders is in excellent condition. The quality of the crosshatch would indicate that these are either factory new cylinders, replaced at overhaul, or perhaps a newer engine with the original cylinders. This condition is only achievable through proper crosshatching subsequent proper break-in. This will allow the optimal "Abbotts Firestone Curve" in layman's terms (flat spot to groove ratio). Only properly crosshatch cylinders, which are properly broken in, will typically look in this good of condition at ~300 hours. The cylinder crosshatch in conjunction with the relatively nonexistent wear on the piston skirts as evidenced by the condition of the machined surfaces are the basis for this conclusion. In our experience, we often see cylinders in this condition operate for an additional 300 to 400 hours.

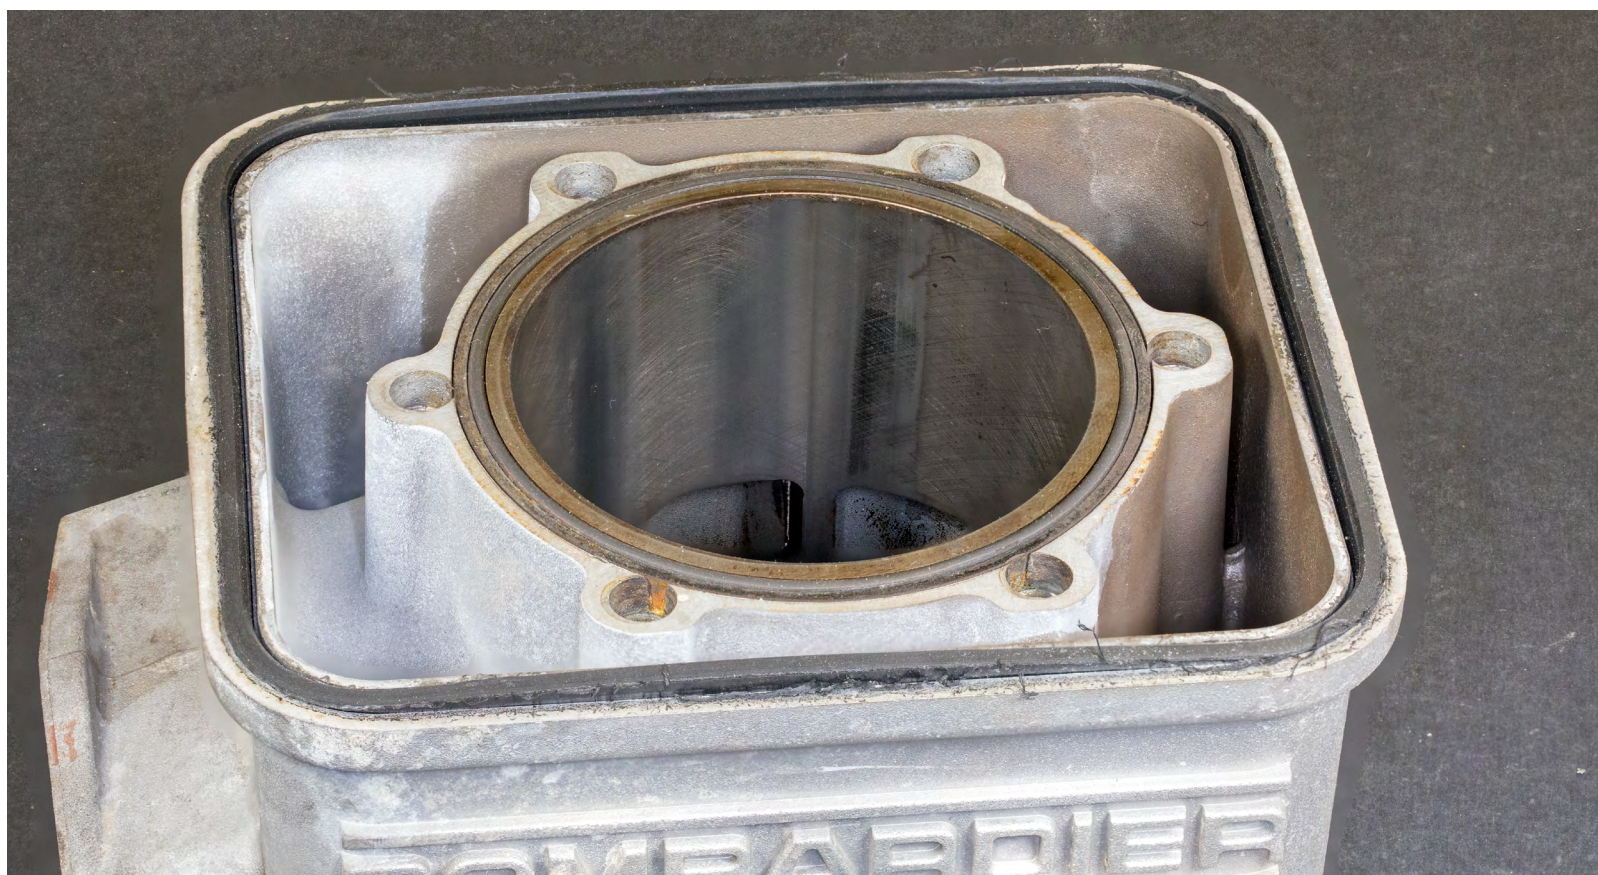
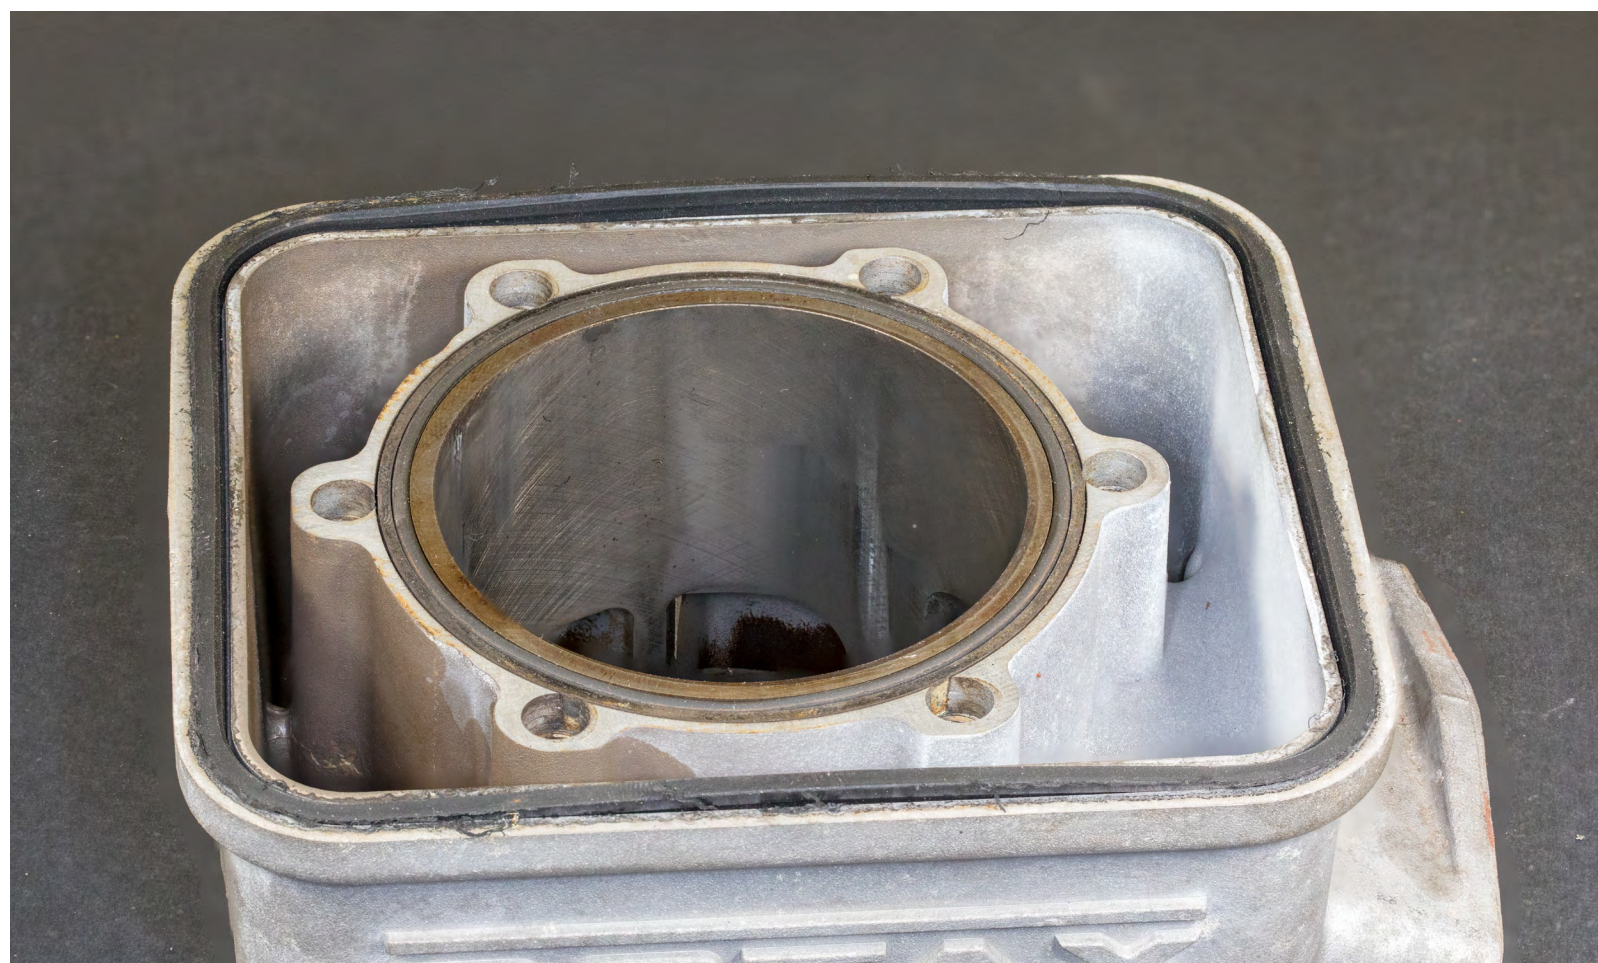
12. Magneto side cylinder: The condition of the magneto side cylinder looks to be similar to that of the PTO side cylinder prior to the engine failure. After the engine failure, transfer of metal corresponding to the seizure locations on the associated piston are consistent with a cylinder in distress as a result of pre-ignition/detonation and subsequent seizure. (Figure: 19)(Figure: 20)

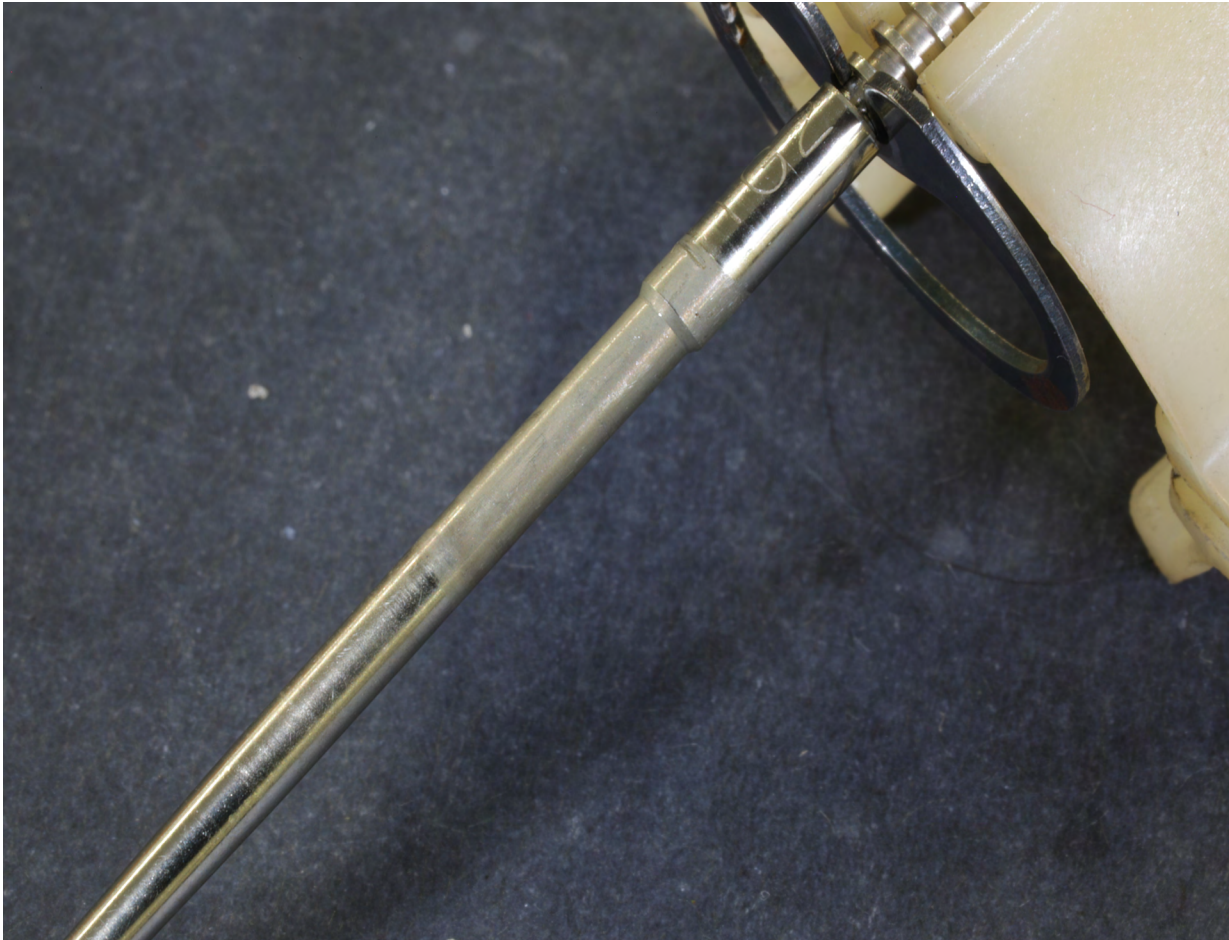
13. Mag side Carburetor: Tear-down inspection observations. [{Main jet, 165} --- {Idle jet, 45} --- {Needle Jet, 2.72} --- {Jet needle, 11G2} --- {Clip position, 4} --- {Air Screw, 1.75}] (Figure: 21) based on the tear-down observations we found several anomalies. (1) The clip position was in groove # 4 instead of groove # 3 as recommended, moving the clip down, or if you want to think of it as moving the needle up, causes an increase in the amount of fuel and enriches the mixture. (2) The idle air screw was set at 1.75 turns instead of 1 turn out from the seated position. (3) The o-ring was missing from the idle jet. (4) The idle jet was a 45 instead of a 55. Although we can provide a fairly lengthy treatise on the probable reasoning behind these anomalies, in this particular fail scenario, we do not feel that this would have any significant implication on the basis for the engine failure, and as such will leave this discussion for some other venue. Based on observation of the spark plugs, pistons, and cylinder head, we see evidence that both carburetors were running rich in the midrange of operation. This can be seen in the carbon deposits on the aforementioned components. Tear-down inspection of both carburetors showed signs that the needle jet, and jet needle (Figure: 21) have significant wear. In addition the cir-clip (Figure: 23) that holds the needle in position inside of the carburetor slide also shows signs of significant wear allowing the needle to rotate inside of the needle jet causing wear of both the needle and the jet. The clip should hold the jet needle securely and not allow the needle to rotate. With vibration the contact surface between the clip and the needle may wear. However, the clip is spring loaded to ensure that even during wear friction is provided to prevent the needle from rotating. Over time, the wear may exceed the limit of the clips ability to provide tension and this can be seen in (Figure: 23) where the two contact surfaces of the clip are now in contact with each other preventing tension on the needle. In this case, the clip can be spun without

Figure: 22 Jet Needle (Mag Side Carb)

resistance around the perimeter of the needle. This, in turn, accelerates the wear on the clip, needle jet, and jet needle. In addition, the o-ring on top of the circlip was missing from the mag side carburetors. The purpose for this o-ring is to help stabilize the needle and reduce the amount of vibration and subsequent wear on the needle jet and jet needle. Running rich in the midrange has correlative importance in this case inasmuch as excessive carbon buildup can be a source of pre-ignition in many scenarios. But more importantly, it may contribute to the reason for the engine failure occurring at the particular point in the mission profile. In the cruise, approach, and landing profile the reduced manifold pressure accompanied by the excessively rich mixture may have prevented the engine from reaching temperatures conducive to pre-ignition. The needle jet/jet needle provide the mixture setting that correlates with the 1/4 - 3/4 throttle setting. Once above the 3/4 throttle setting the primary controller of the mixture is the main jet. At full throttle, as in the case of this engine failure, the needle jet and jet needle have no effect upon the mixture. Upon inspection, the main jet is the proper jet and appears to be in proper operating condition, and free from contamination or corrosion. The float level (Figure: 24) is also set up correctly. The wear on the carburetor slide is indicative of a carburetor that has been in service longer than the last ~300 hours of operation since the estimated of the last engine overhaul. In addition, the overall condition of the carburetor looks as though the engine overhaul at ~300 hours ago may have been the last time that the carburetors were also overhauled. This is supported by the amount of wear on the needle jet and jet needle, condition of O-rings (Figure: 25), and age and deterioration of gaskets.

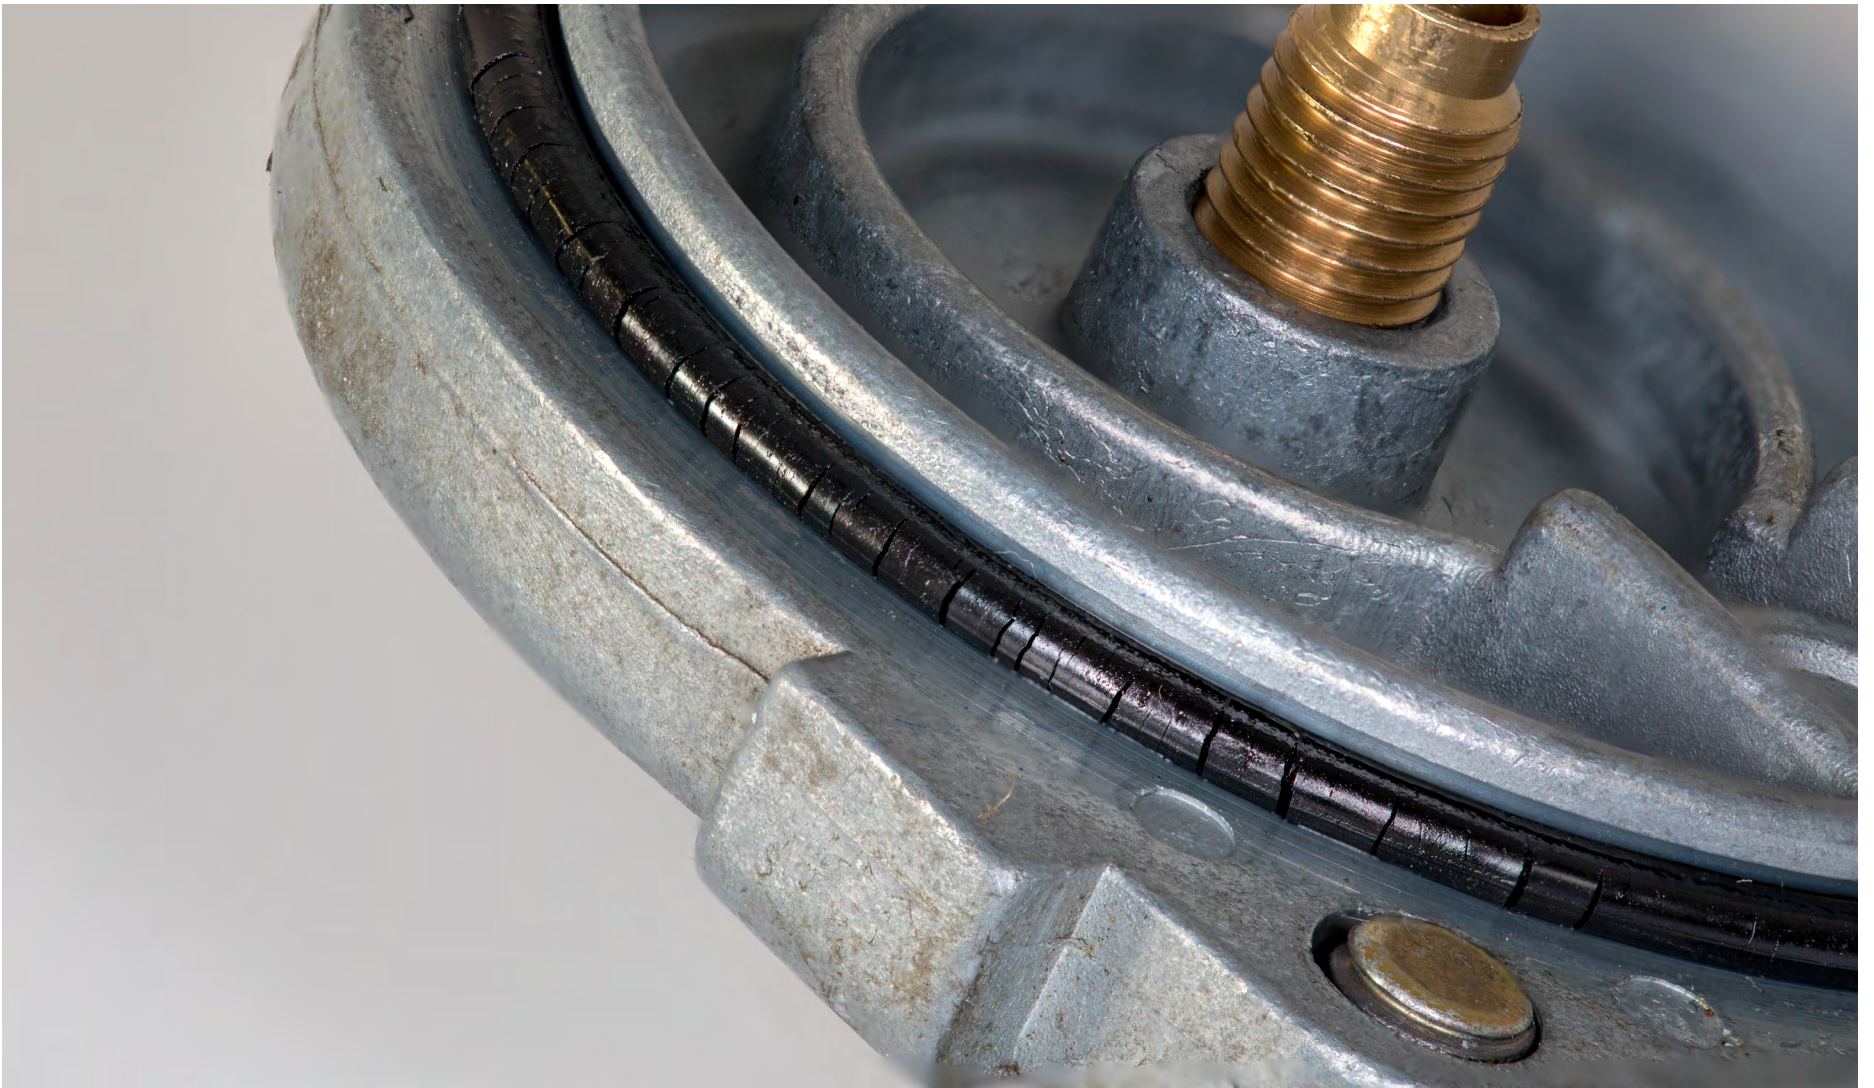
*Figure: 25 Carb Cap O-Ring (Mag Side Carb)*

14. Carburetor Top Cap: having an air leak around the o-ring for carburetor top cap does have the potential to allow air to leak into the top of the carburetor and transition through the bleed holes in the slide causing a slightly leaner mixture. This can also be true if the rubber boots on the throttle cables have deteriorated as well. Although, we have ample evidence that the majority of aircraft operating these type of carburetors have deteriorated cable boots, the number of direct failures as a result of this condition remains unknown. There is a sound theoretical basis for concern and the result is invariably a leaner condition within the

engine throughout the entire range of operation. And although considered unacceptable, there are enough airplanes operating in this configuration to assume that it leans the mixture only slightly in the entire scheme of things. This being said, in a critical situation this may contribute to certain failures and the possibility of it contributing to this failure must be taken into account. In the case of the GT-500, both carburetors were suffering from degradation of the o-ring around the perimeter of the cap.

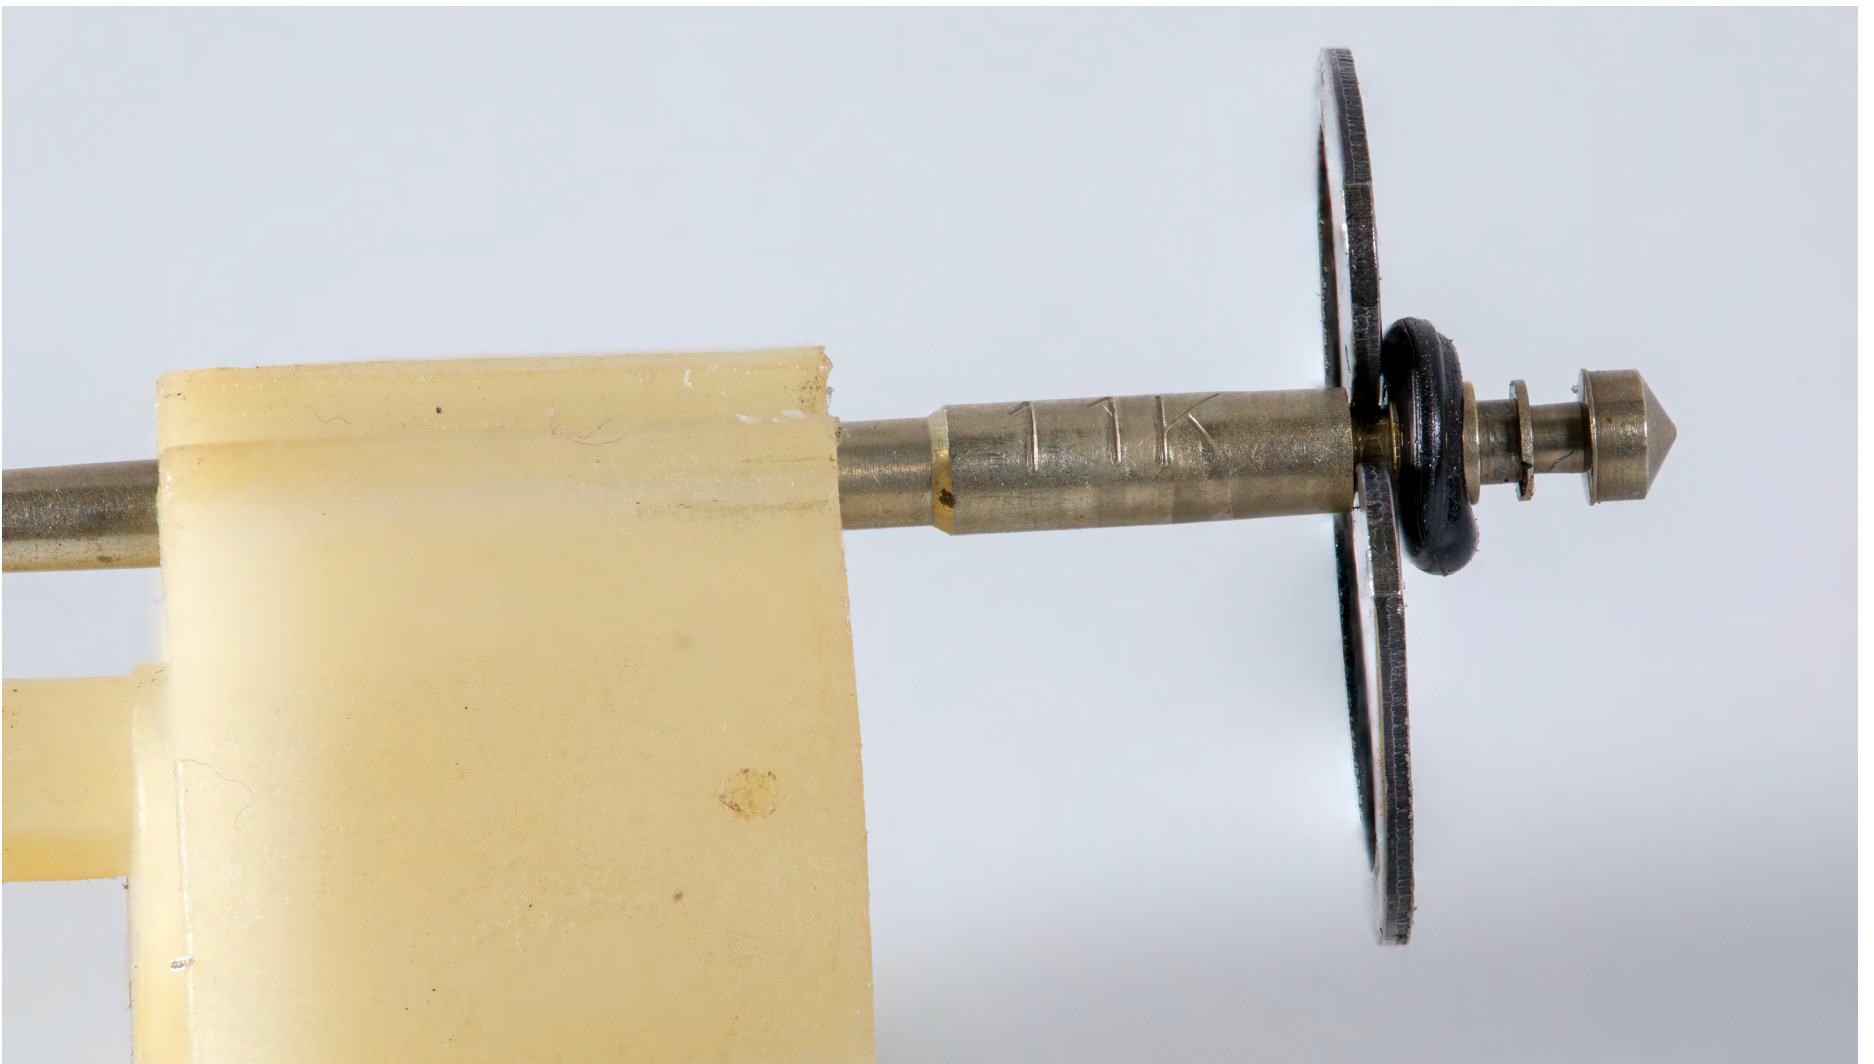
*Figure: 27 11K2 Jet Needle (PTO Side Carb)*

15. PTO Side Carburetor: Tear-down inspection observations. [{Main jet, 165} --- {Idle jet, 55} --- {Needle Jet, 2.72} --- {Jet needle, 11K2} --- {Clip position, 4} --- {Air Screw, .5}] (Figure: 21) several anomalies were found on this carburetors well. (1) The clip position was in groove # 4 instead of groove # 3 as recommended. This would cause the mixture to be enriched in the midrange. (2) the idle air screw was set at .5 turns instead of 1 turn out from the seated position. (3) The o-ring was missing from the idle jet. (4) The float level was improperly adjusted. (Figure: 26) In this case, the float level was set higher than normal. This would increase the mixture throughout the entire range of power settings. This would also support the hypotheses that the PTO cylinder was running richer and as a result cooler, this causing the failure of this cylinder to lag behind slightly in its failure in comparison to the magneto side cylinder. (5) The jet needle (Figure: 27) was an 11K2 instead of 11G2. The higher code letters will produce a richer mixture below at the half throttle setting and below. One of the primary indicators of excessive wear on the needle is a visual inspection of the area with the needle part number stamped into the body of the needle. In this case, you can see an excessive amount of wear to the point that the numeral 2 is completely worn away. This is the area where the needle makes contact with the carburetor slide. And although this clip is tight against the needle groove and has the o-ring intact, based on the amount of wear an inspection of the clip reveals

that the gap between the clip faces has reached its limit. Experience has shown that this should have been removed from service well over 100 hours ago.

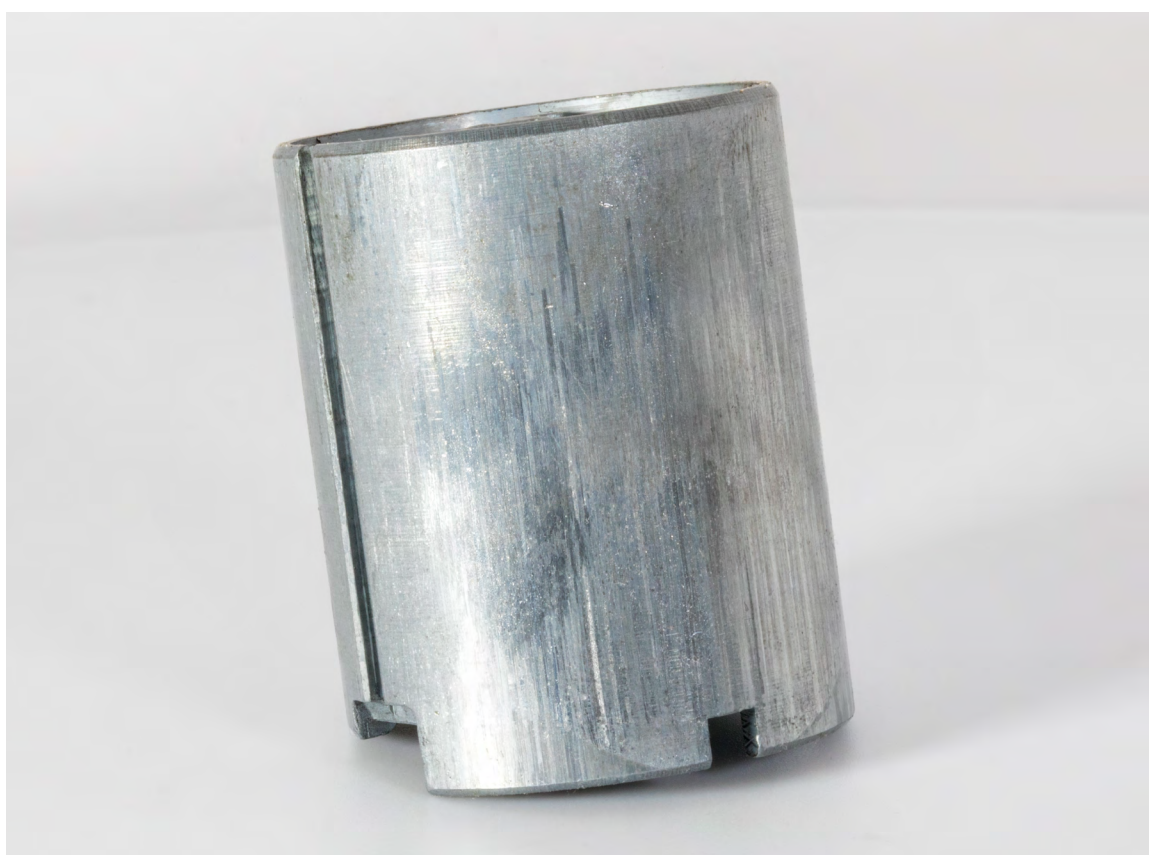
*Figure: 28 Carburetor Slide (PTO Side Carb)*

16. Carburetor wear: carburetor wear is not only found on the needle jet / jet needle, and E clip, but on all moving parts within the carburetor including the piston/slide. (Figure: 28) All of this wear is symptomatic of a greater problem. The root cause of the wear within both carburetors can be attributed to many different factors. (1) Idling at two low of RPM or improper idle mixture settings. In this case, we know that both carburetors are fairly screwed up when it comes to the idle circuit. (2) High moment of inertia propellers. This aircraft

uses a Warp drive, three bladed, solid carbon fiber, ground adjustable propeller which has a relatively high moment of inertia. (3) Propeller tracking (not checked) (4) propeller balance (also not checked) (5) Carburetor synchronization, which was found to be mis-adjusted. Depending on the severity of any one of these different anomalies will determine the amount of wear that occurs not only on the carburetor, but the rest of the engine and airframe as well. Although, all of this wear is of importance in the bigger picture, all of the components suffering from wear were not a factor in the primary cause of engine stoppage. In the full throttle configuration, only the main jet is controlling the mixture setting. And the main jets were found to being good condition and the proper part number with no evidence of modification.

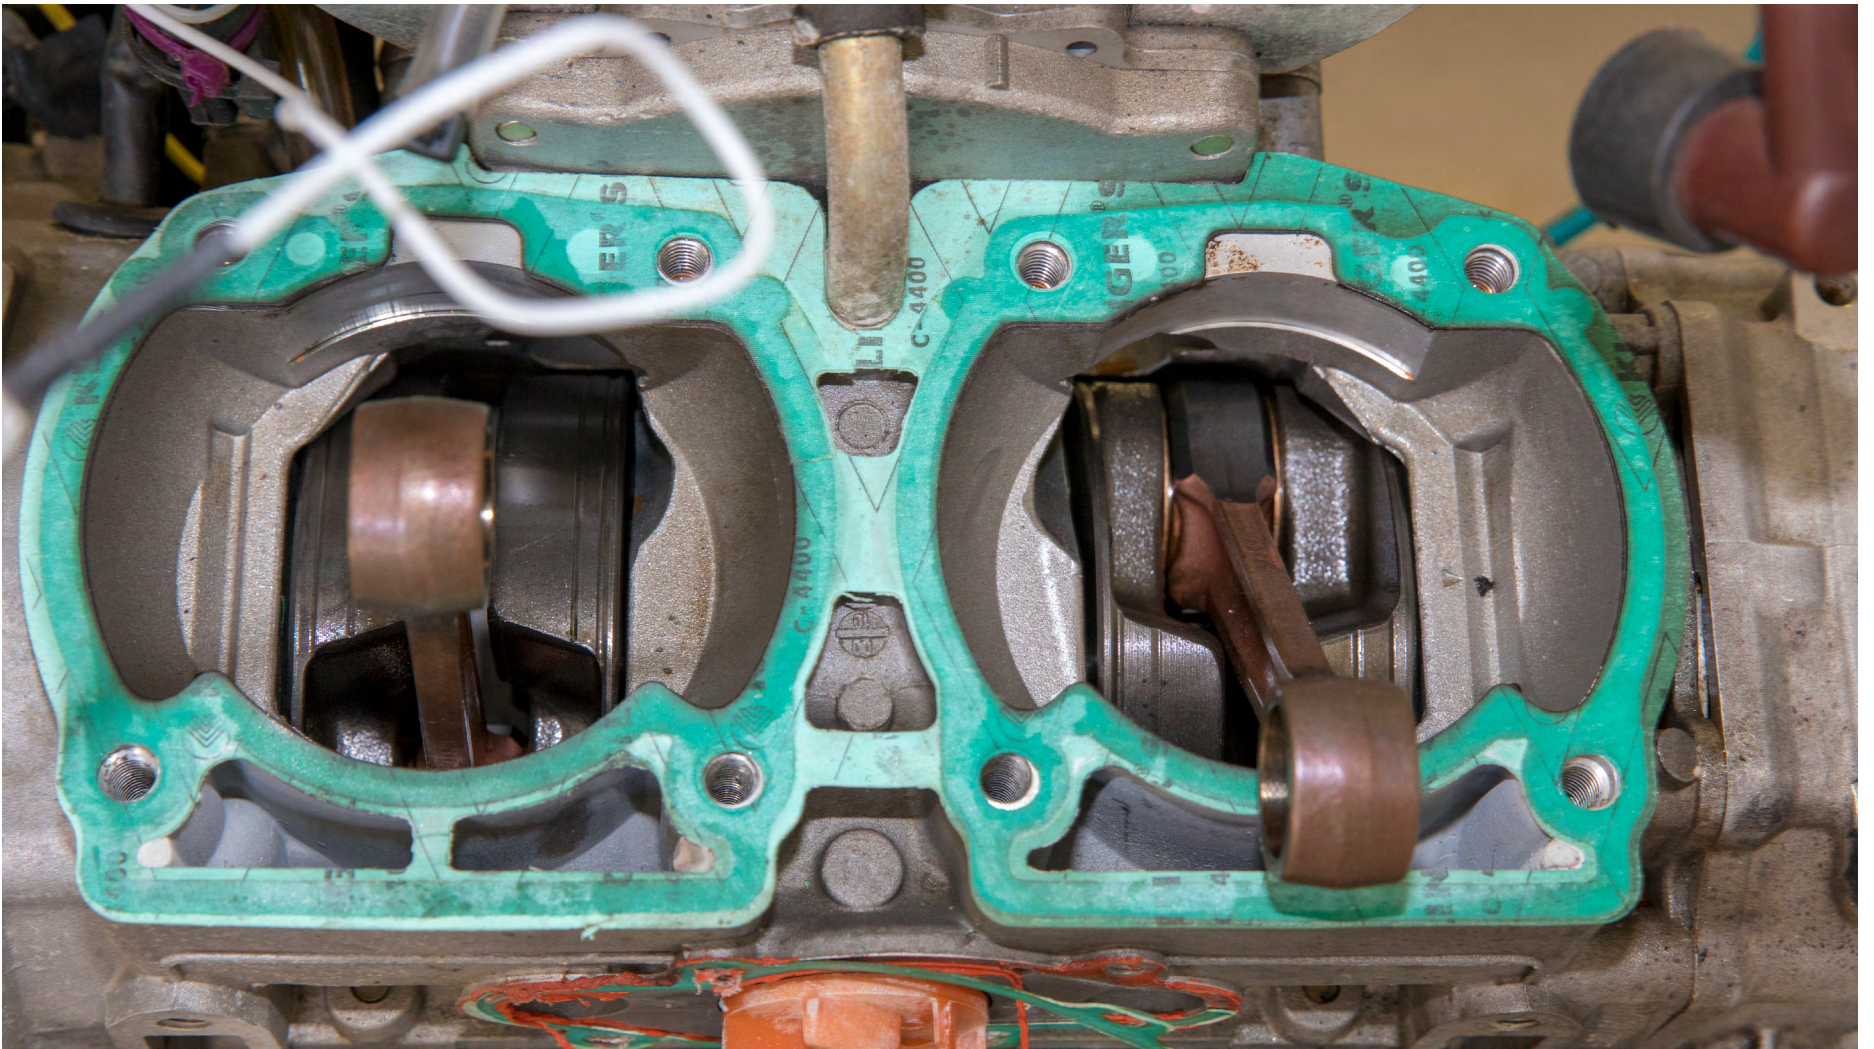
*Figure: 29* Crank Case and Crankshaft

18. Crankshaft and Crankcase: (Figure: 29) Inspection of the crankshaft, main bearings, and connecting rod bearings showed no anomalies. In fact, the bottom end of the engine appeared to be in excellent condition.

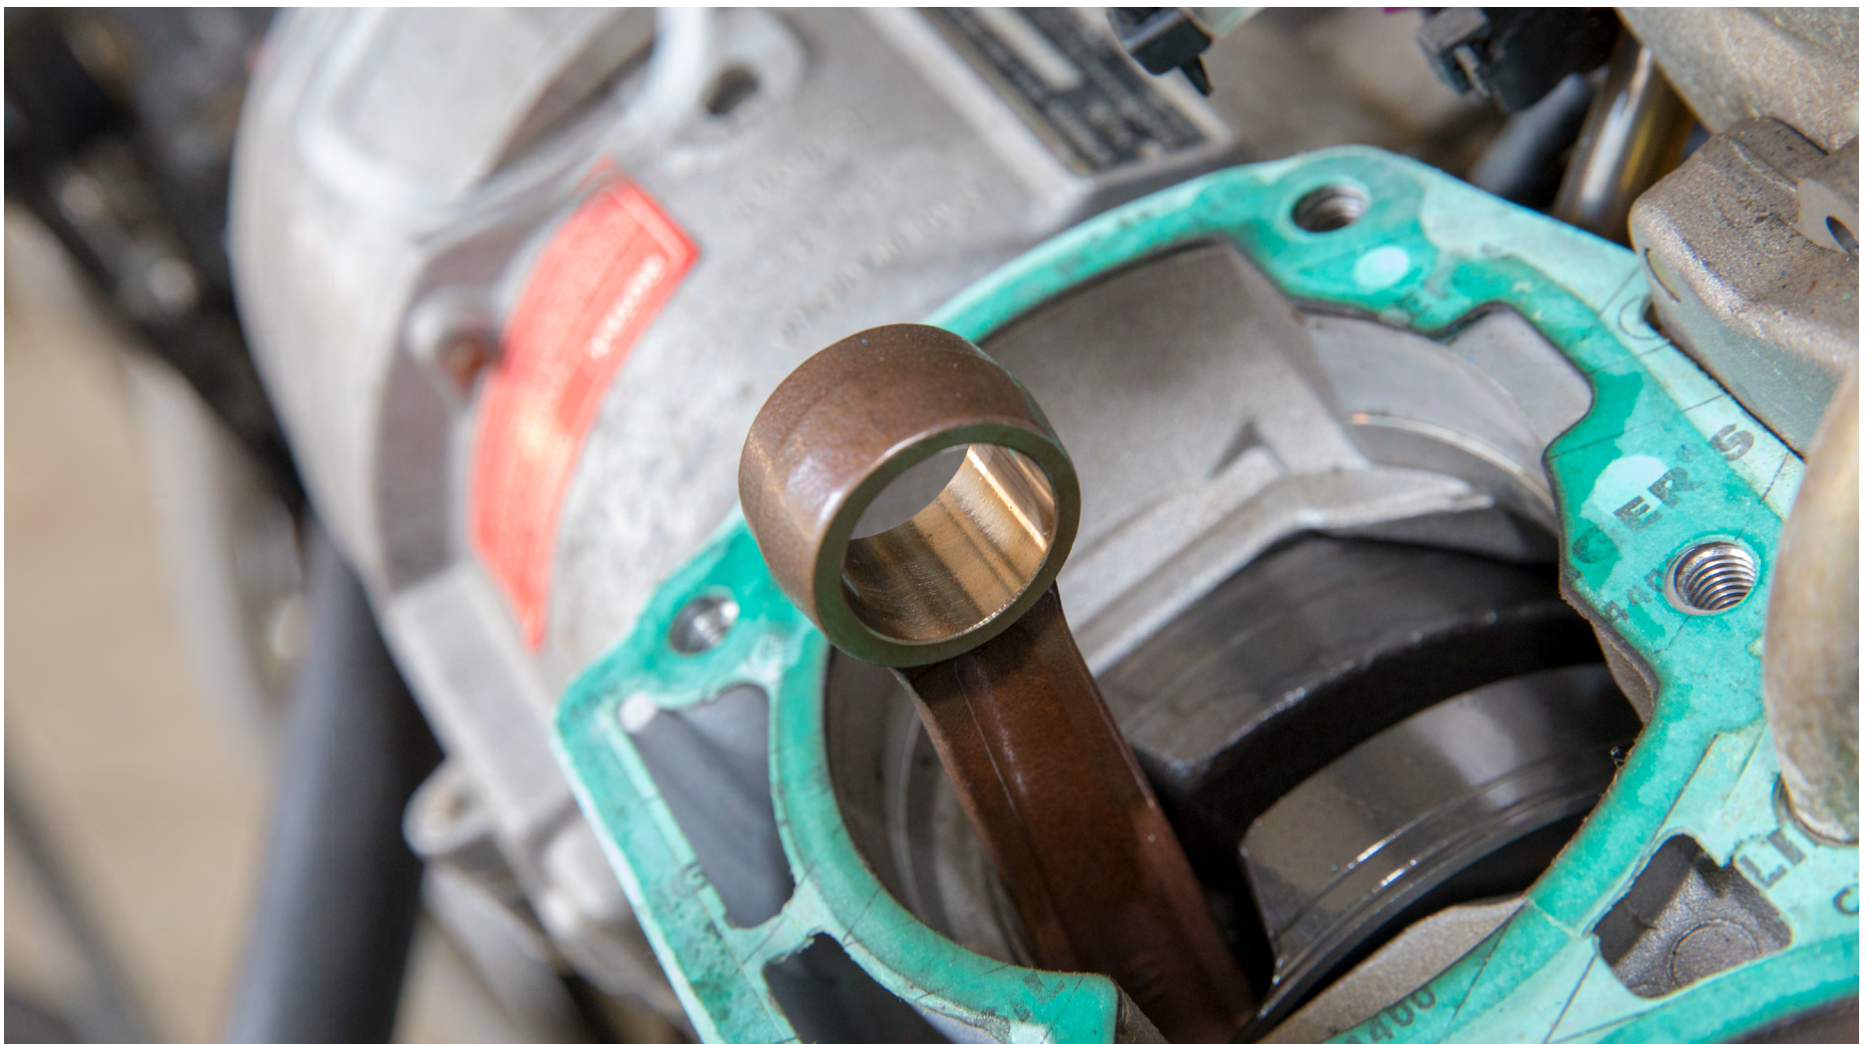
*Figure: 30* Connecting Rod

19. Connecting Rod: (Figure: 30) Inspection of the connecting Rod revealed no anomalies. However, it is important to look at the wrist pin and needle bearing race. Typically, when an engine has been running hot

for quite some time, we will see discoloration of this area of the connecting rod. In this case, there is no evidence of excessive heating over a long period of time. This may provide further evidence that the heating that we see on the pistons was a fairly recent phenomenon.

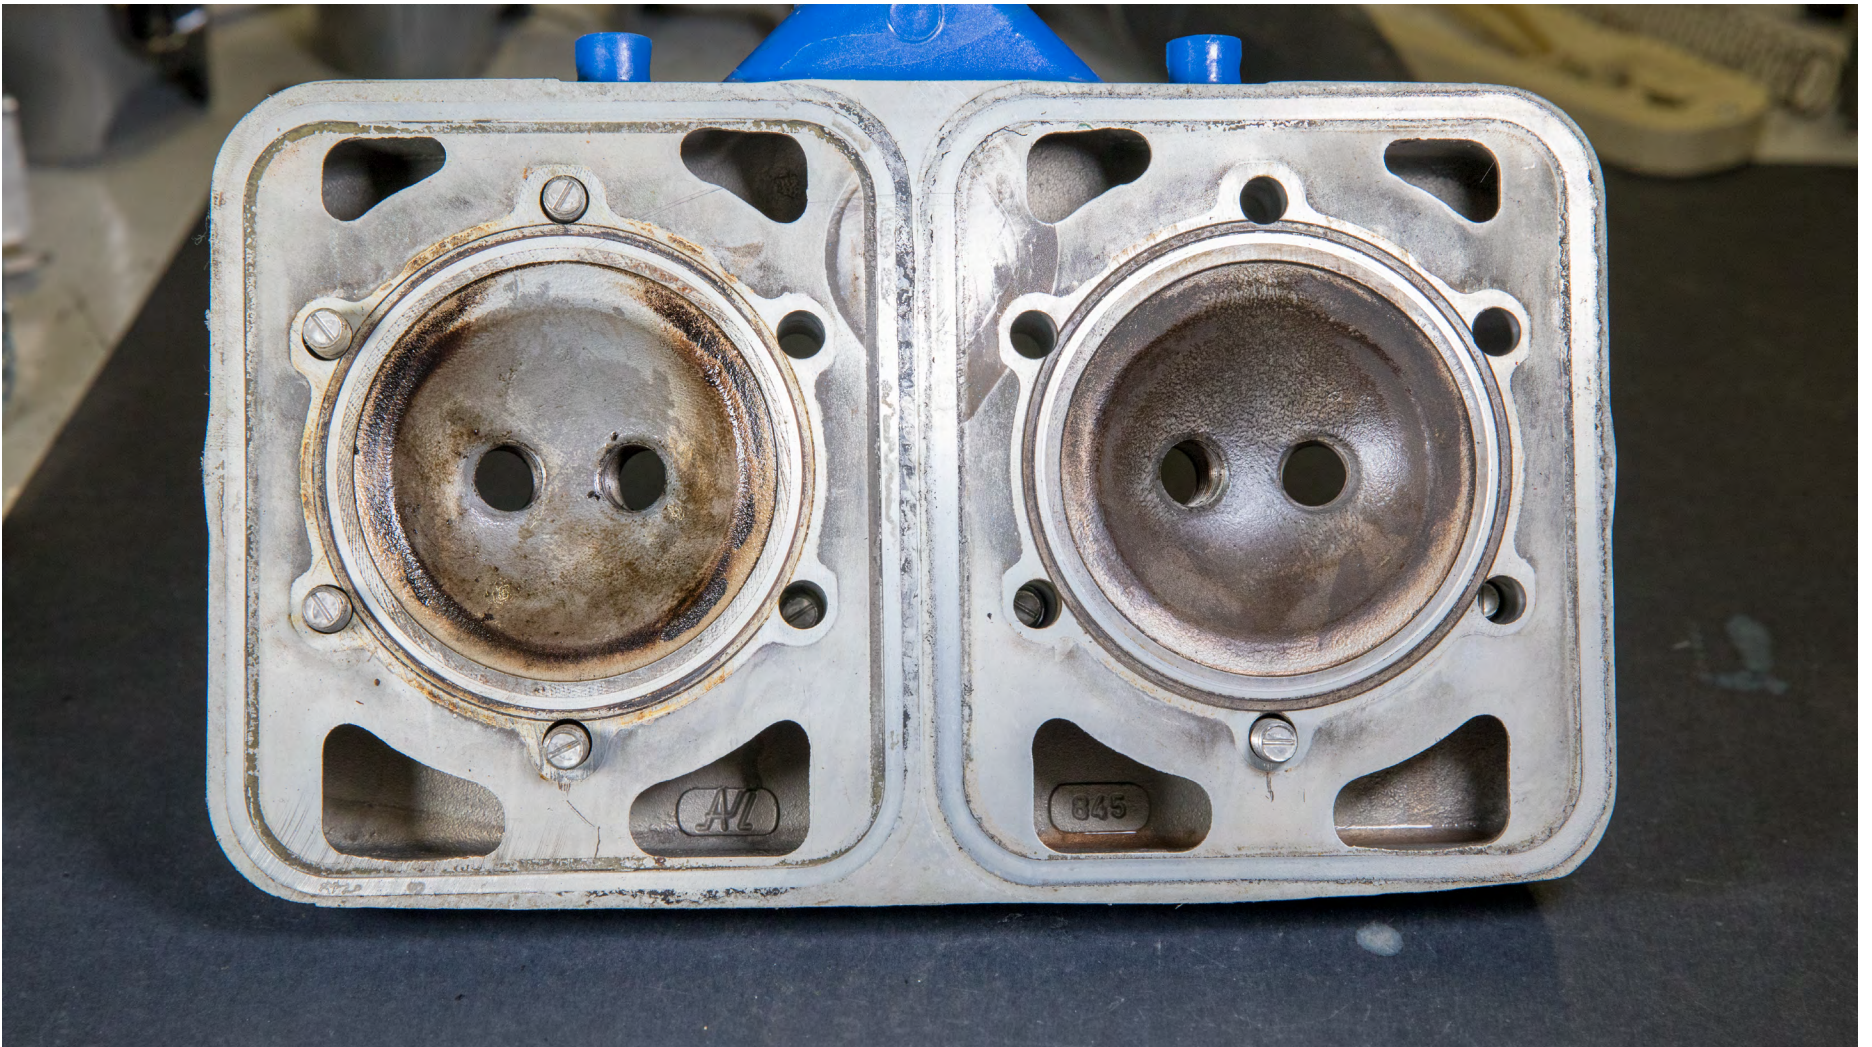
*Figure: 31 Cylinder Head*

20. Cylinder Head: (Figure: 31) shows indications that are consistent with the findings within the cylinders and on the pistons. In this picture, the PTO cylinder is on the left and the magneto cylinder is on the right. The shock-wave disruptions of the carbon buildup show a typical end gas detonation condition within the “squish zone” (outer perimeter). Due to the mass of aluminum within the head, even with the lack of water within the cooling system, it is typical for the pistons to show the first sign of degradation prior to damage to the cylinder heads.
