## **NATIONAL TRANSPORTATION SAFETY BOARD**

# **ENGINE EXAMINATION REPORT**

**WPR18LA039**

Location: Redding, CA  
Date: November 2, 2017  
Aircraft: Cessna 172R, N2103T  
NTSB Investigator-in-Charge: Tealeye Cornejo

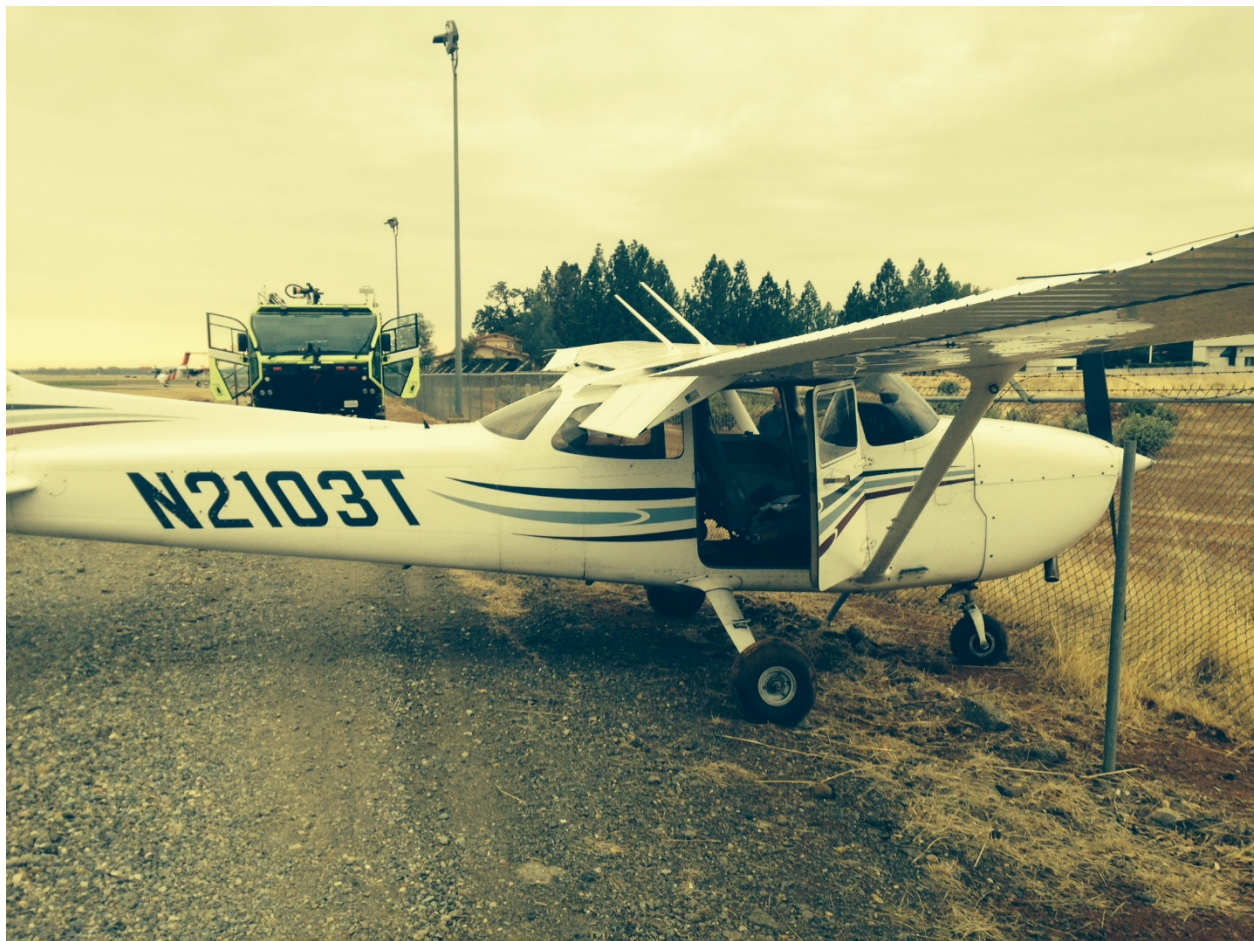
Figure 1: View of the main wreckage (Airport)

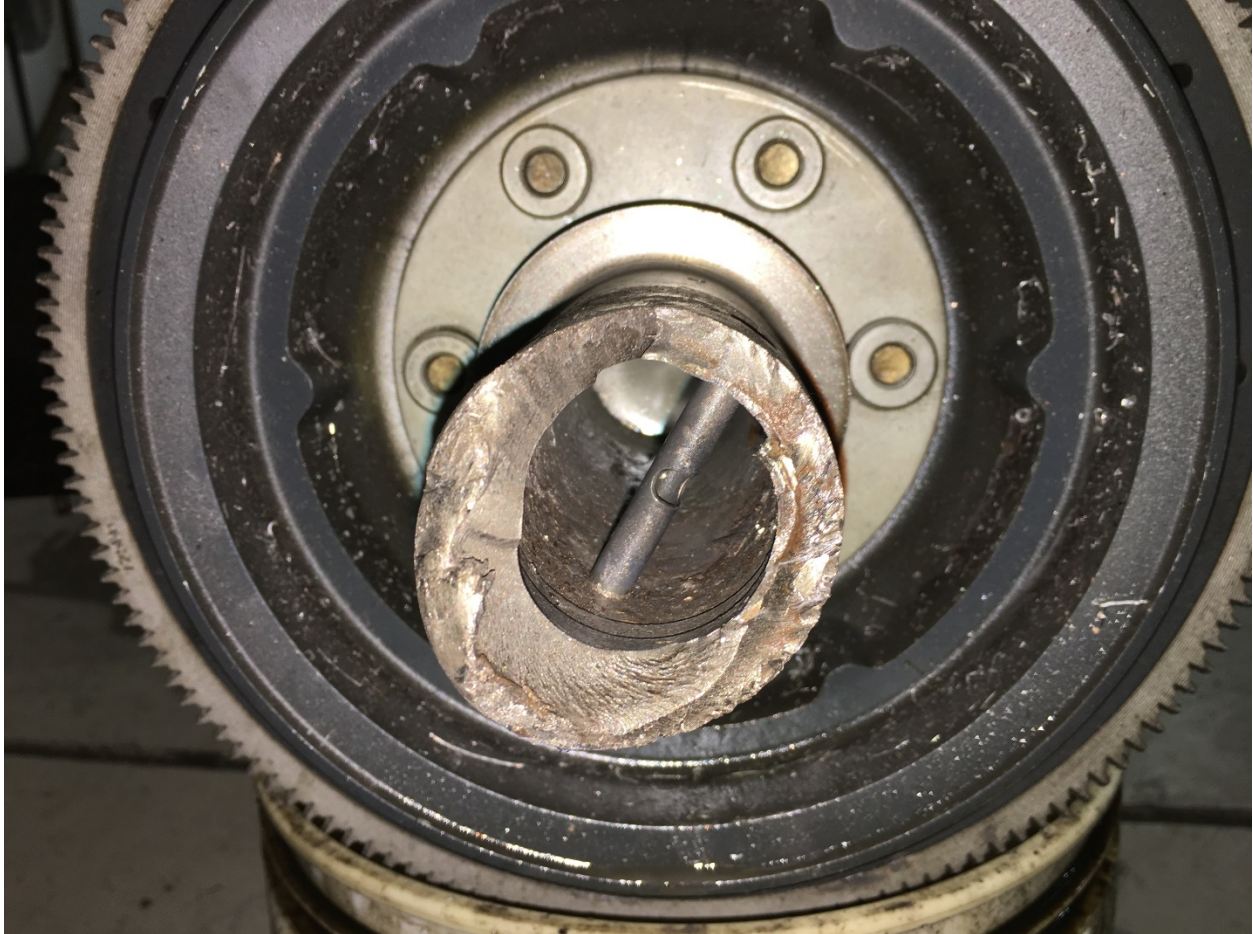
Visual examination of the engine revealed that the crankshaft had separated at the propeller hub assembly.

Figure 2: View of the propeller crankshaft (NTSB)

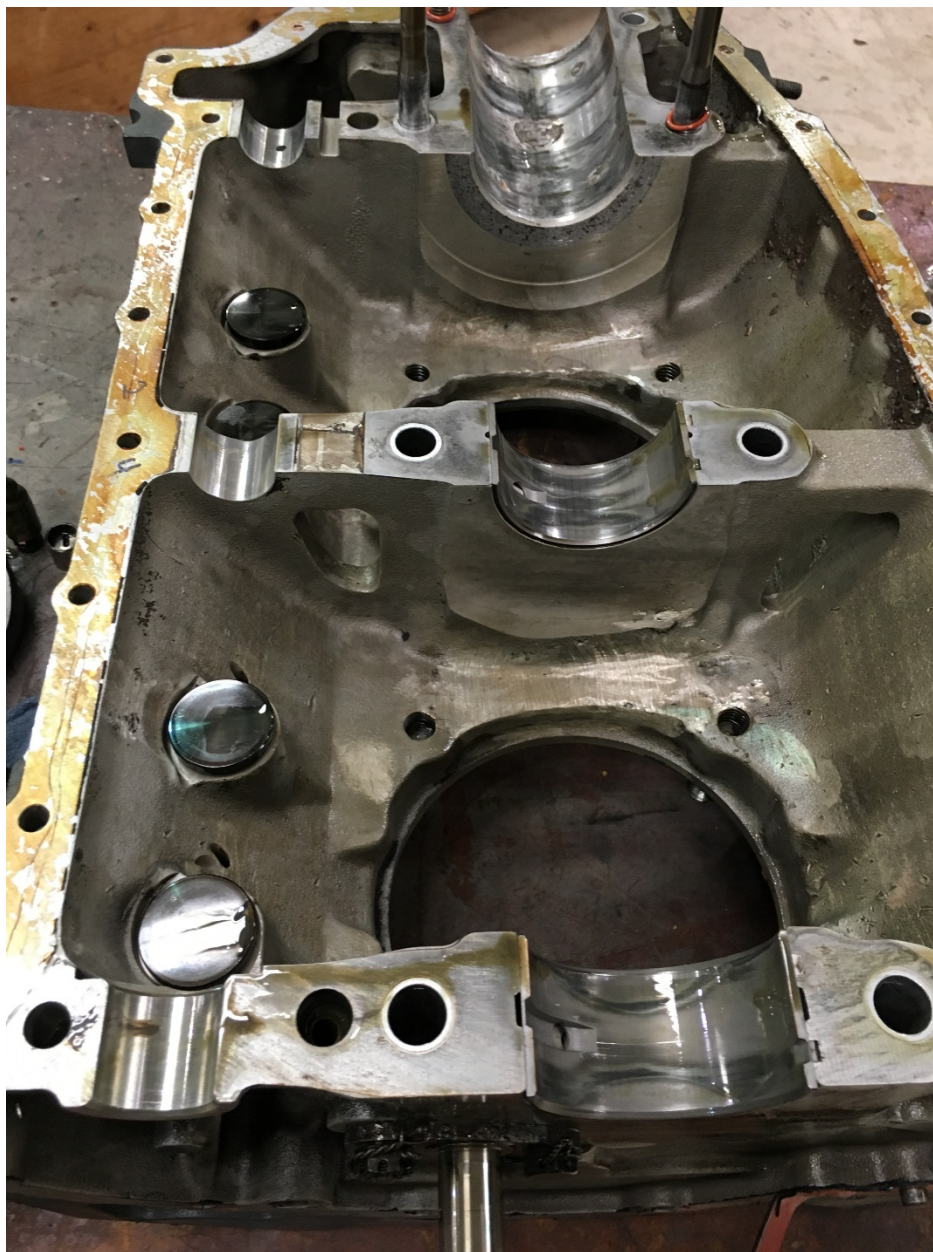
The engine case was split apart. the crankshaft, cam shaft, lifters and bearings all showed signs of lubrication. The engine case itself had areas of deformation where the crankshaft arms had contacted the inside of the case. The main bearing exhibited signs of deformation, with metal smearing on the inside of the bearing. The other two bearings were lubricated and exhibited some metal transfer.

**Figure 3: Split engine case (NTSB)**

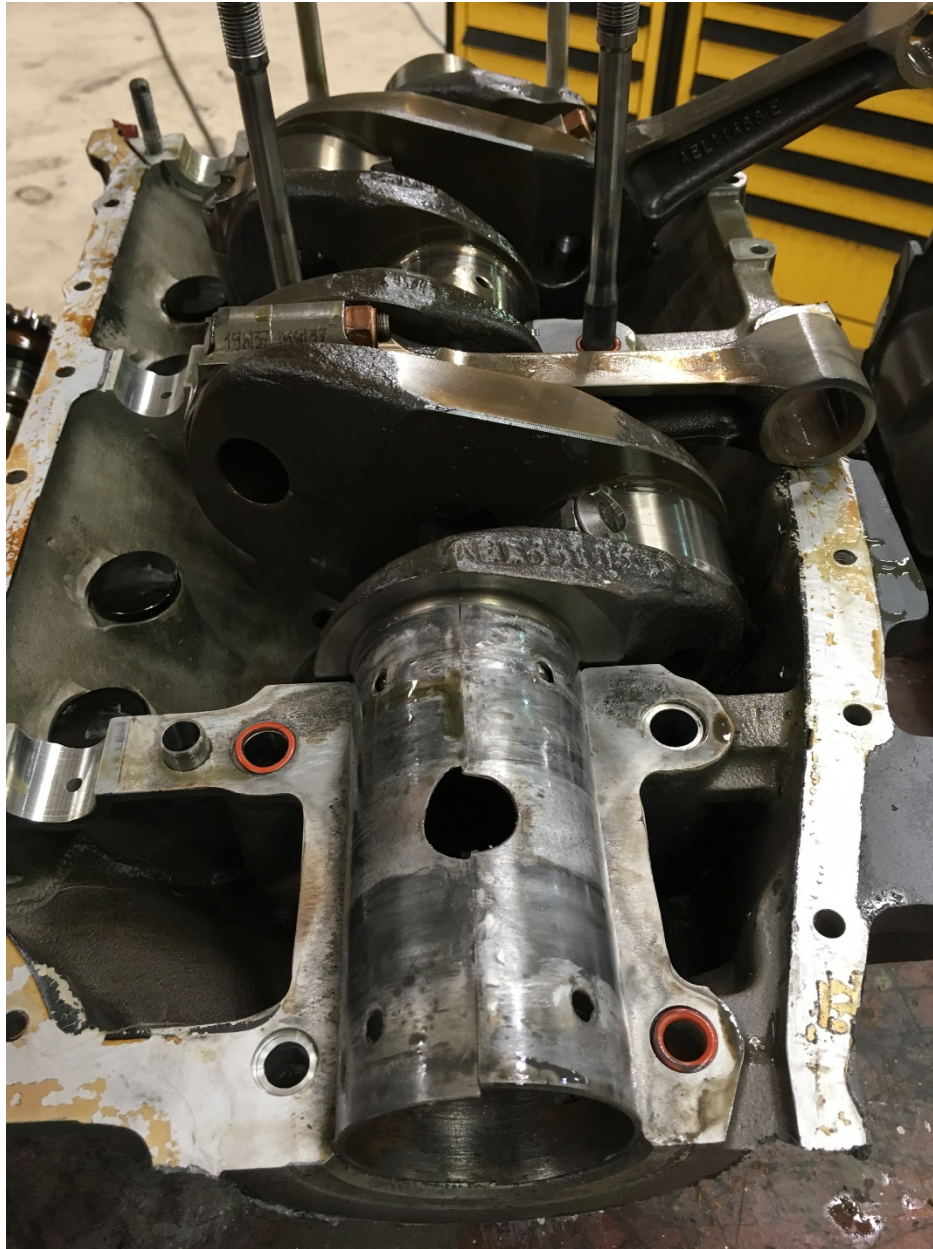
**Figure 4: Split engine case with crankshaft (NTSB)**
