# NATIONAL TRANSPORTATION SAFETY BOARD

## MATERIALS LABORATORY FACTUAL REPORT

Report No. 18-073

Place : Redding, California  
Date : November 2, 2017  
Vehicle : Cessna 172R, N2103T  
NTSB No. : WPR18LA039  
Investigator : Tealeye Cornejo, AS-WPR

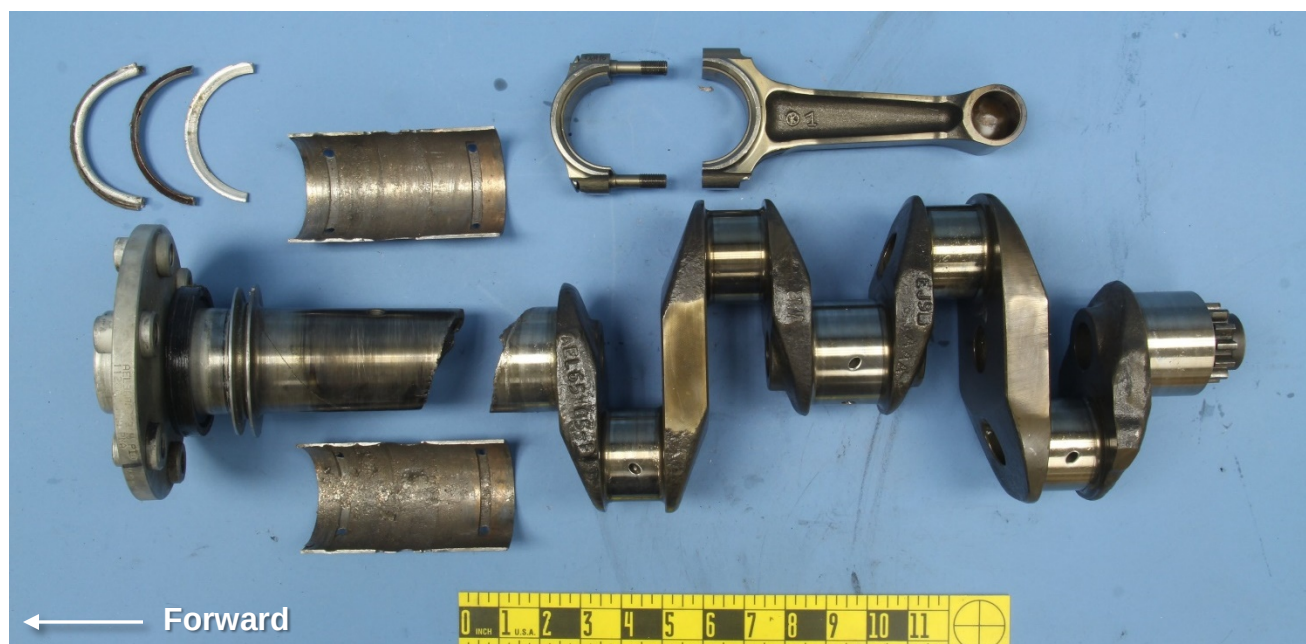
The components from the engine are shown in Figure 1, as received. These included a crankshaft, a connecting rod and cap with two bolts, two bearings, three flange fragments. The crankshaft had fractured into two halves at the main bearing journal on the forward side, located 3.40 inches aft of the flanges located aft of the propeller flange (see Figure 2). The fracture consisted of two primary mating crack faces, one circumferential and one spiral through a lubrication hole.

Figure 1 – The components from the engine, as received.

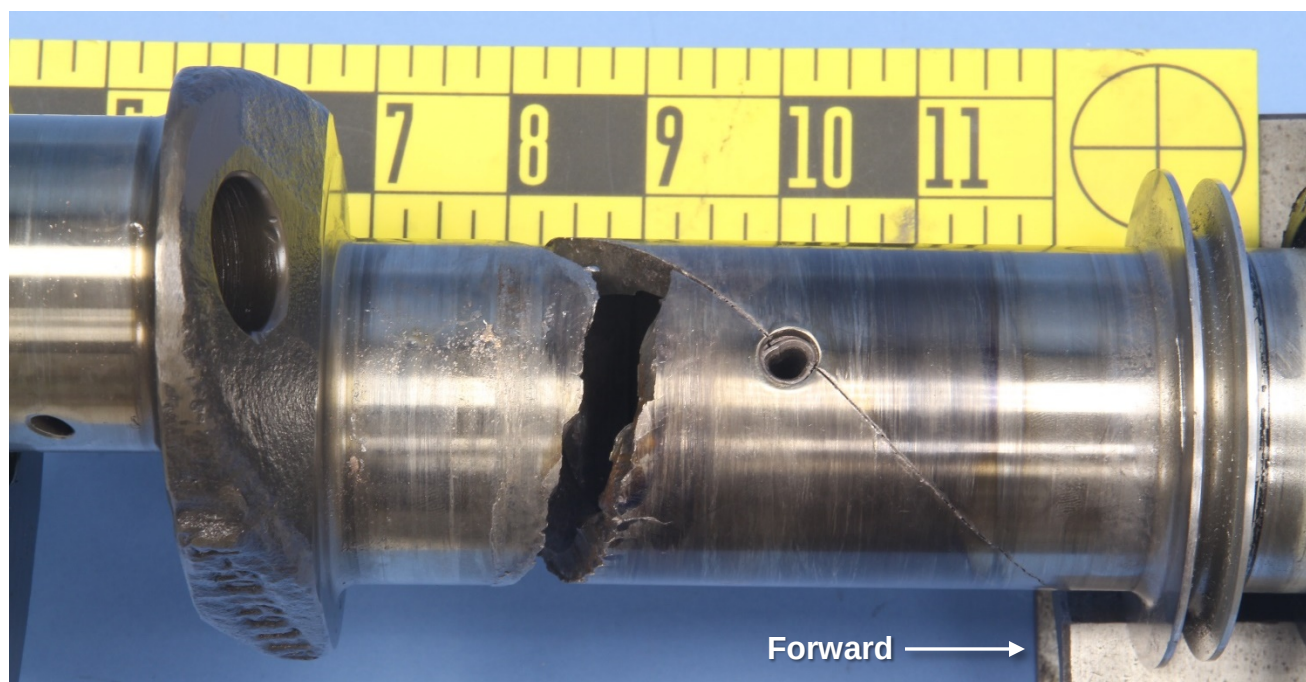
Figure 2 – View of the fractured portion of the crankshaft main journal, showing cracking across a lubrication hole, just forward of the circumferential fracture.

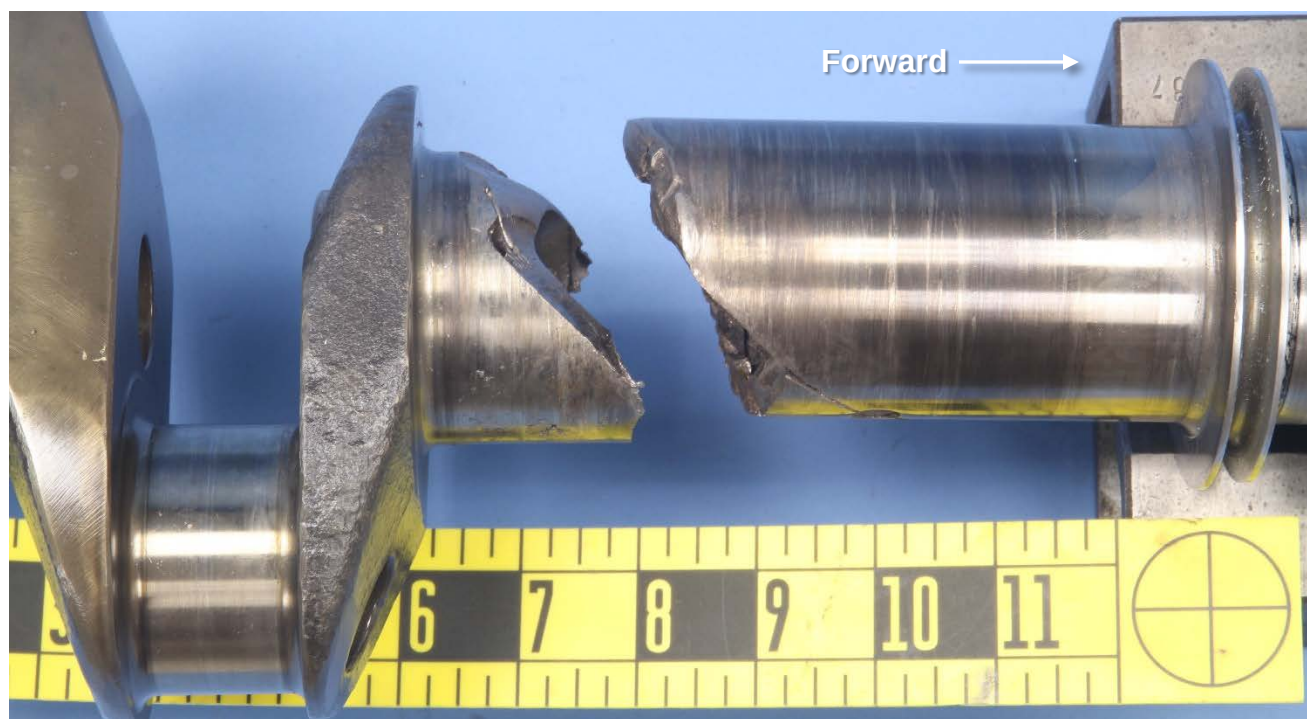
The circumferential fracture ran a lateral distance of 1.3 inches along the length of the main journal. The forwardmost part of the circumferential fracture was located 0.772 inches aft of the lubrication hole (Figure 3). Figure 4 shows the mating faces of the circumferential fracture. The fracture surfaces exhibited features such as crack arrest marks, indicative of progressive fracture, later determined to be fatigue. As annotated with white dashed arrows in Figure 4a, the crack arrest marks had propagated from the spiral fracture. The areas outside the fatigue crack exhibited features consistent with subsequent overstress fracture.

Figure 3 – View of the fractured portion of the crankshaft main journal, rotated 90° from Figure 2.

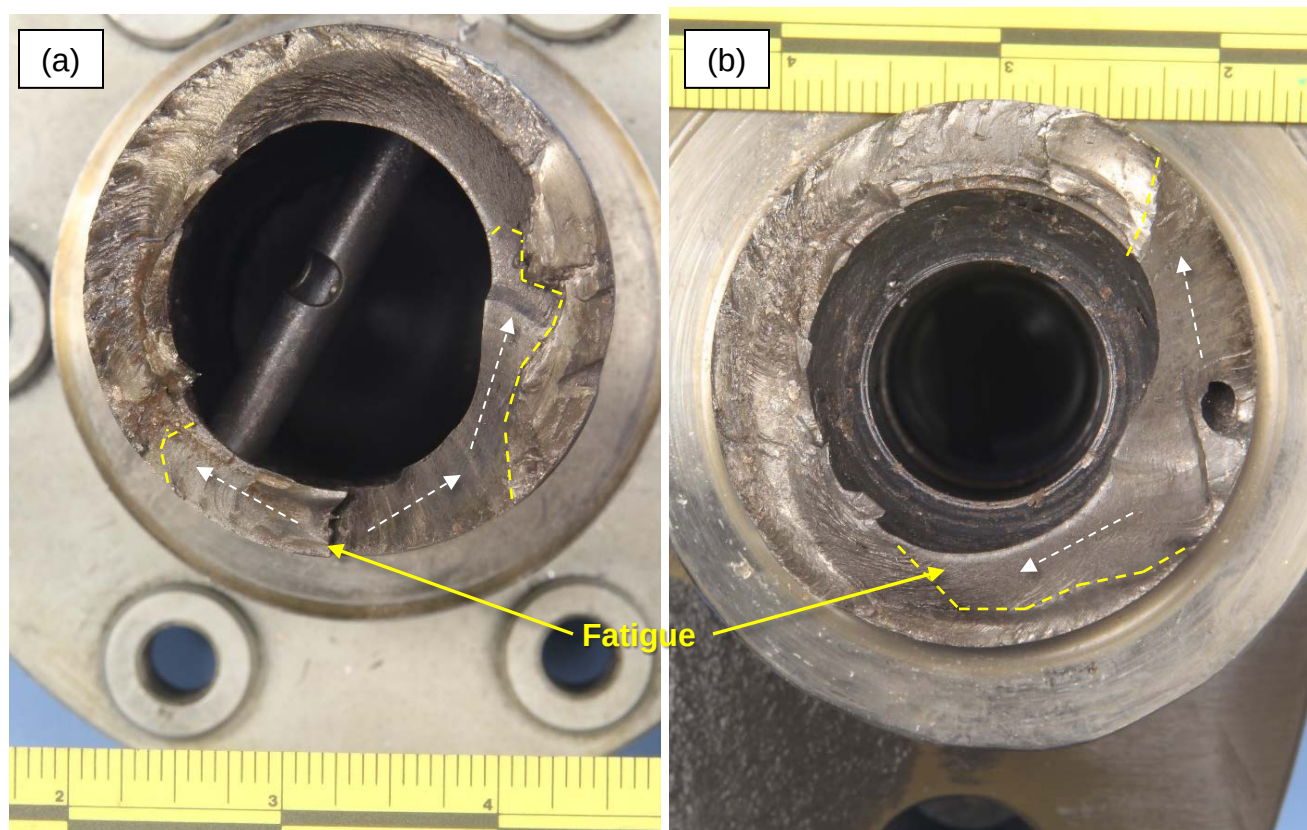
Figure 4 – View of the circumferential portion of the fracture surface on the crankshaft main journal, viewed from (a) the forward and (b) the aft faces.

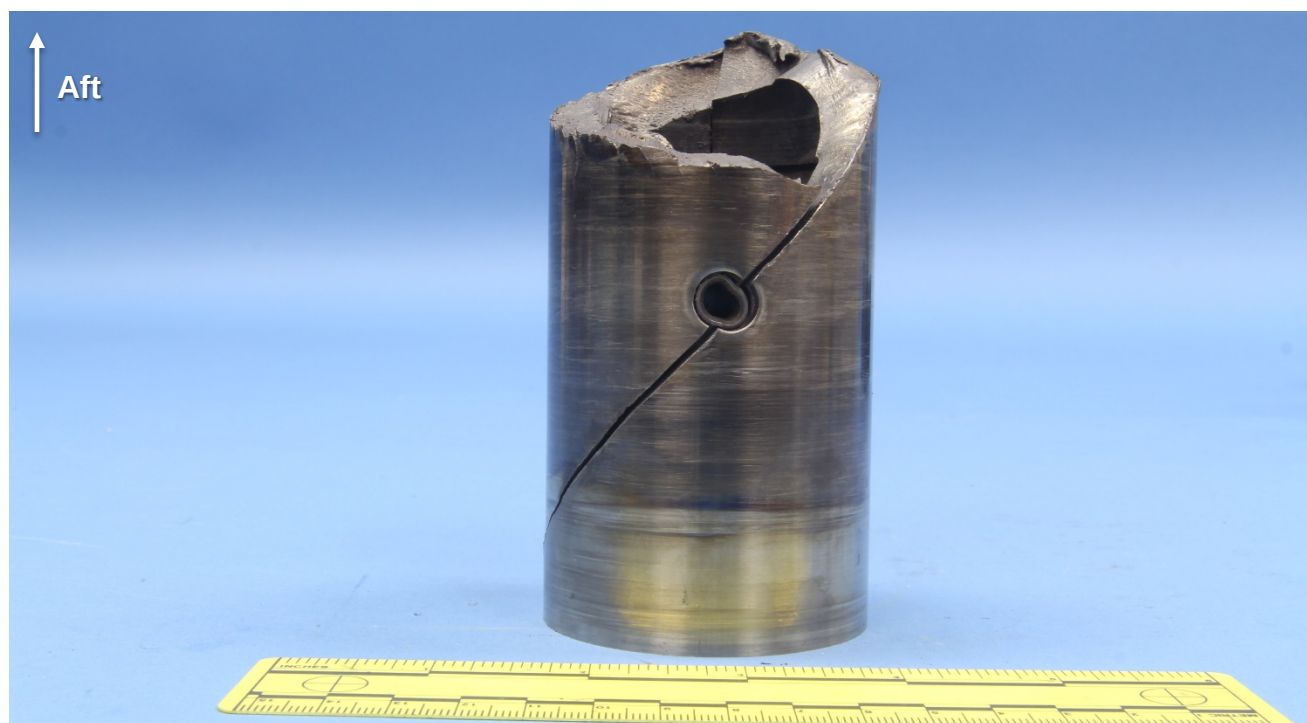
Figure 5 shows the forward portion of the crankshaft main journal, after sectioning from the forward part of the crankshaft. The spiral fracture was located across the lubrication hole depicted in Figure 5. The journal section was cut longitudinally 180° from the position shown in Figure 5. The opened spiral fracture is illustrated in Figure 6. These mating fracture surfaces exhibited crack arrest marks, consistent with progressive crack growth. No features consistent with other fracture modes were observed on these surfaces.

Figure 5 – The forward portion of the crankshaft main journal, after sectioning.

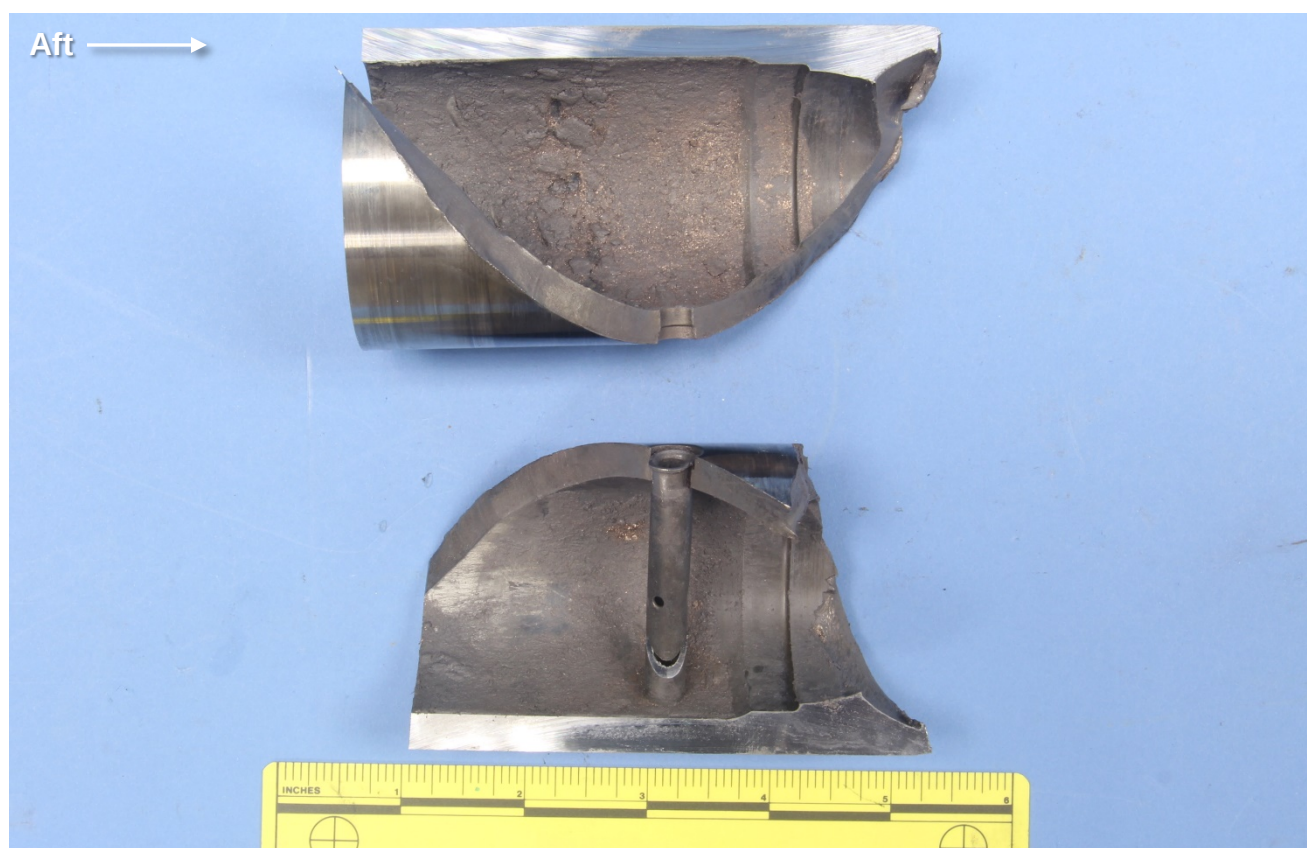
Figure 6 – The crankshaft journal in Figure 5, after opening to expose the spiral fracture. The sludge tube is on the bottom section, with a small cut artifact from the crankshaft sectioning.

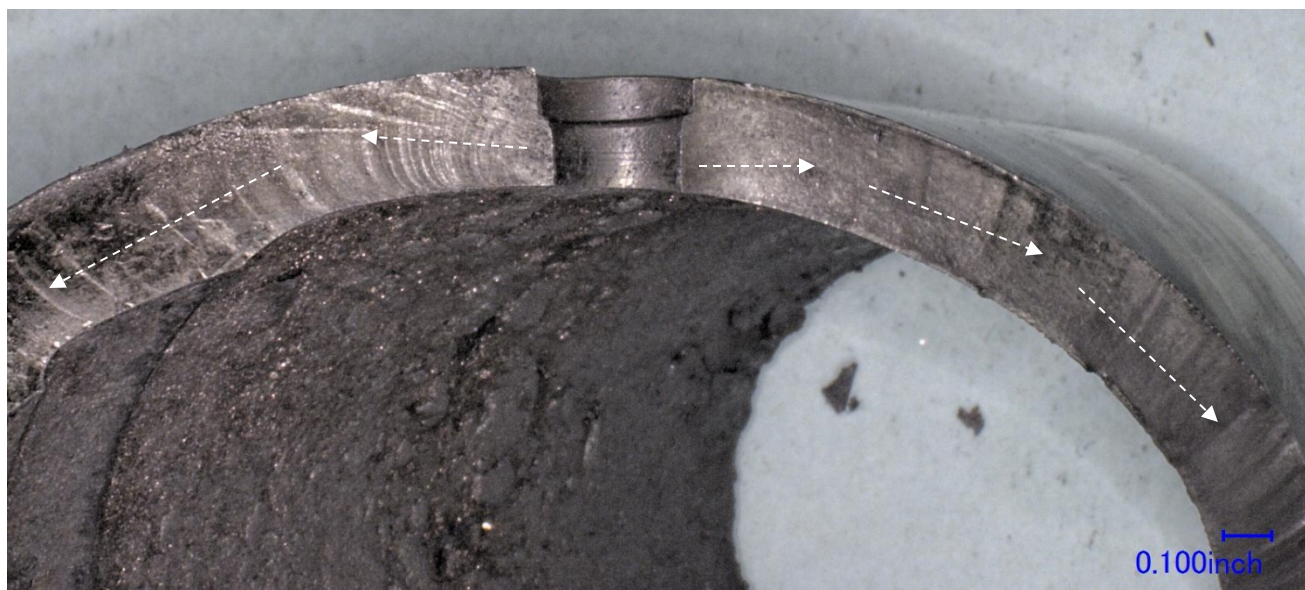
Closer views of the mating fracture surfaces are shown in Figures 7 through 10. On both mating surfaces, the crack arrest marks emanated from the lubrication hole. The sludge tube was still in place on one of the fracture surface holes (Figure 8). The tube exhibited deformation consistent from compressive crushing in the direction of the fracture.

Figure 7 – The fracture surface from the upper section in Figure 6, showing crack arrest marks emanating from the lubrication hole. Dashed white arrows depict the crack propagation direction from the oil hole.

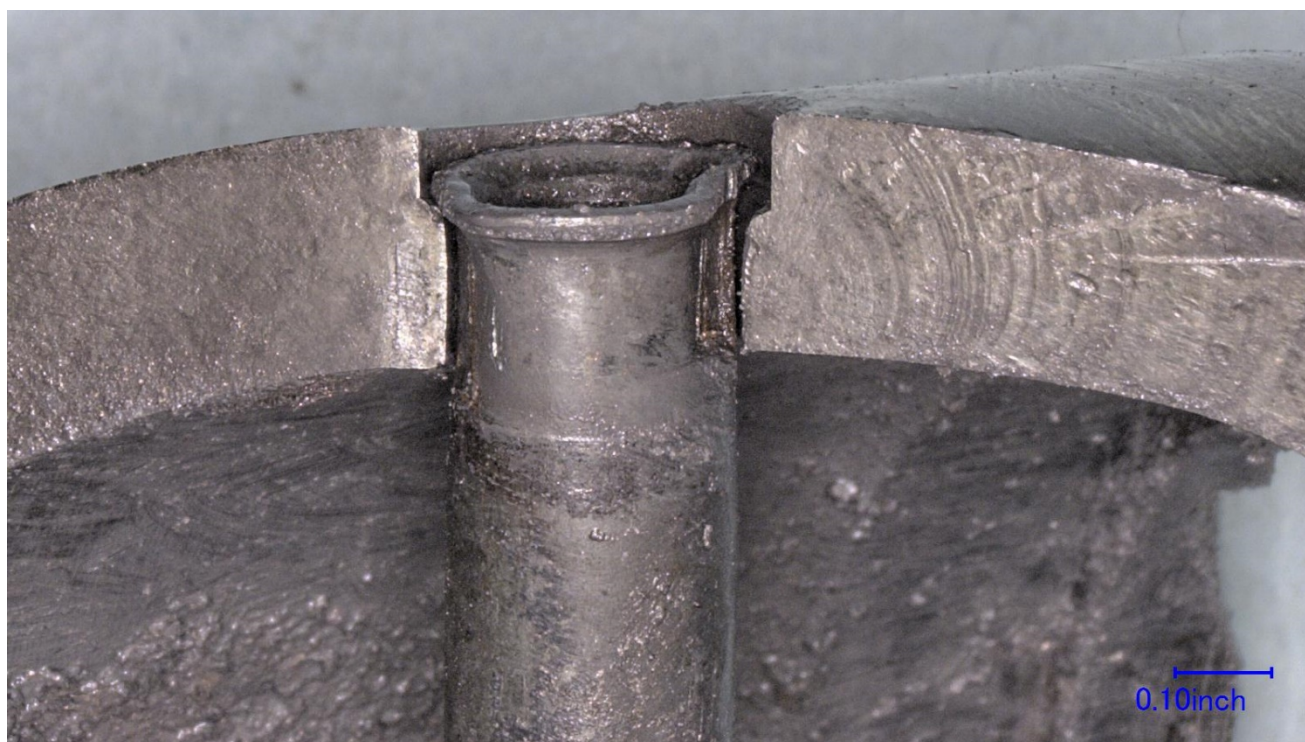
Figure 8 – The fracture surface from the lower section in Figure 6, showing crack arrest marks emanating from the lubrication hole, which still had the oil tube in place.

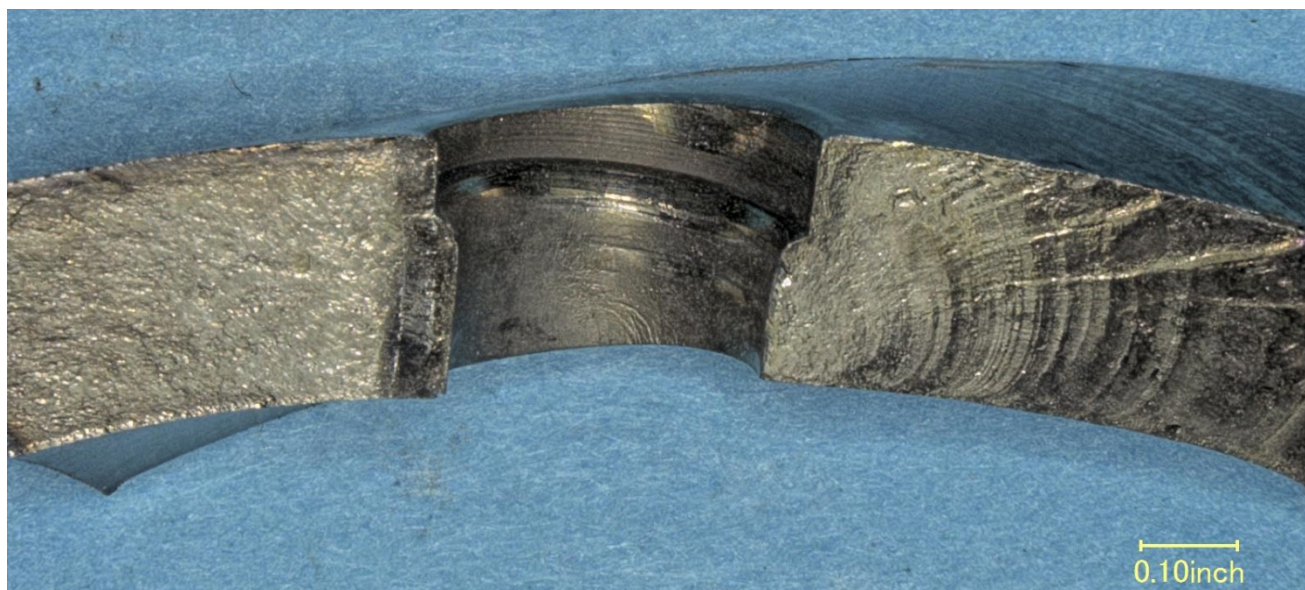
The section of the spiral fracture surface about the lubrication hole was excised and cleaned, as depicted in Figures 9 and 10. The lubrication hole had been chamfered to allow seating of the tube lip. The hole exhibited witness marks consistent with rotational wear. As shown in Figure 10, the crack arrest marks originated from the inside portion of the hole walls.

Figure 9 – The sectioned and cleaned portion of the journal fracture surface in Figure 8.

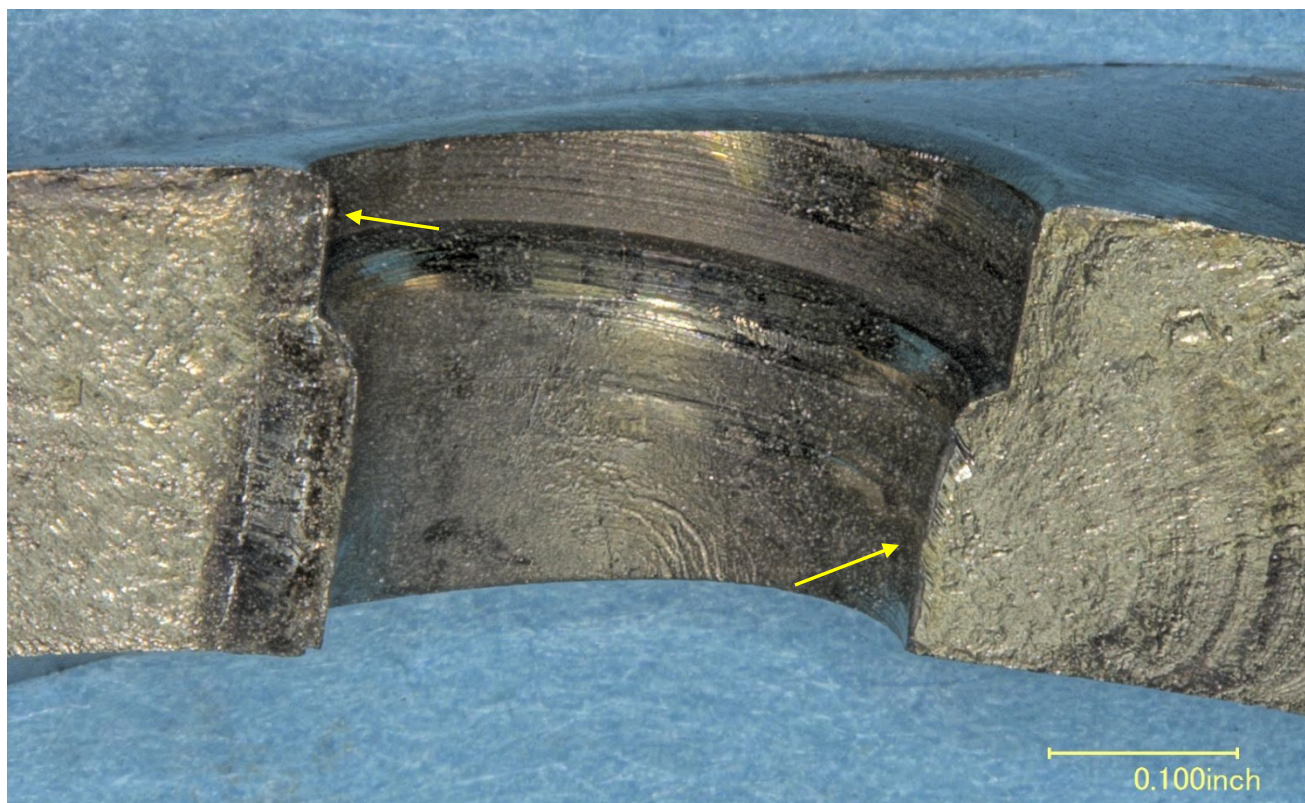
Based on these observed fracture features, the crankshaft fractured from a fatigue crack that initiated at a lubrication hole on the main journal, towards the inside surface of the crankshaft journal. The fatigue crack progressed in a spiral direction outward from the hole, until the forward progressing crack split and progressed circumferentially. When the

remaining cross section of the crankshaft journal could not sustain the stress due to the size of the crack, the part succumbed to overstress and fractured into two pieces.

Figure 10 – The crack initiation sites of the main journal fracture at the lubrication hole in Figure 9. The two arrows depict the fatigue crack initiation sites.

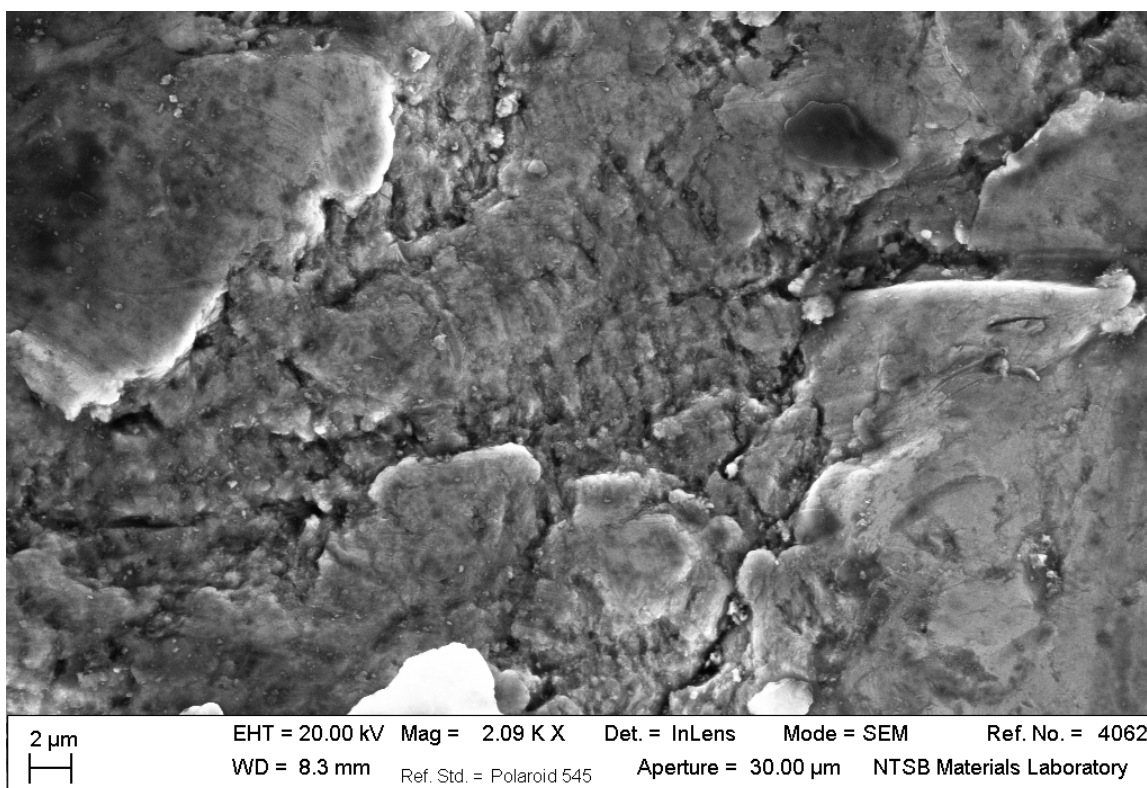
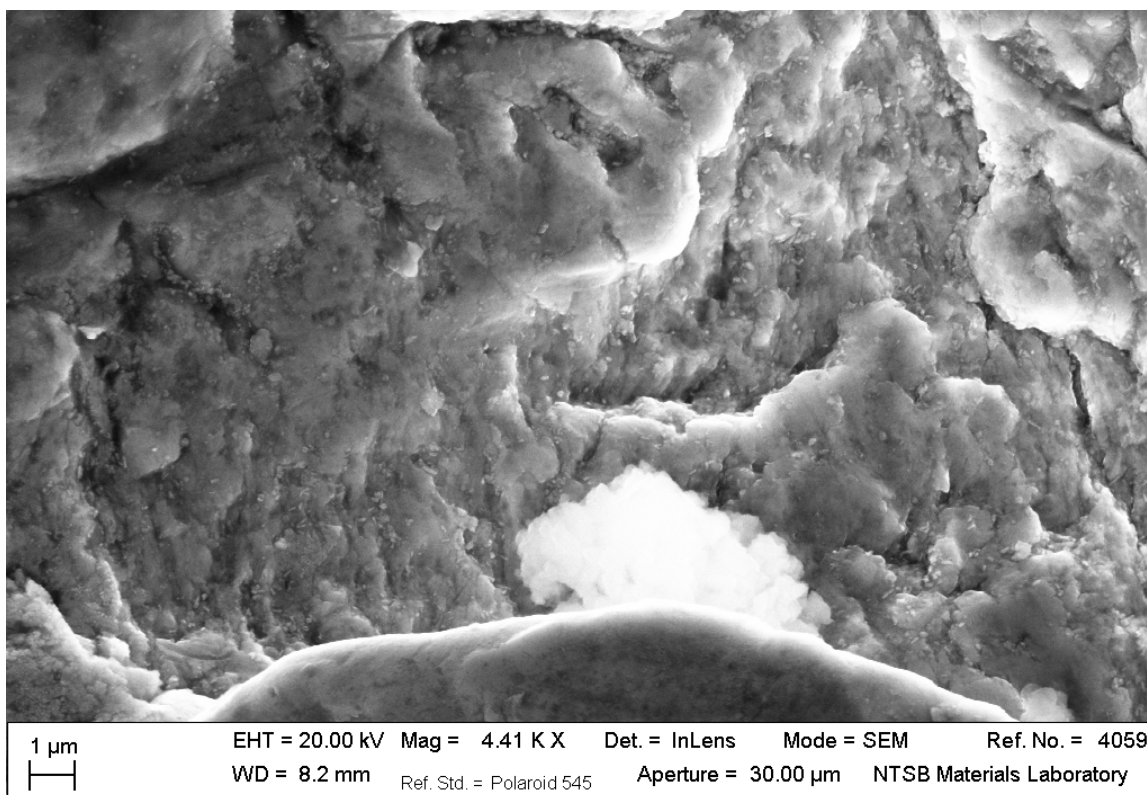
The fracture surface was examined using a scanning electron microscope (SEM). While much of the fracture surface exhibited smearing, consistent with post-fracture contact and rubbing, fatigue striations were observed on undamaged portions. Figures 11 and 12 show fatigue striations at different magnifications. The varied size of the fatigue striations was consistent with spectrum (or non-uniform) loading of the crankshaft as the crack propagated.

Figure 11 – Secondary electron (SE) micrograph of fatigue striations on the journal fracture surface.

Figure 12 – SE micrograph of fatigue striations on the journal fracture surface.

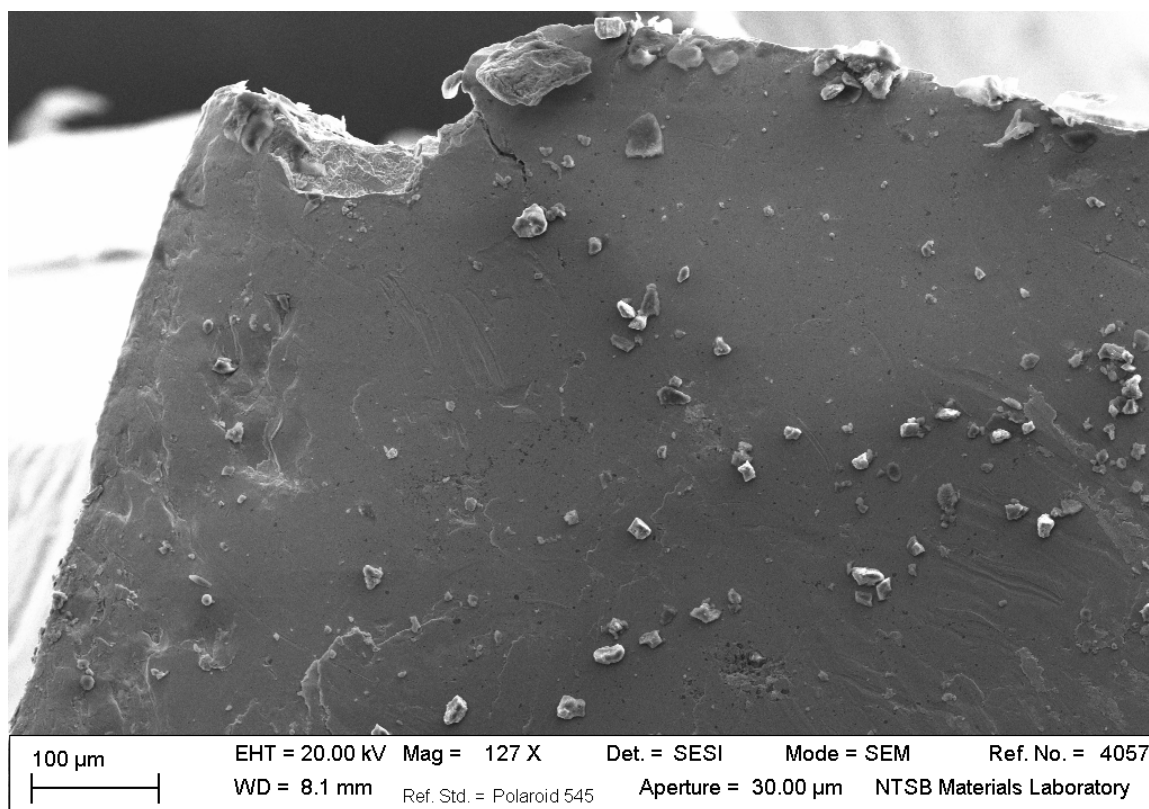
Figure 13 shows one of the fatigue crack initiation sites of the spiral fracture adjacent to the lubrication hole. Due to post-fracture damage, any observable features of the initiation site had been obliterated. Observation of the surface of the lubrication hole found three other cracks, in locations consistent with that of the spiral fatigue crack (the inside corner of the hole). One of these cracks is illustrated in Figure 14.

Figure 13 – SE micrograph of one of the crack initiation sites of spiral fracture.

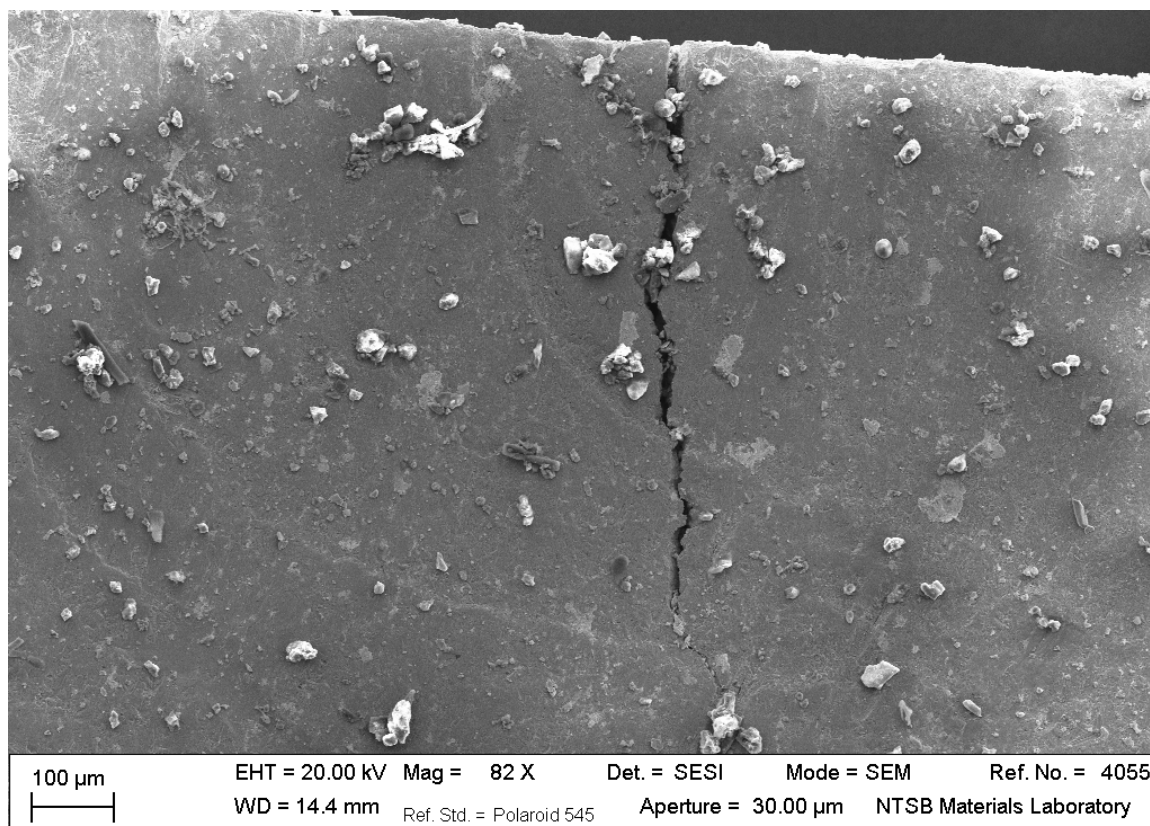
Figure 14 – SE micrograph of additional cracks in the lubrication hole.

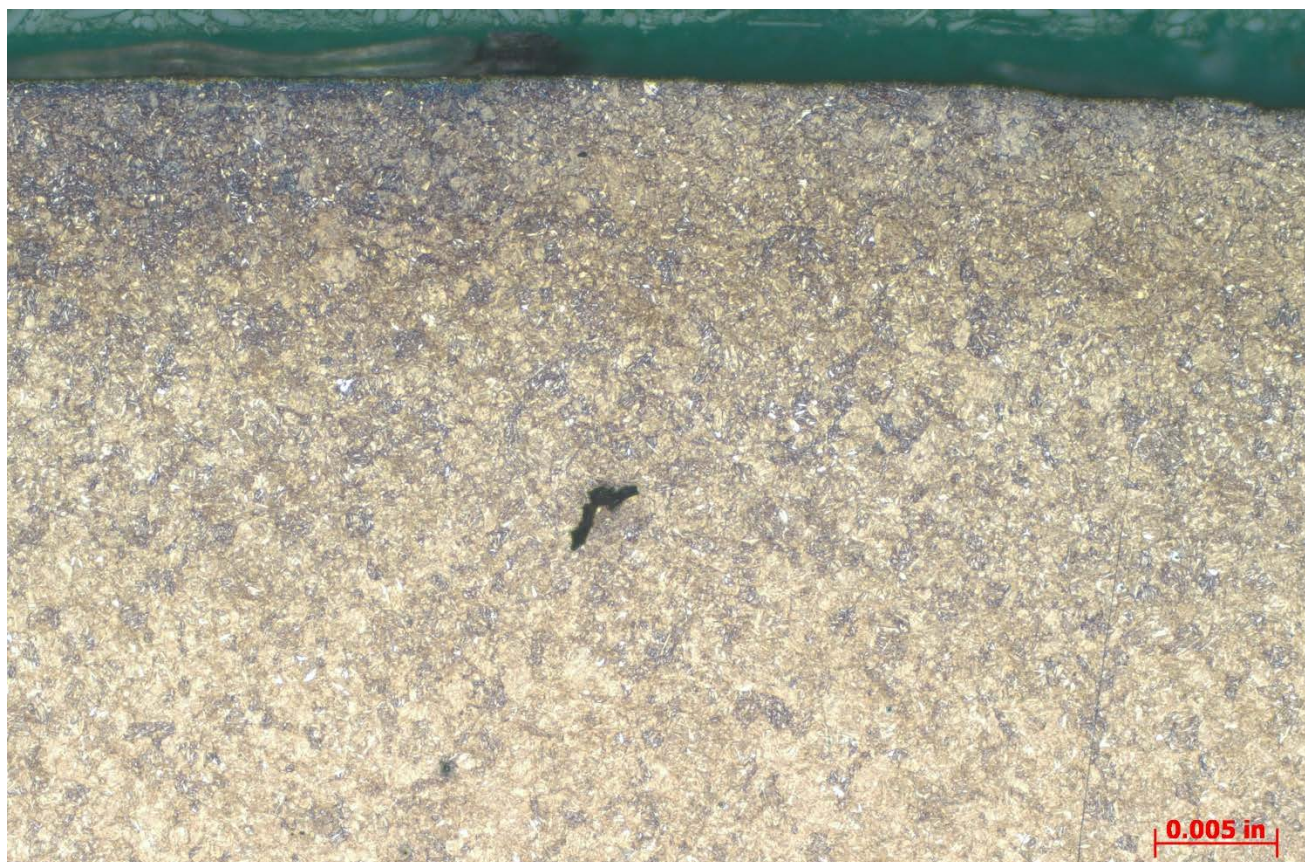
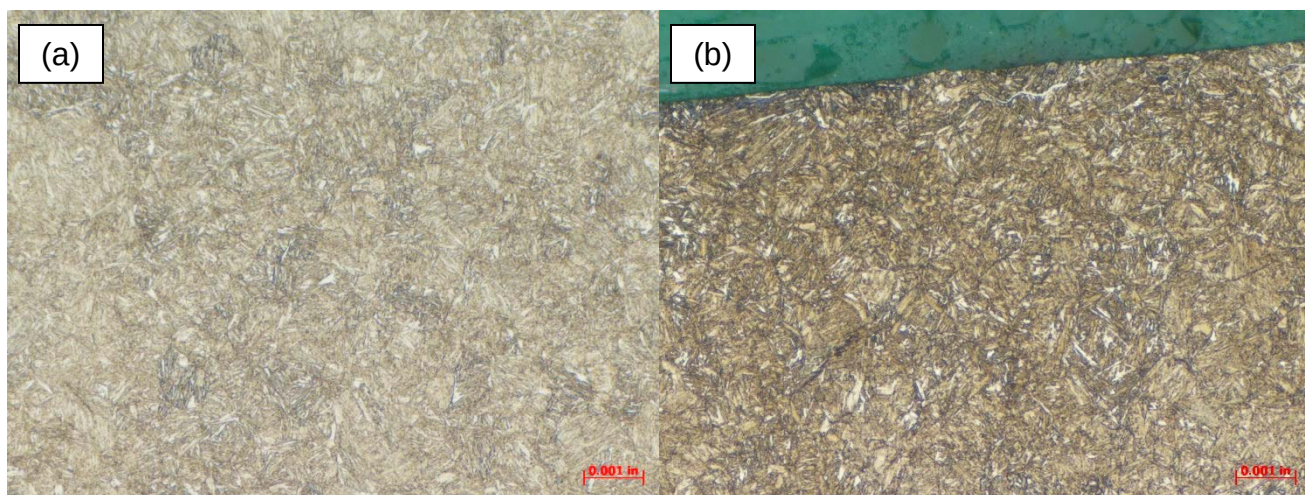
A section of the crankshaft surface was mounted, polished, and etched for metallographic examination (see Figure 15). The microstructure was consistent with that of tempered martensite, the typical microstructure for this alloy steel (Figure 16a). The etching process produced a darker hue towards the surface, consistent with higher interstitial content from a case hardening surface treatment (Figure 16b).

Figure 15 – Bright-field (BF) optical micrograph of the crankshaft main journal surface (~100X, etched 2% Nital).

Figure 16 – BF optical micrographs of the crankshaft main journal microstructure from (a) the core and (b) near the surface (~200X, etched 2% Nital).

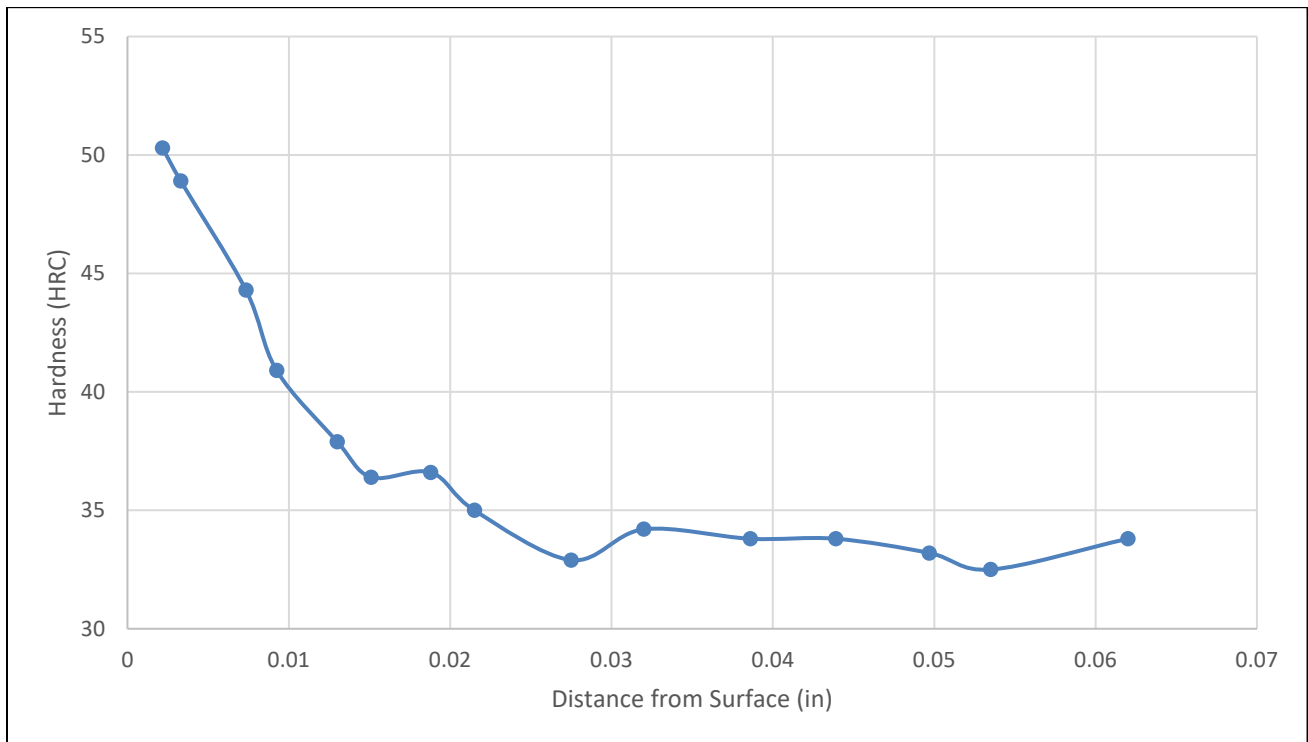
The surface hardness of the crankshaft was inspected using microindentation hardness per ASTM E384.<sup>2</sup> The hardness data were plotted against distance from the surface in Figure 17. The hardness peaked over 50 HRC approaching the surface, before leveling off to an average of 34 HRC approximately 0.025 inches below the surface. These hardness data were consistent with a case-hardened layer, which was consistent with the observed microstructure of the surface in Figure 15. The core hardness of 34 HRC was typical for this alloy and microstructure. Surface hardness measurements from a case hardening (such as nitriding or carburizing) typically exceed 60 HRC.

Figure 17 – Hardness (in HRC) of a cross section of the crankshaft, showing higher hardness values in the 0.020 inches closest to the surface.

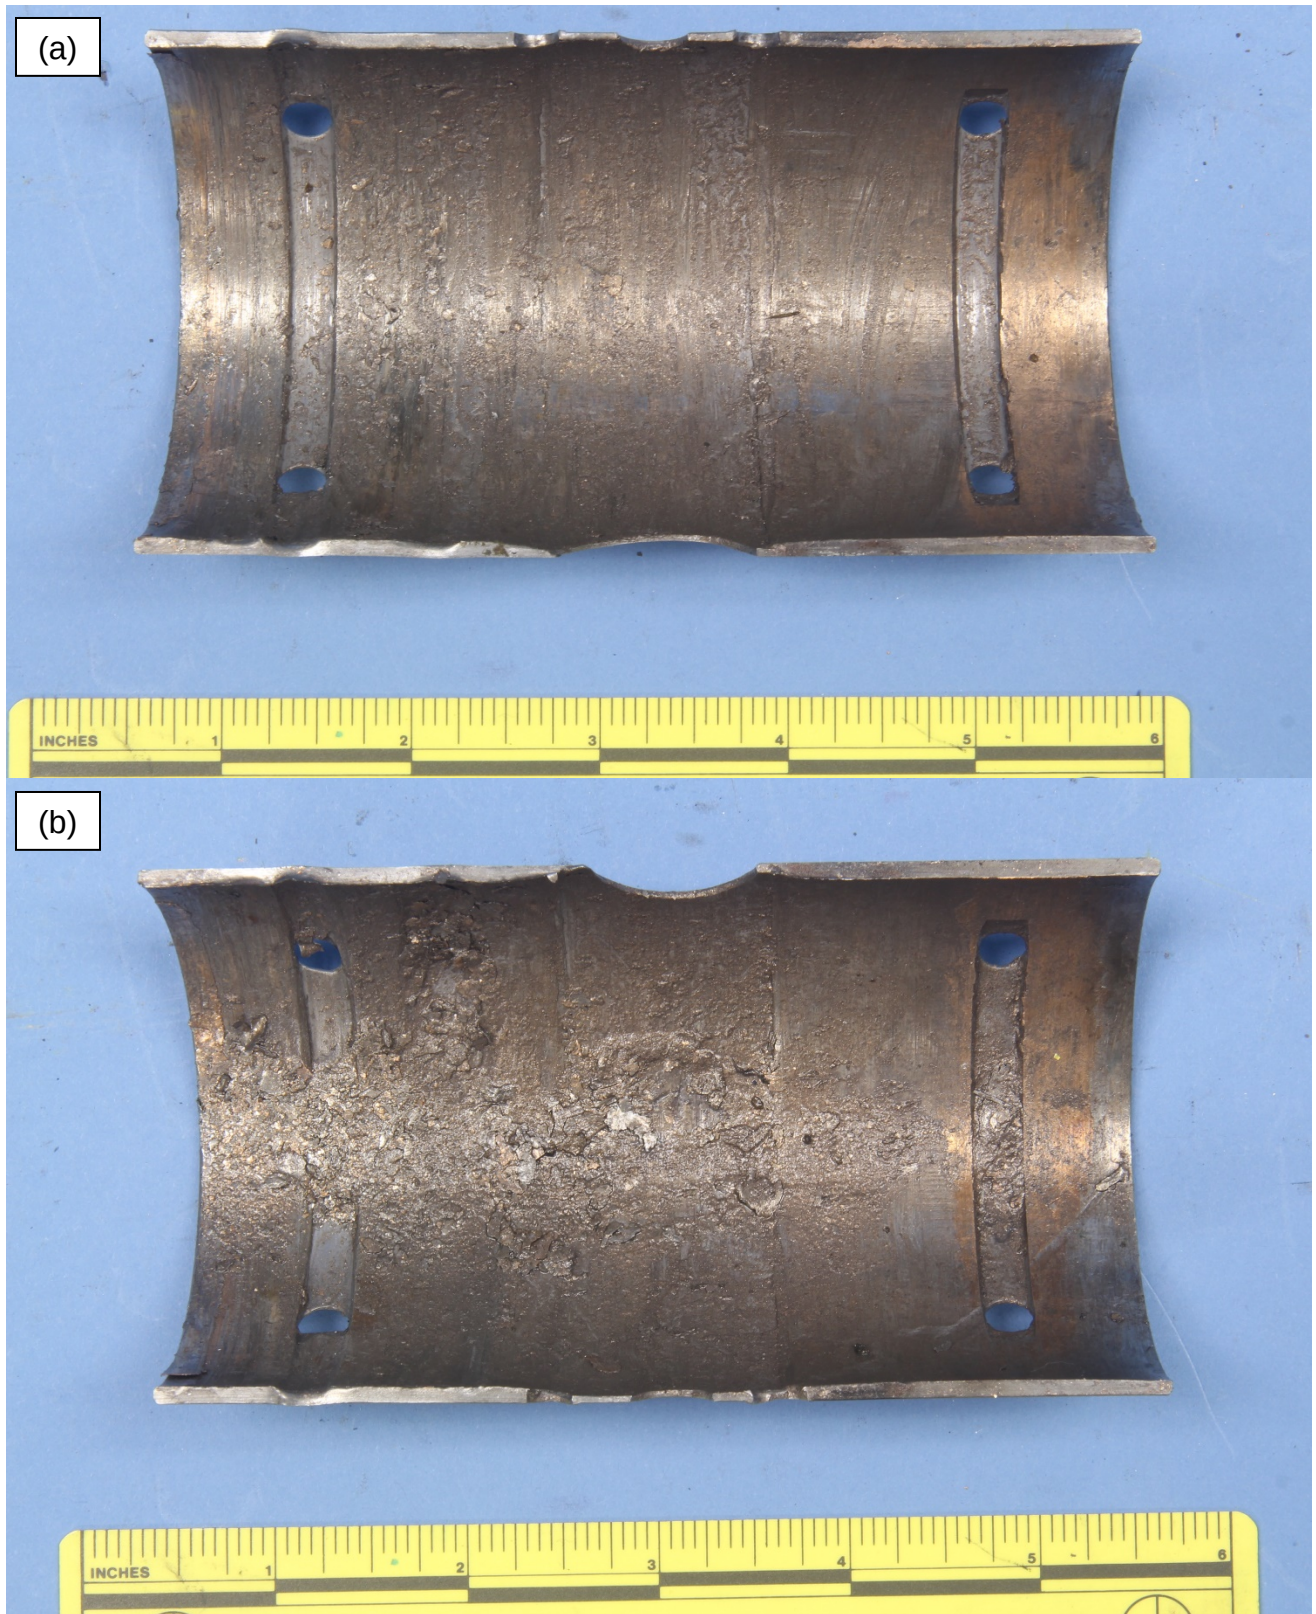
Figure 18 shows the inner surface of the thrust bearings, as received. These bearing surfaces showed wear significant enough for material to spall off the inner surface. The inner surfaces also exhibited material smearing in circumferential directions, most apparent at the bearing edges. Circumferential wear marks were also evident on the outer surfaces of the bearings, but no severe material loss such as spalling was present (Figure 19).

Figure 18 – The main journal bearings, viewed from the inside bearing surface which exhibited wear and material spalling.

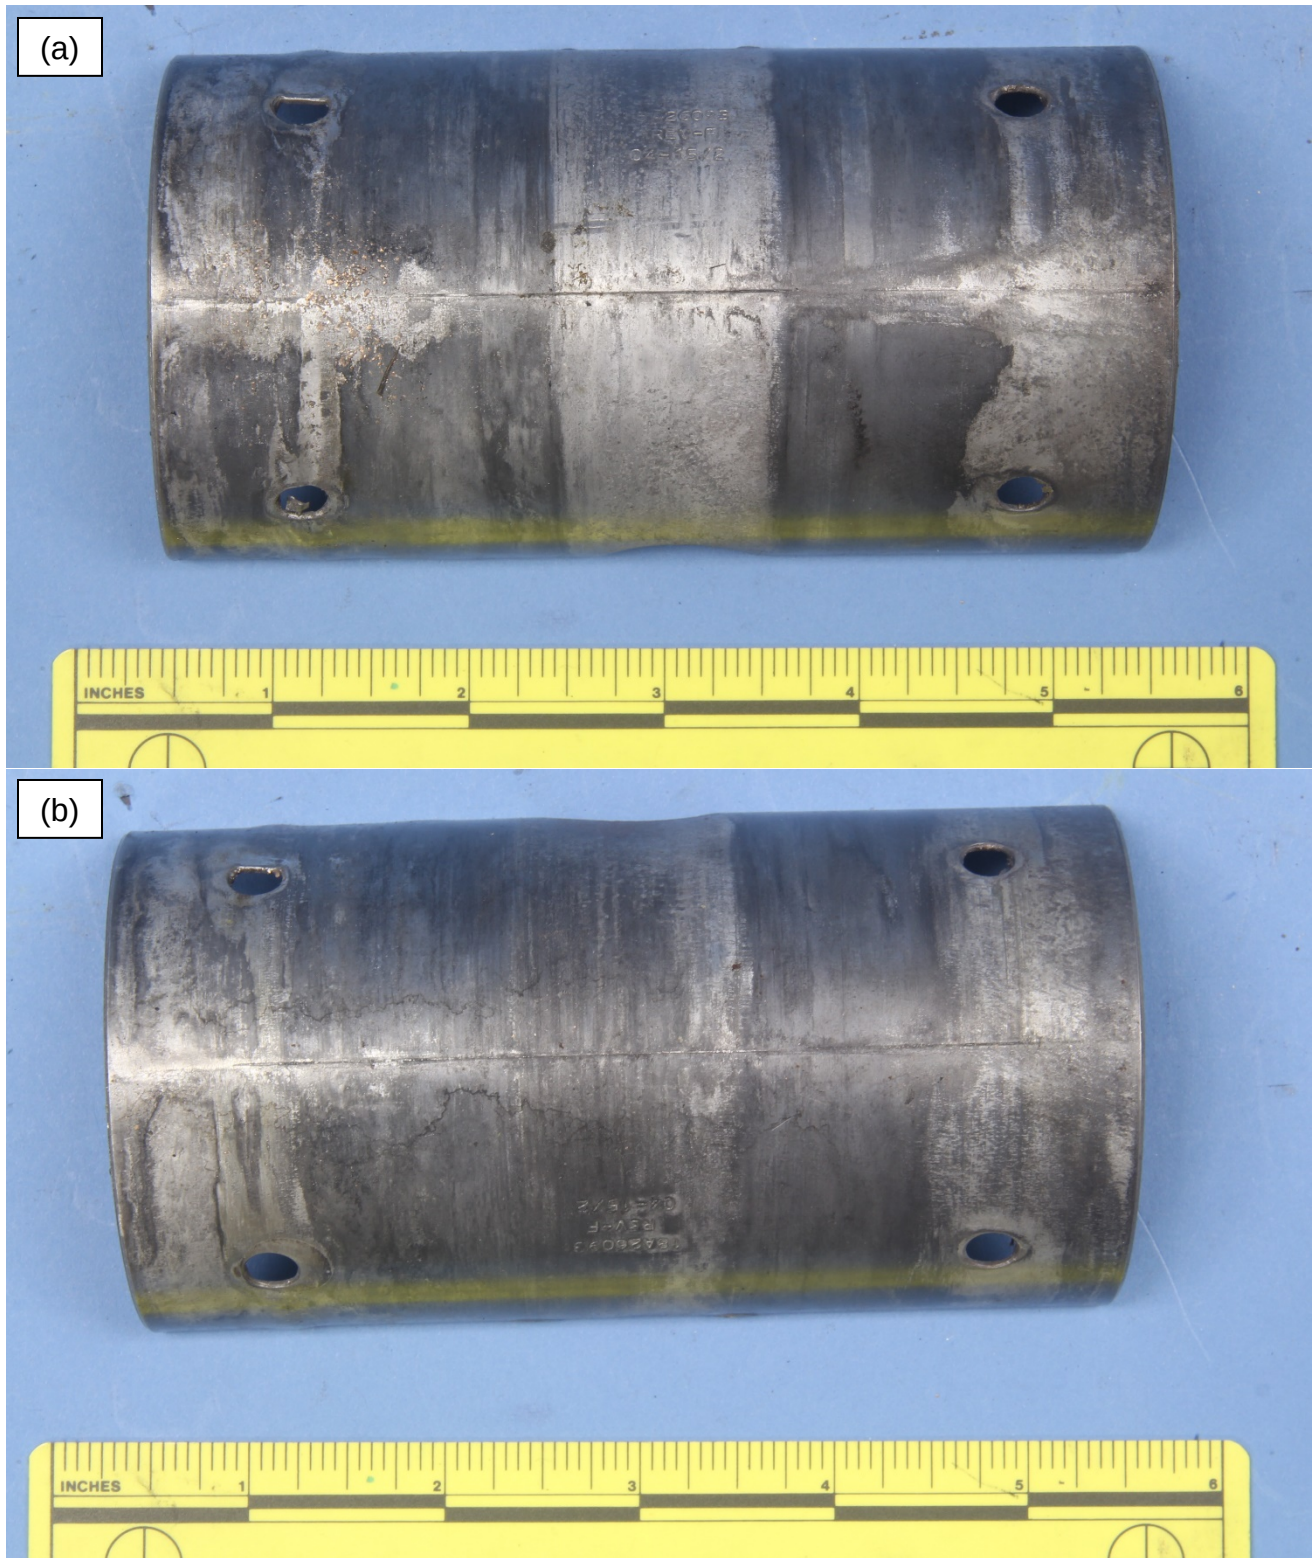
Figure 19 – View of the outer surface of the main journal bearings, showing circumferential wear marks.
