# NATIONAL TRANSPORTATION SAFETY BOARD

## MATERIALS LABORATORY FACTUAL REPORT

Report No. 18-073

Place : Redding, California  
Date : November 2, 2017  
Vehicle : Cessna 172R, N2103T  
NTSB No. : WPR18LA039  
Investigator : Tealeye Cornejo, AS-WPR

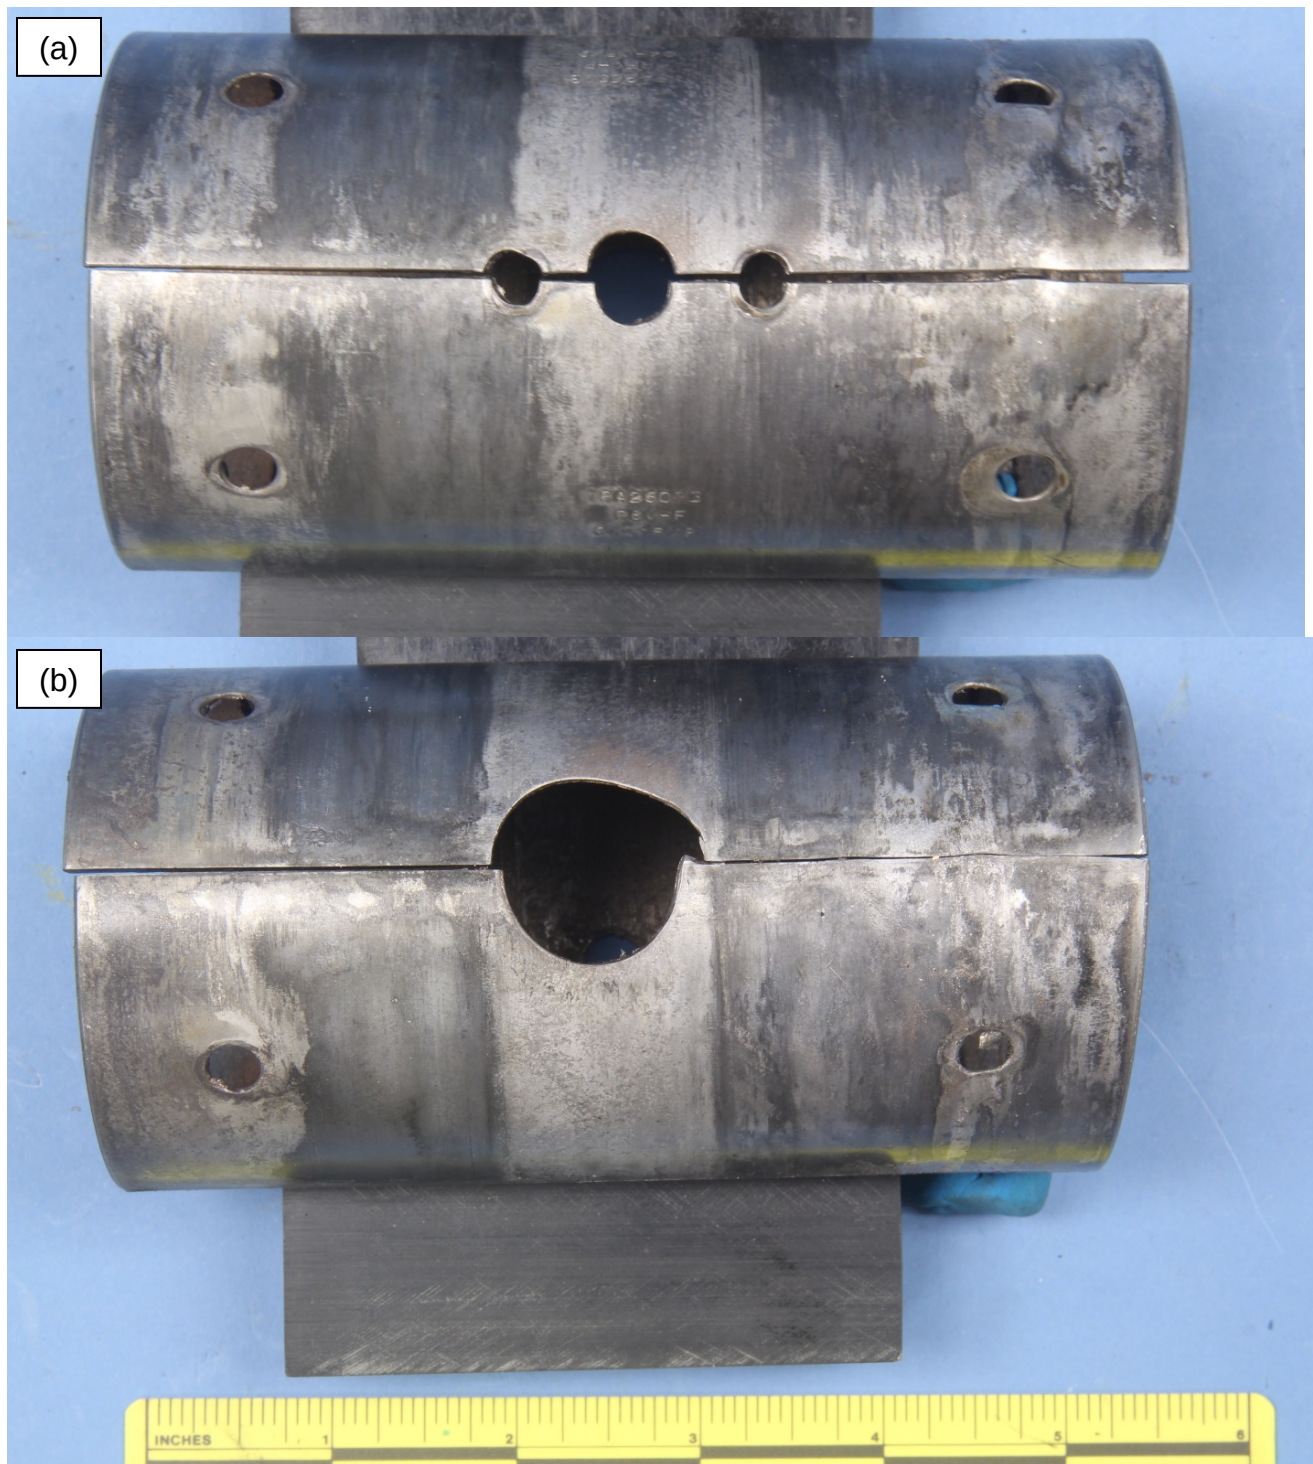
Of note in mating the two bearing halves was apparent mismatch in size (see Figure 20). As shown in Figure 20, the three smaller holes and the one large hole did not line up seamlessly. These surfaces also exhibited distortion and indications consistent with deformation.

Figure 20 – The outer surfaces of the main journal bearings, mated to show minor deformation and material smearing.

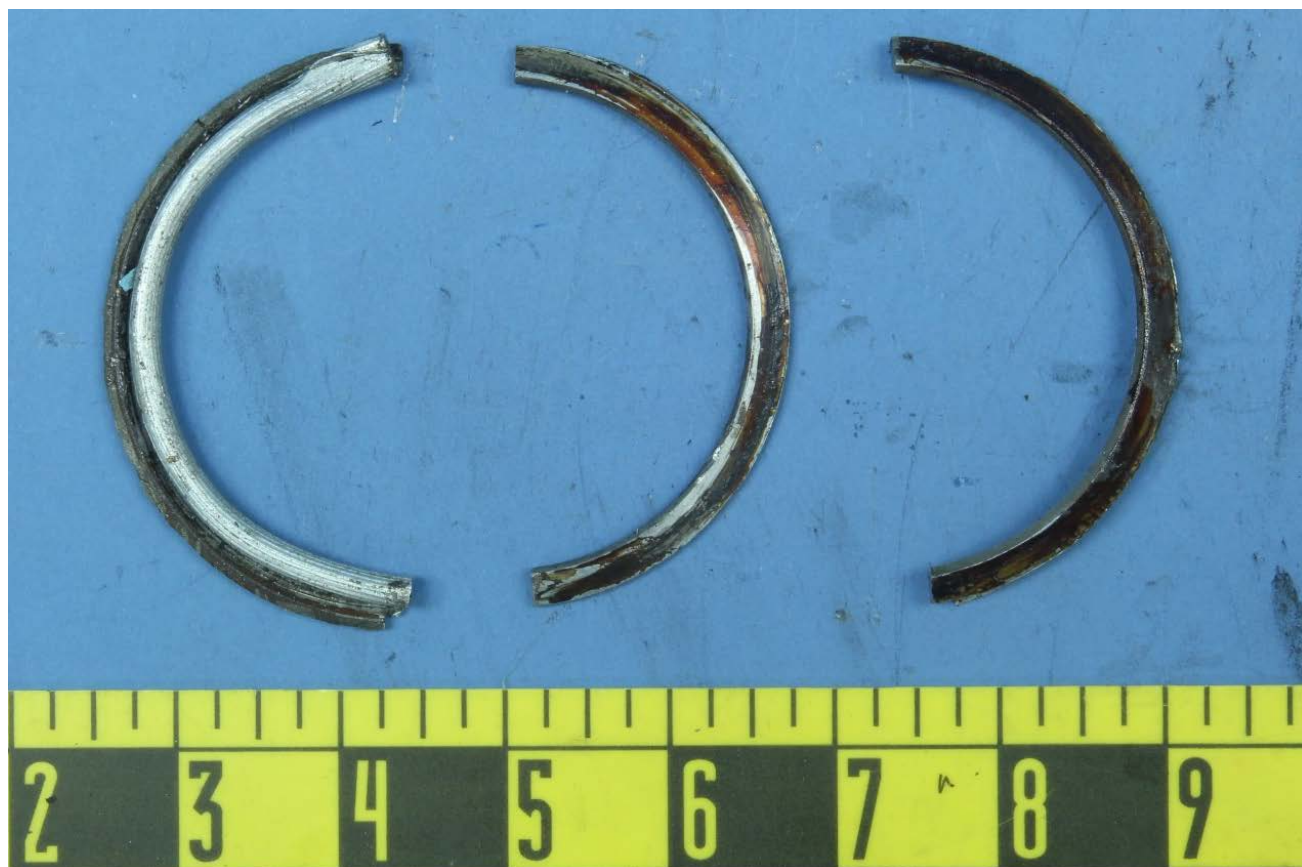
Figure 21 shows the three flange fragments, as received. Each of the flanges exhibited features consistent with overstress fracture along one of the edges, as well as circumferential wear marks. On one of the flanges, this wear was severe enough to leave a thin wedge of material that had undulated and folded in on itself, exposing an underlying metallic filament (Figure 22). Another flange had been deformed severely enough to curl, as exemplified on the edge illustrated in Figure 23.

Figure 21 – The three flange pieces, as received.

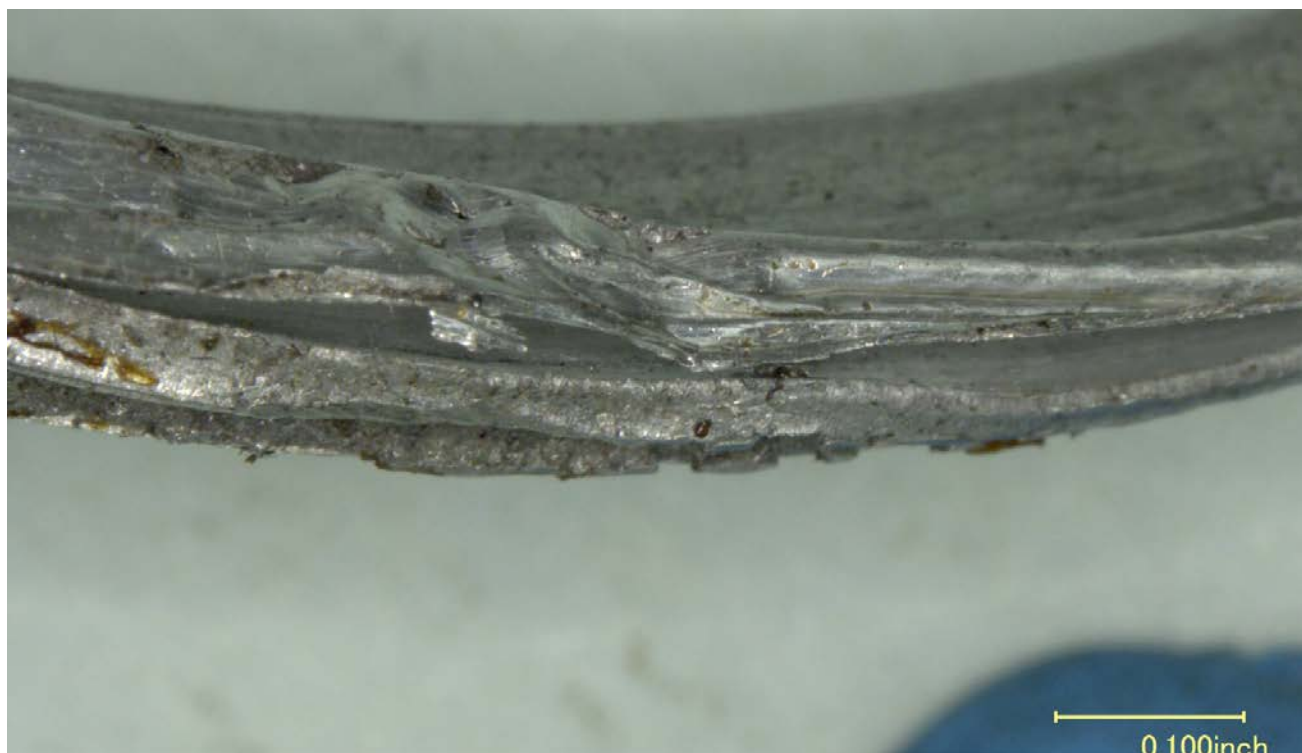
Figure 22 – Damage on the edge of one of the flanges.

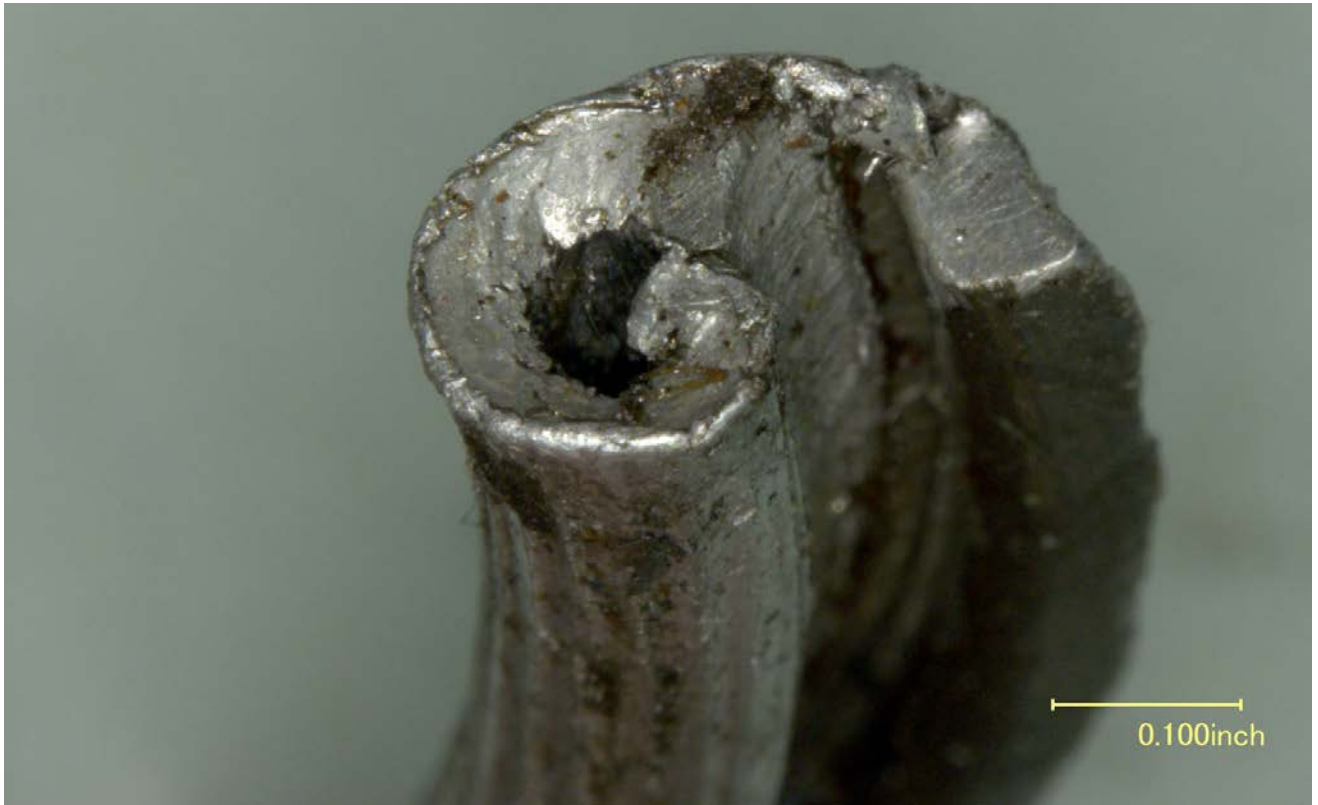
Figure 23 – Deformation on one of the flanges severe enough to curl over on an edge.

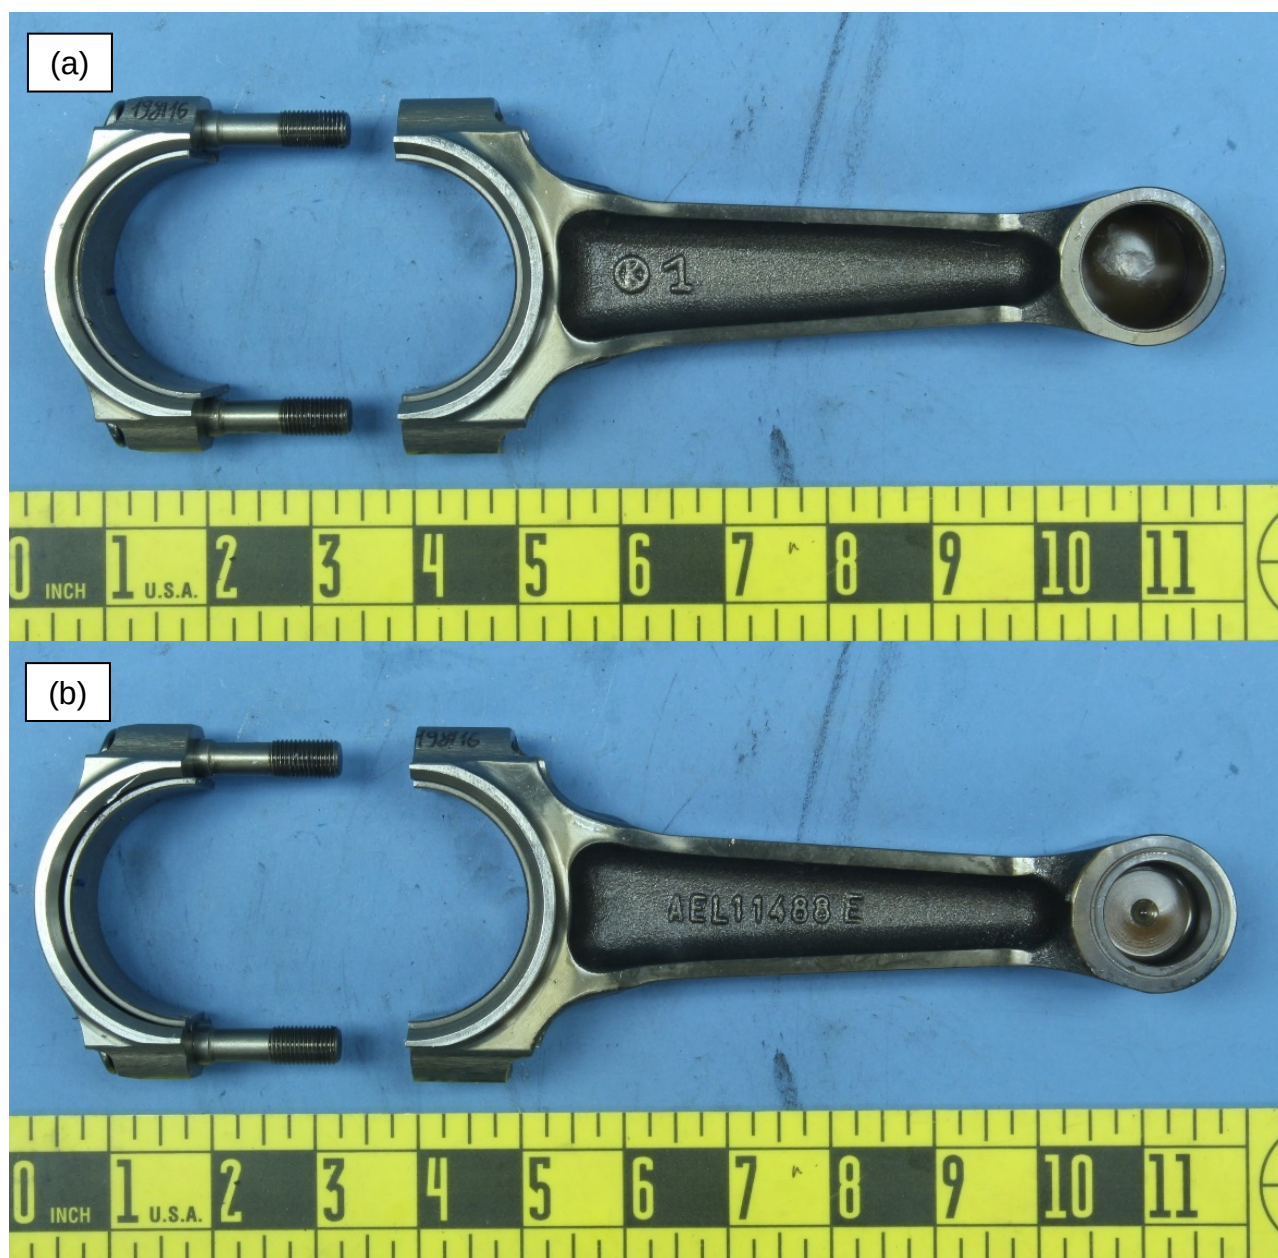
Figure 24 shows the submitted connecting rod assembly, as received. The connecting rod, cap, and two bolts were intact with no apparent damage or deformation.

Figure 24 – The #1 connecting rod and cap viewed from (a) the obverse side and (b) the reverse side.

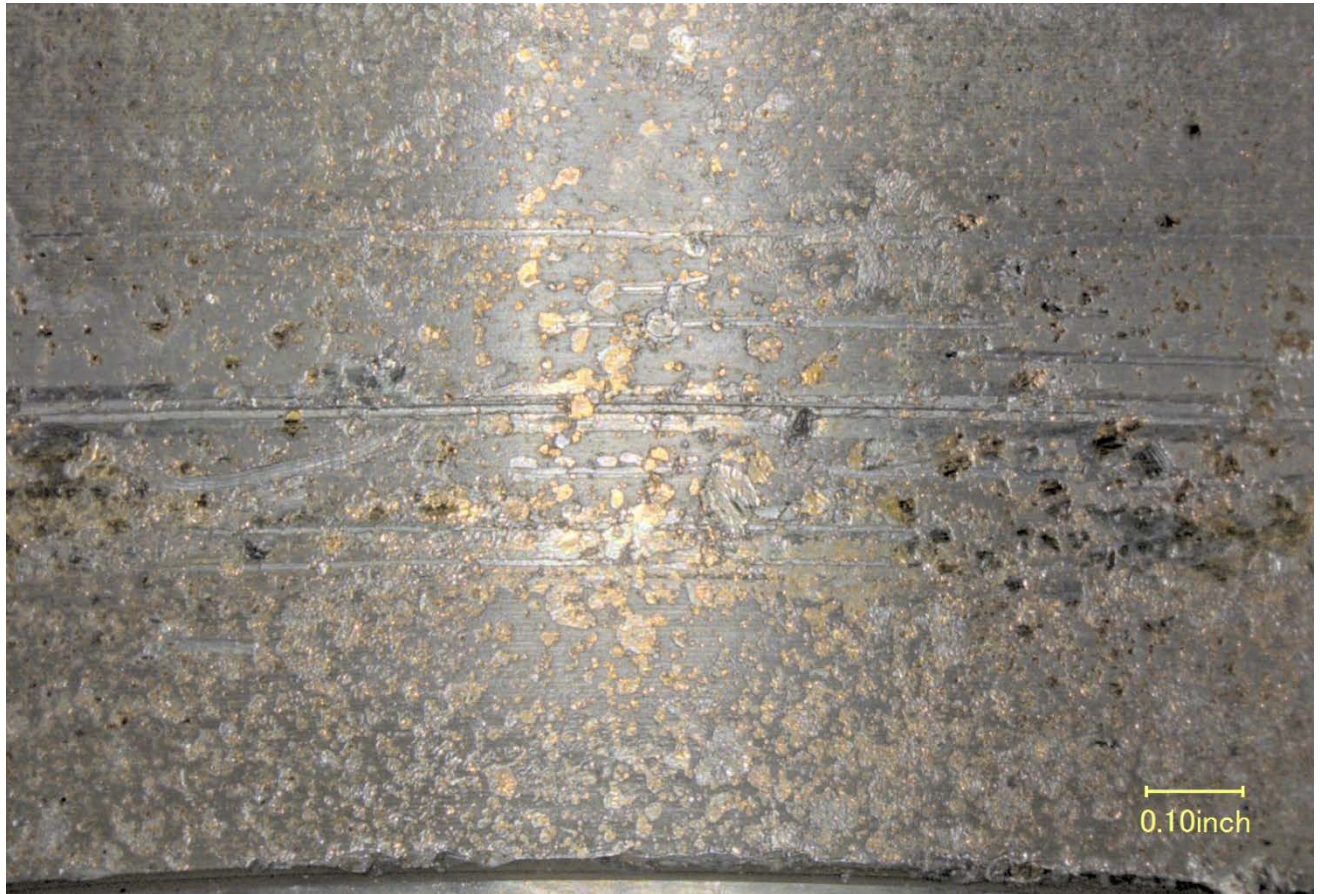
The bearings for the connecting rod and the cap, however, did exhibit damage. As shown in Figure 25, the cap bearing surface exhibited indications of gouging and material spalling. The gouging was circumferential in orientation, consistent with wear from loose material abrading the surface during rotation. These wear patterns were not mirrored on the #1 crankshaft rod journal.

Figure 25 – The inner bearing surface of the connecting rod cap, showing scrape marks and material spalling.
