## **NATIONAL TRANSPORTATION SAFETY BOARD**

# **AIRFRAME AND ENGINE EXAMINATION**

**WPR17LA040**

Location: Near Ukiah, Oregon  
Date: November 25, 2017  
Aircraft: Piper PA-28, N57351  
NTSB IIC: Michael Huhn

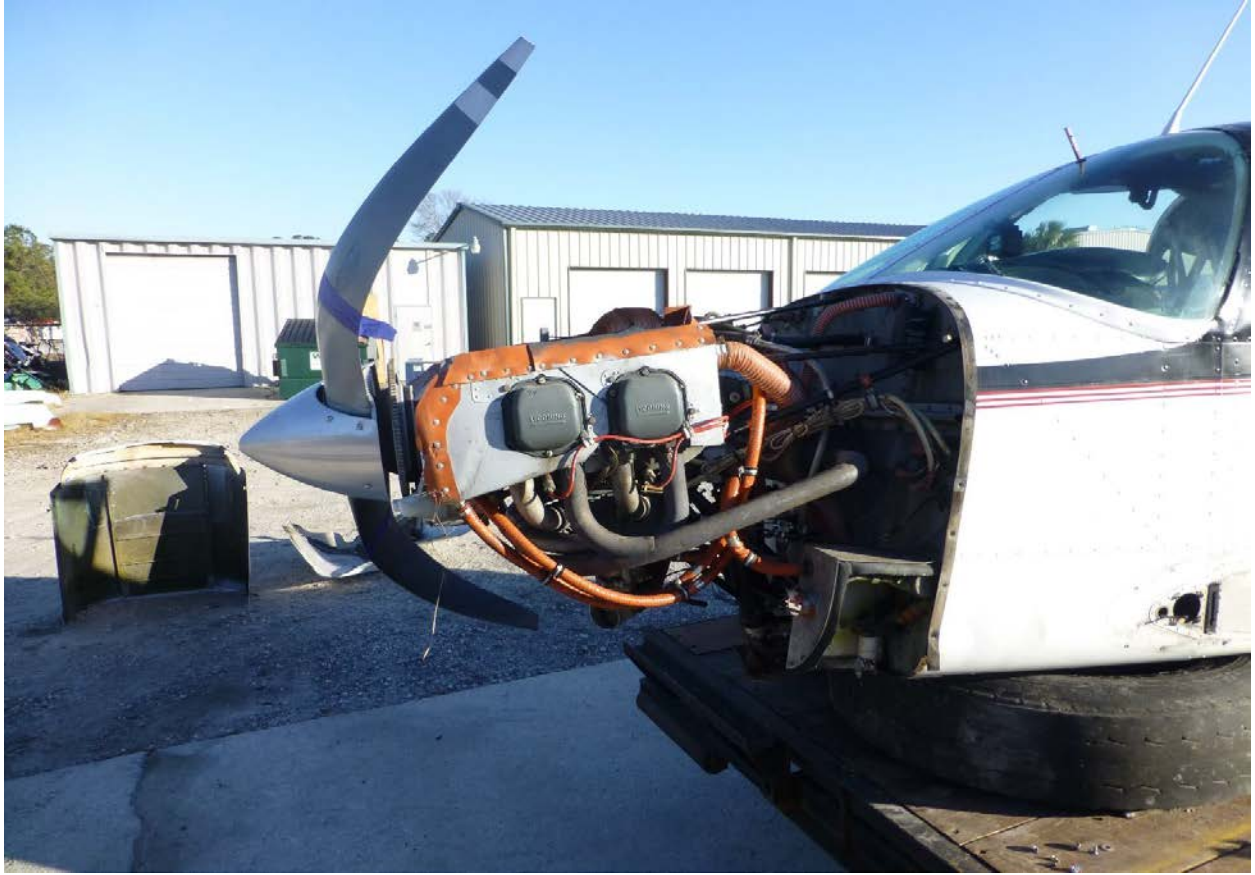
**Figure 1 - Airframe with Engine Attached**

The engine looked intact. The propeller blades were bent aft, midblade. (photo 1). The top spark plugs were removed for boroscoping with a lighted digital boroscope. All the valves and pistons looked like normal wear. The spark plugs looked grey in color and had normal wear. The fuel selector valve was removed and disassembled. No defects noted.

An external fuel tank was connected to the inlet side of the gascolator. The primer was utilized and the electric fuel pump worked and pumped gas to the engine. The battery was weak and a booster was used to jump the battery for starting. After several revolutions the engine started right up and idled without problems. After engine start, it was noted that the oil pressure gauge line was fractured during the accident and started leaking oil at the cracked fitting. The engine was shut down at that point. No mechanical issues were noted with the engine.
