## **NATIONAL TRANSPORTATION SAFETY BOARD**

# **CARBURETOR EXAMINATION**

**WPR18LA042**

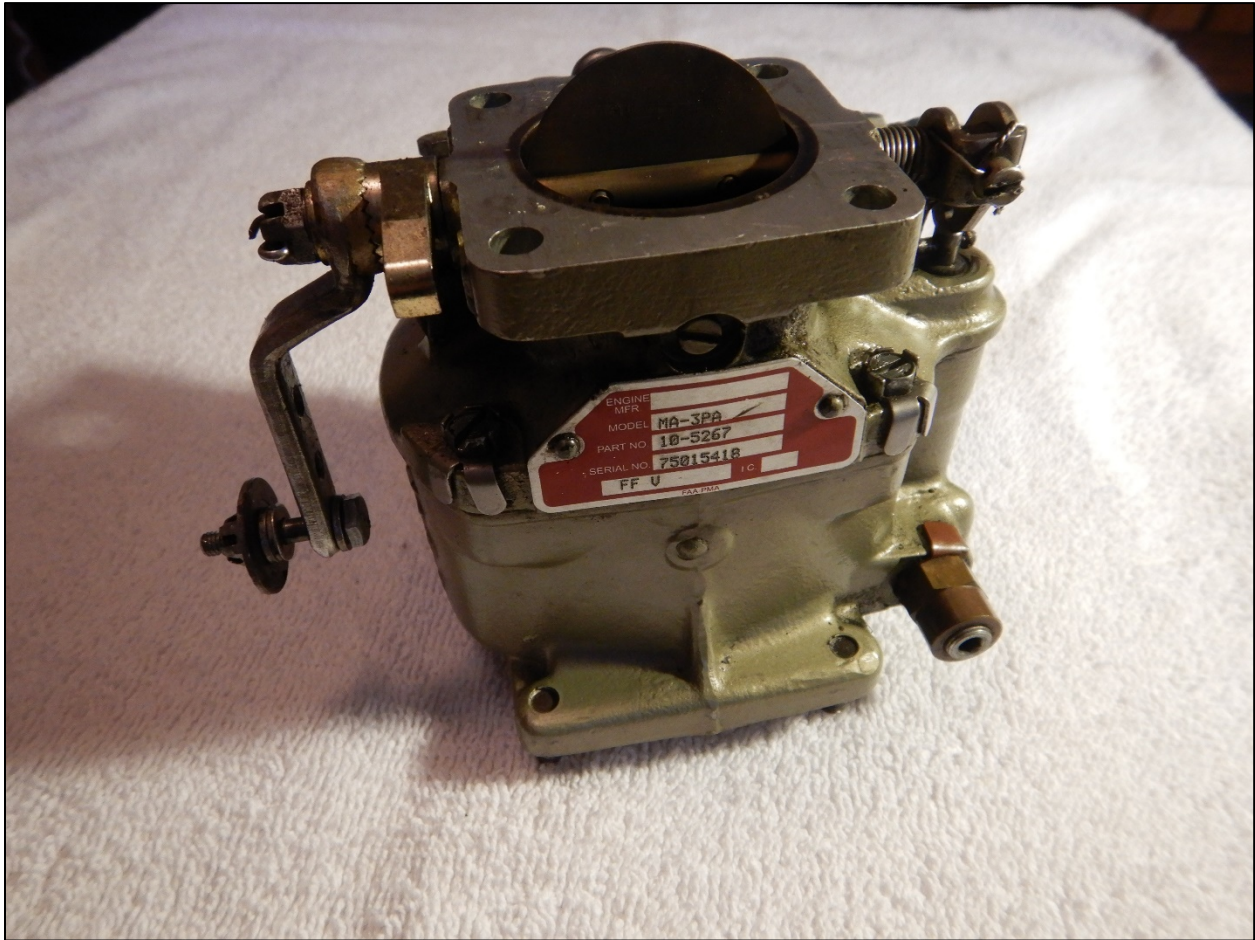
The carburetor shipment was intact and sealed. The carburetor was removed from the shipping material and was undamaged. The throttle valve and linkage moved freely by hand and no fuel exited from the accelerator pump jet. The mixture lever moved freely by hand with no restrictions. The throttle body valve and internal surfaces were dark in color.

Figure 1-Carburetor assembly.

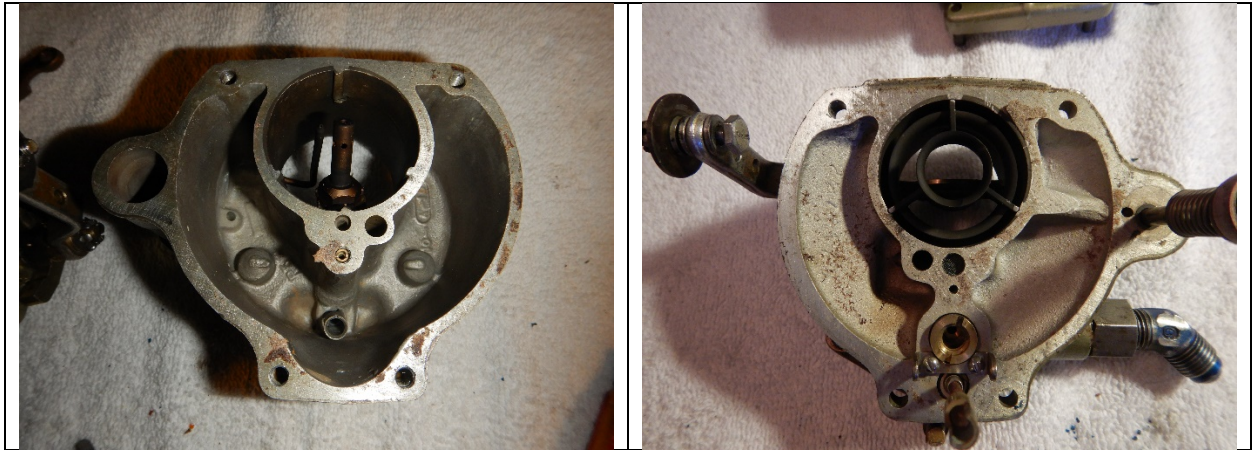
During the disassembly of the carburetor, the float bowl gasket was attached to both the float bowl and the top side of the carburetor. A razor blade was used to separate the gasket from the carburetor. The carburetor float bowl gasket was damaged during its removal. The float bowl was empty of fuel and was free of contaminants and debris.

Figure 2-Carburetor bowl and top side.

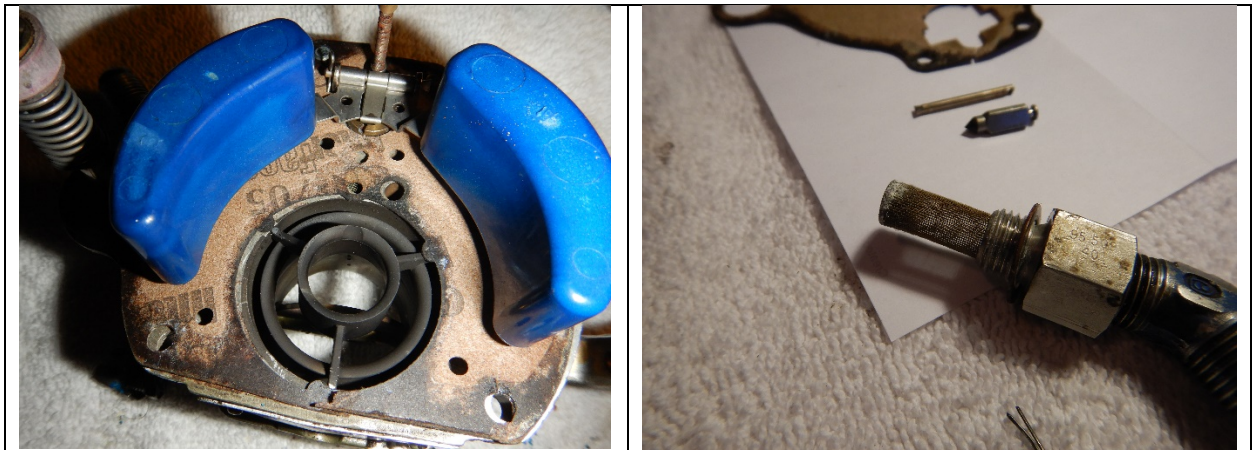
The float and linkage assembly and the bowl gasket were removed. An oily residue was found on the interior surface of the top of the carburetor. The needle valve was removed and was unremarkable. The needle valve seat was visible and unremarkable. The gascolator inlet screen was removed and clear of debris. Jets and ports were unobstructed when air was introduced.

Figure 3-Float assembly and inlet fuel screen.
