# NATIONAL TRANSPORTATION SAFETY BOARD

## MATERIALS LABORATORY FACTUAL REPORT

Report No. 18-098

Place : Rio Oso, CA  
Date : 12/4/2017  
Vehicle : Beech A36, N251E  
NTSB No. : WPR18LA043  
Investigator : Tealeye Cornejo

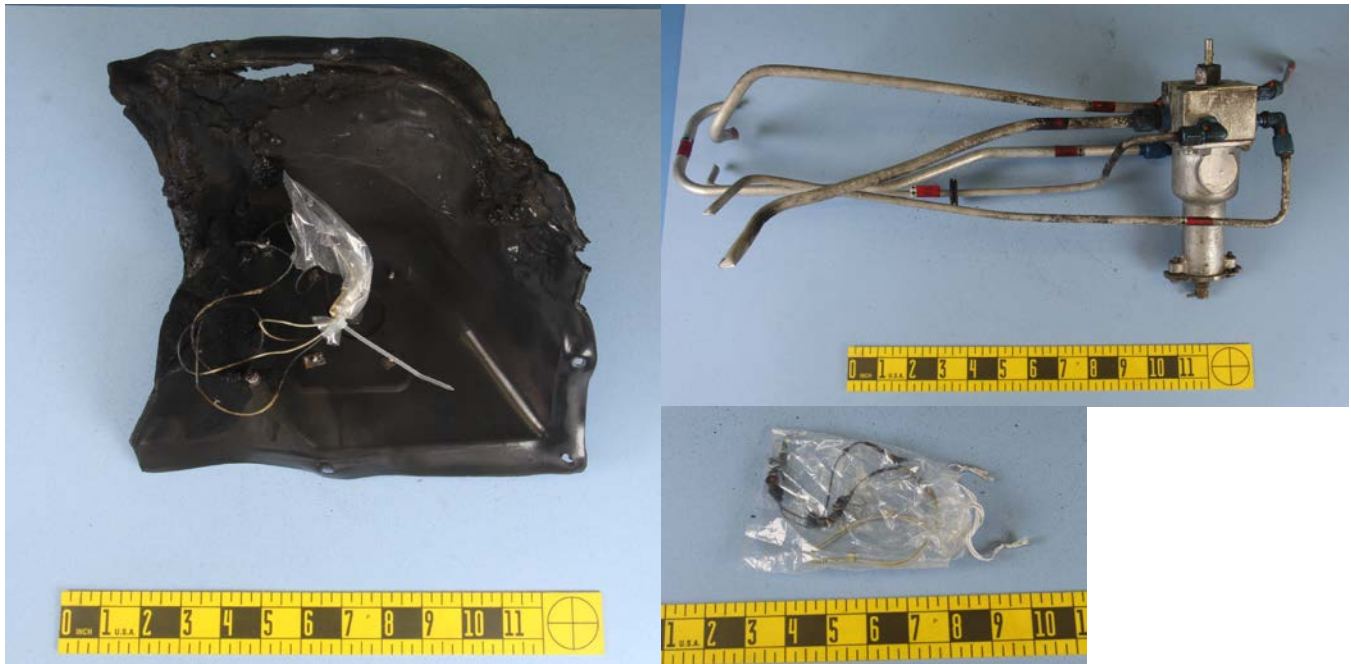
Figure 1: Accident parts as received.

The components submitted for examination were a fuel selector valve trim panel with attached wires, a fuel flow valve with fuel lines attached, and portion of electrical wiring figure 1.

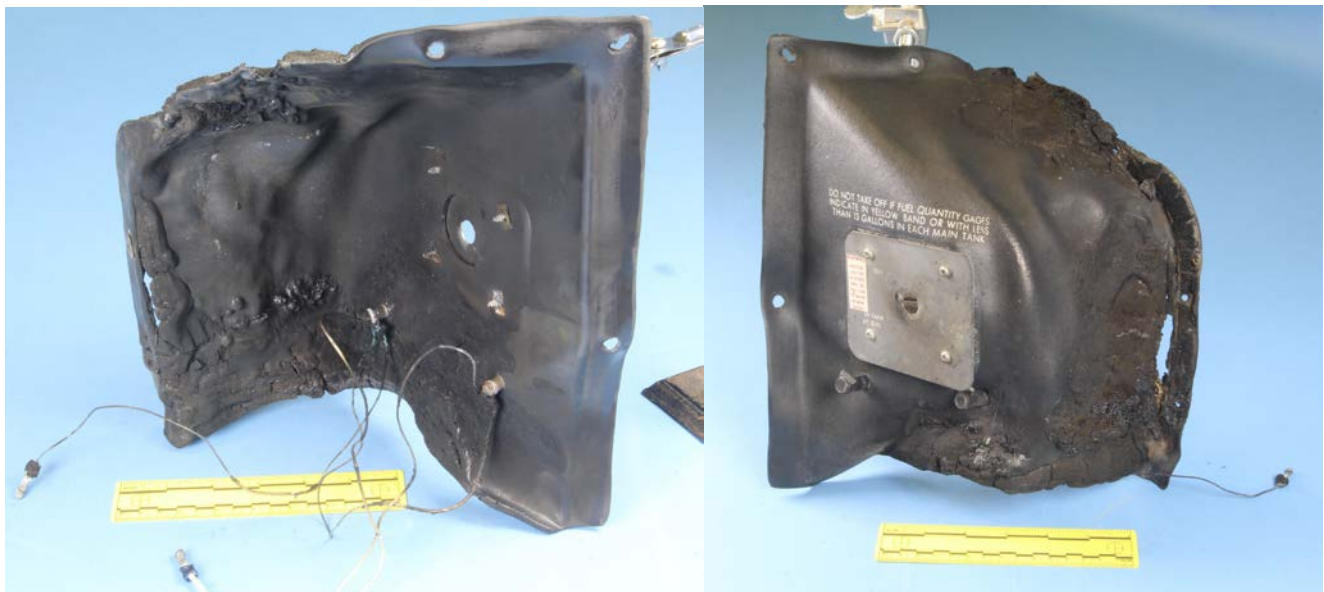
The trim panel for the fuel selector valve consisted of a molded plastic panel with a metal plate attached where the valve stem would protrude from behind the trim panel. The trim panel exhibited melting and carbonization along the bottom, top and forward edge (figure 2). The trim panel also included two indicator lamps and their associated wiring. The wiring exhibited melted and missing insulation consistent with exposure to a fire environment. The wiring that was attached to this trim panel did not exhibit evidence of electrical arcing.

Figure 2: Inboard and outboard facing sides of the trim panel.

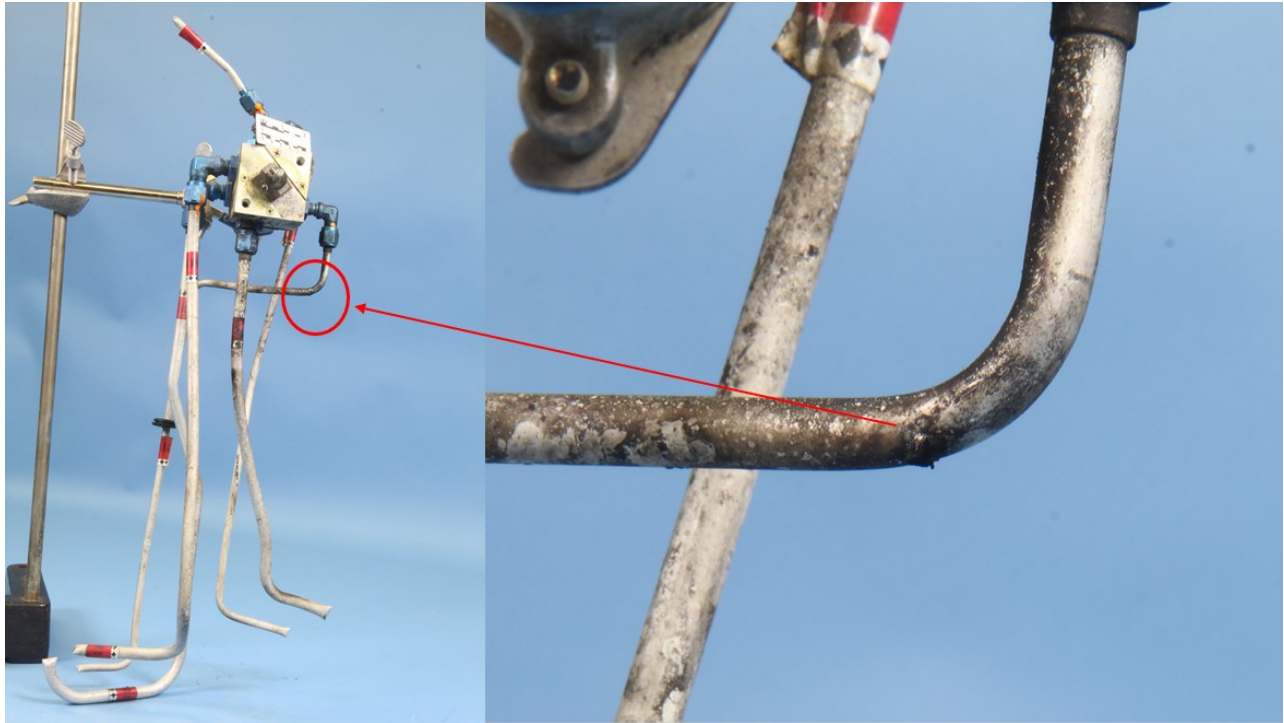
The fuel selector valve exhibited sooting on some of the fuel lines as well as a fuel line with a rough spot and pin hole near a 90-degree bend (figure 3). Examination of the rough spot revealed cratering and re-solidified metal splatter adhering to the fuel line surface as well as a hole through the fuel line wall (figure 4). These features are consistent with electrical arc erosion of the fuel line.

Figure 3: Fuel selector valve with fuel lines exhibiting sooting and arc erosion damage.

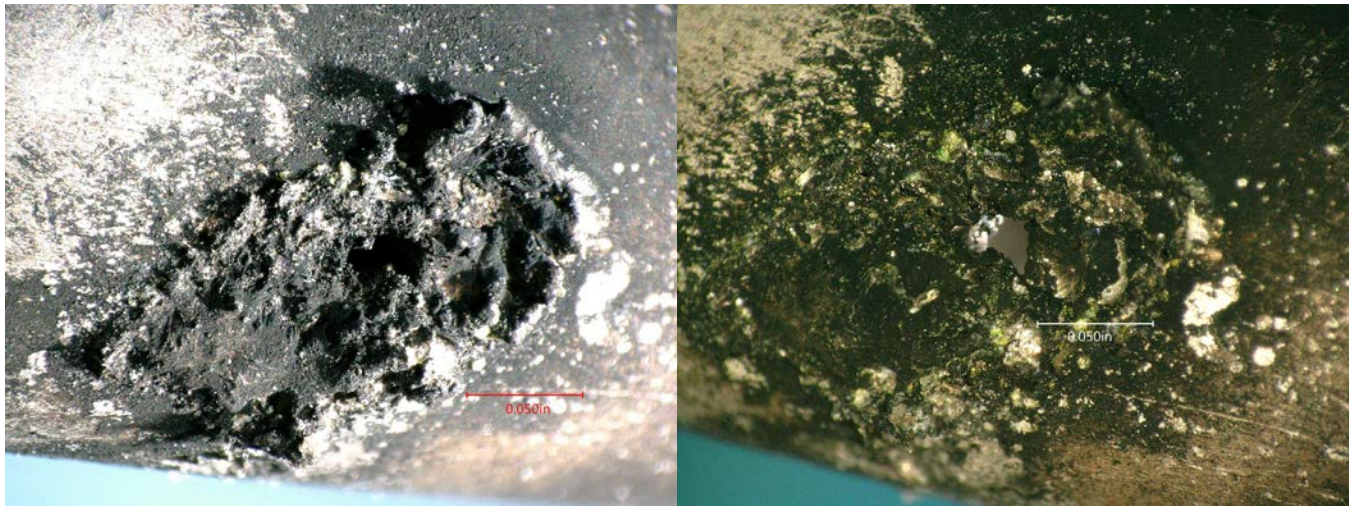
Figure 4: Images from digital microscope showing arc erosion and a hole through the fuel line wall.

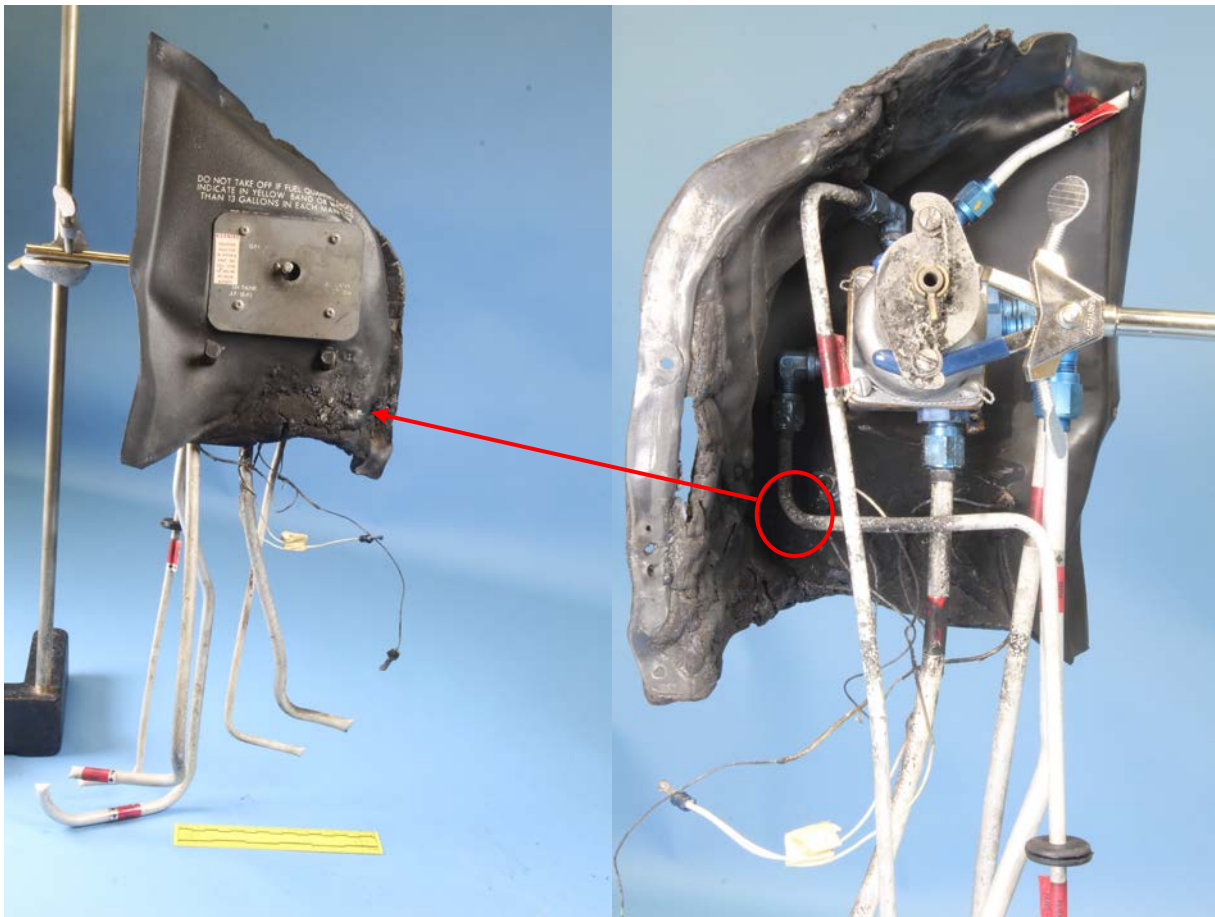
Examination of the trim panel and fuel selector valve placed together as they would have been installed in the accident aircraft (figure 5) revealed that the damaged portion of the fuel line was in alignment with the damage observed on the trim panel.

Figure 5: Alignment of fuel selector valve and trim panel. The location of the damaged fuel line is shown by the red circle.

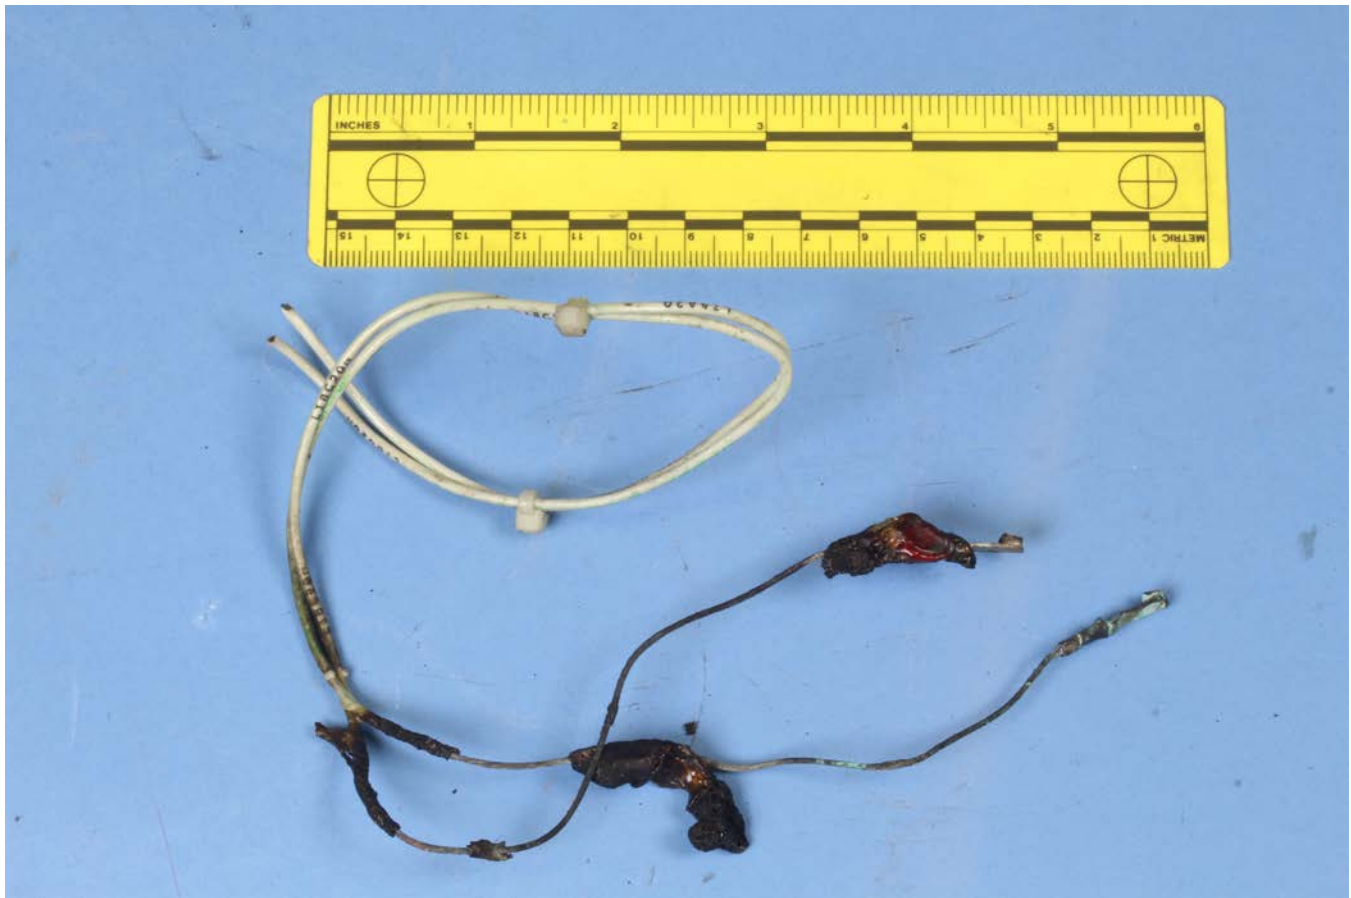
The portion of electrical wiring (figure 6) consisted of two conductors fastened together. One end of the portion of wiring was cut for removal and the other end had terminal connectors attached. The end of the wiring with the terminal connectors attached exhibited missing and charred insulation. Examination of the terminal

Figure 6: Portion of electrical wiring exhibiting fire damage.

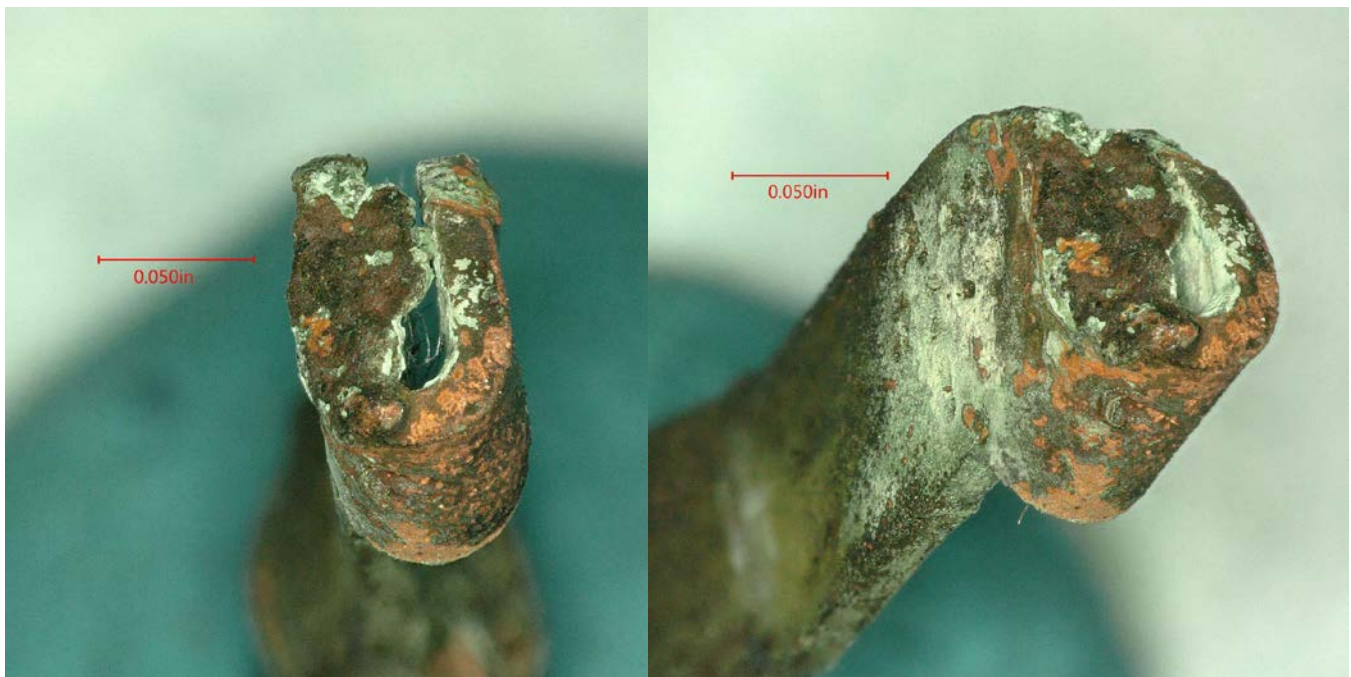
connectors revealed surface features on one of them consistent with electrical arc erosion (figure 7).

Figure 7: Terminal connector exhibiting electrical arc erosion.
