Here is our statement for the events that occurred on the night of December 5th, 2017 to N47536, a 1977 Piper Seneca II, aircraft total time since new was approximately 1,700 hours. Our comments at the end of the statement are to bring light on what the statements and comments are from the other parties involved and from what the evidence shows in the pictures. This is supplemented with the extensive experience we have operating these specific type of aircraft in the flight training environment.

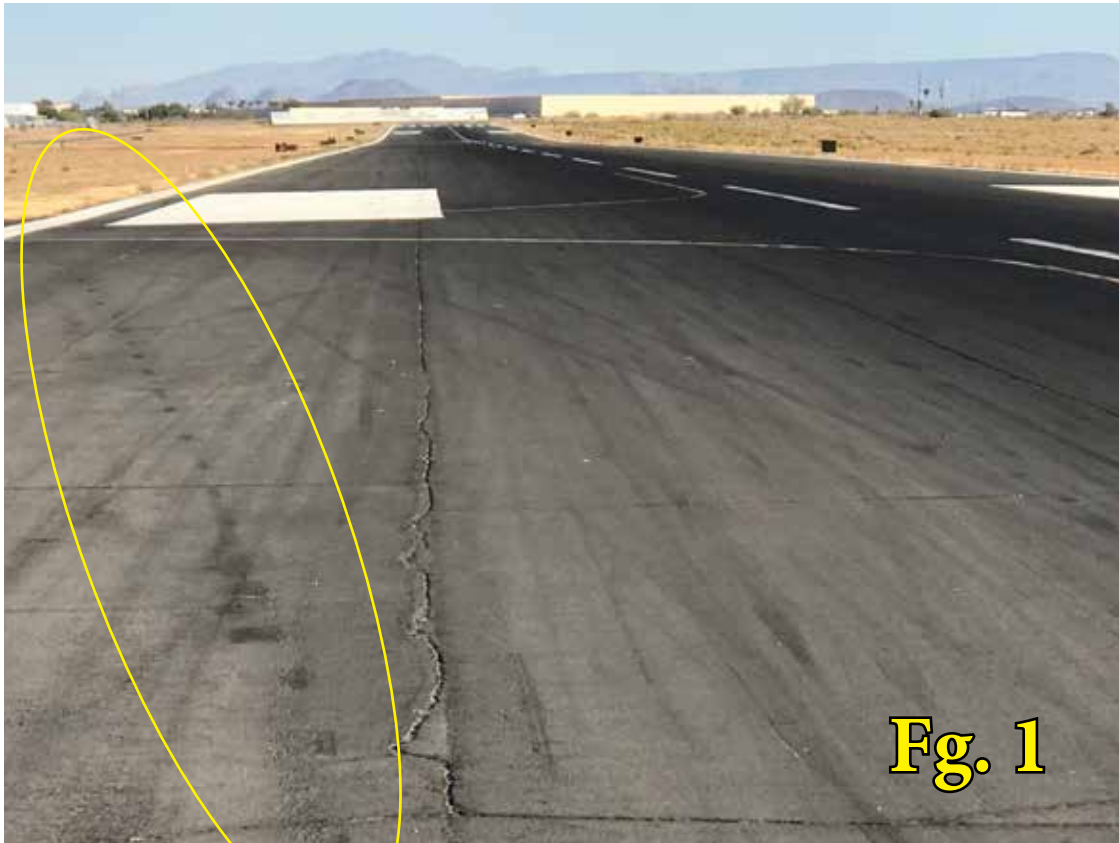
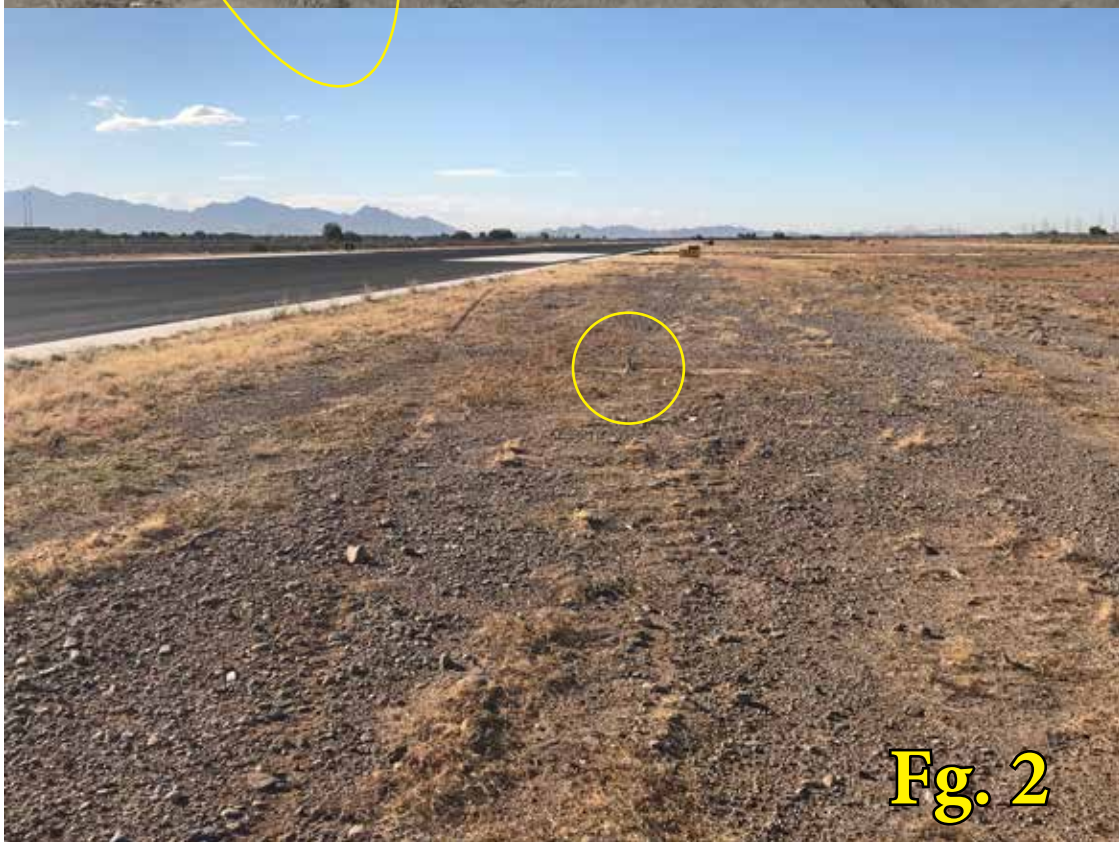
These photos were taken right after the incident on, December 5, 2017 by Michael Schubert. We have highlighted the skid marks made by the left main landing gear tire on the image below which indicates that the gear has not failed at this point due to the width of skid marks.

- In doing this procedure this will cause the landing gear oleo struts to compress and the aircraft to settle.
- If the aircraft is at high speeds on landing rollout, the flaps have not been retracted and the weight of the aircraft has not been able to settle on the landing gear, the pilot's brake effectiveness will be limited and will cause the aircraft tire to "chirp", possibly leaving skid marks, when braking is applied. This can be seen in figure 1 and 3

- If an aircraft stays on the PAPI glidepath until touchdown, the aircraft will either touchdown on or after the runway 1000' markings.
- In figure 1 and 3 you can clearly see where the tire skid marks from the left main landing gear tire begin which are well before the Runway 01 1000' markings and well left of centerline.

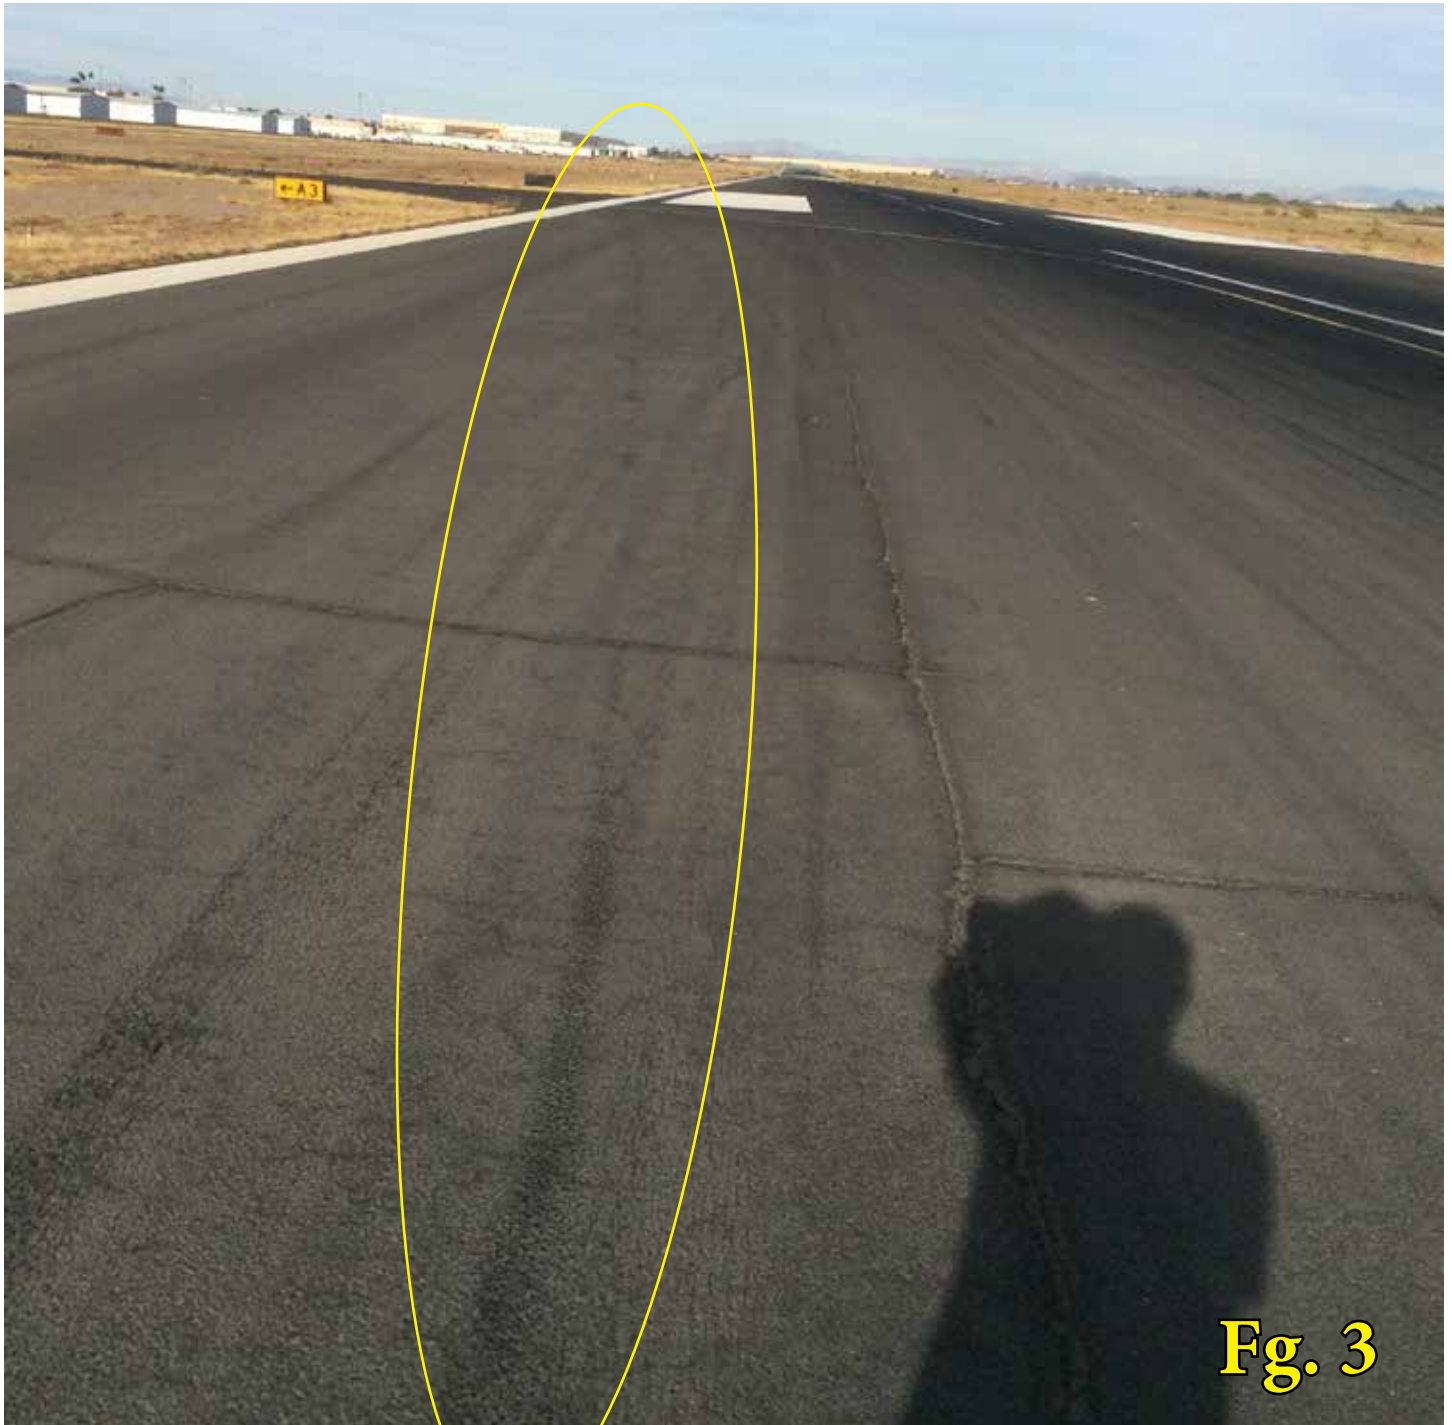
**Fg. 3**

I took this picture December 11, 2017. At this point, you can see that they were clearly off of the center line several hundred feet from the approach end of the runway.

- In figure 2, you can see the aircraft has now departed the hard runway surface and the left landing gear is now in the runway infield dirt.
- It can be seen in figure 2, distinct tire marks in the dirt from the right hand main landing gear and the location where the aircraft struck a runway edge light and the runway distance marker with the left prop/nose of the aircraft.

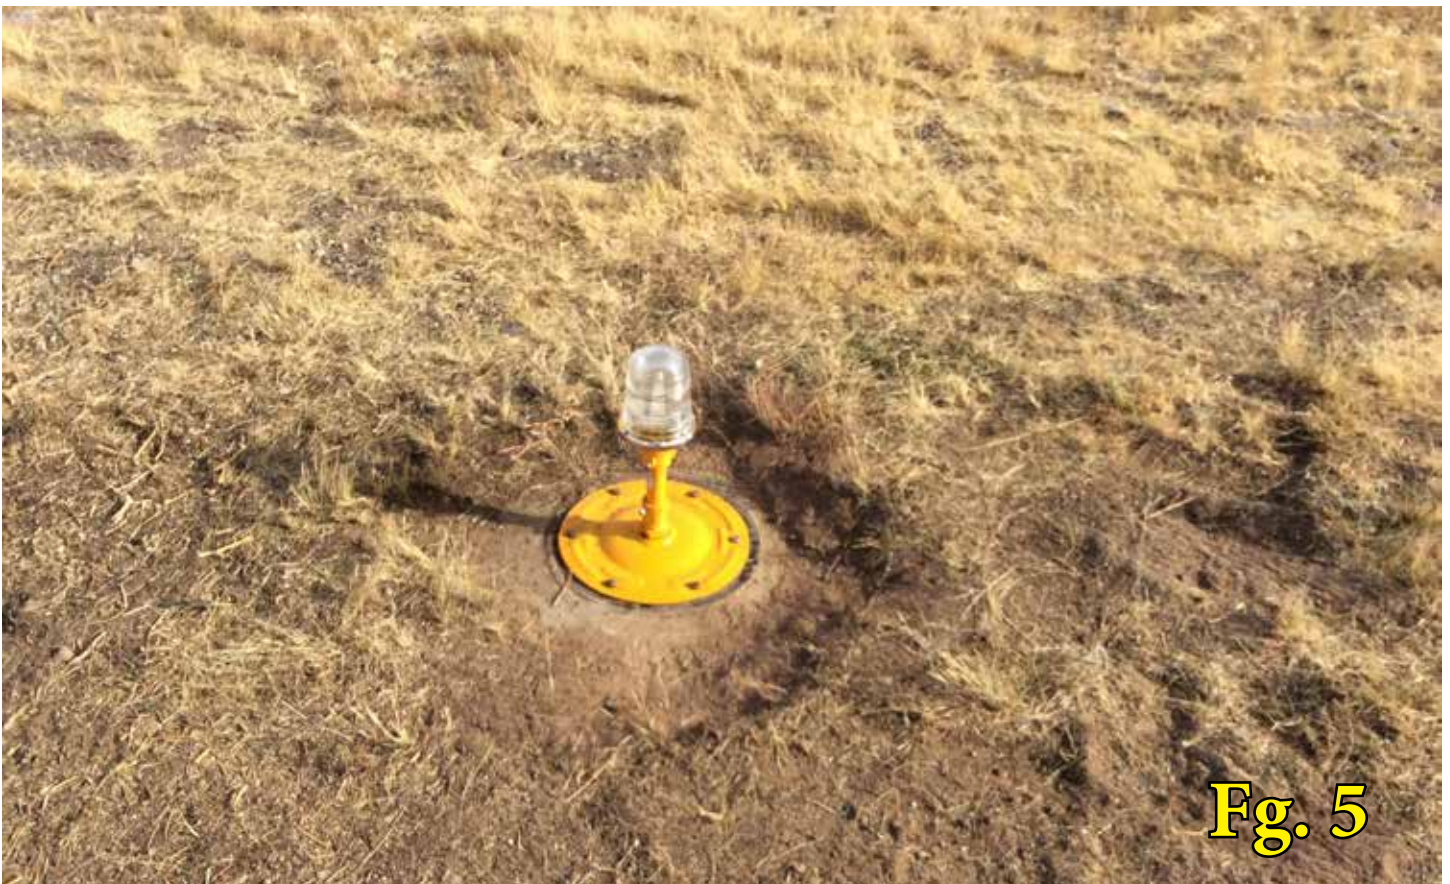
**Fg. 5**

These photos were taken December 11, 2017 after the airport removed the runway light. You can see the prop mark on the shaft of the light in the photo above.

- Figure 4 is the first indication that the prop struck the runway edge light.
- Figure 9-11 shows that due to the uneven surface and slope of the runway infield, the propeller has now begun to strike the ground but still no indication of aircraft component failure.
- The first and only indication that the left main landing gear has failed is after the aircraft struck the runway distance marker. See figure 25 and 26.
- The aircraft had to be traveling at a very high speed to land, veer off the runway, contact the runway distance marker, collapse the left main landing gear and then travel across the entire runway infield.

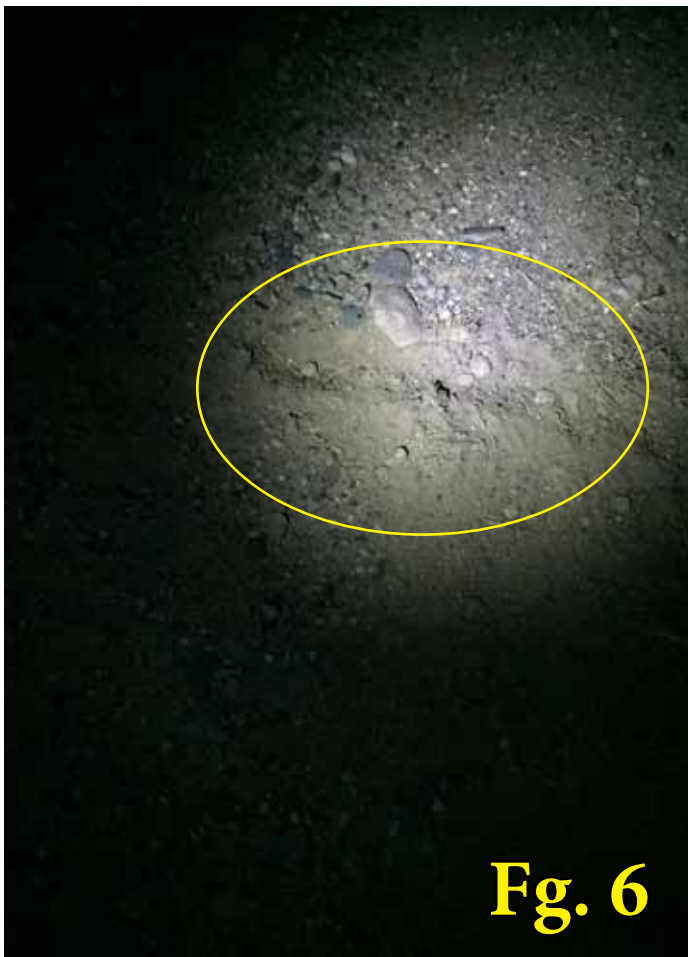
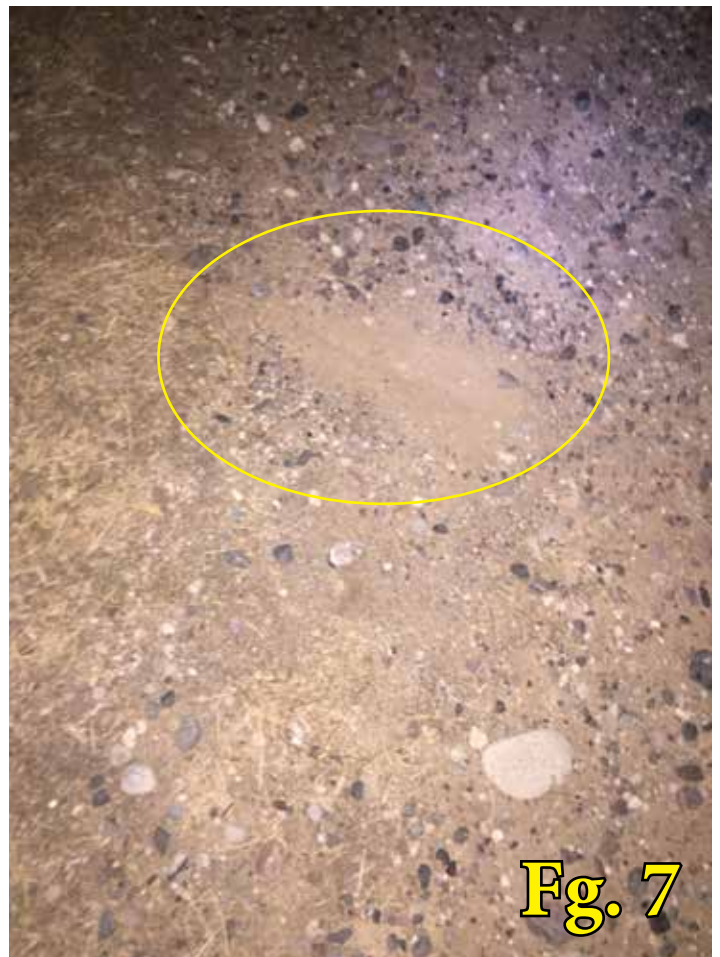
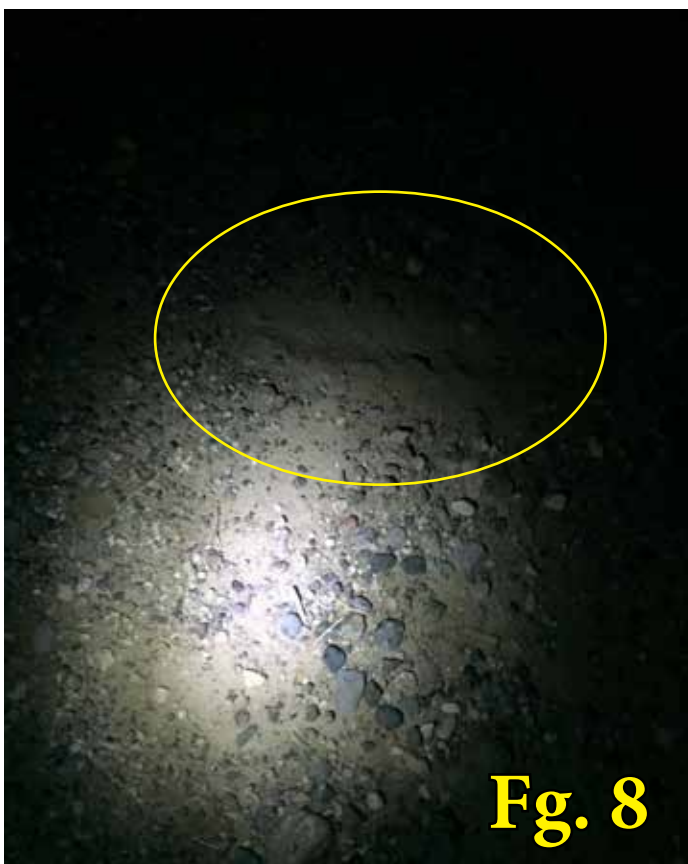
These are the first prop strike marks after the runway light and prior to the runway distance marker.

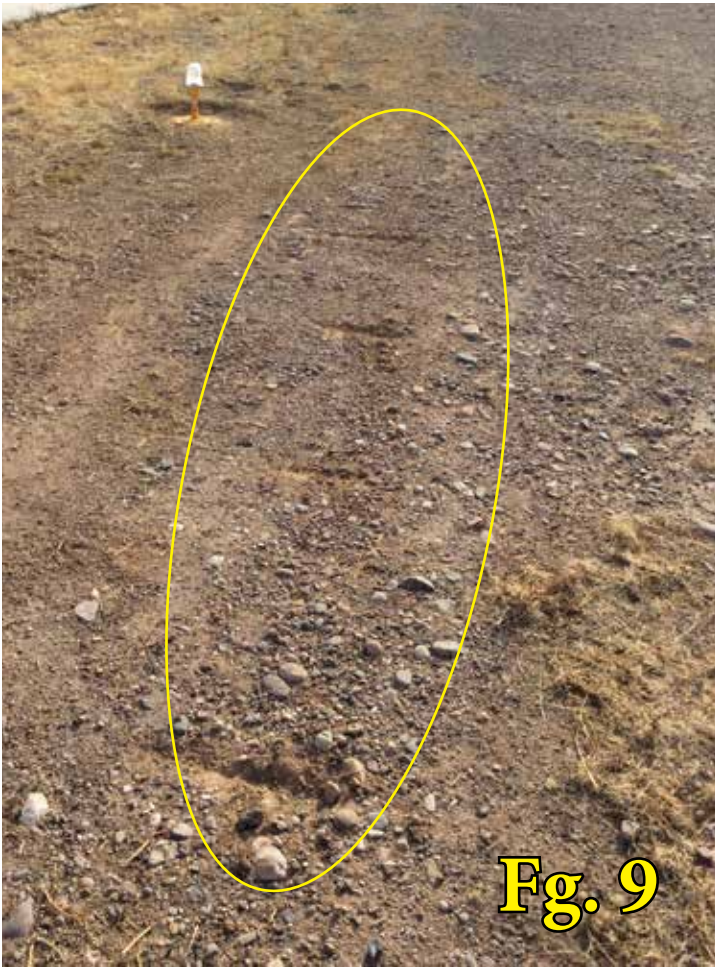
**Fg. 9**

These pictures were taken December 11, 2017 with the new runway edge light installed. The first signs of any prop strikes between where the nose gear apparently hit the runway light and where the runway marker is.

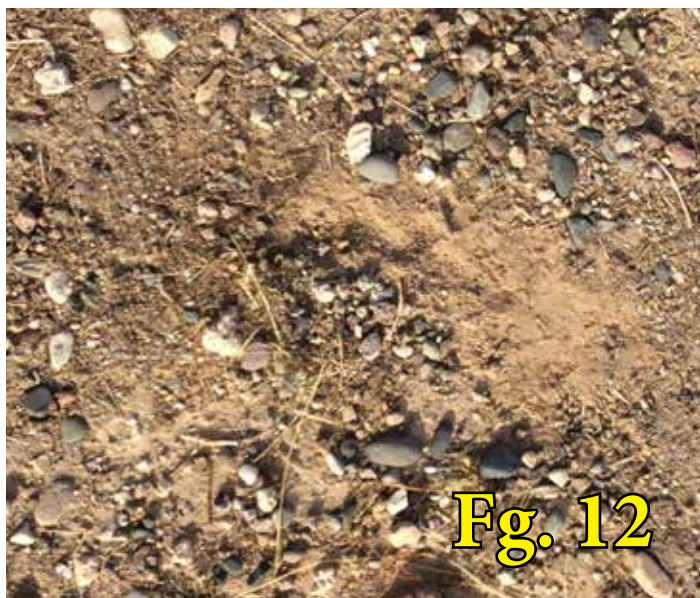
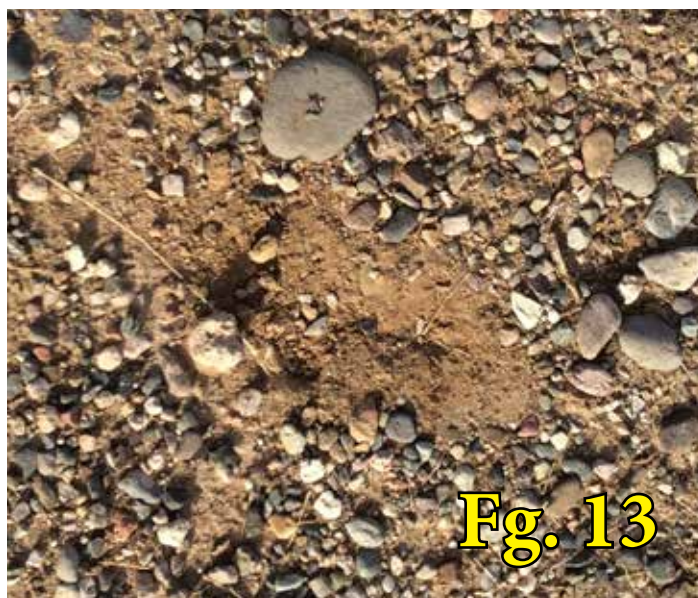
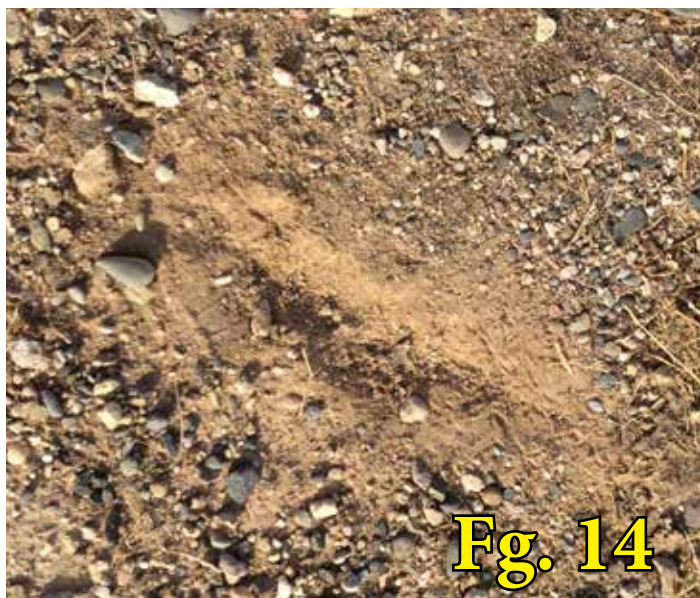
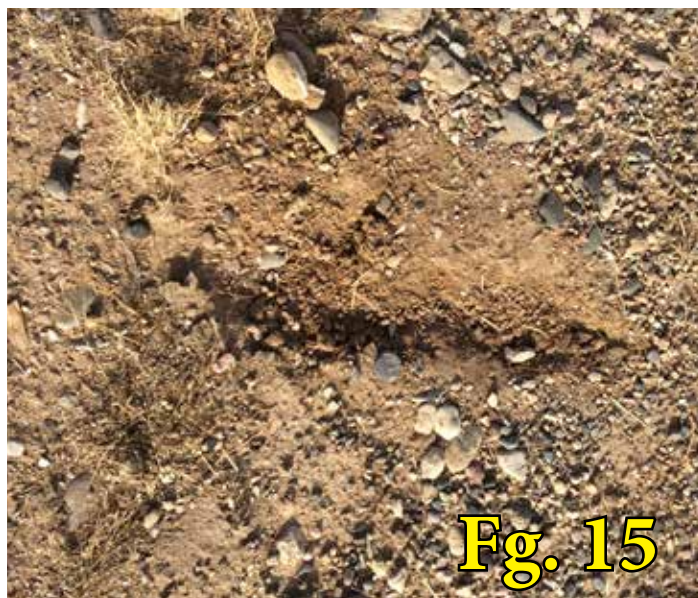
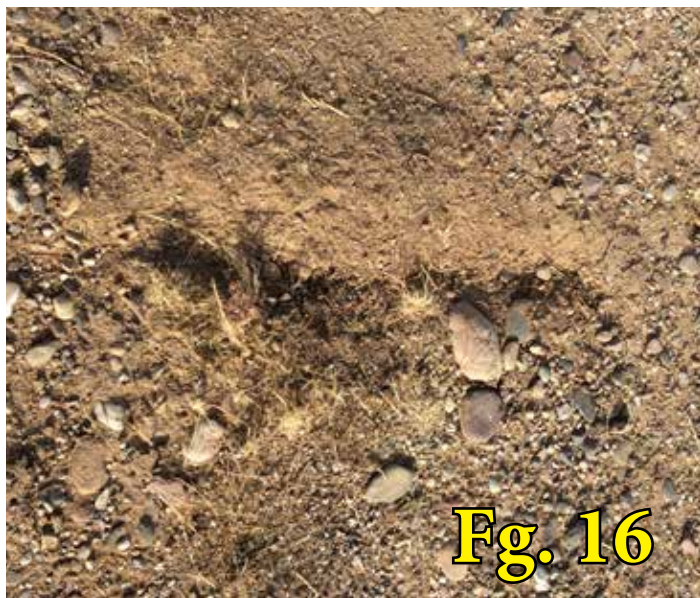
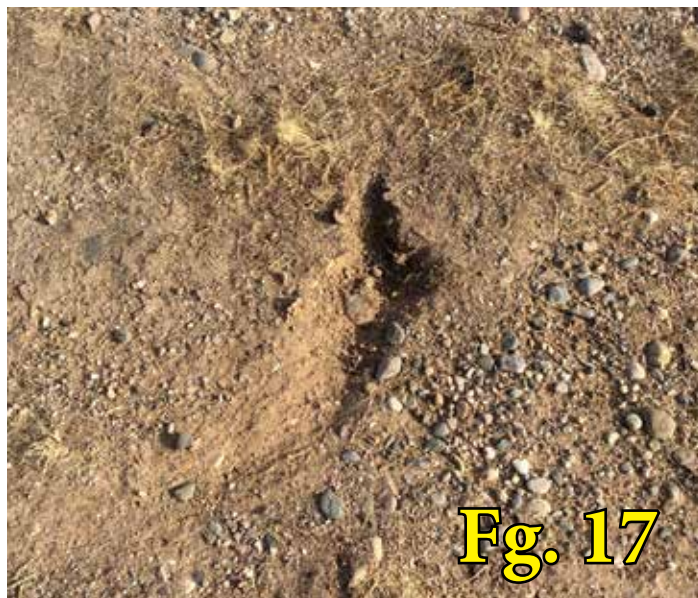
- This would indicate there is still no failure of any aircraft component, mainly the landing gear and the aircraft is still on the runway.
- If there was any landing gear failure at this point we would see prop strike marks in the runway asphalt like you only see well after the aircraft has departed the runway surface in Figures 6-17.

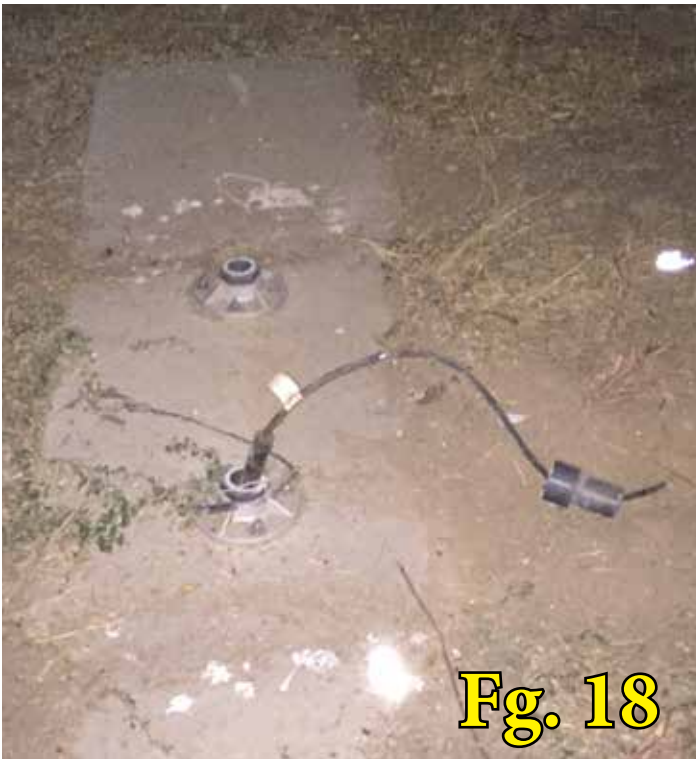
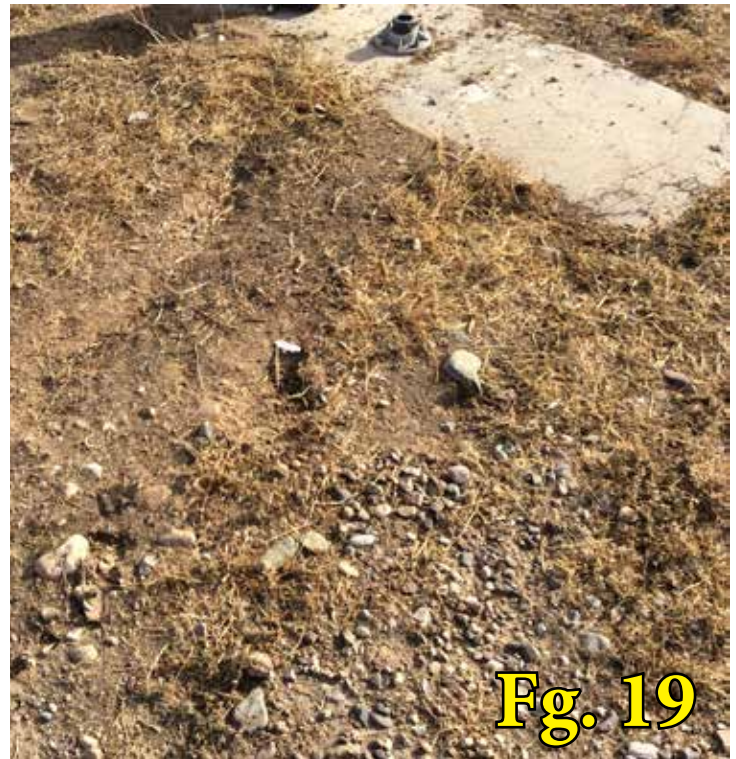
It appears that this is where the nose gear and the left main gear impacted the runway sign.

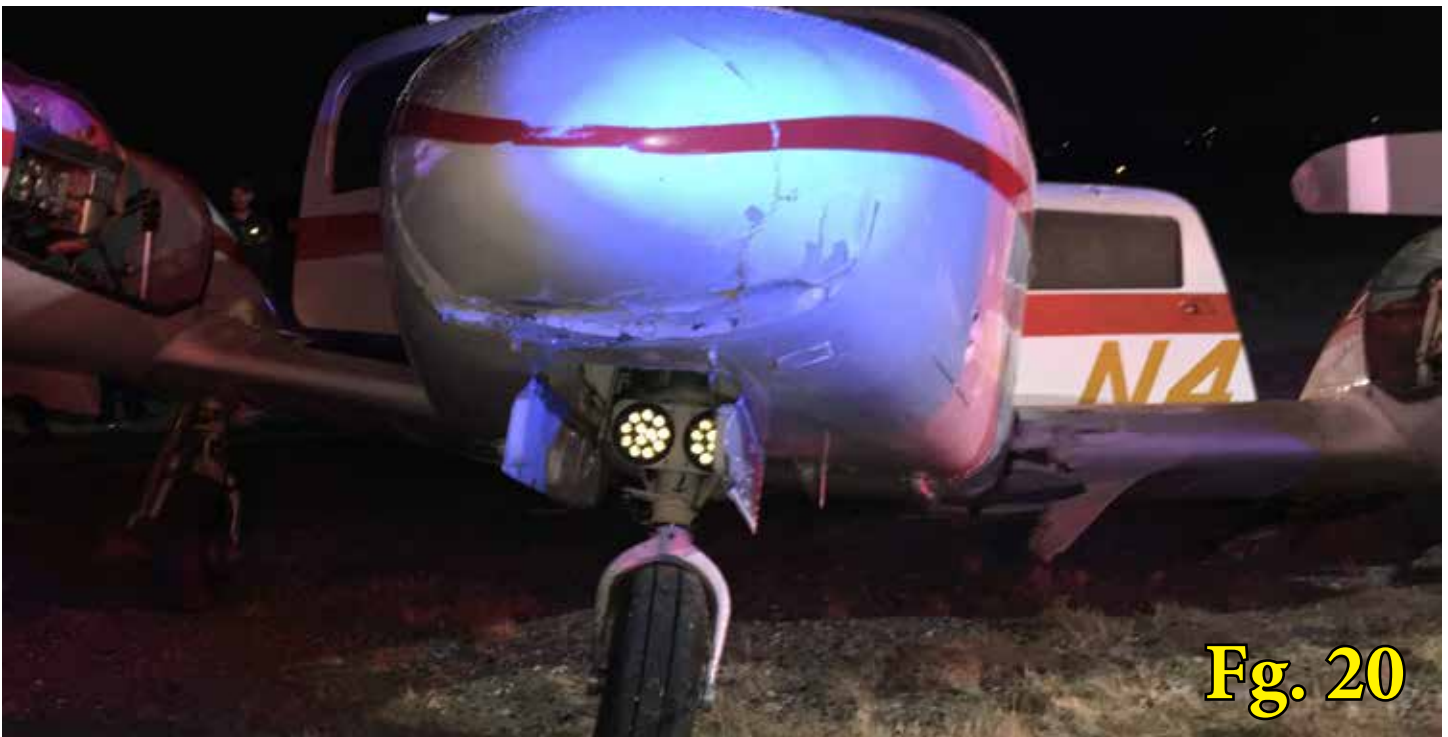
**Fg. 20**

Nose cone damage and left wing root fairing damage apparently from the runway sign.

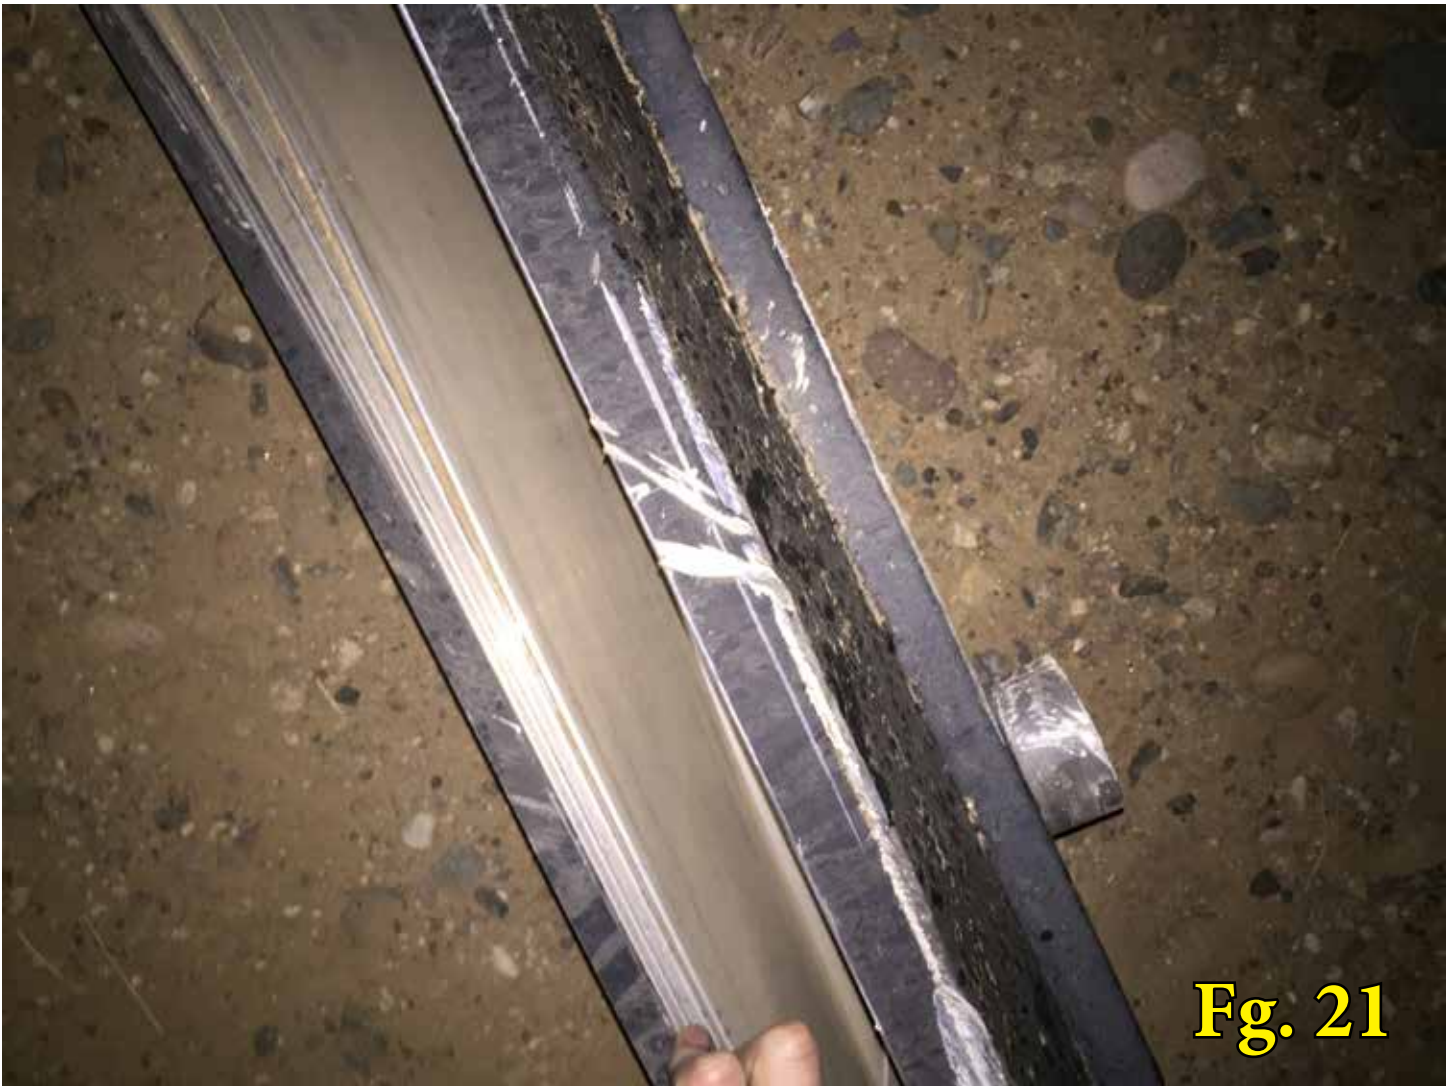
Prop strike damage to the runway sign which clearly shows that there was not gear failure at this point of the incident.

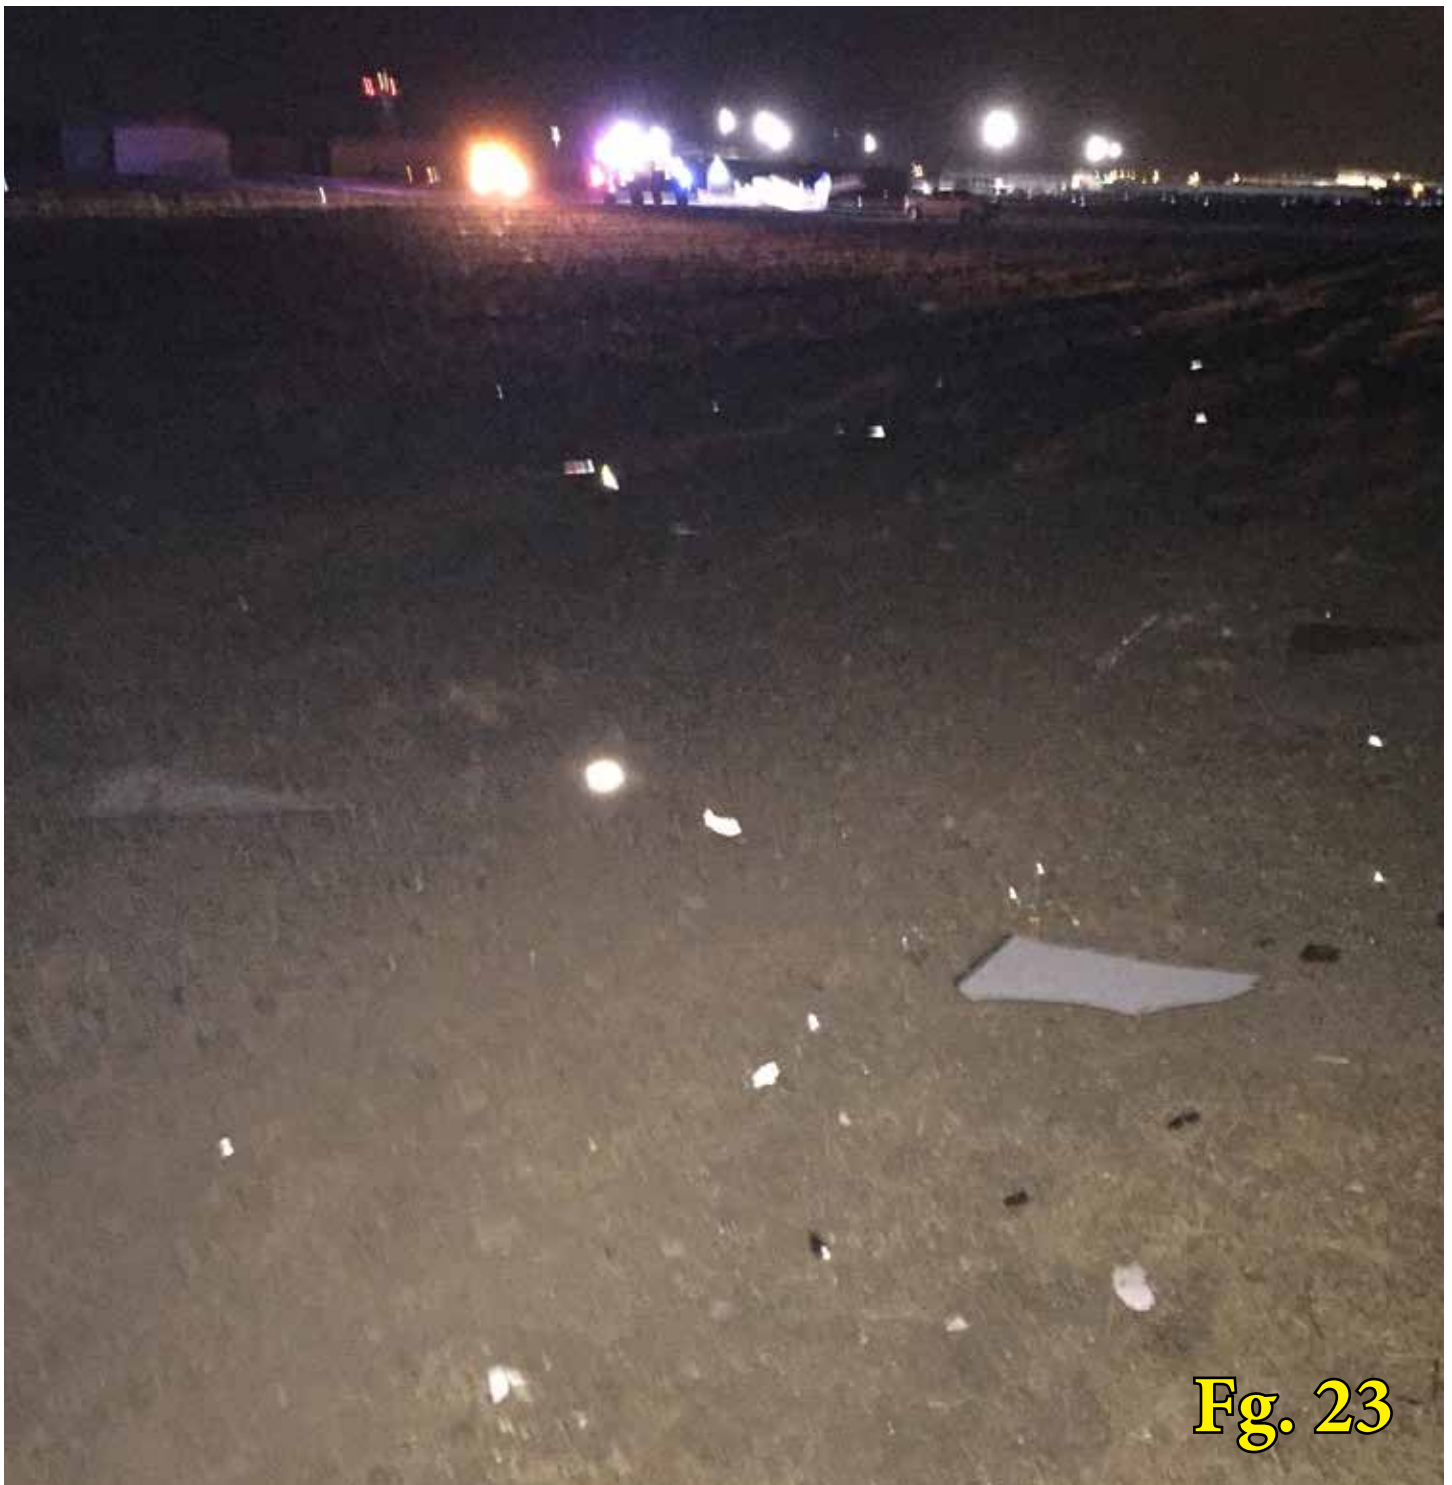
This is the debris from the runway sign and the horizontal stabilizer (mainly the horizontal stabilizer) so the tail of the airplane was still undamaged until it hit the runway sign.

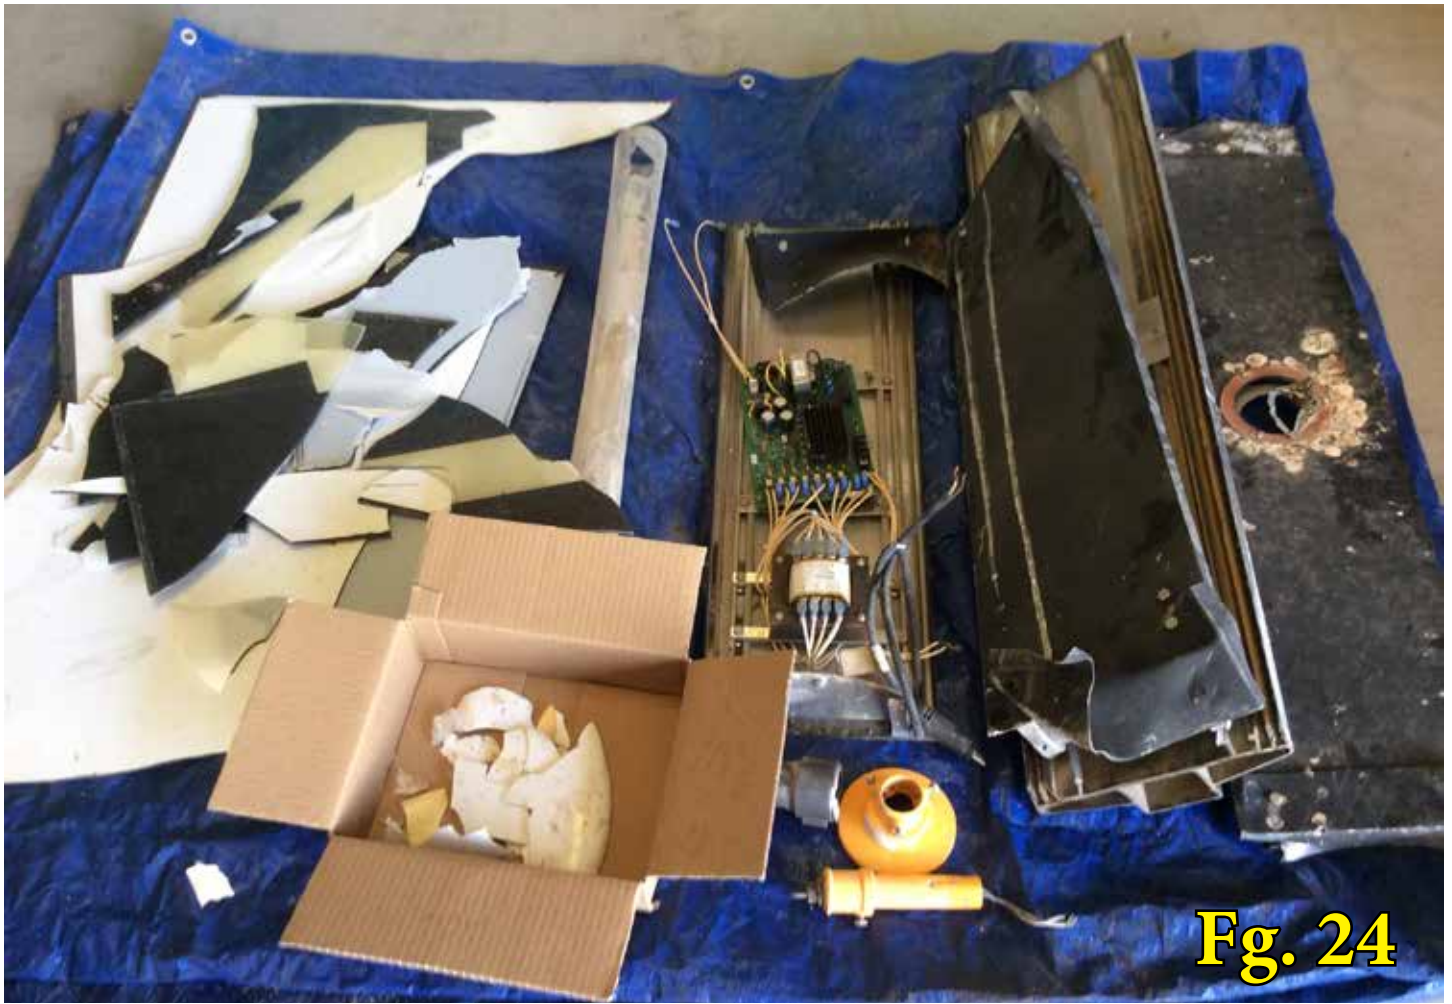
**Fig. 24**

The airport crew picked up the debris from the runway sign and stabilator (in the cardboard box) which are shown in the photo above.

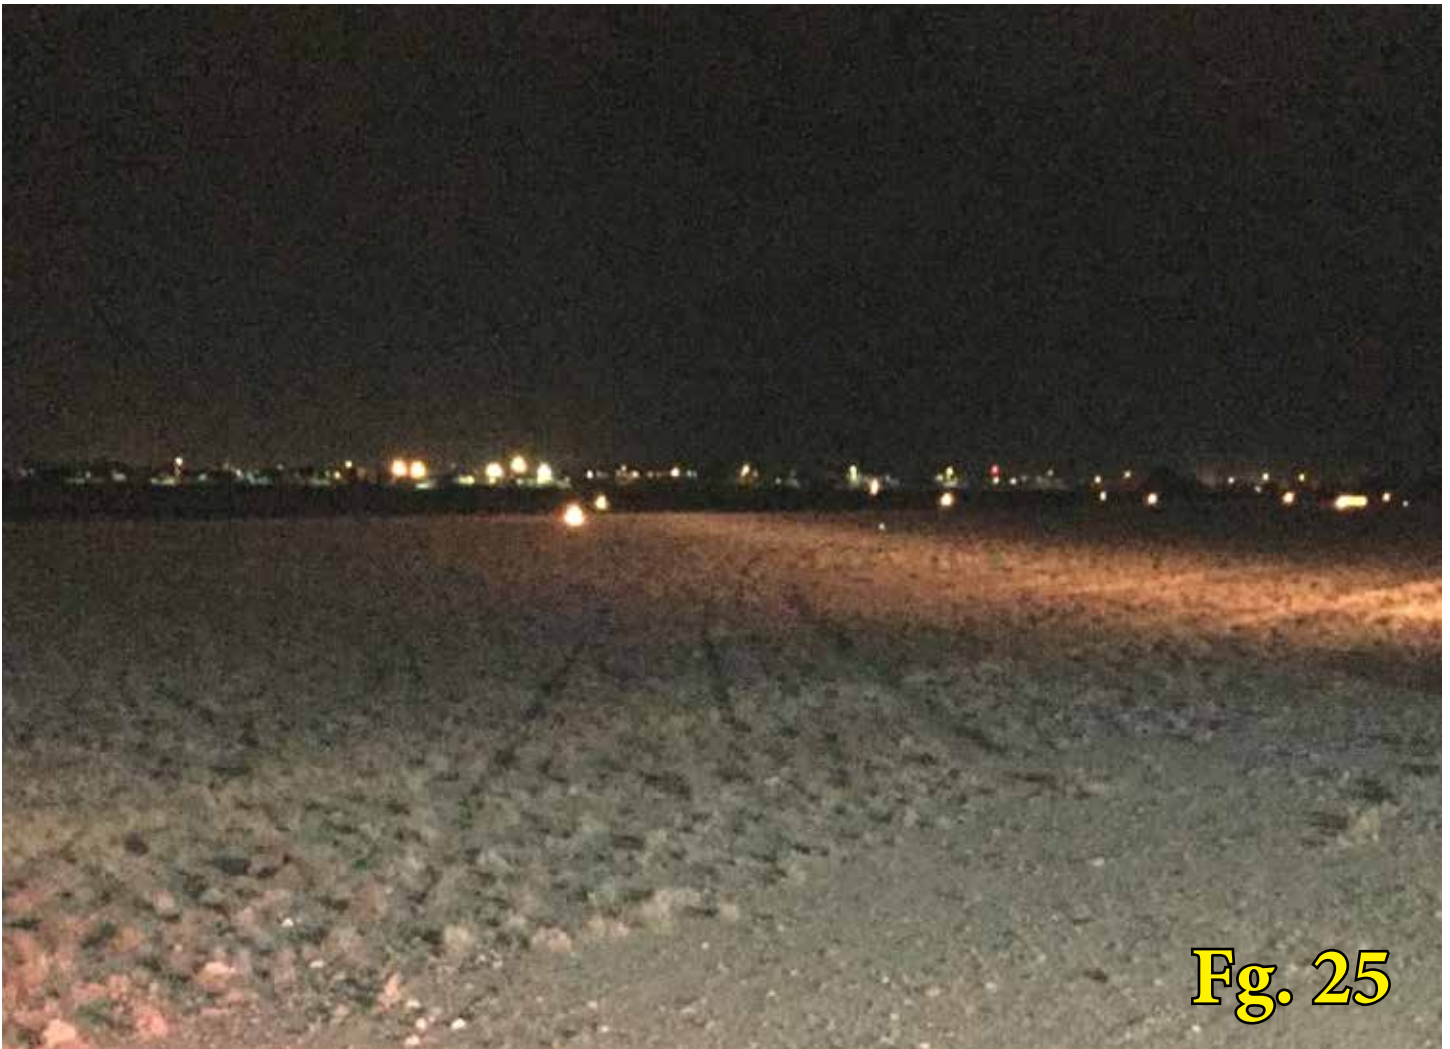
This photo was taken December 5, 2017 the night of the incident, looking back toward the runway sign.

You can clearly see the marks from the nose gear and the right main landing gear are the correct size of a tire. But the left side is much wider because the left landing gear is now riding completely on the side wall, after the plane hit the runway sign.

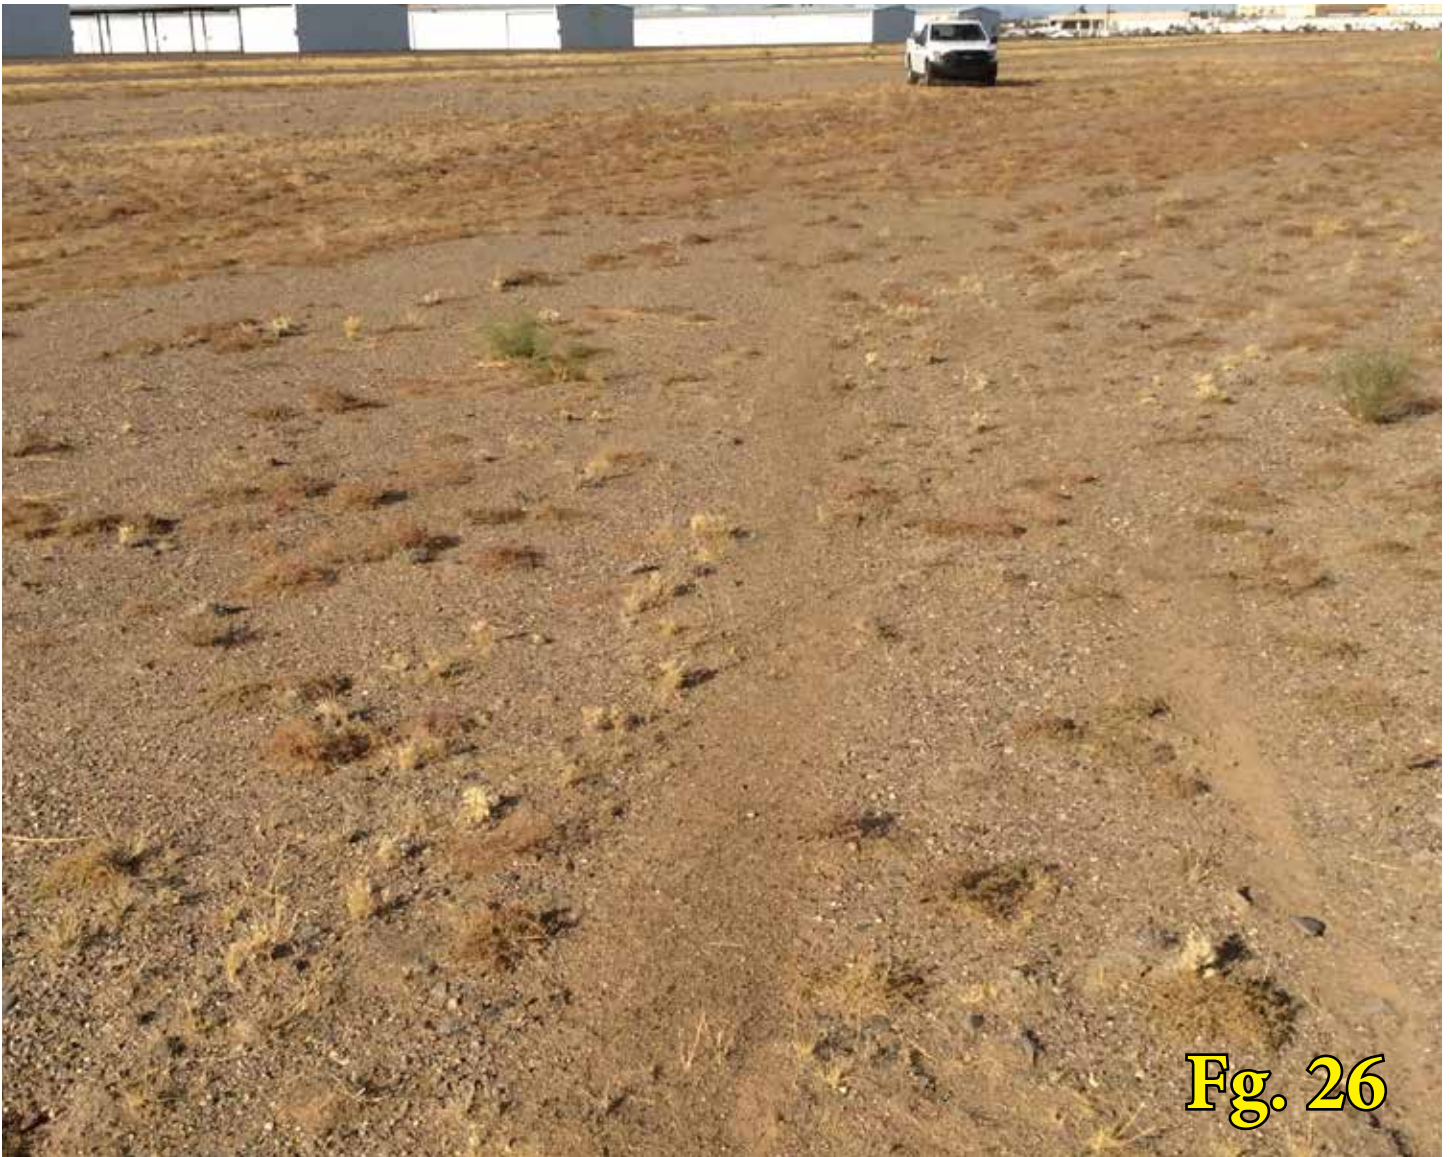
Photo taken December 11, 2017 and you can see on the right-hand side of the photo, the nose gear is the correct tire width. In the center of the photo, you can see how extremely wide the mark is from the left main landing gear because the aircraft is now riding on the sidewall of the tire. v
