Here is our statement for the events that occurred on the night of December 5th, 2017 to N47536, a 1977 Piper Seneca II, aircraft total time since new was approximately 1,700 hours. Our comments at the end of the statement are to bring light on what the statements and comments are from the other parties involved and from what the evidence shows in the pictures. This is supplemented with the extensive experience we have operating these specific type of aircraft in the flight training environment.

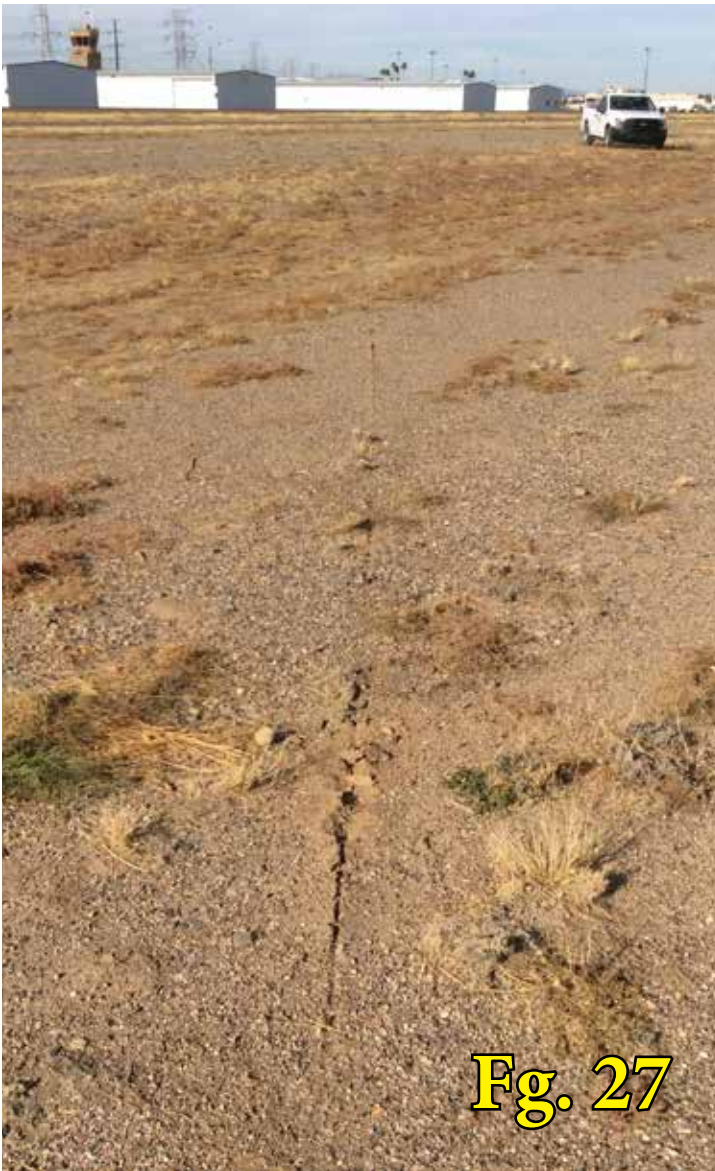
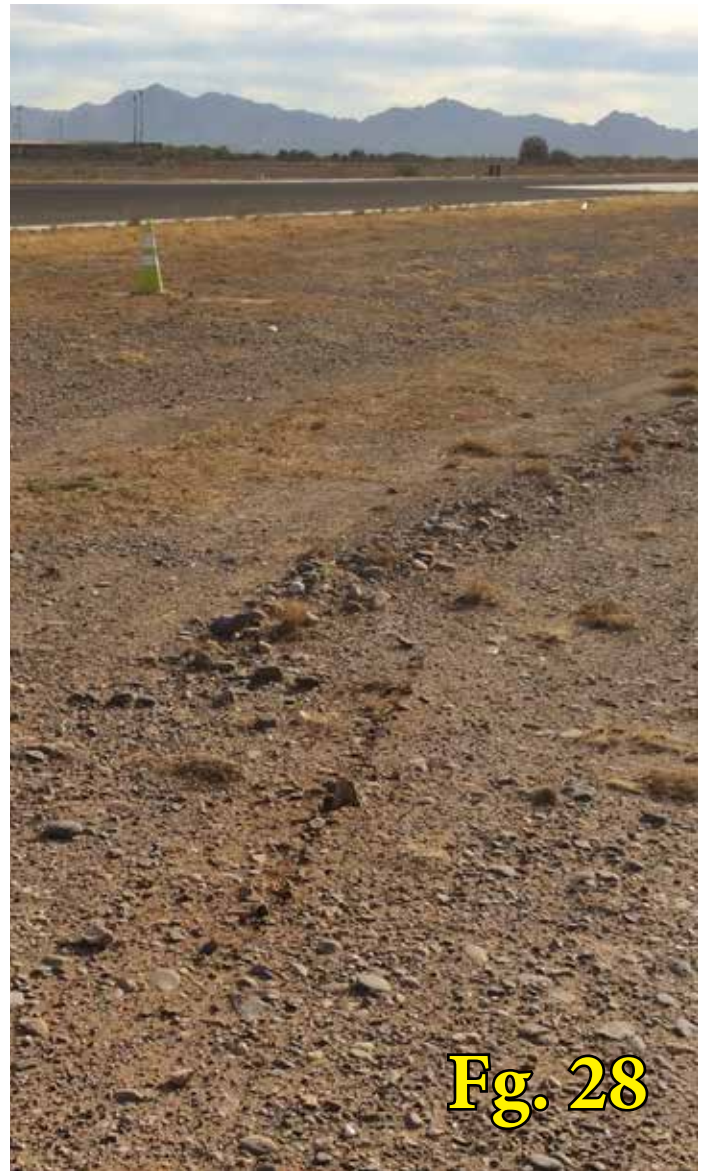
This photo was taken December 11, 2017, Fig. 27 is looking towards where the aircraft came to a stop and Fig. 28 is looking back toward the runway. This is the first sign of the wing and aileron bracket contacting the ground after the aircraft impacted the runway distance marker.

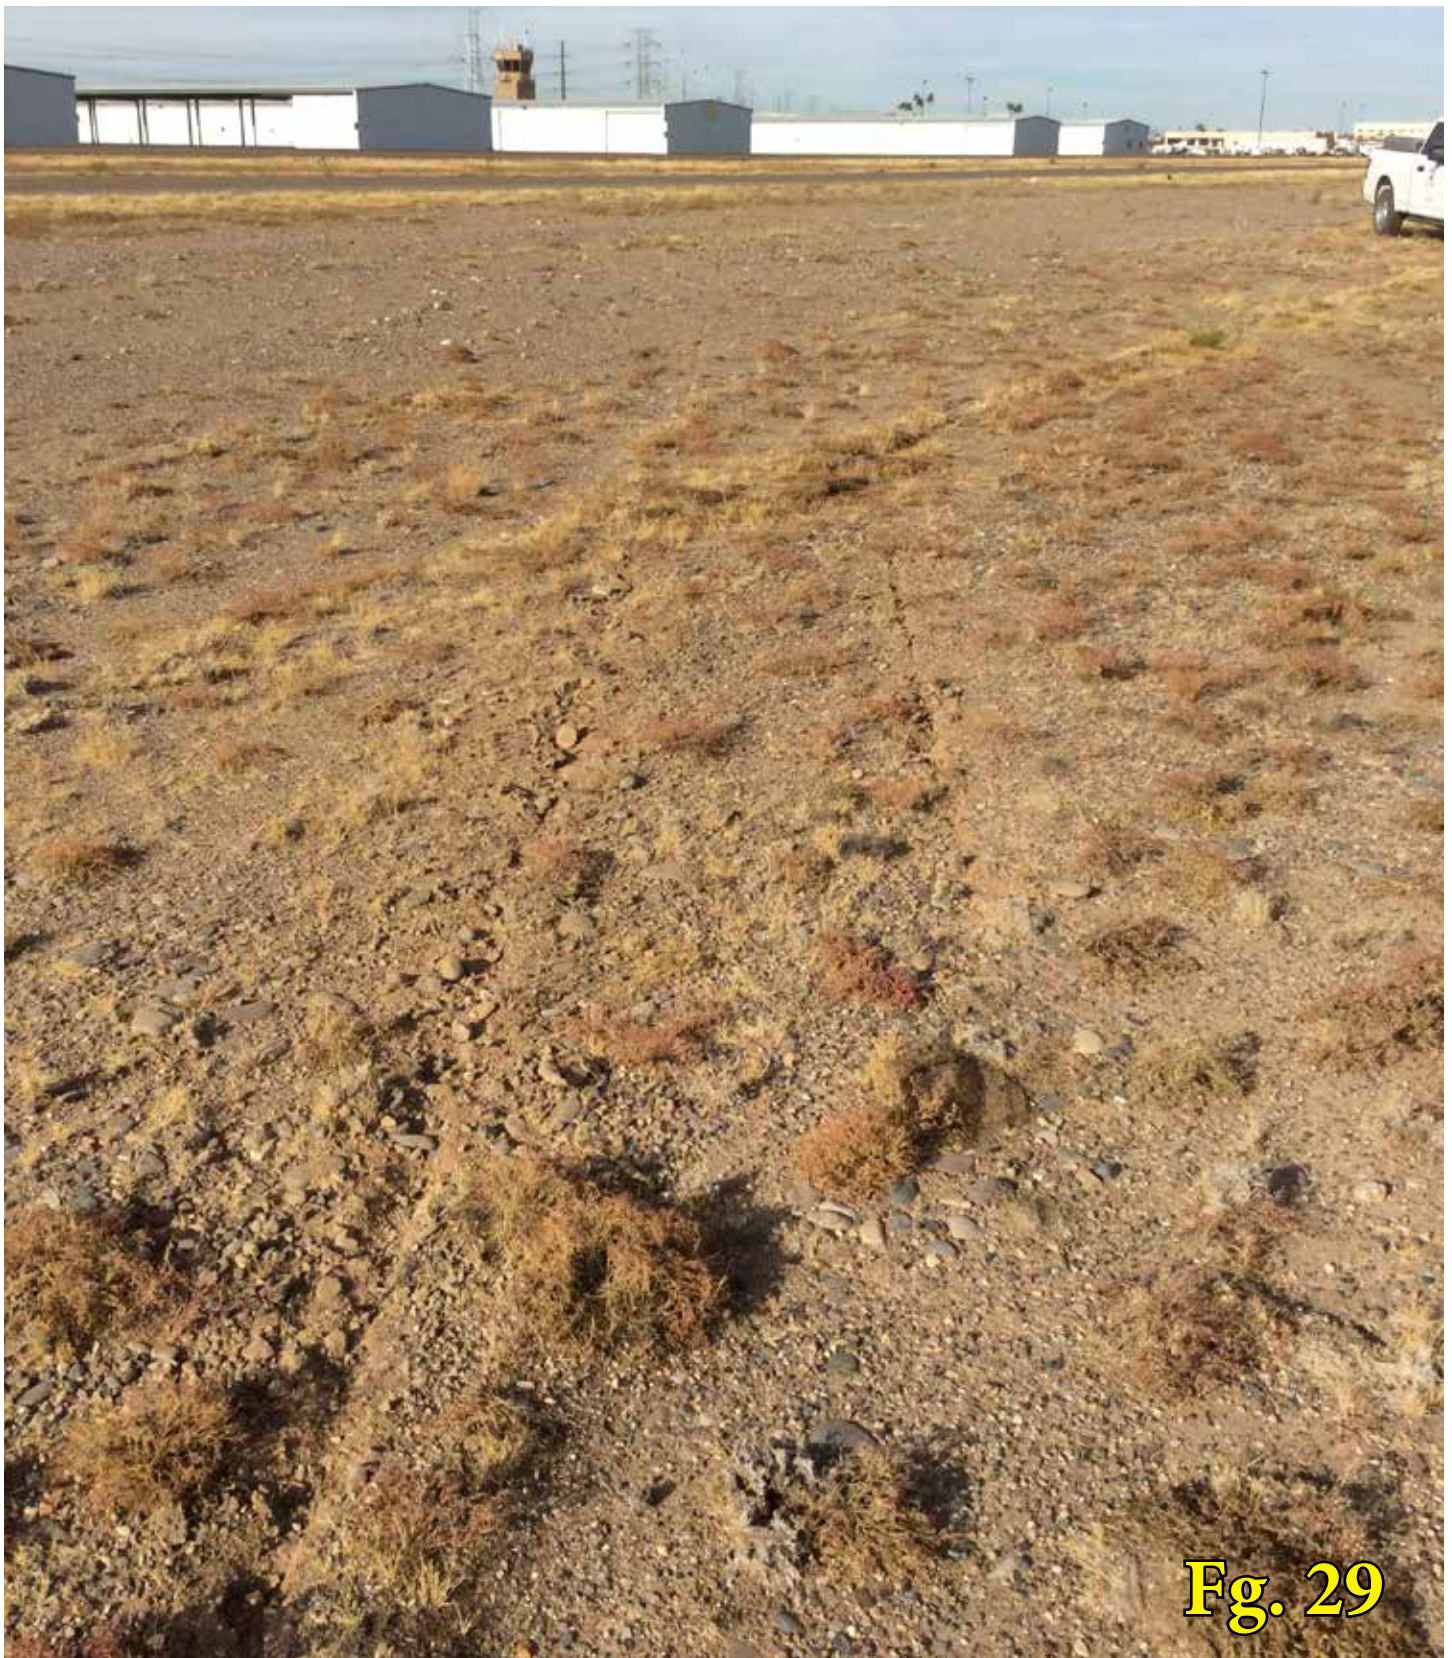
**Fig. 29**

This photo was taken December 11, 2017, showing where BOTH left wing aileron brackets are digging into the ground after the aircraft hit the runway sign.
