# **NATIONAL TRANSPORTATION SAFETY BOARD**

**MATERIALS LABORATORY FACTUAL REPORT**

**Report No. 18-019**

Place : Glendale, AZ  
Date : 12/5/2017  
Vehicle : Piper PA-34-200T  
NTSB No. : WPR18LA044  
Investigator : Maja Smith

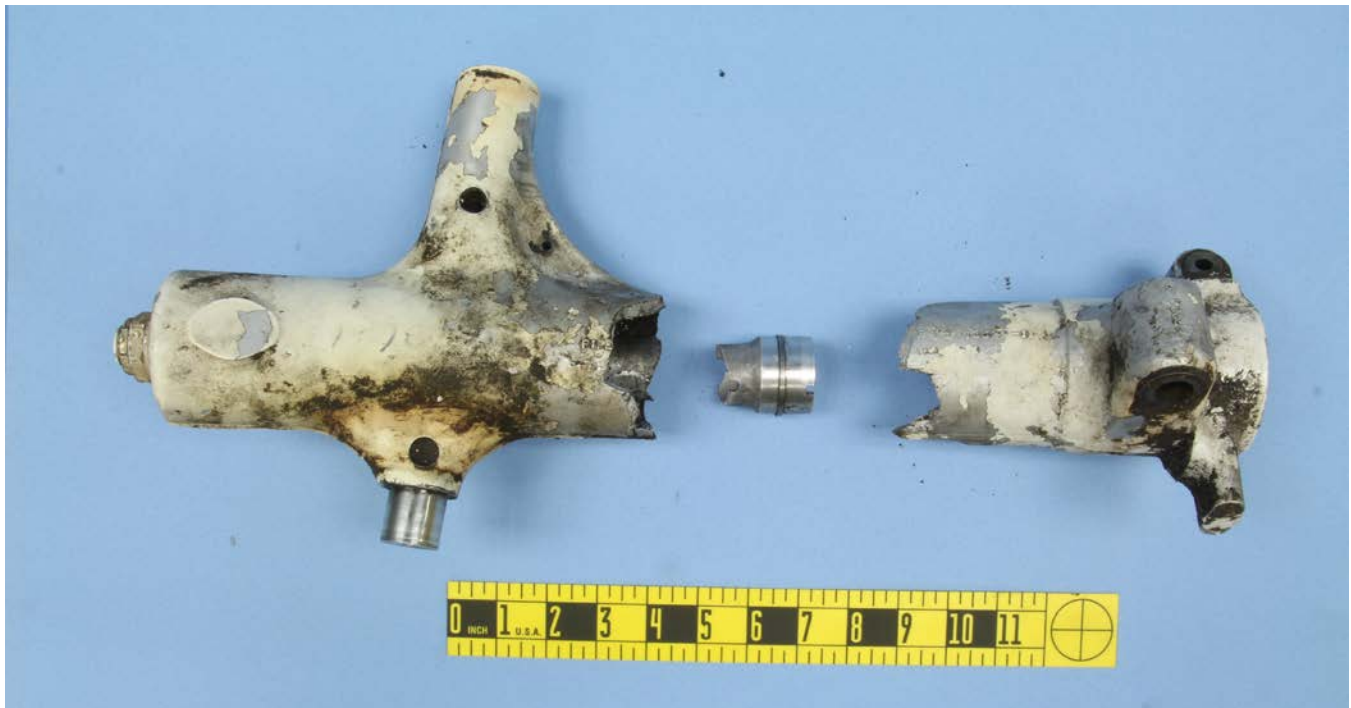
Portions of the left landing gear strut (figure 1).

Figure 1: Portions of the left landing gear strut as received.

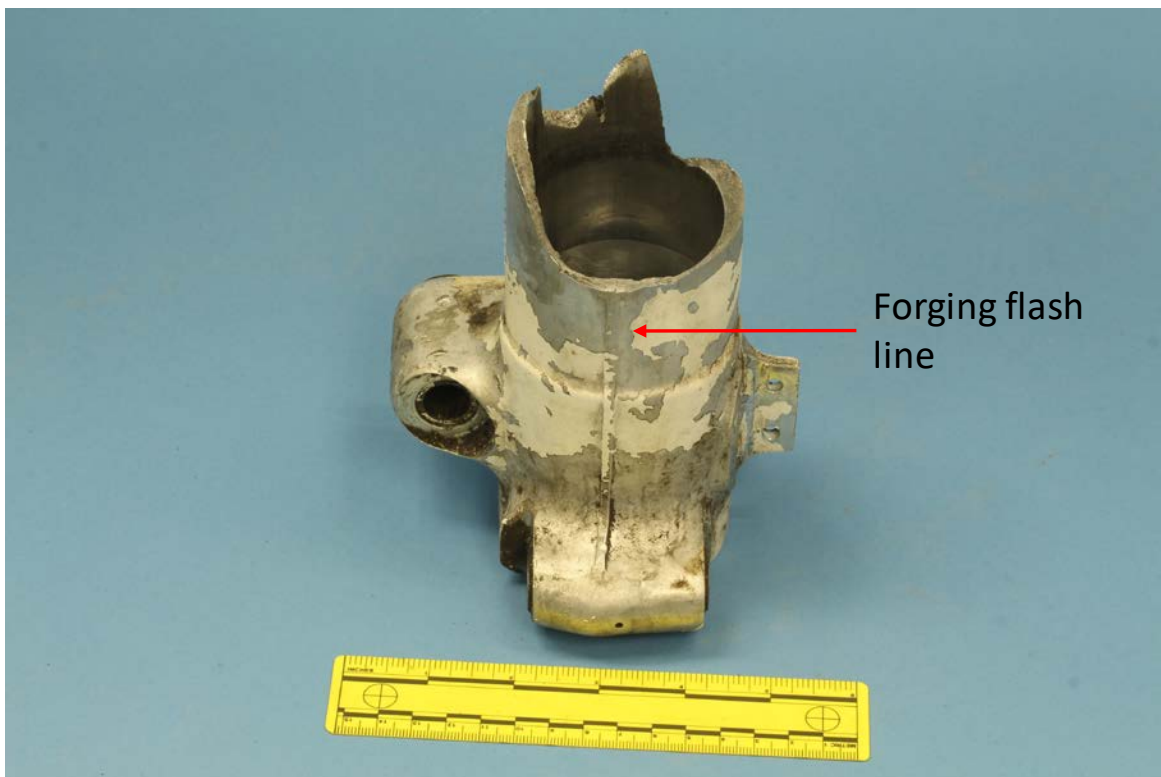
Examination of the fracture surfaces of one of the portions (figure 2) of the landing gear strut revealed that most of the fracture surface was characterized by slant fractures consistent with an overstress failure. One small area of the fracture surface, coincident with the forging flash line, exhibited a flat fracture surface. A sample containing this flat fracture area was cut out of the landing gear strut for examination in the scanning electron microscope (SEM) (figures 3,4). SEM examination of this sample revealed that the flat fracture area contained striations consistent with a fatigue fracture (figure 5).

Figure 2: Fracture surface characterized mostly by slant fractures and a flat fracture at the forging flash line.

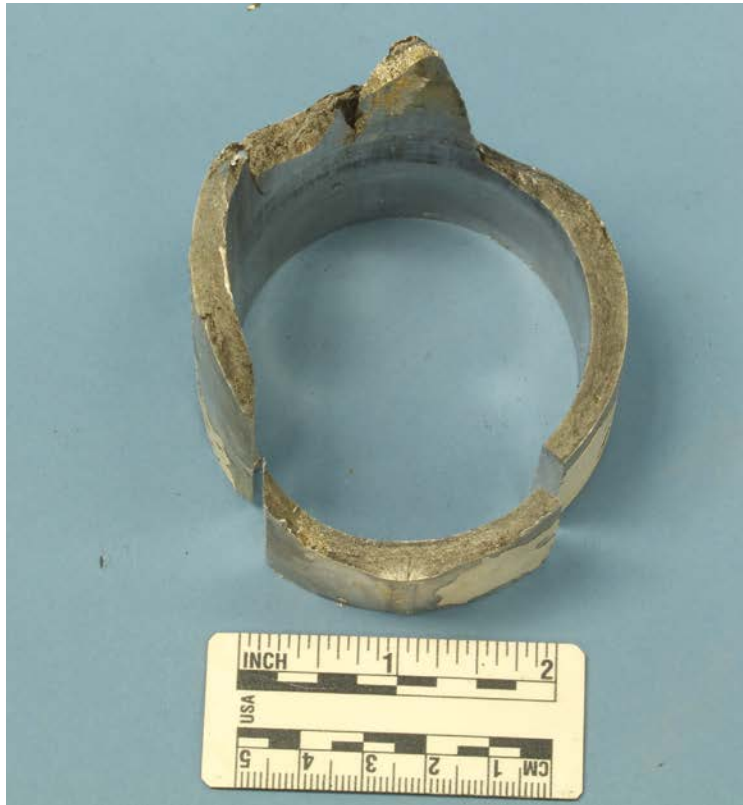
Figure 3: A sample containing the flat fracture area was cut from the remainder of the fracture surface.

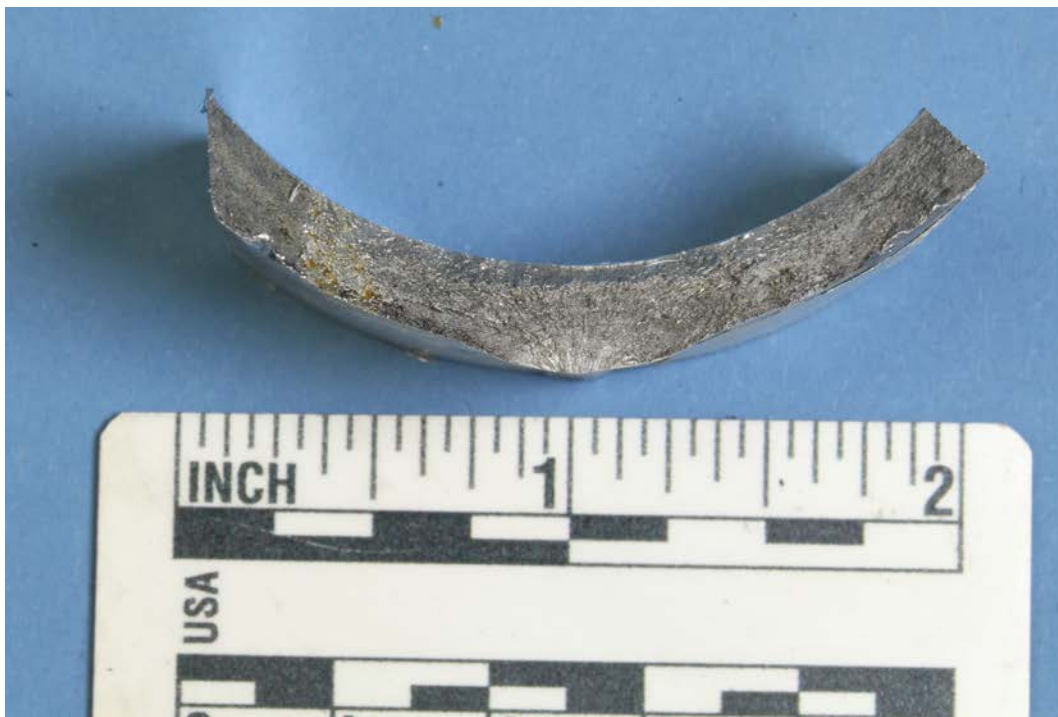
Figure 4: close-up of the sample containing the flat fracture area.

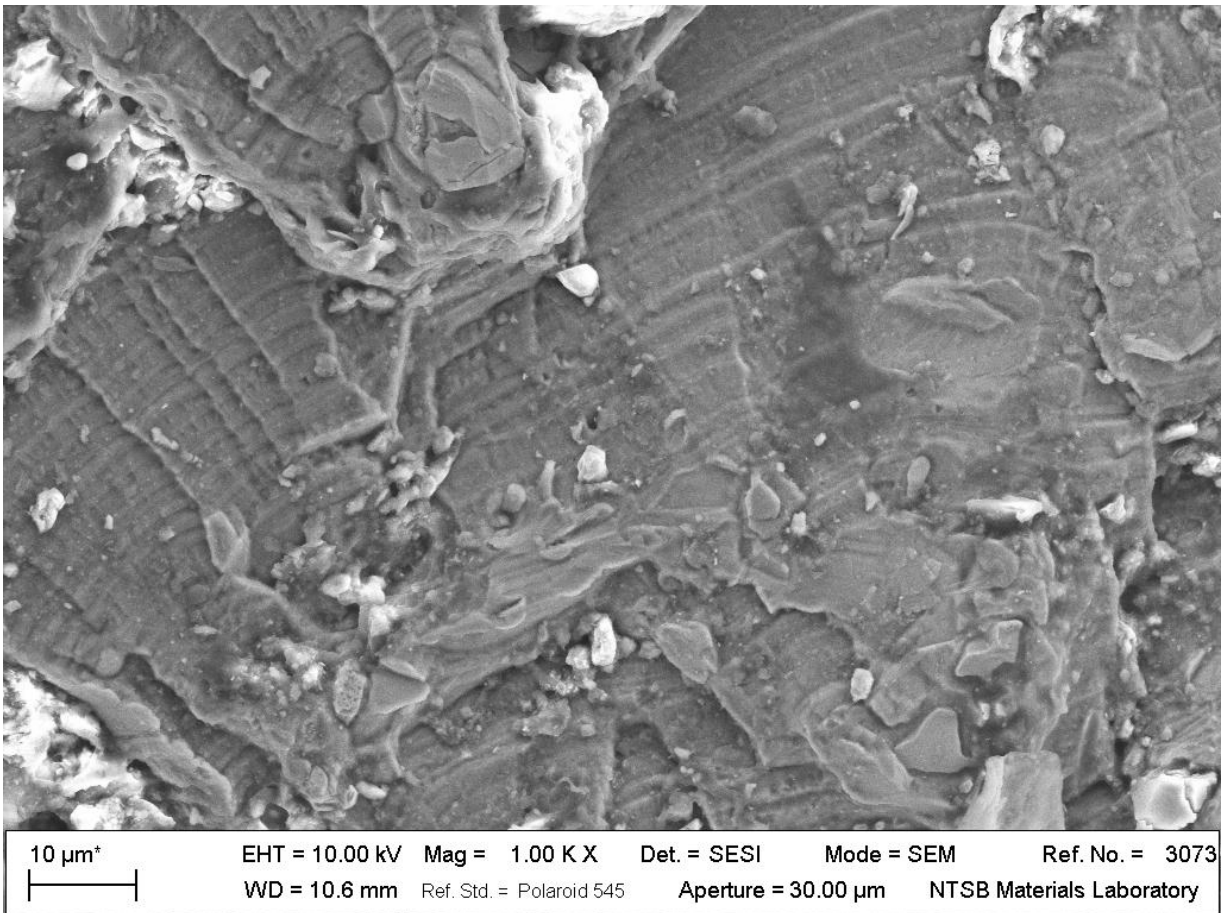
Figure 5: SEM micrograph depicting striations in the flat fracture area of the sample.
