# NATIONAL TRANSPORTATION SAFETY BOARD

## MATERIALS LABORATORY FACTUAL REPORT

Report No. 18-051

Place : Hinesville, Georgia  
Date : December 17, 2017  
Vehicle : Piper PA-32-300, N4326X  
NTSB No. : WPR18LA051  
Investigator : Maja Smith, AS-WPR

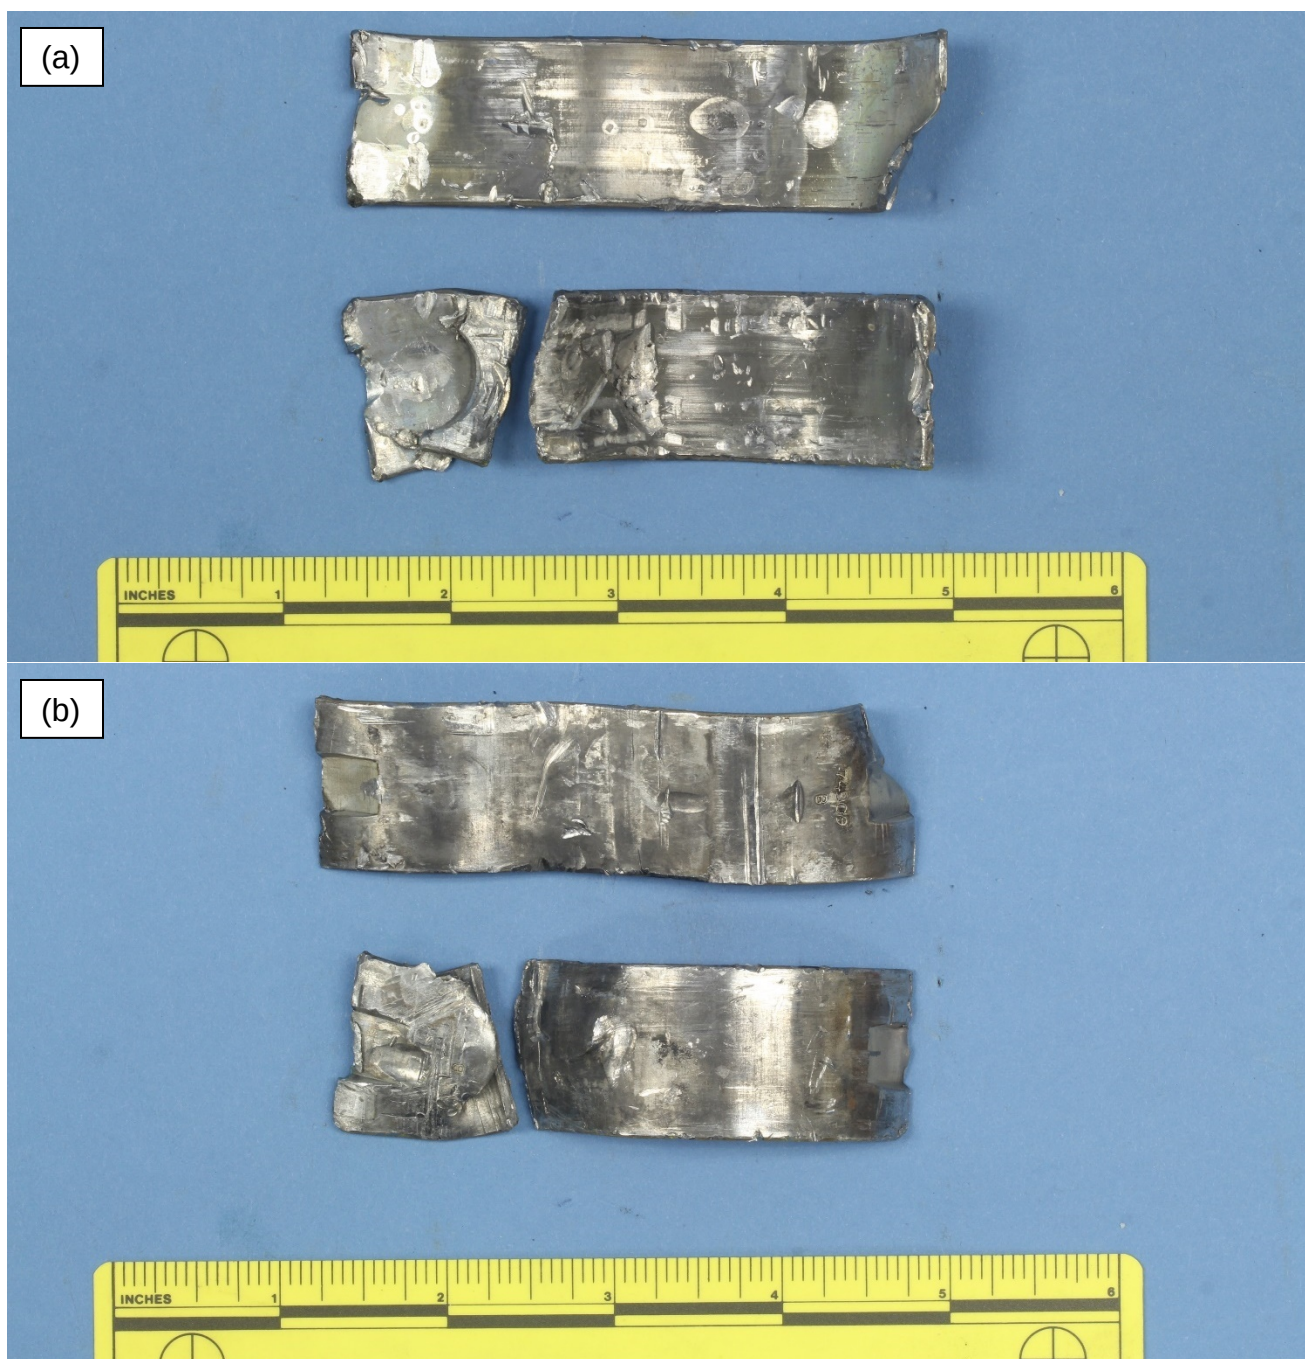
Figure 1 shows the bearing halves from the connecting rod, as received. Both halves, typically circular, had been deformed and flattened. One of the halves was intact whereas the other had fractured. The intact half exhibited markings on the outer surface, stating, "74-09" and "B". The analogous area on the fractured bearing had been smeared such that the only discernible marking was a "B".

Figure 1 – The pieces of both halves of the connecting rod bearing, as received, from the (a) inner bearing surface and (b) outer bearing surface.

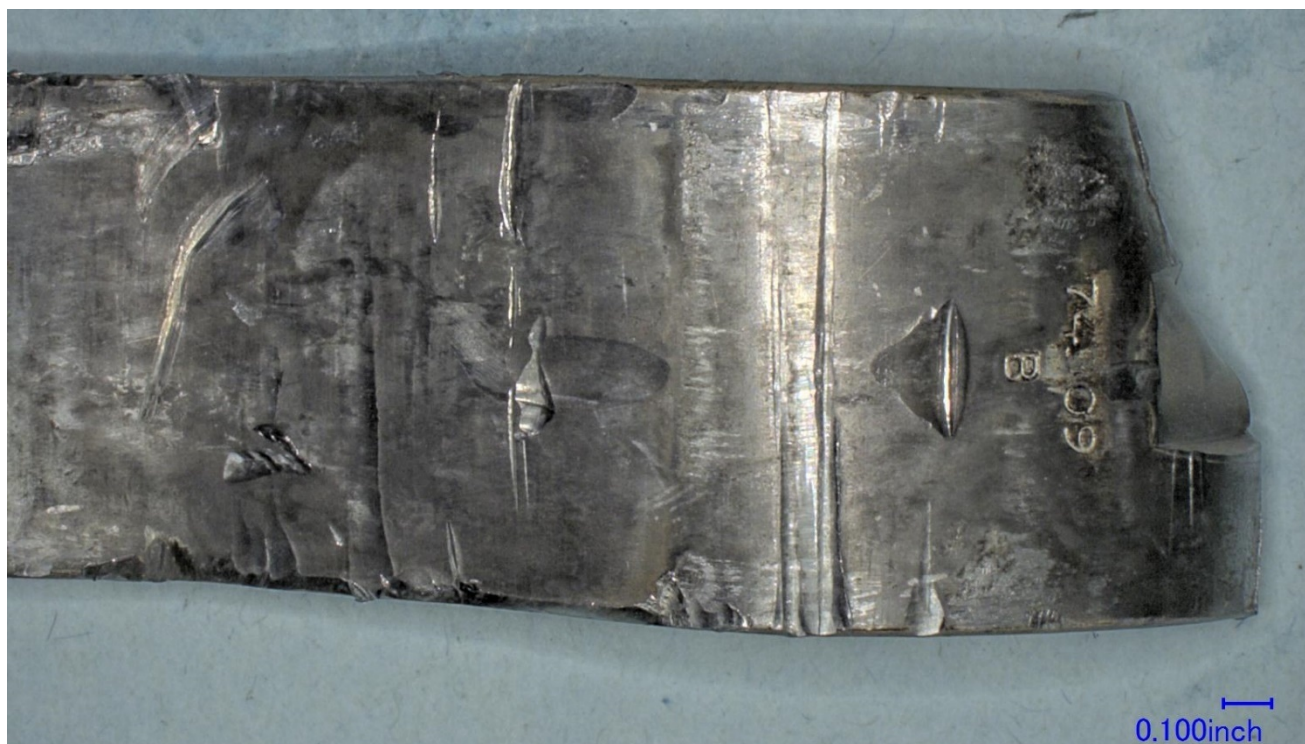
Figure 2 – View of the end of the intact bearing half from the outer surface, showing identification marks, impact marks, and inward deformation.

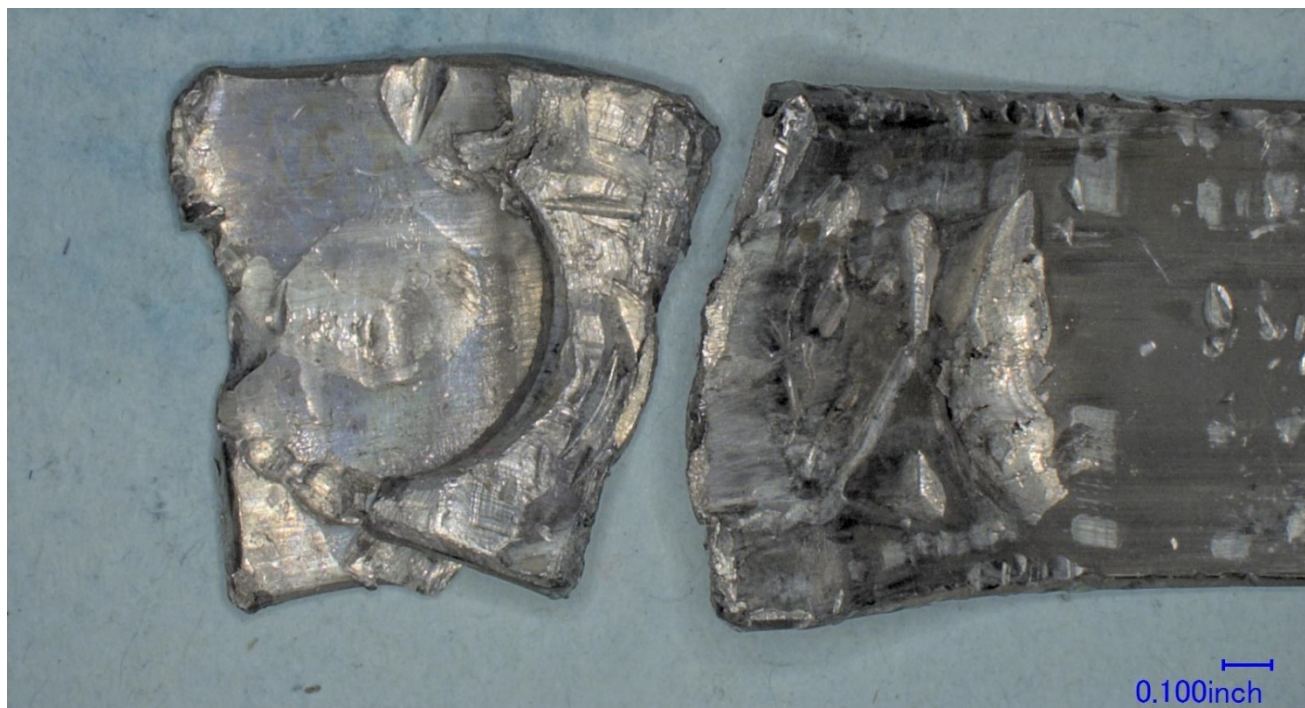
Figure 3 shows the fractured portion of the broken bearing half. The fracture was oriented perpendicular to the longitudinal rolling direction of the bearing. The mating fracture surfaces had been heavily damaged and obliterated, obscuring most of the

fracture features. This damage was consistent with post-fracture damage. Portions of the undamaged fracture surface, as exemplified in Figure 3, exhibited features consistent with tensile overstress. The fracture surface exhibited a general rough texture with a dull luster, as shown in Figure 4. The areas adjacent to the fracture surface exhibited local plastic deformation in the form of thinning or necking. These features were consistent with overstress fracture. No features consistent with other fracture modes were observed.

The smaller fractured piece in Figure 3 exhibited a circular indentation, consistent with post-fracture batter. This impression was consistent with impact from the head of a connecting rod bolt.

Figure 3 – The mating fracture faces of the fractured bearing half, showing a circular impact imprint.

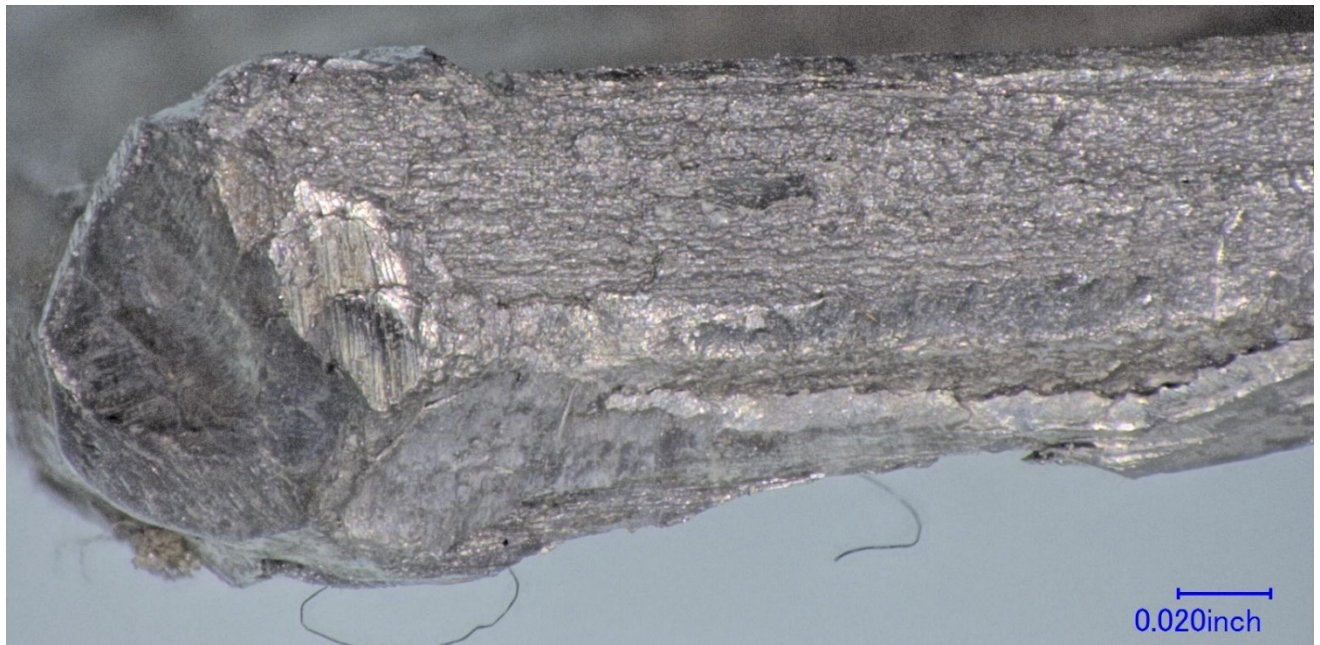
Figure 4 – Closer view of one of the bearing fracture surfaces from Figure 3.

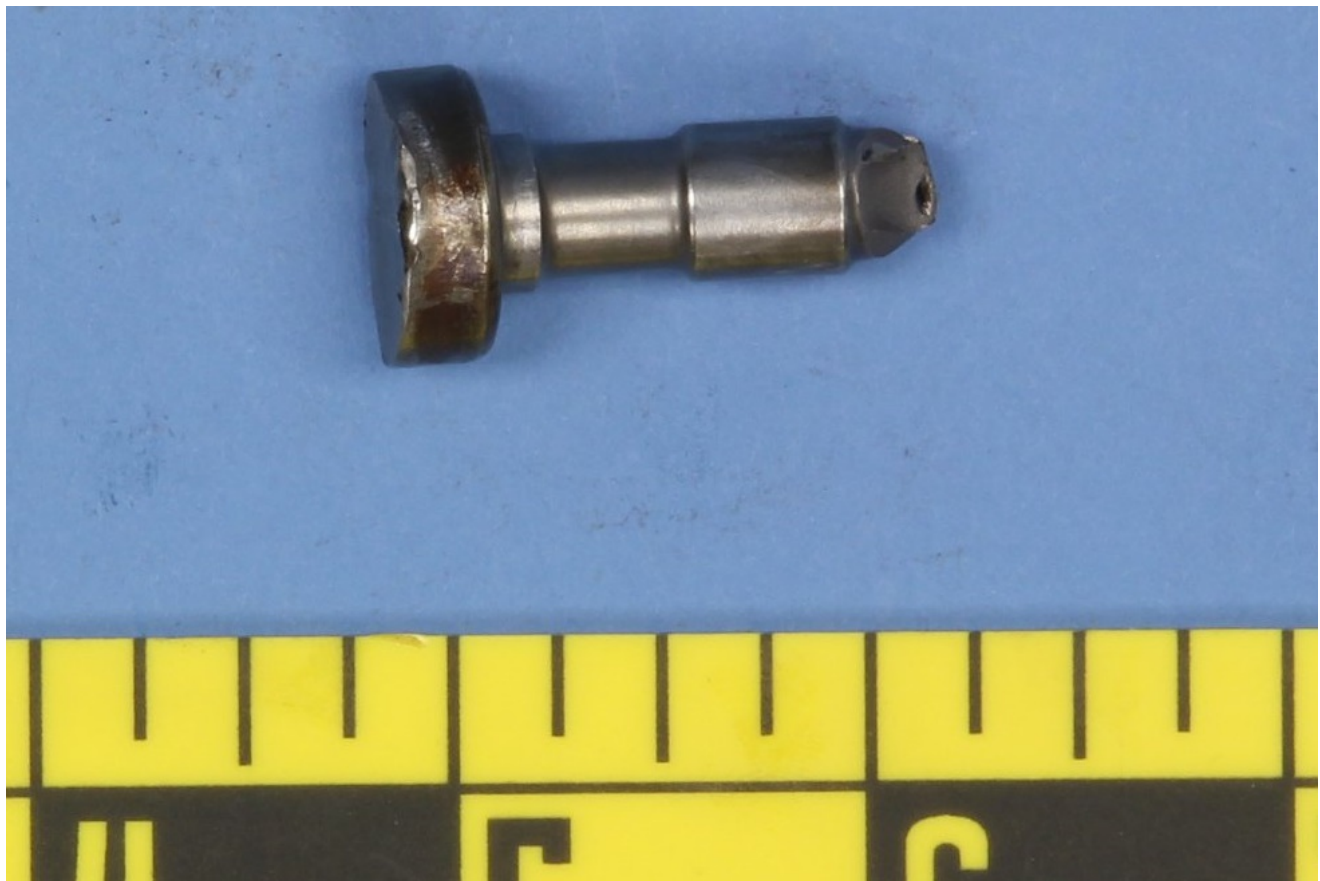
Figure 5 shows the submitted fragment of a connecting rod bolt. The bolt had fractured about mid length. Figure 6 shows the fracture surface of the bolt. About half of the surface was flat in orientation and exhibited a sharper angled ridge on the other half. The fracture features were generally rough in texture and flat in luster. These features were consistent with fracture from bending overstress.

Figure 5 – Side view of the fractured connecting rod bolt, as received.

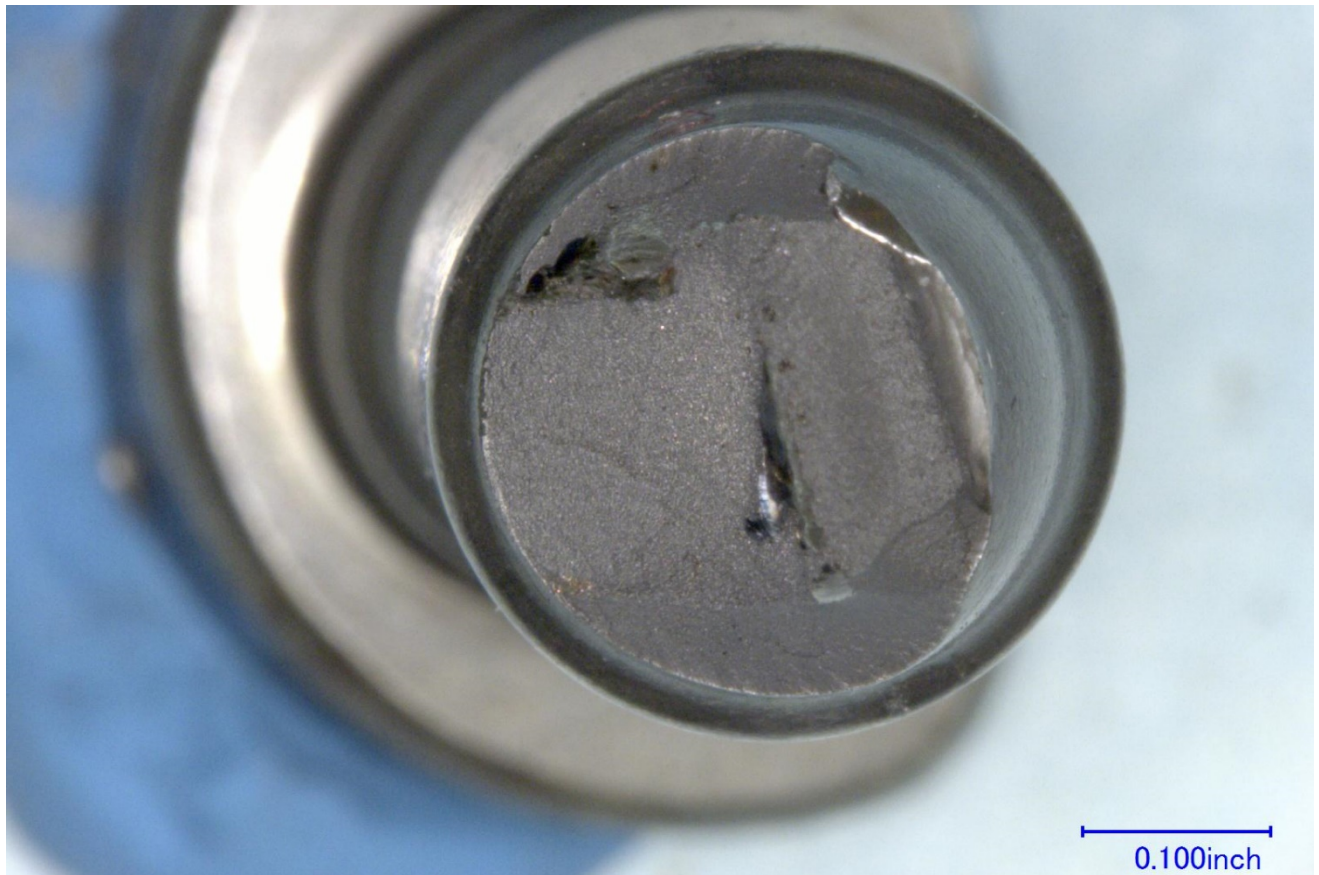
Figure 6 – The fracture surface of the connecting rod bolt, showing a deformed ridge on the right side.

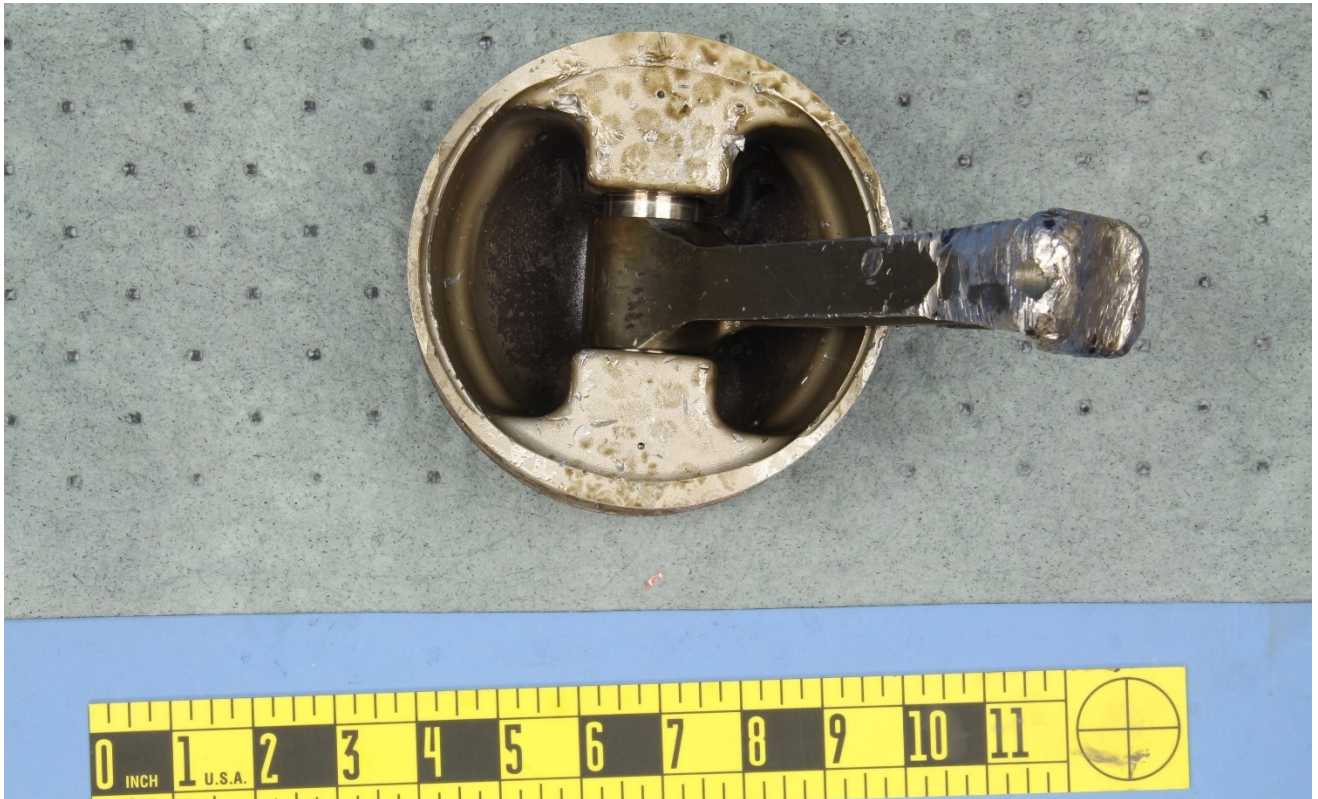
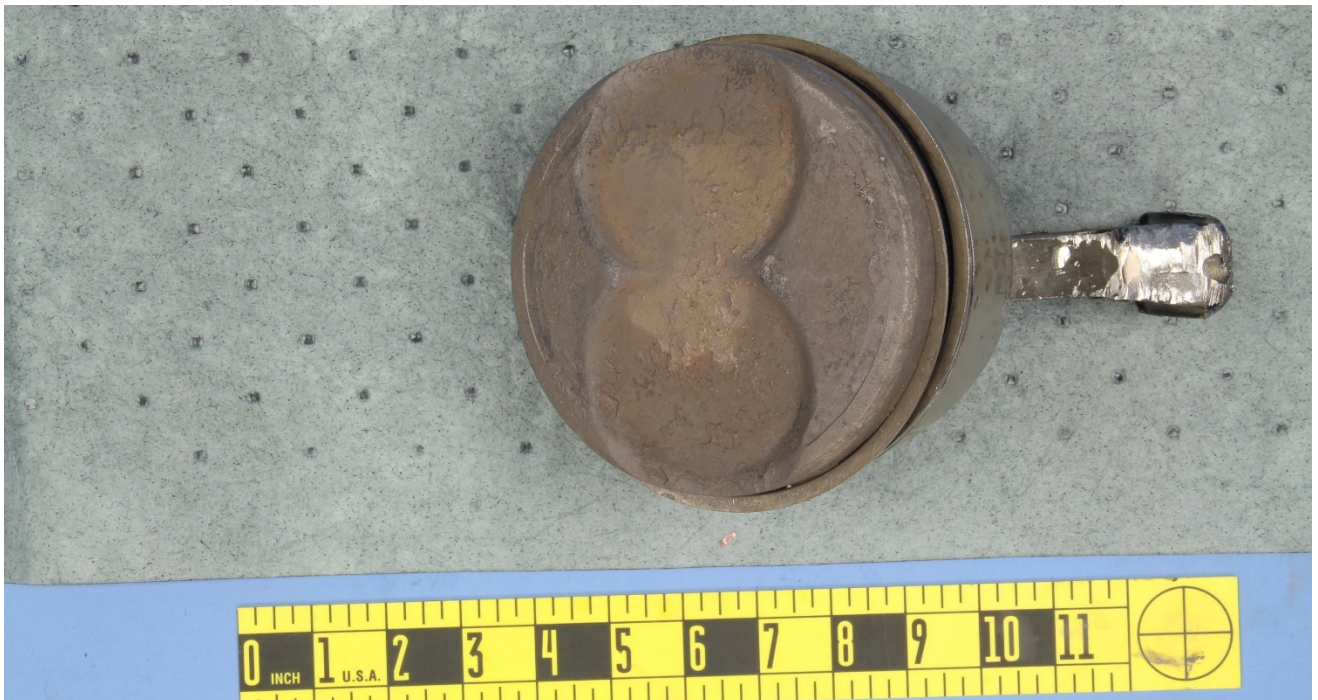
Figures 7 and 8 show the piston assembly, as received. The piston was intact, with the connecting rod still affixed to piston with the piston pin. The connecting rod had fractured near the crankshaft side at the rod yoke. The connecting rod cap was not received.

Figure 7 – The underside of the piston assembly, with the connecting rod fragment still attached via the piston pin.

Figure 8 – Reverse view of Figure 7, showing the crown of the piston and the other batter damage to the connecting rod.

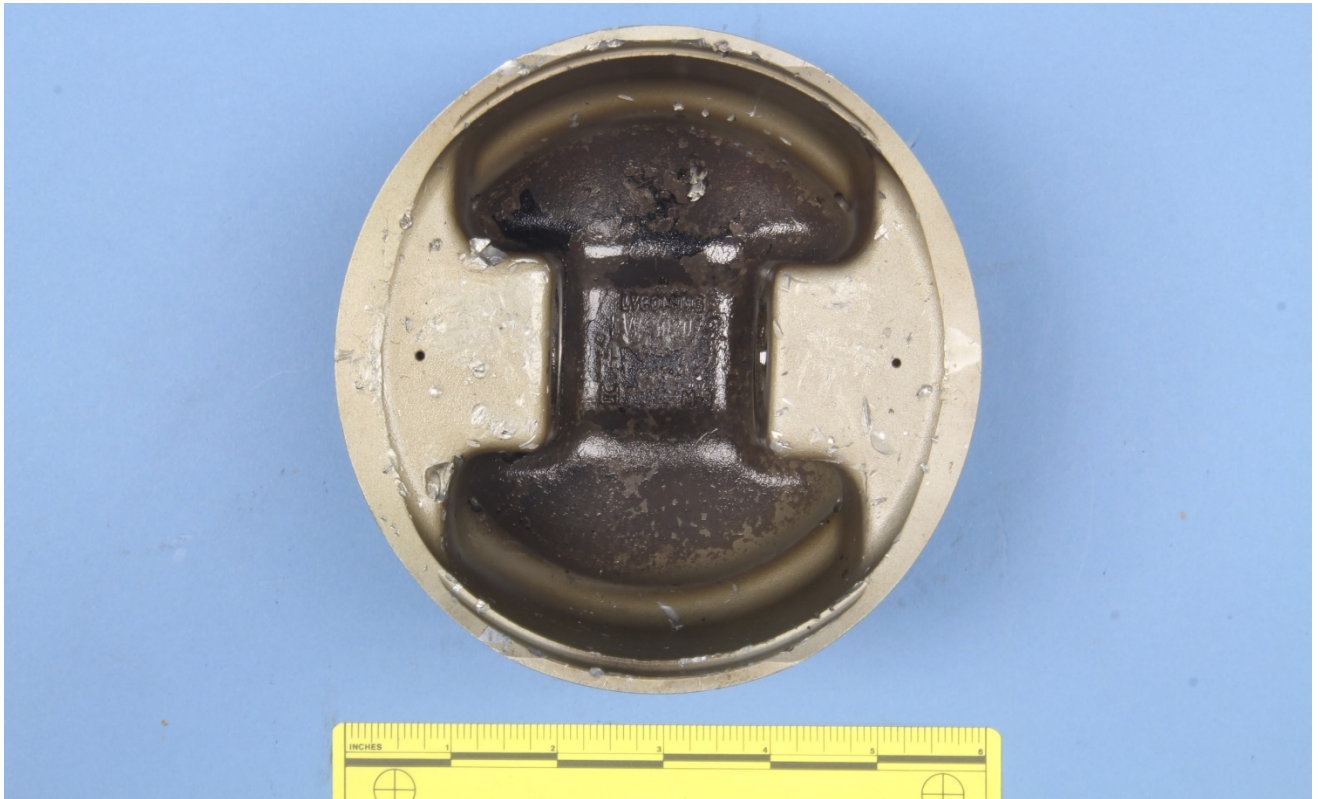
The assembly was taken apart by removing the piston pin caps and removing the pin. Figures 9 and 10 show the piston from the underside and from the crown, respectively. There were no cracks or indications of severe deformation on any portion of the piston. The underside of the piston exhibited multiple impact and gouge marks, consistent with repeated batter of adjacent or loose components.

Figure 9 – Underside of the piston, after disassembly.

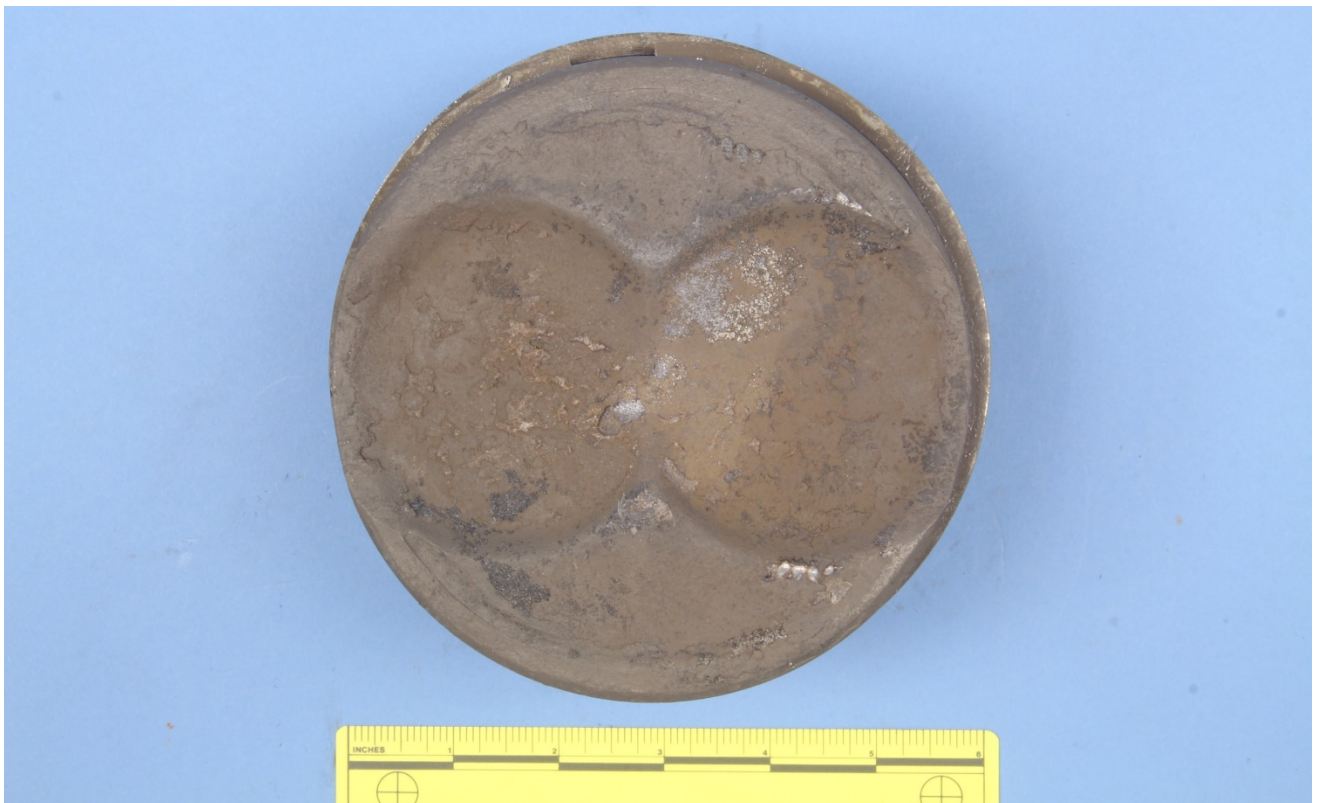
The crown of the piston was of a dimpled configuration, allowing more room for the exhaust and intake valve heads. The piston crown surface exhibited a coating of a brownish-yellow colored, flaky compound. This layer was thick enough that portions had spalled off. These compounds were consistent with compounds that form after combustion of tetraethyl lead and other additives in aviation gasoline (avgas).

Figure 10 – The crown of the piston, after disassembly.

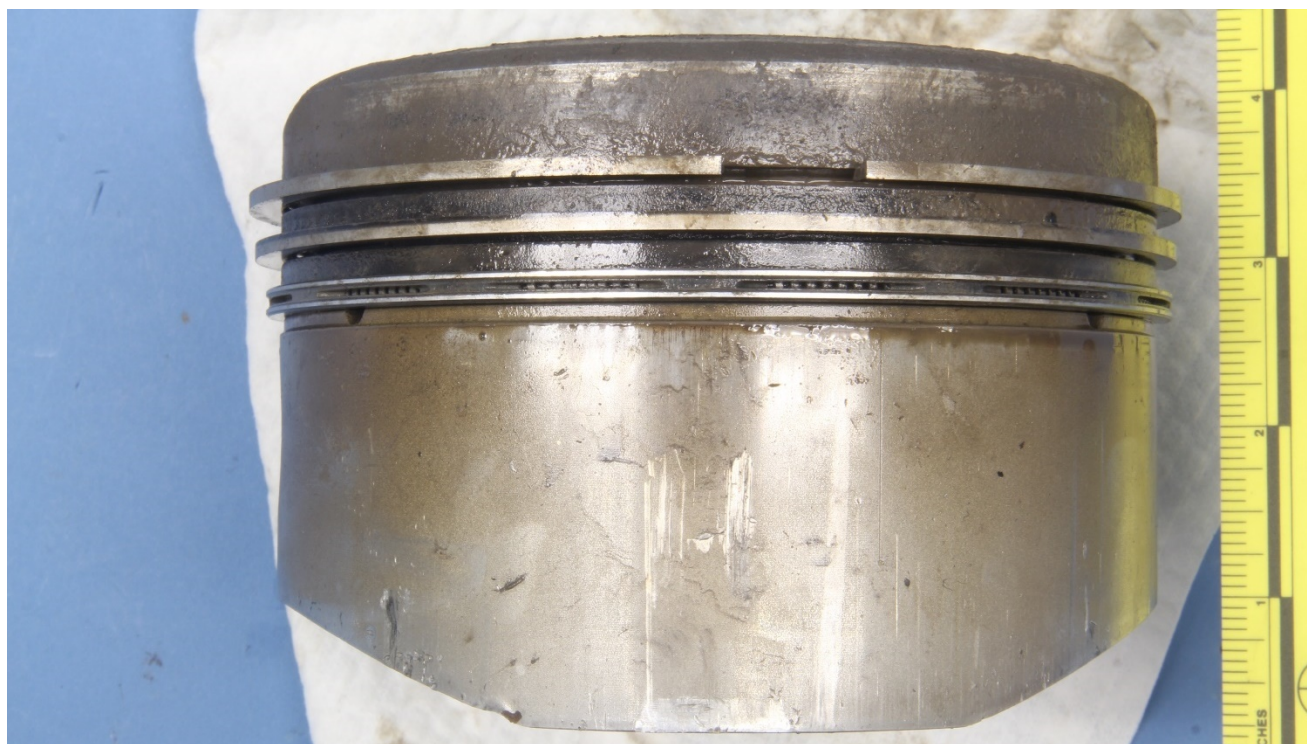
The side of the piston is illustrated in Figure 11. The two upper scraper rings and the lower oil ring were in their respective positions in the piston grooves. There was no indication of cracking, excessive wear, or other damage to these components. The side of the piston skirt, as shown in Figure 11, exhibited vertical witness marks. These marks were consistent with sliding wear with the adjacent cylinder wall, or material trapped between the piston and the cylinder.

Figure 11 – The side of the piston, after disassembly, showing the scraper and oil rings, and vertical scuff marks on the piston skirt.

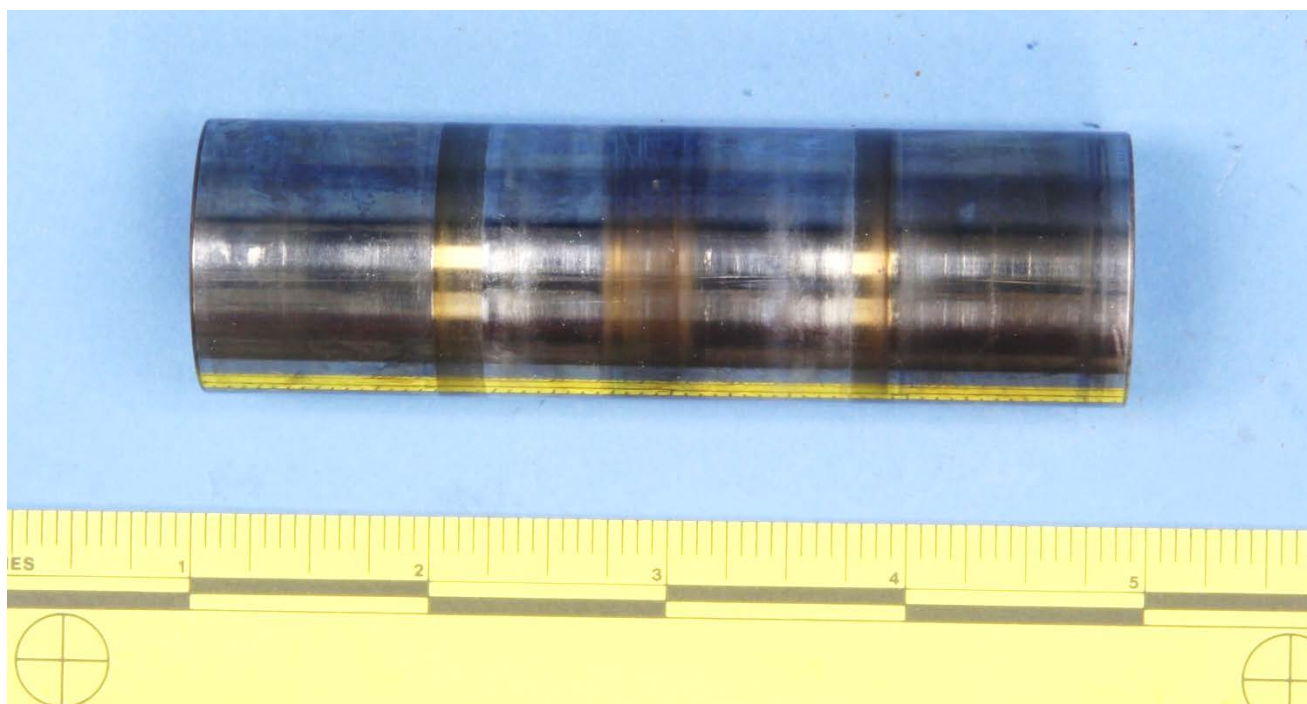
Figure 12 shows the piston pin after disassembly of the piston and connecting rod. The pin exhibited circumferential wear marks consistent with the location of the connecting rod. The wear marks match those observed in the pin-side bearing bore of connecting rod. The wear pattern on the pin was typical of those in service, and there were no indications of sliding or excessive wear consistent with poor fit or lack of lubrication in this region.

Figure 12 – The piston pin, after disassembly.

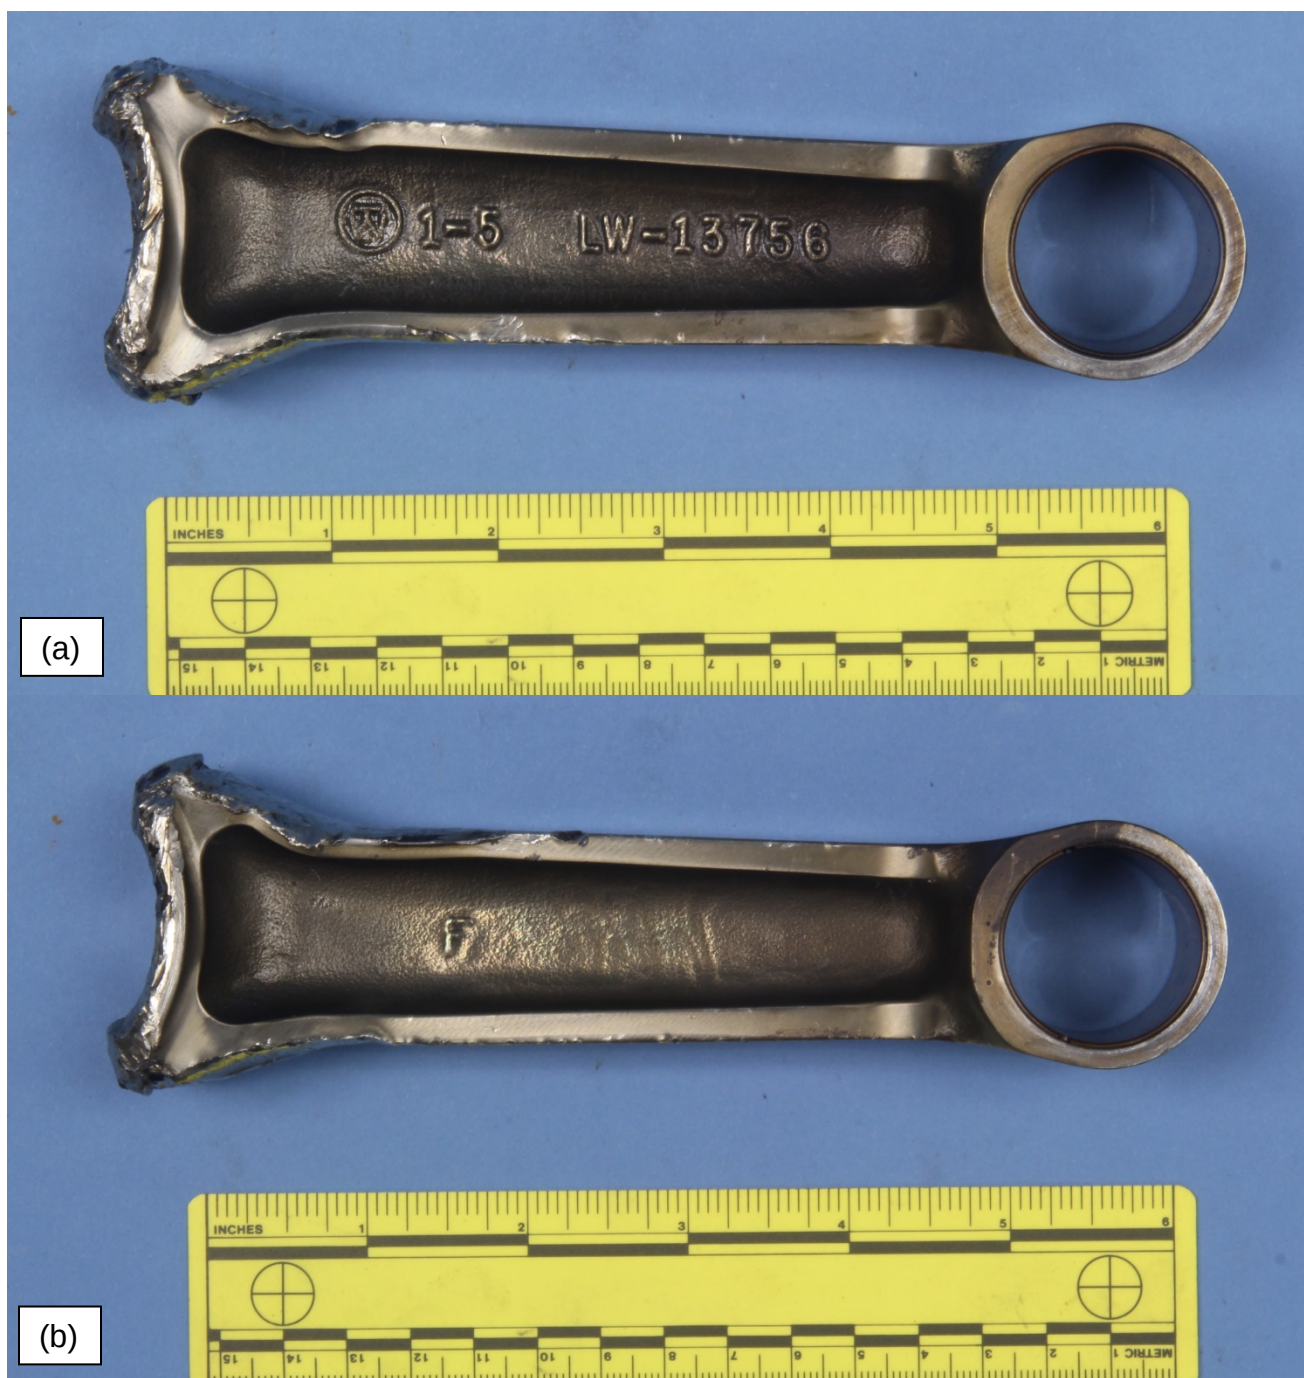
Figure 13 shows the connecting rod fragment from both sides, after disassembly. The side with the markings, in Figure 13a, stated "TW 1-5" "LW-13756". The reverse side, shown in Figure 13b, stated only "F". The portions of the connecting rod along the crankshaft bearing surface were missing and fractured, and much of the connecting rod near the yoke had been severely battered. The sides of the connecting rod above the yoke exhibited batter severe enough to fold material over the flanges of the connecting rod (see upper portions of Figures 13a and 13b).

Figure 13 – The connecting rod after removal from the piston assembly from (a) the side with markings and (b) the reverse side.

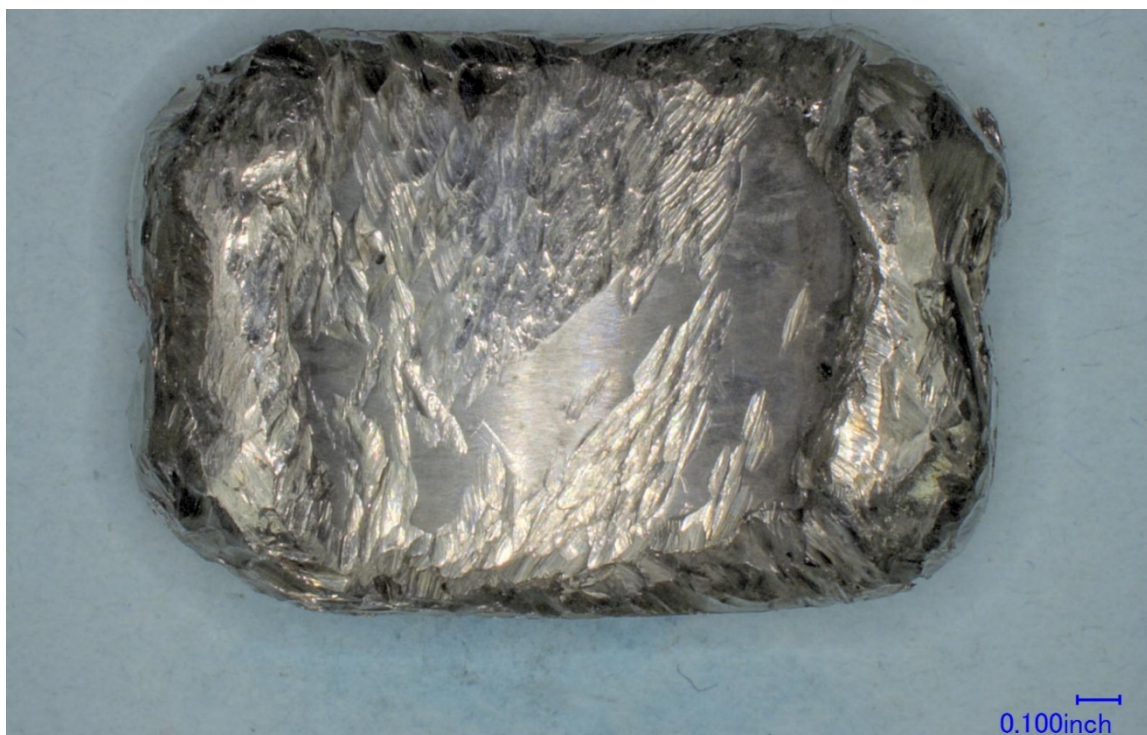
The fracture surface of the connecting rod was sectioned and cleaned using soapy water and then ethyl alcohol. Figure 14 shows the bearing side of the connecting rod fracture surface. Both tangs were missing, and any fracture features that may have been present were obliterated. Almost all the fracture and bearing surfaces exhibited sharp, angled impressions, consistent with repeated contact with adjacent components.

Figure 14 – View of the battered fracture surface of the connecting rod from the bearing surface.

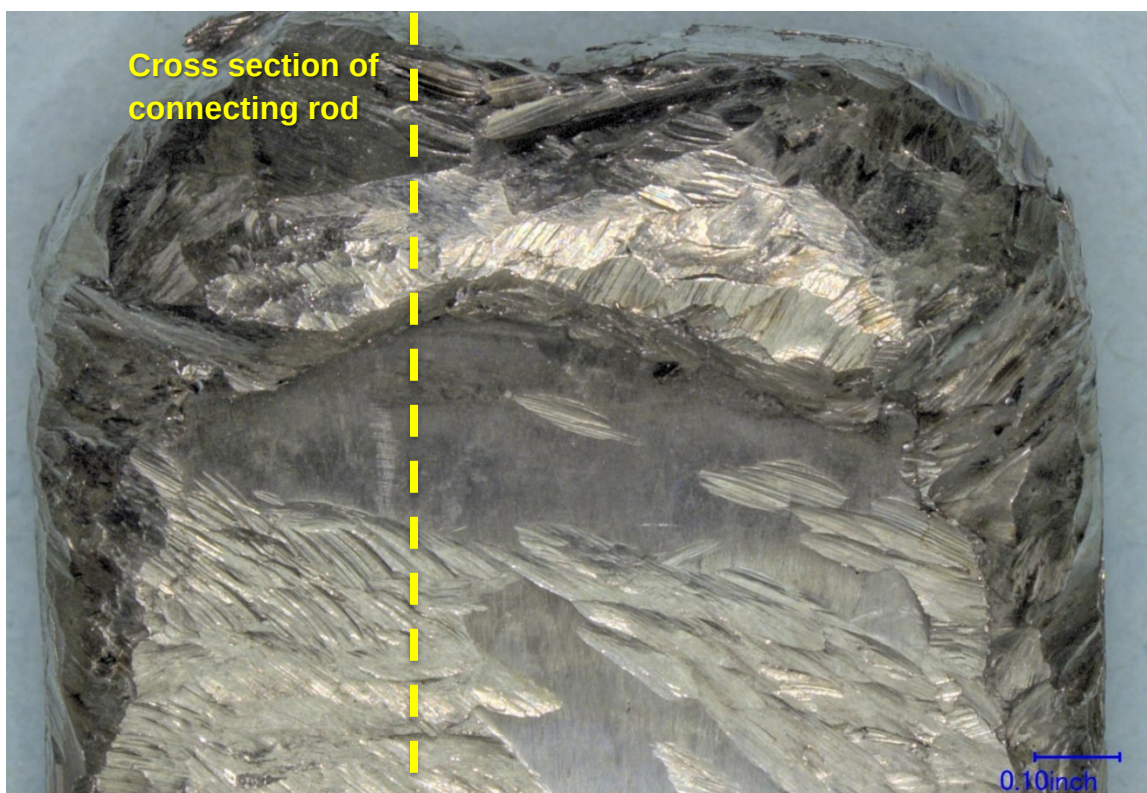
In order to examine if there were any underlying fracture features or material discrepancies, the battered fracture surface of the connecting rod was sectioned as shown in Figure 15. The sectioned portion was mounted, polished, and etched with a 2% Nital solution.<sup>2</sup>

Figure 15 – Closer view of the battered connecting rod fracture, showing the location of the metallographic cross section through the part.

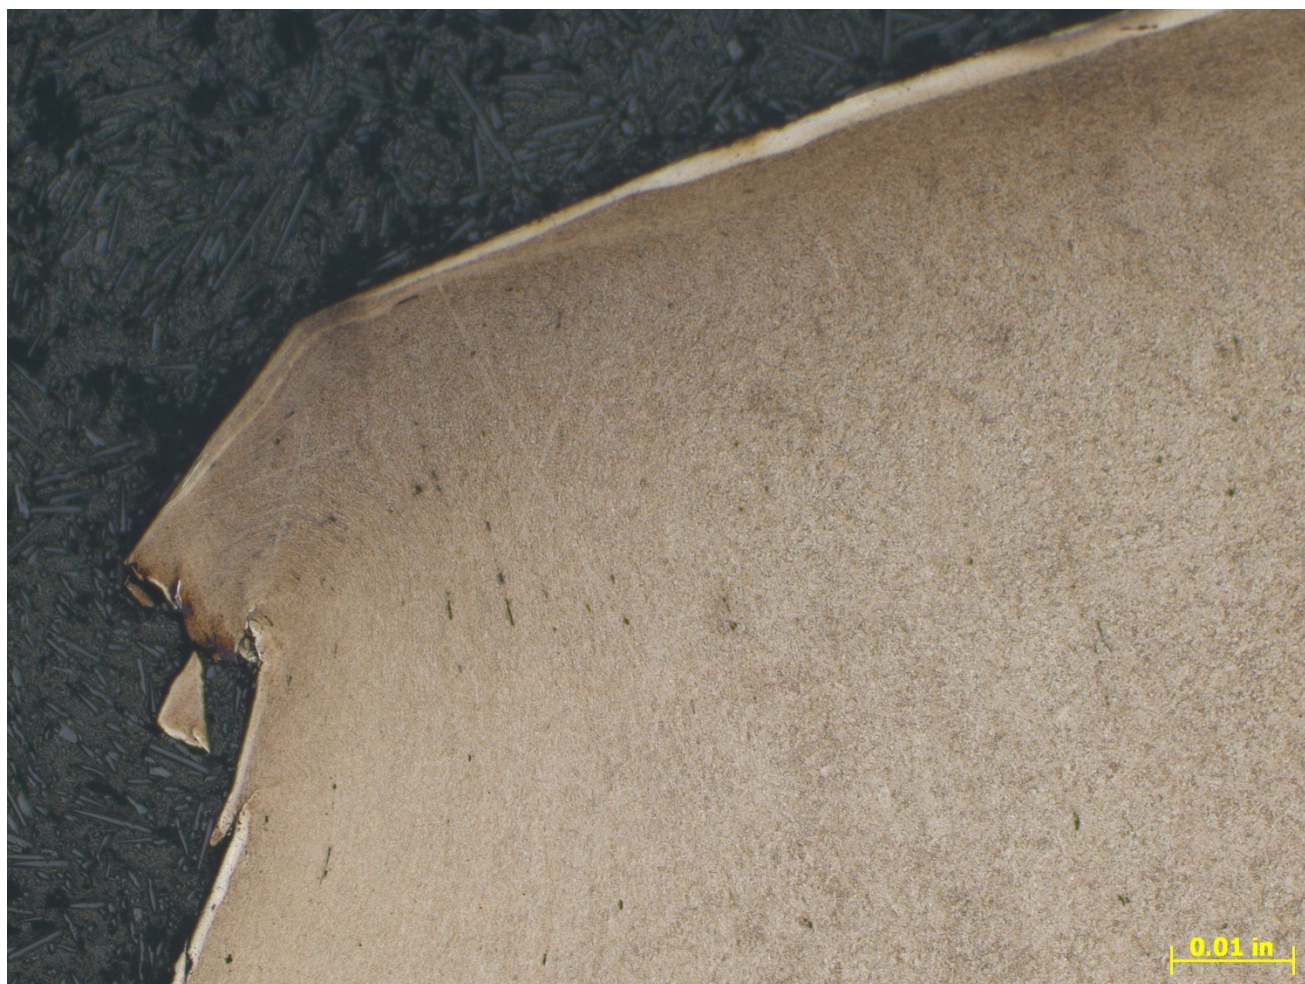
Figure 16 shows a typical cross section of the battered fracture surface of the connecting rod. Consistent with the forging direction of the part, the grain flow orientation would be vertical in Figure 16. However, near the battered surface (top of Figure 16), the grain orientation became parallel with the surface, approximately horizontal in the figure. This change in grain flow was consistent with heavy plastic deformation of the part at elevated temperature.

Figure 16 – Bright field (BF) optical micrograph of the cross section in Figure 15, showing grain flow from severe deformation, and a surface white layer (~50X, etched 2% Nital).

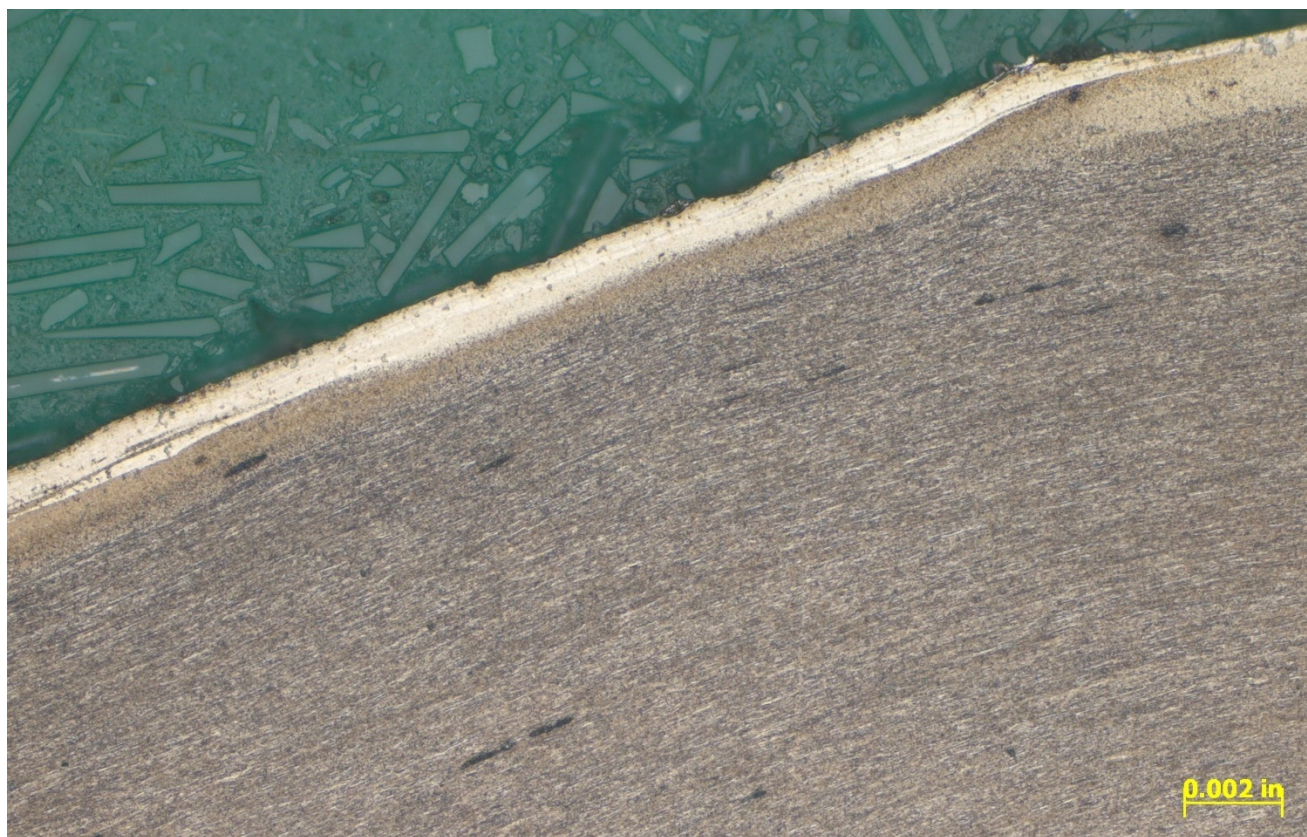
Figure 17 shows a closer view of the battered surface. This shows the changed grain orientation, oriented parallel to the battered surface. In addition, the surface portion exhibited a white-colored layer approximately 0.001-inch thick, containing cracks parallel to the surface. For this material and etchant, the white-colored layer was consistent with untempered martensite. The presence of this microstructure was indicative of the connecting rod bearing surface having reached temperatures more than 1340 °F (727 °C).

Figure 17 – BF micrograph showing the surface in Figure 17, showing grain flow perpendicular to the forging direction of the connecting rod, and white layer consistent with untampered martensite (~200X, etched 2% Nital).

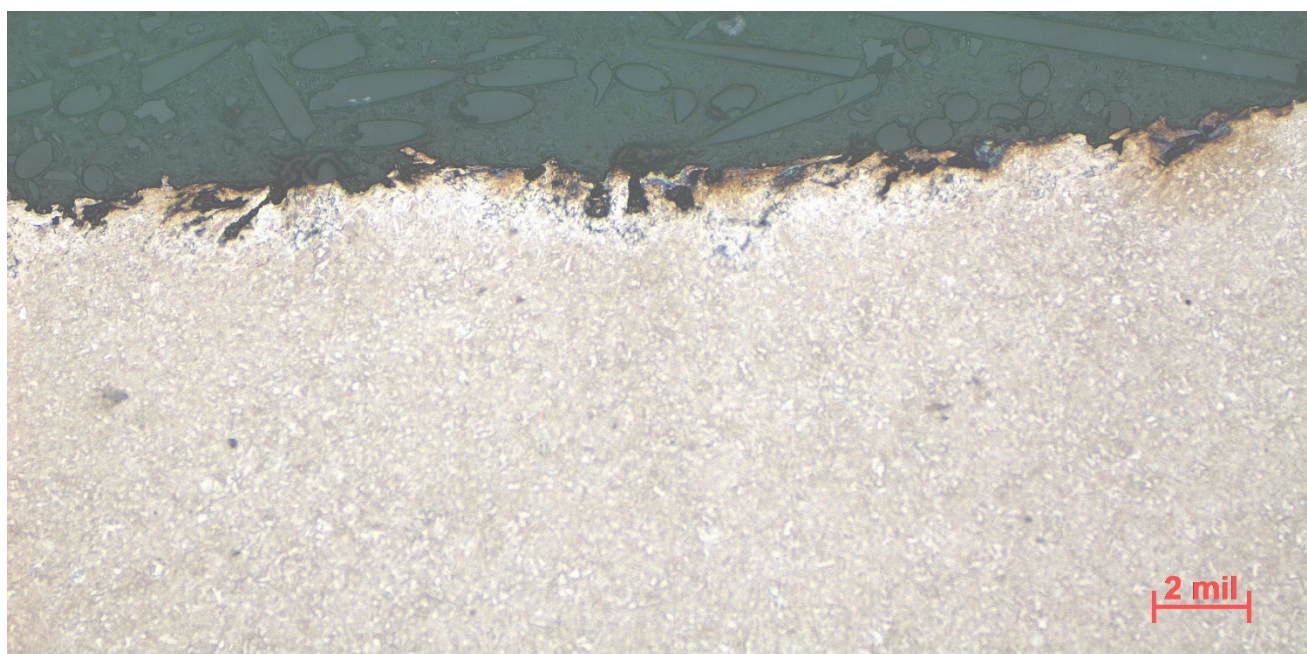
Areas away from the fracture surface were also examined. Figure 18 shows a typical section of the connecting rod surface, away from mechanical damage and batter. The surface was rough, exhibiting pit-like features along the surface. A typical area of the interior of the connecting rod is shown in Figure 19. This microstructure was consistent with tempered martensite, the expected and typical microstructure for this component.

Figure 18 – BF micrograph below the bearing surface of the connecting rod, showing surface pitting and discontinuities (~200X, etched 2% Nital).

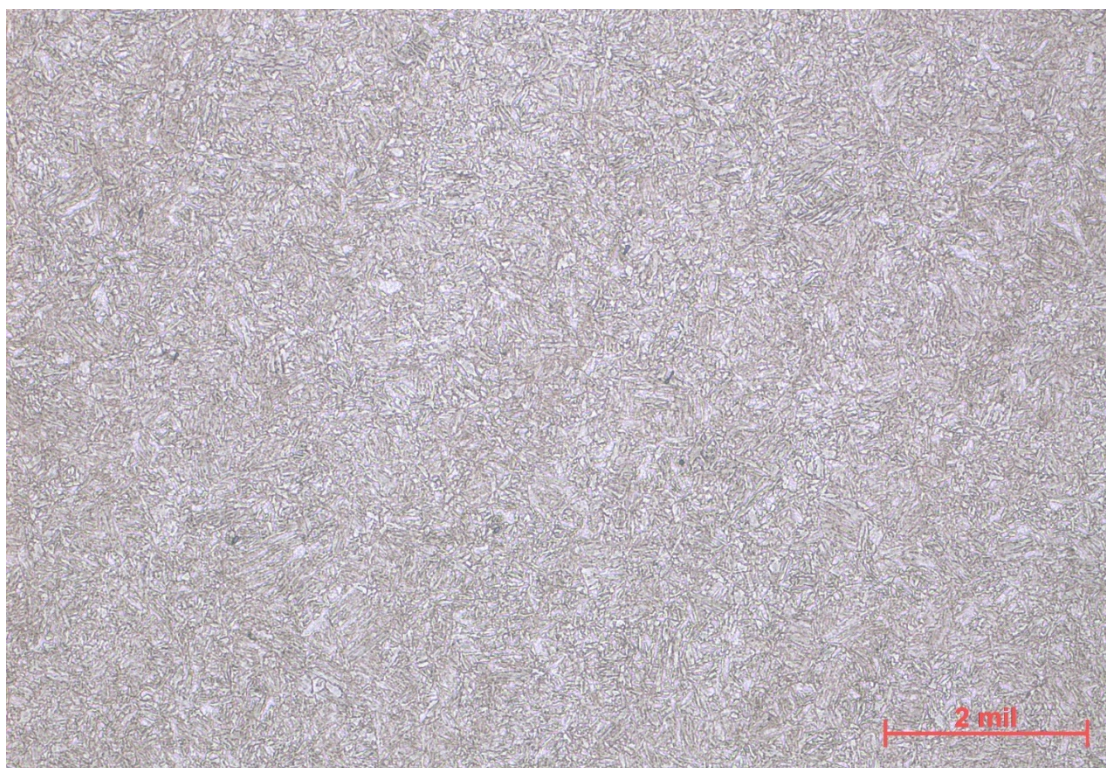
Figure 19 – BF optical micrograph of a typical area of the connecting rod microstructure, showing tempered martensite (~500X, etched 2% Nital).
