# NATIONAL TRANSPORTATION SAFETY BOARD

## MATERIALS LABORATORY FACTUAL REPORT

Report No. 18-051

Place : Hinesville, Georgia  
Date : December 17, 2017  
Vehicle : Piper PA-32-300, N4326X  
NTSB No. : WPR18LA051  
Investigator : Maja Smith, AS-WPR

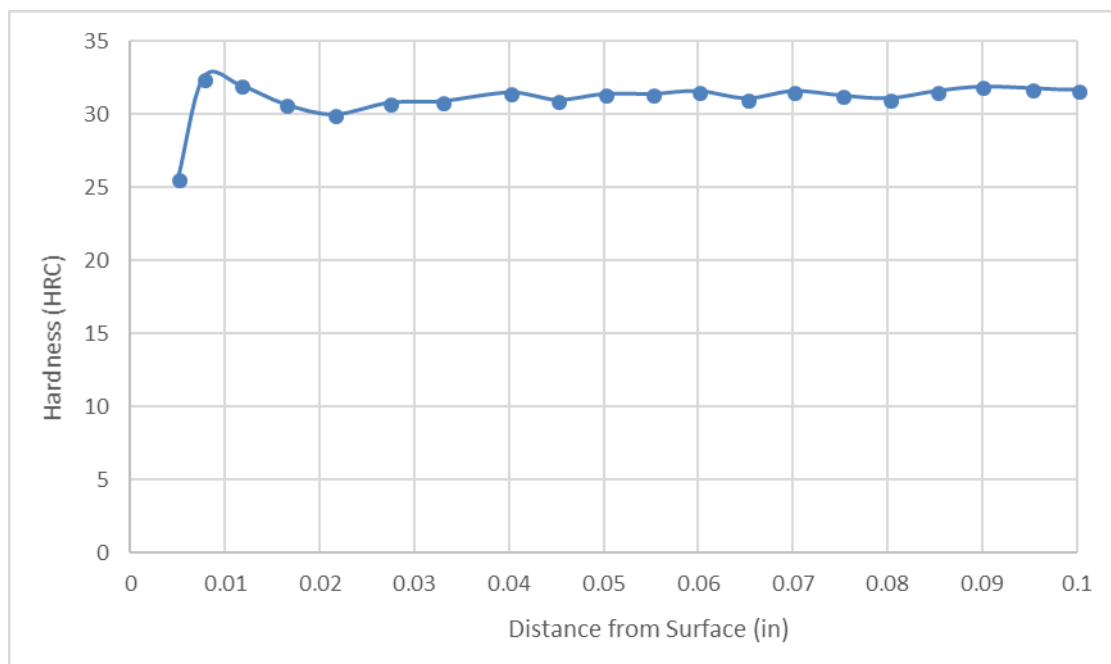
The hardness near the surface was inspected to determine if there may have been significant decarburization of the connecting rod.<sup>4</sup> Figure 20 shows a plot of microindentation hardness values versus distance. While the area adjacent to the surface exhibited a lower hardness, this did not persist past 0.005 inches into the surface—consistent with partial decarburization.

Figure 20 – Chart showing the change in hardness (in HRC) with depth from the surface (in inches) of the connecting rod mounted and polished cross section.

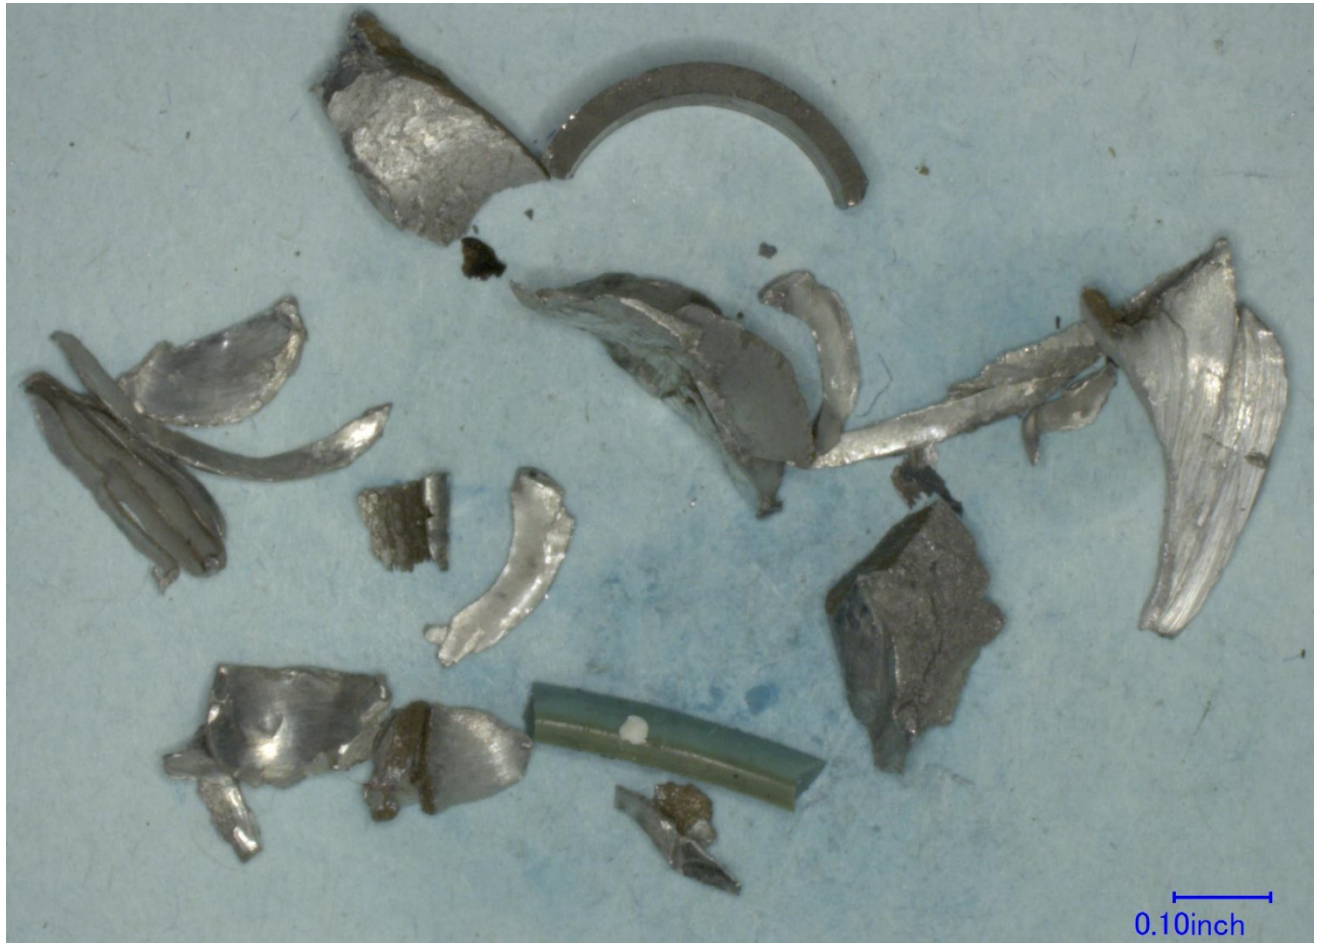
A bag with small pieces of fractured debris was submitted. Figure 21 shows these debris fragments, after cleaning with acetone. These pieces were consistent with either steel or aluminum alloys. The discernible fracture features were examined using optical microscopy. All the fracture surfaces with discernible features exhibited features that were consistent with overstress fracture. There were no indications of other fracture modes present on these pieces.

Figure 21 – View of the fragments from the bag of debris, shown after cleaning with acetone.
