**8/10/2018 EA-FSDO-39 ASI Jerry L. Toms**

Opened the Box containing a carburetor from the NTSB, Stephen Stein labeled WPR18LA056.

Evidence Control Number WPR18LA056-NC-001

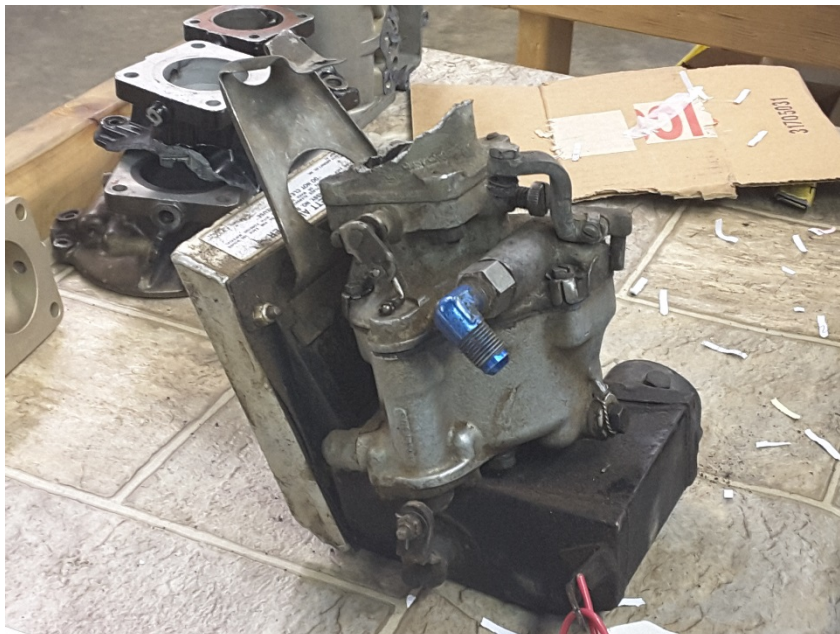
Casting at top of carburetor, in direction of intake manifold, fractured across entire cross section, but damage was above the attachment flange at the top of the carburetor body. Removed this broken section and bagged it with attachment hardware and gasket.

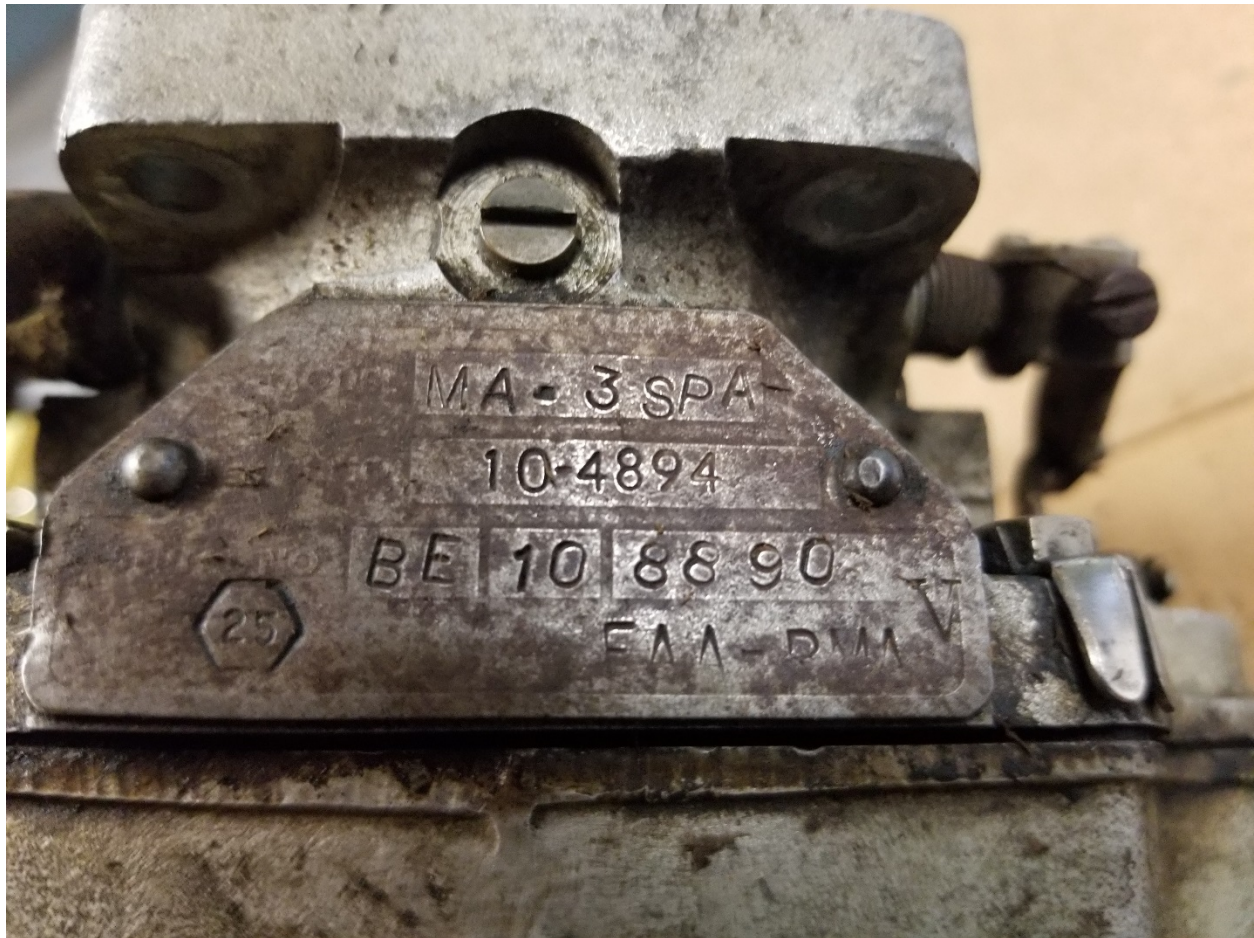
Removed Air box and filter. Airbox damage: Deformed, requiring technician to bend distorted metal to access attachment hardware and remove the airbox from the carburetor. ID plate seemed unreadable prior to efforts at cleaning by Inspector Toms: MA-3 SPA, 10-4894, BE 10 8890, FAA-PMA.

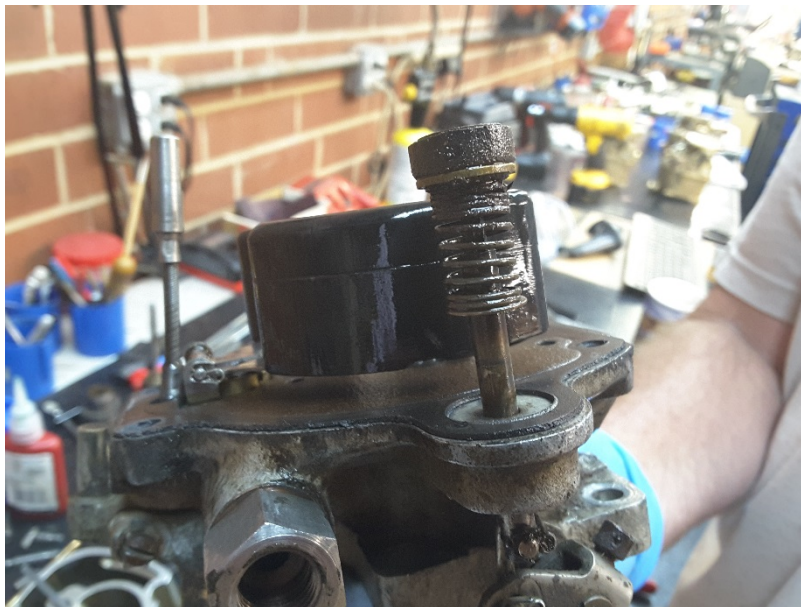
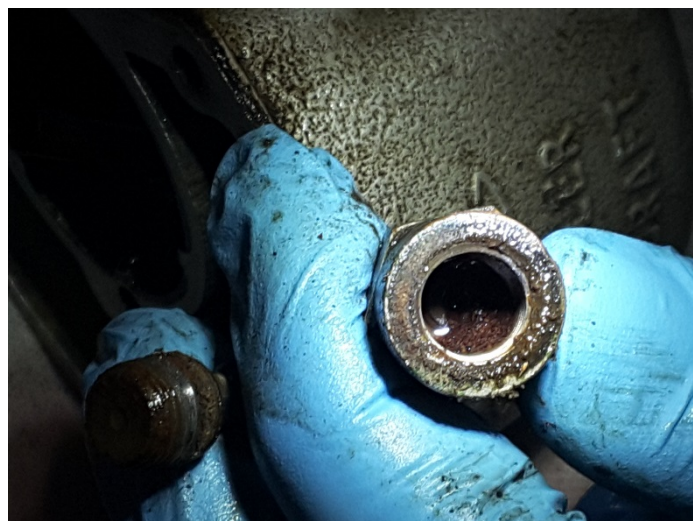
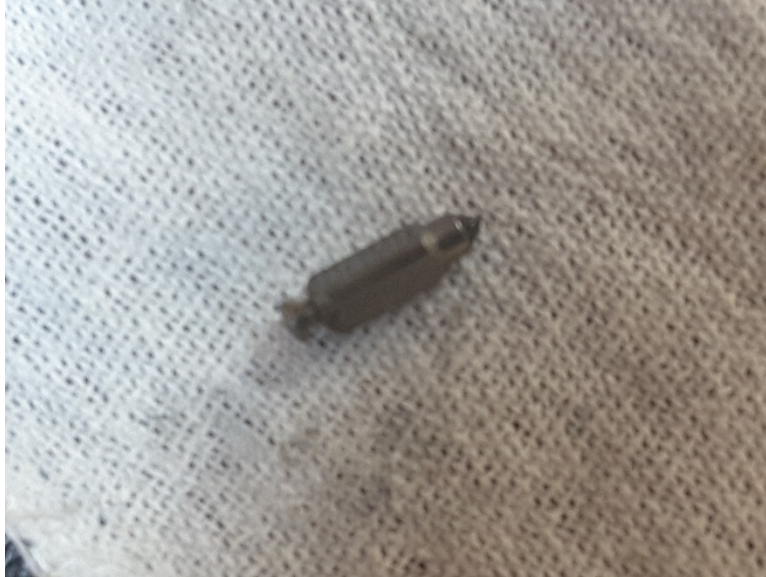
**Determined: NO IDLE CUTOFF; accelerator pump passages plugged with contaminants.**

**Contaminants found in accelerator pump check valve.**

Debris existed within the carburetor in the float bowl area, in the area of the accelerator pump check valve, and in the output area of the Venturi airflow outputs.
