**Federal Aviation  
Administration**

## **AIRCRAFT AND LANDING GEAR SYSTEM INSPECTION/FUNCTION REPORT**

**Date:** January 8, 2018

**Aircraft:** The subject aircraft was identified as N2122S, a Cessna T210L, serial number 21061084 by the presence of registration markings and the aircraft internal and external data plates. The aircraft was in Willamette Aviation's maintenance hangar on the ground with the wing jacks in place with the appropriate wing jack adapters installed on each wing. The aircraft interior furnishings, including the front seats, carpet, left and right forward side panels and floorboard inspection panels had been removed. Willamette Aviation mechanic Ed Stearns reported that no other maintenance had been completed on the aircraft.

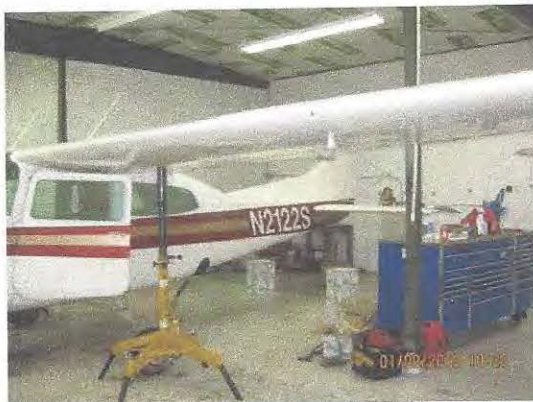
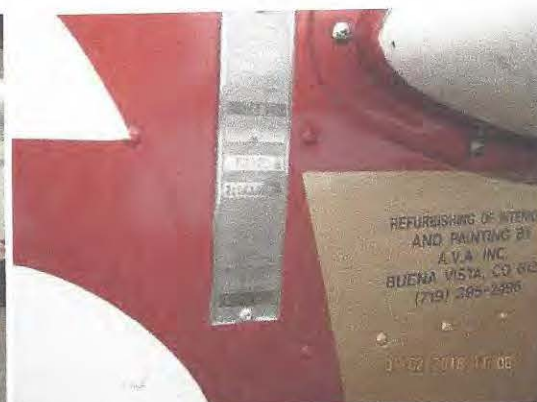
The aircraft exterior was inspected and it was noted that there is very minimal, if any damage to the fuselage of the aircraft. The right horizontal stabilizer and elevator are damaged both by bending upward and abrasive damage on the bottom outboard portions. The right wing tip is very minimally damaged by the scraping of paint at the aft lower portion of the tip but not with enough force to break the plastic wing tip. Someone has crimped the end of the right wing fuel tank vent line shut with a pair of vise grip style pliers, most likely in an effort to stop or slow the leakage of fuel while the aircraft was leaning on its right wing. No other exterior damage attributable to the accident was noted.

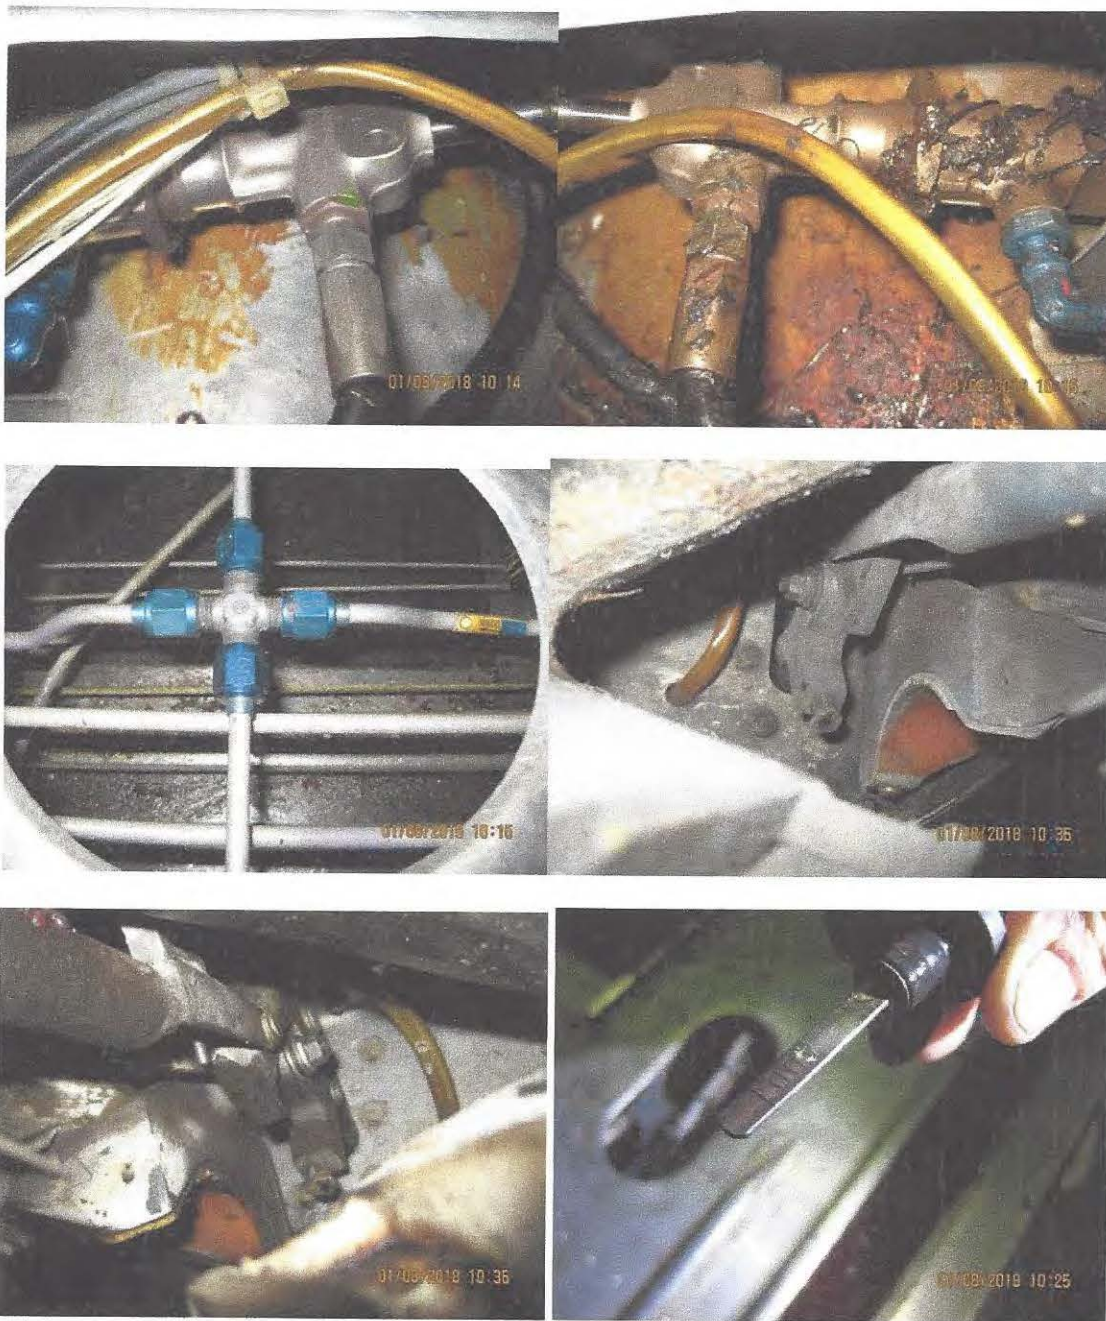
**Inspection:** The landing gear hydraulic lines, electrical wires, actuators, locks, valves and other landing gear system components were visually inspected for condition, security and leakage prior to the application of power to the system. No obvious defects were noted. The hydraulic system fluid was visually inspected, appeared bright, of appropriate color and was noted as smelling normal (lack of burnt or contaminated smells). The fluid level was noted as being adequately above the "ADD" mark on the hydraulic reservoir dip stick.

There was a slight (trace) amount of hydraulic fluid in the belly of the aircraft in the compartments where hydraulic components were located but no obvious leaks from any specific component were noted. Also, there was excess grease noted on and around the main landing gear actuators but appeared to be from excessive servicing rather a sign of a failure.
