# NATIONAL TRANSPORTATION SAFETY BOARD

## MATERIALS LABORATORY FACTUAL REPORT

Report No. 18-063

Place : San Bernardino, CA  
Date : 12/29/2017  
Vehicle : Cessna 210  
NTSB No. : WPR18LA058  
Investigator : Jack Vanover

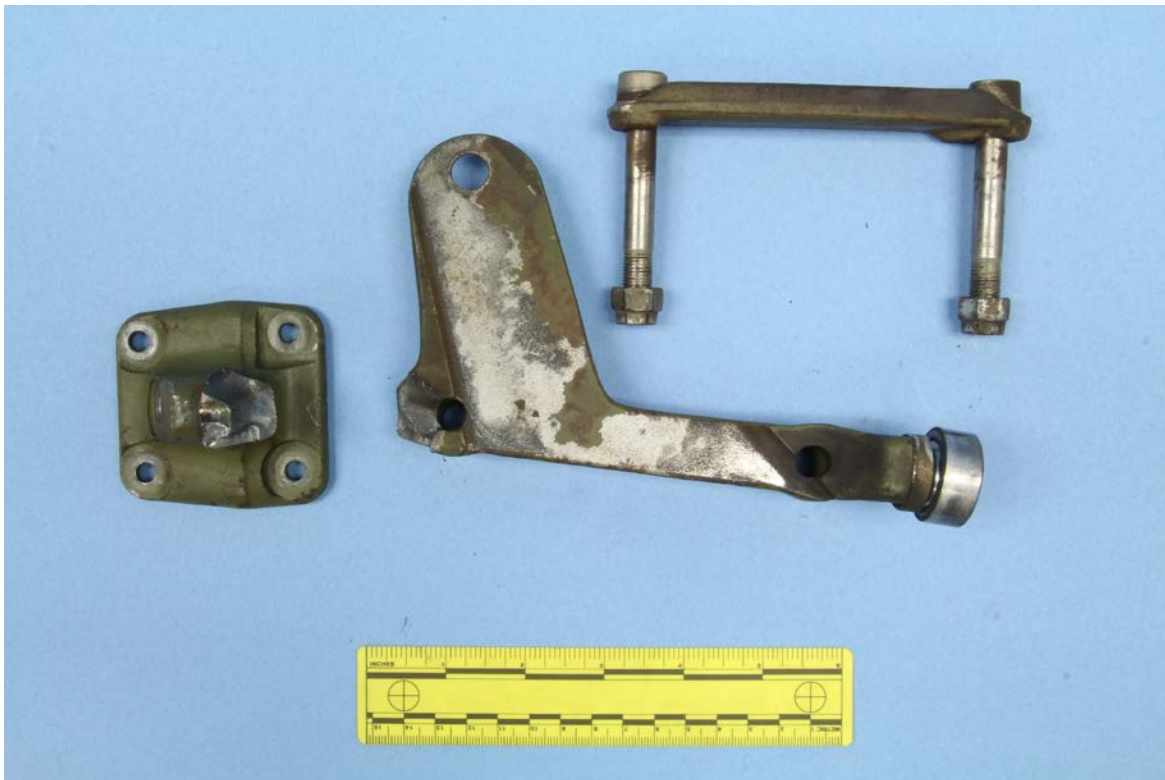
Main landing gear saddle assembly (figure 1)

Figure 1: Main landing gear saddle assembly as received.

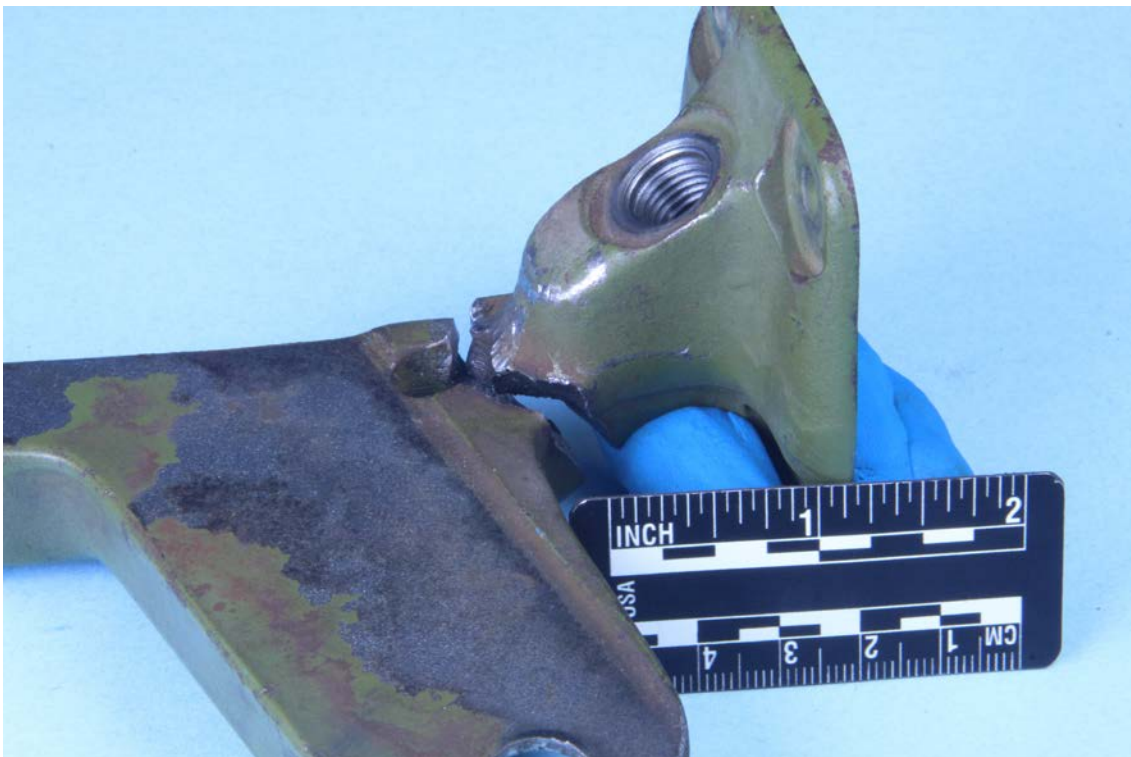
The main landing gear saddle assembly had fractured as depicted in figure 2. Examination of the fracture surface using a stereo microscope revealed fracture surface features consistent with a fatigue fracture. These features included ratchet marks at the origin of the crack and two distinct crack arrest fronts. Additionally, an area with a series of crack arrest fronts was also observed on the fracture surface. These features are identified in the digital microscope photographs in figure 3.

Figure 2: Portions of the saddle assembly showing the orientation of the fracture.

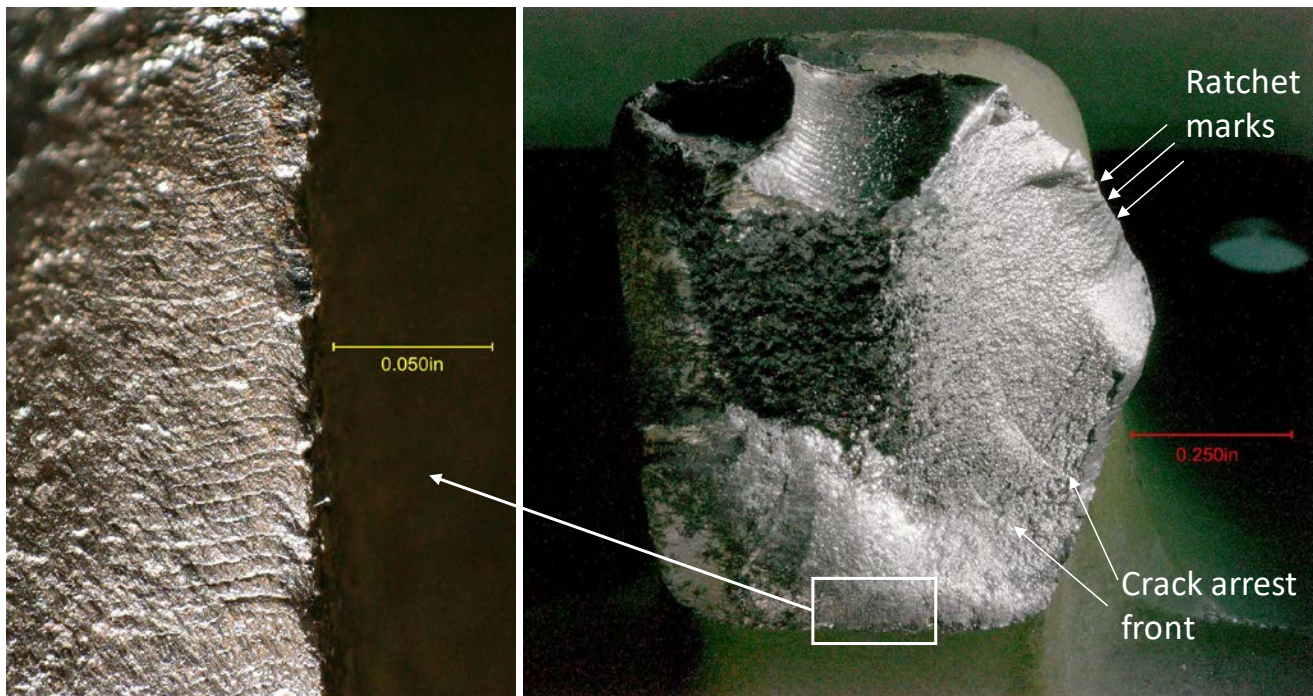
Figure 3: Fracture surface exhibiting ratchet marks and crack arrest fronts.
