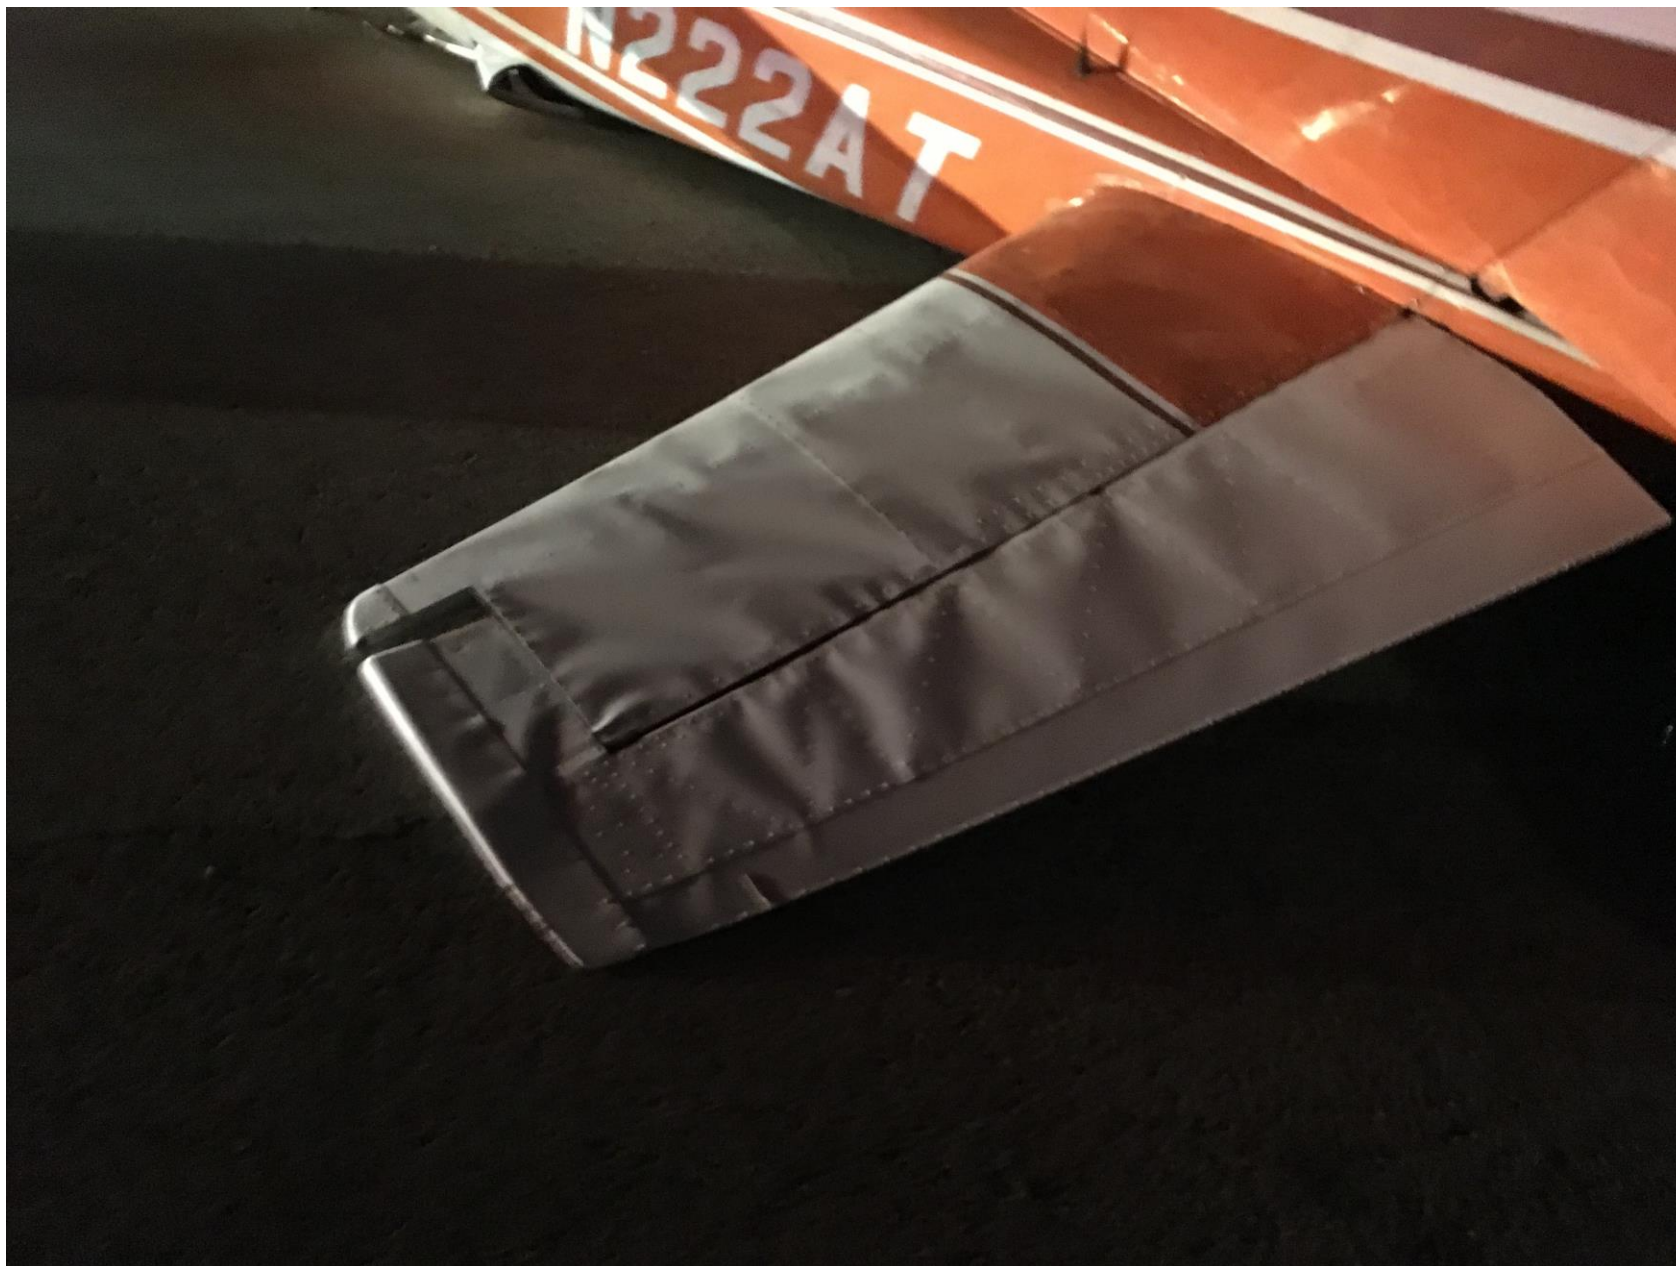
**Photo 1 – View of empennage damage (photo courtesy of the FAA).**

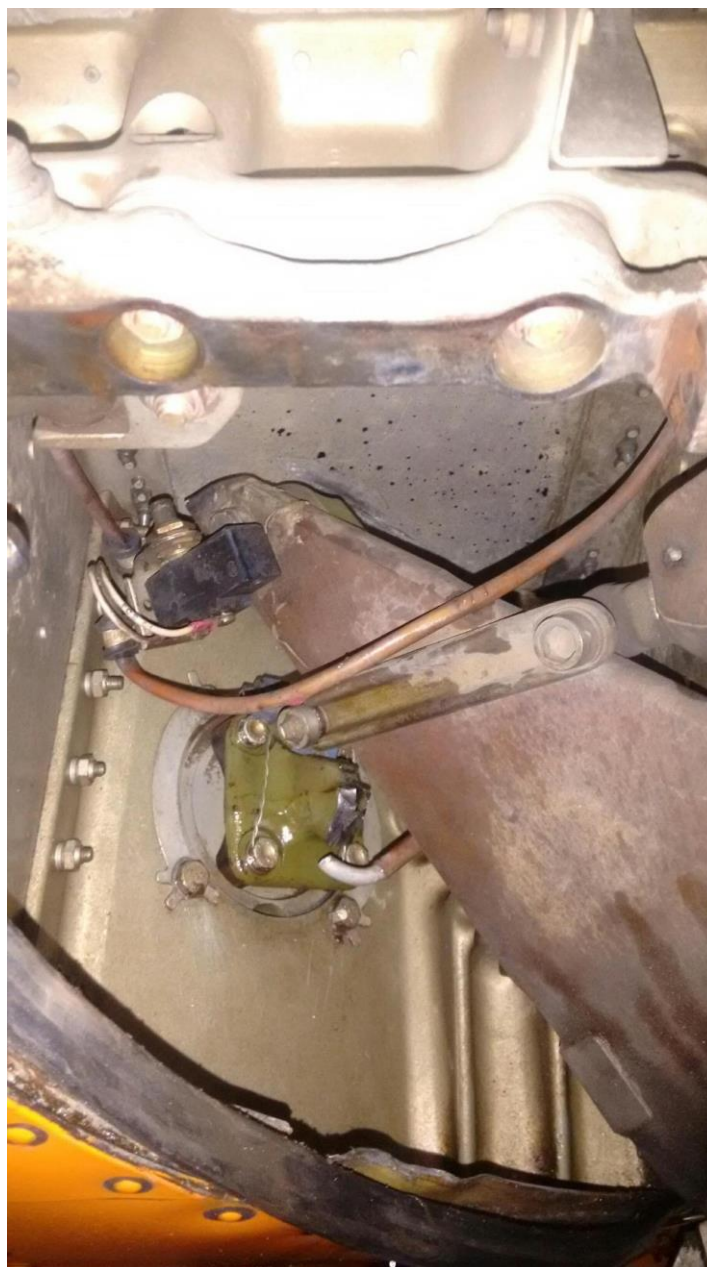
**Photo 2 - View of broken left landing gear saddle (photo courtesy of the FAA).**

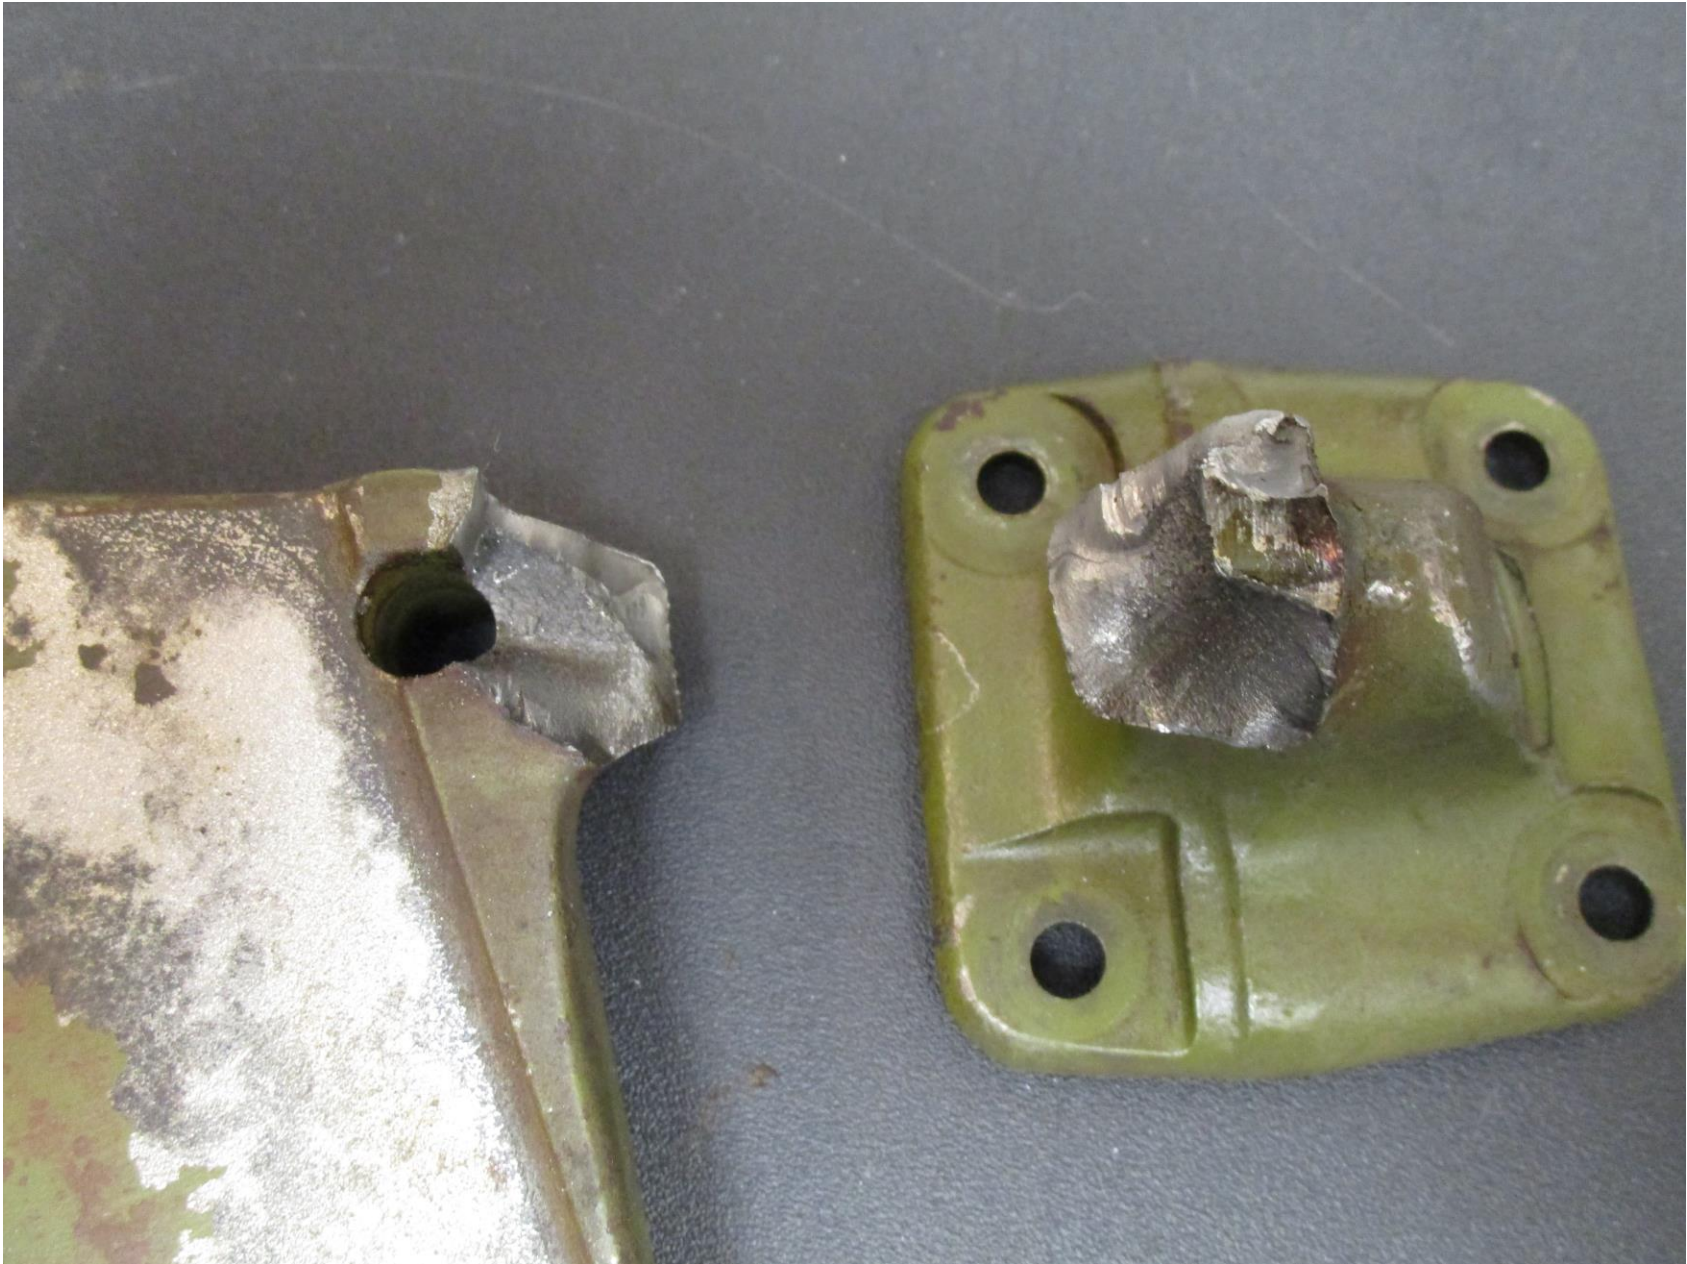
**Photo 3 - View of broken left landing gear saddle after removal (photo courtesy of the FAA).**

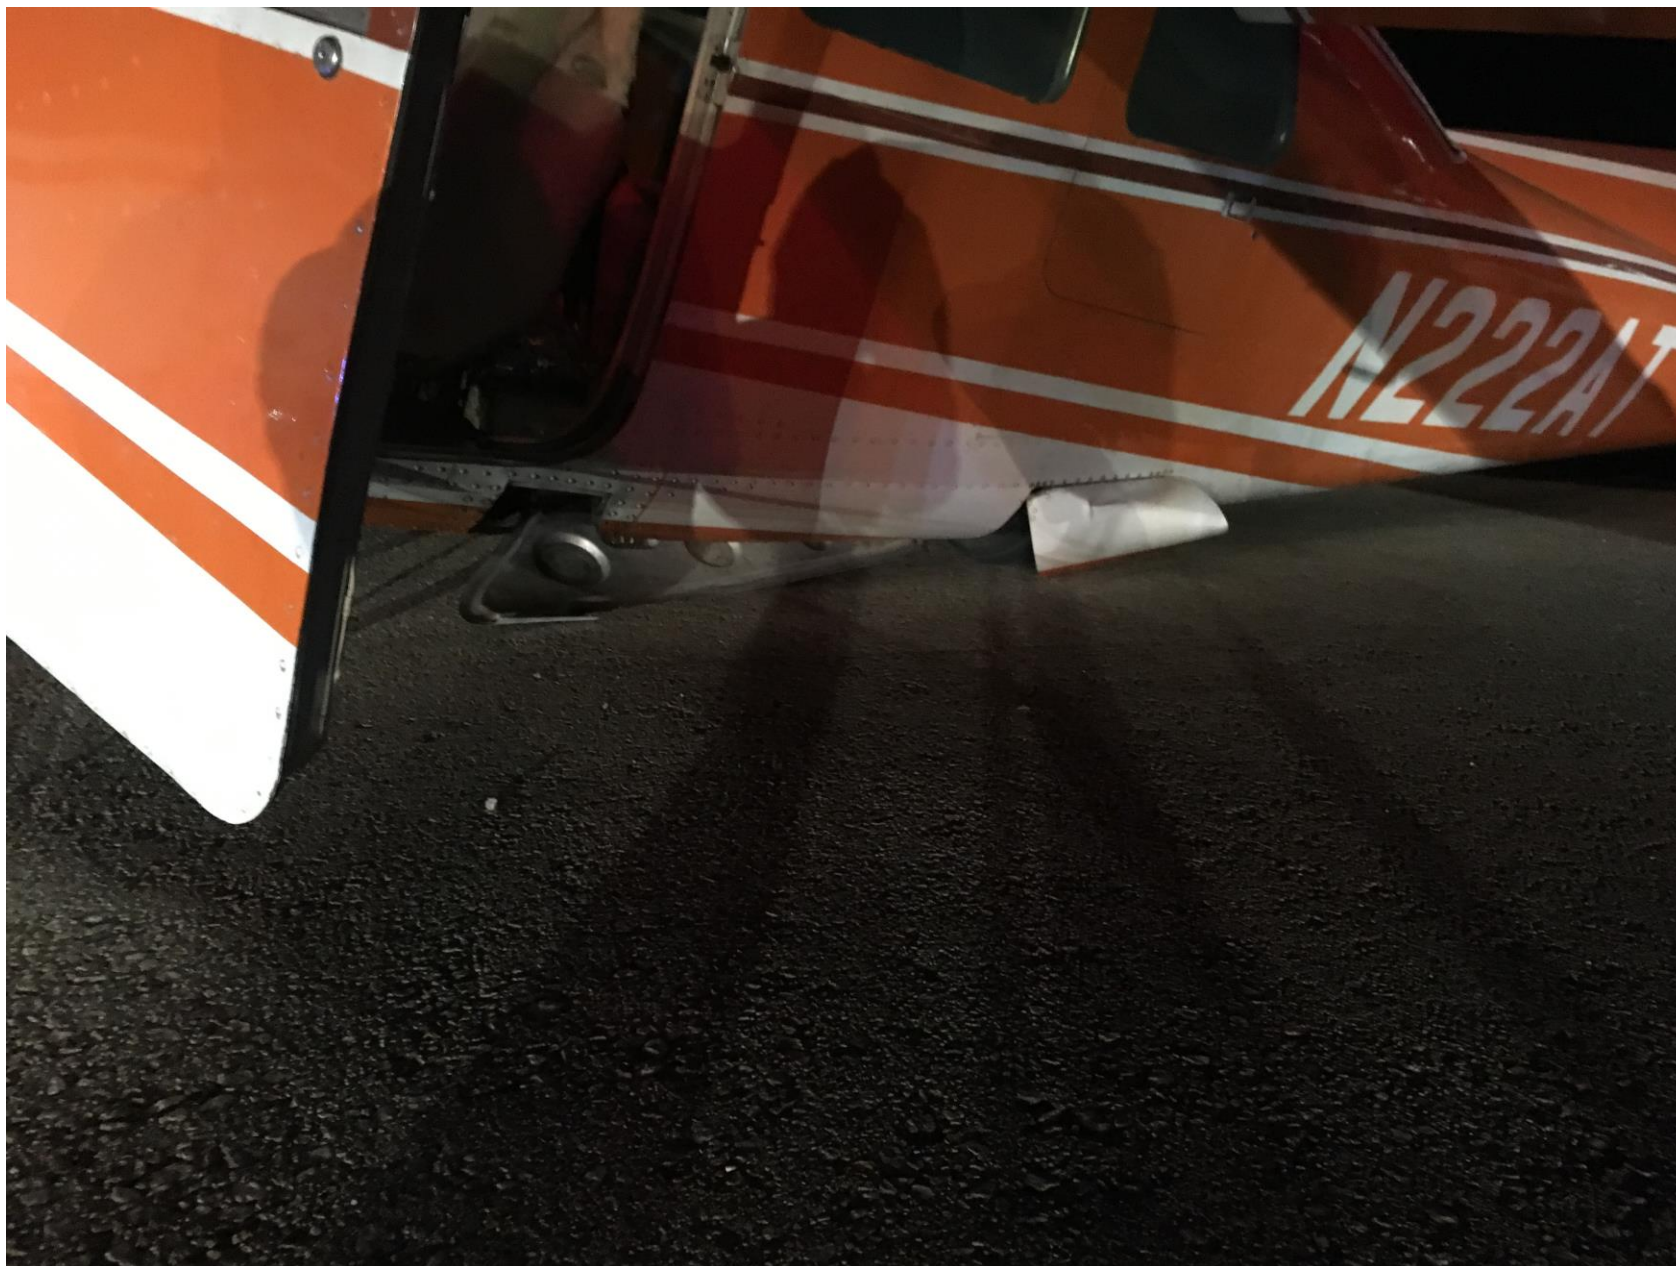
**Photo 4 - View of wreckage on runway (photo courtesy of the FAA).**
