# NATIONAL TRANSPORTATION SAFETY BOARD

## MATERIALS LABORATORY FACTUAL REPORT

Report No. 18-065

Place : Kapolei, HI  
Date : 1/13/2018  
Vehicle : Experimental JA30 Superstol  
NTSB No. : WPR18LA065  
Investigator : Maja Smith

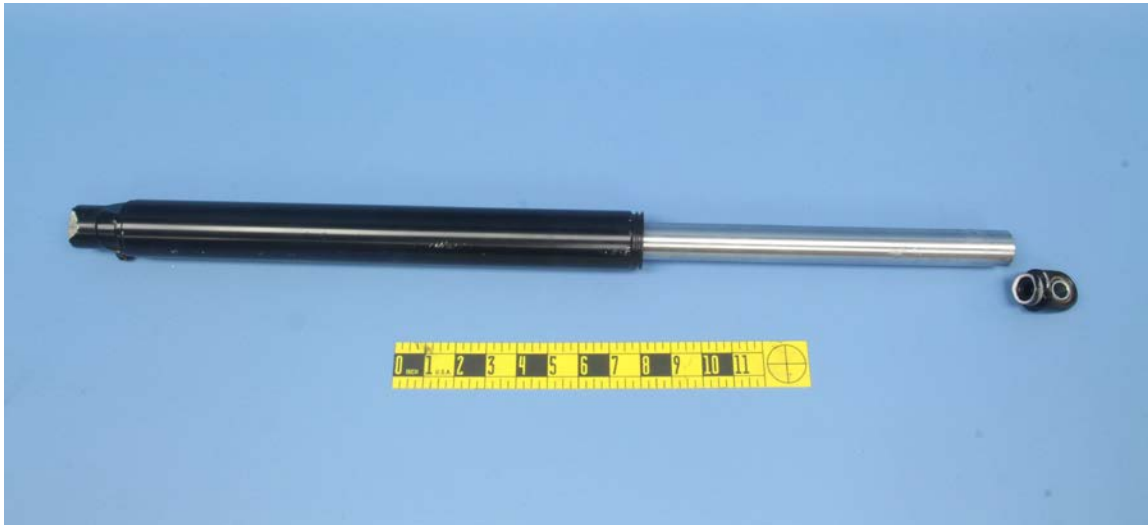
Left landing gear strut (figure 1)

Figure 1: Left landing gear strut as received.

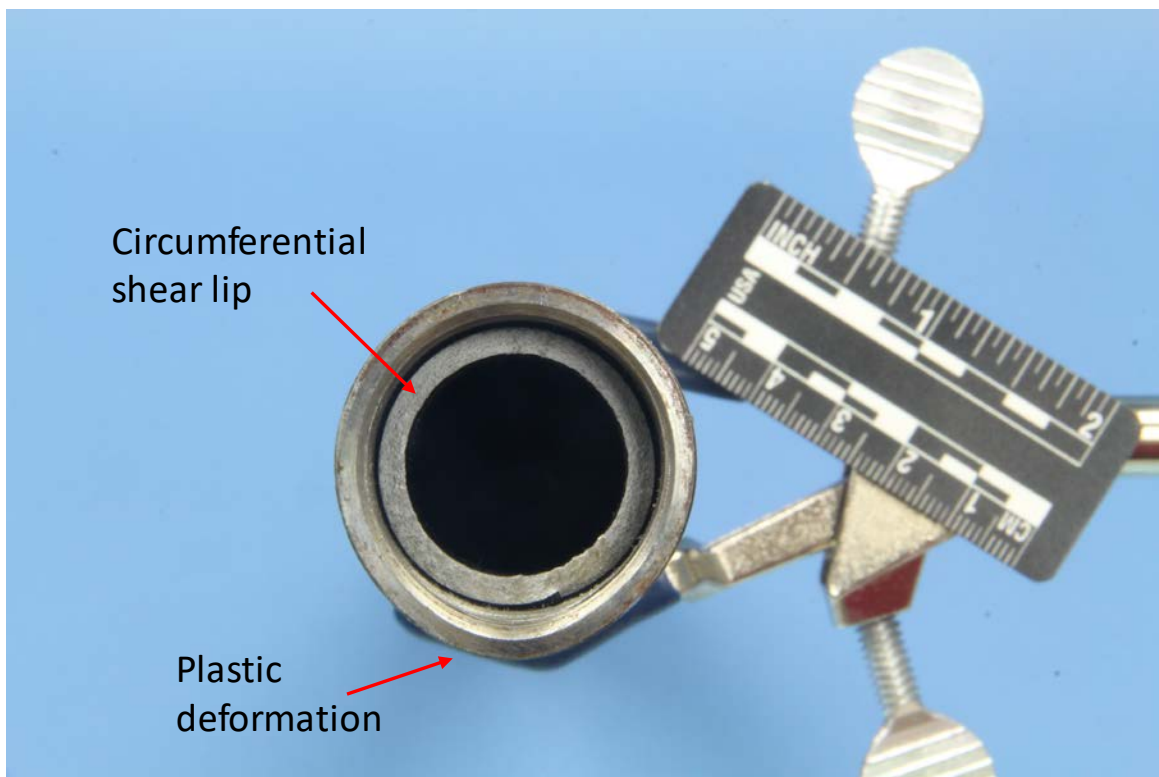
The landing gear strut fractured and separated at the end fitting. Examination of the landing gear strut's cylinder revealed plastic deformation of the cylinder and a portion of the end fitting remaining inside. The portion of the end fitting remaining inside the cylinder exhibited a shear lip around the circumference of the fracture surface (figure 2). The separated end fitting exhibited plastic deformation (figure 3). The shear lip fracture surfaces and plastic deformation of both the cylinder and end fitting are consistent with an overload type of failure.

Figure 2: Plastic deformation of the strut cylinder and shear lip around the circumference of the portion of the end fitting remaining inside the cylinder.

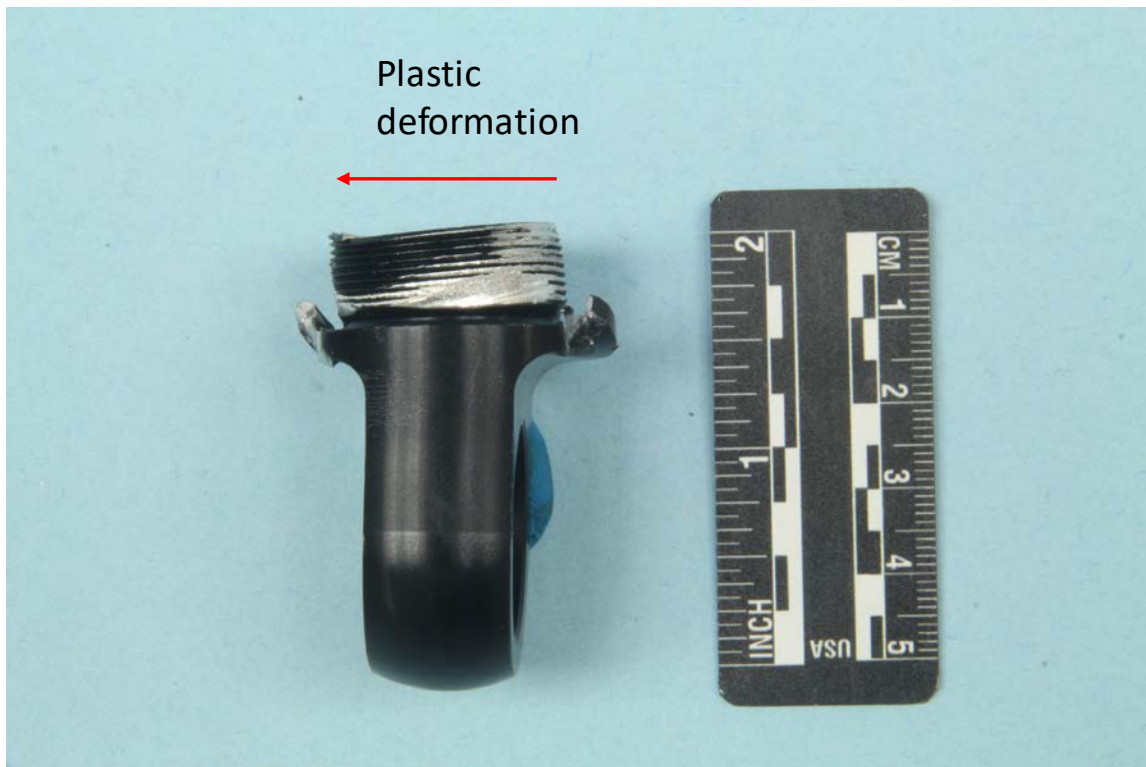
Figure 3: Portion of the end fitting exhibiting plastic deformation.
