## **NATIONAL TRANSPORTATION SAFETY BOARD**

# **AIRFRAME EXAMINATION**

**WPR18LA094**

Location: Elko, NV  
Date: February 21, 2018  
Aircraft: Soko Galeb G-2, Registration Number: N90SR  
NTSB IIC: Albert Nixon

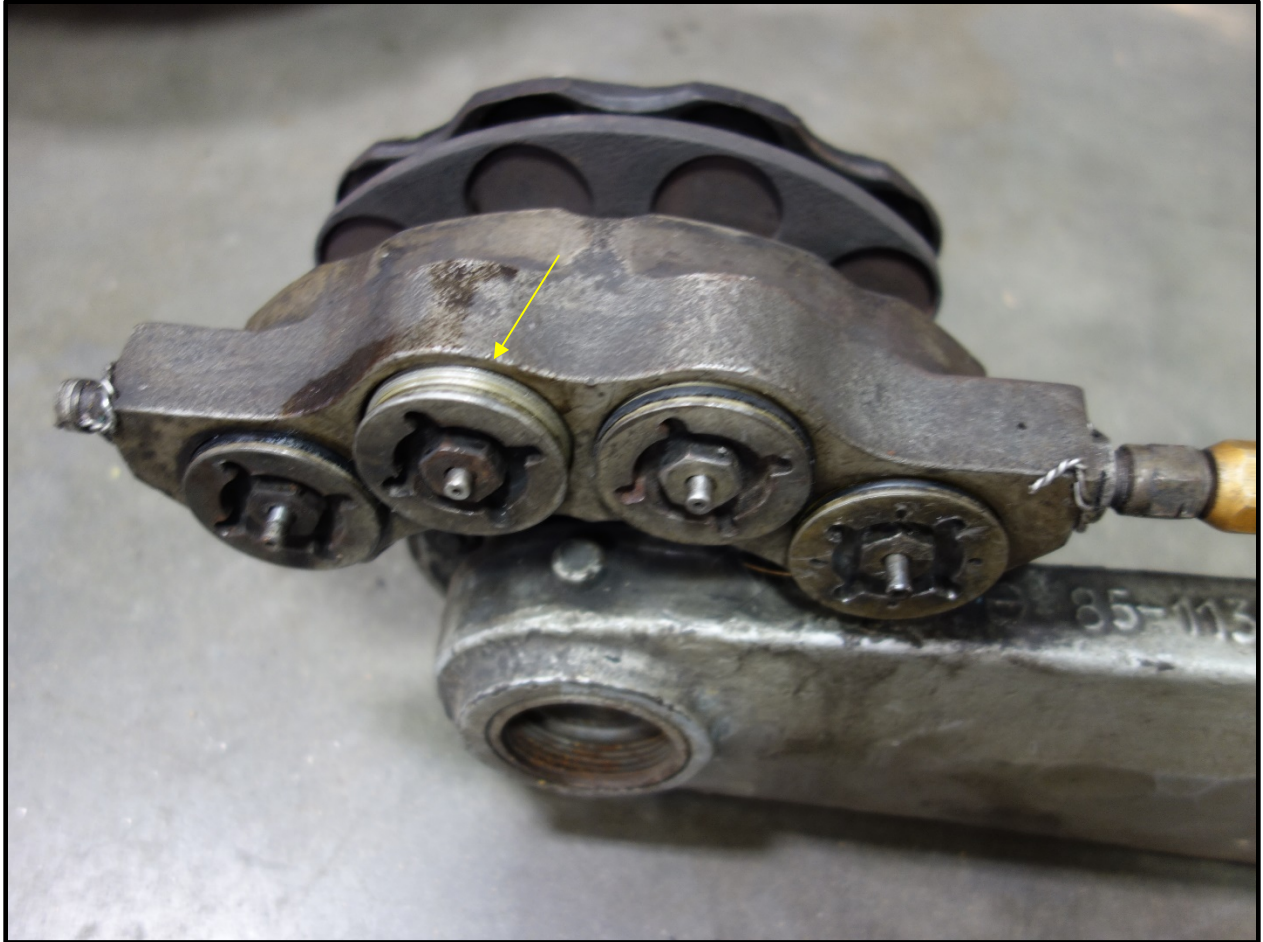
The nose gear strut and left main landing gear strut had separated from the airplane. The left main landing gear strut was separated about at the mid-point of the strut. Examination and disassembly of the left brake assembly revealed that the hydraulic line separated end was still secured and appropriately safety wired to the brake assembly. 2 brakes rotors were extremely loose, and the No. 2 brake cylinder (2<sup>nd</sup> lowest to the ground of the 4 cylinders) worn pin indicator was recessed. The other 3 brake cylinder's wear pins were observed in the normal position.

Further examination of the No. 2 brake cylinder revealed that it was not properly installed and allowed movement of the brake pucks. The movement of the brake pucks, resulted in 3 of them separating from the brake assembly. Separation of the brake pucks would result in the No. 2 cylinder piston to move to the full-scale inward position. The full-scale deflection of the No. 2 cylinder would result in a hydraulic fluid leak and cause insufficient hydraulic pressure to be provided to the other brake cylinders, rendering the brake ineffective.

Figure 1: Left brake cylinders.
