**City of Elko**  
**Elko Regional Airport**  
[REDACTED]  
**Elko, NV 89801**

#### N90SR Report Summary

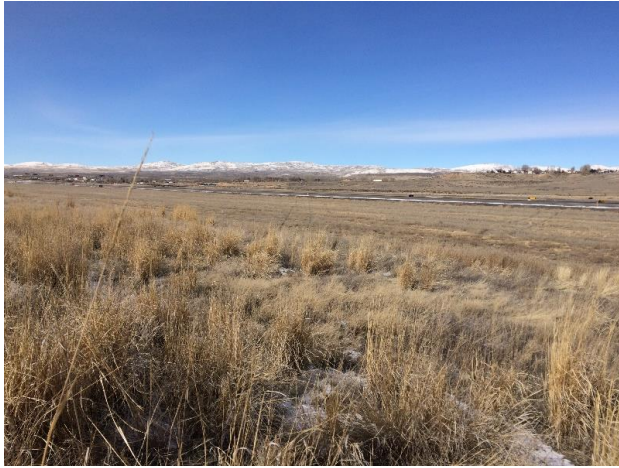
Ruts in the grass and dirt from where the aircraft left Runway 6. Picture taken looking northwest.

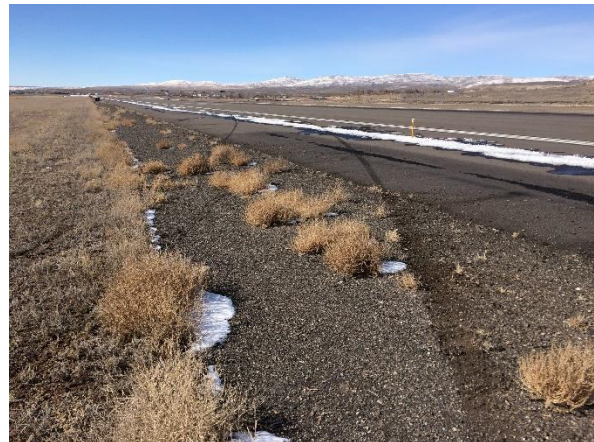
Tire marks and ruts. Facing west towards the approach of Runway 6 opposite direction of landing

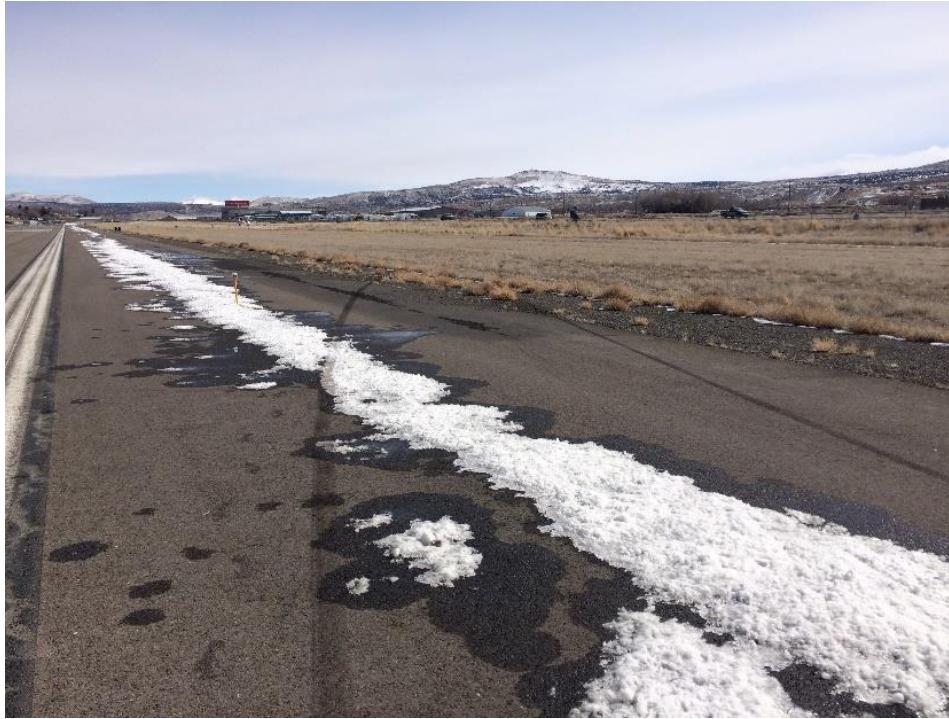
Tire marks leaving Runway 6 facing southeast. In direction of landing. Tip of aircraft tail can be seen in the distance.

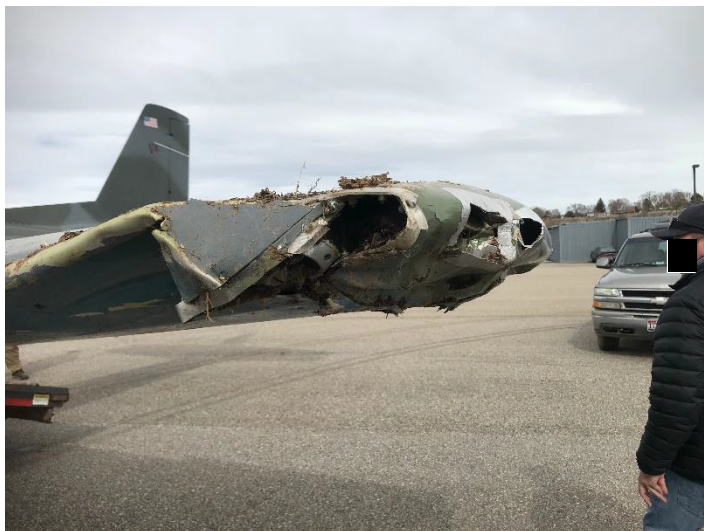
Damage to the left wing tip

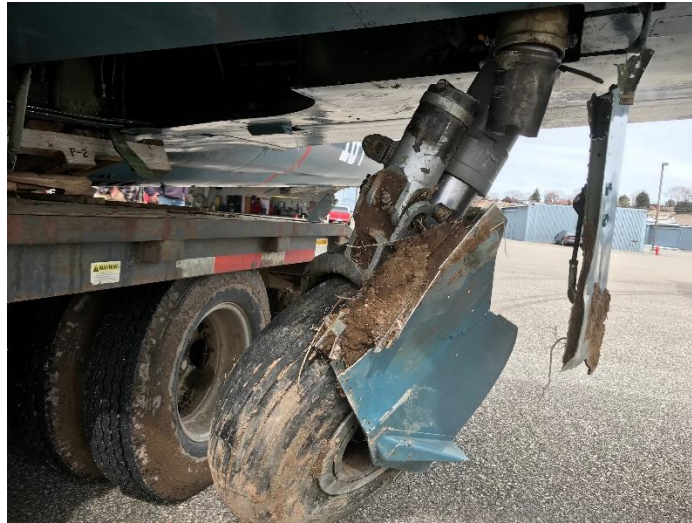
Damage to the left main previously thought to have sheared off due to impact.

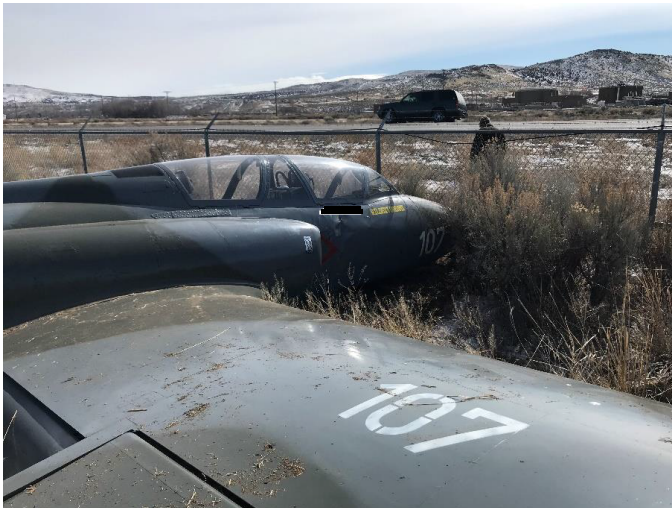
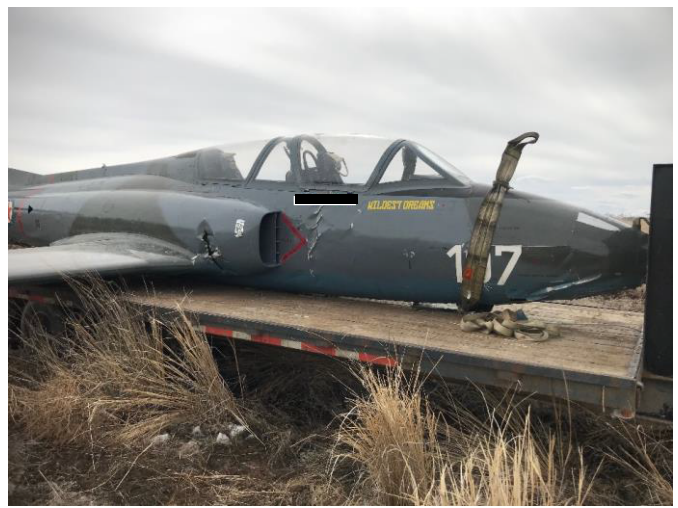
Damage from the canopy forward/engine intake sustained during accident. Damage to the engine air intake cowling sustained during aircraft recovery.

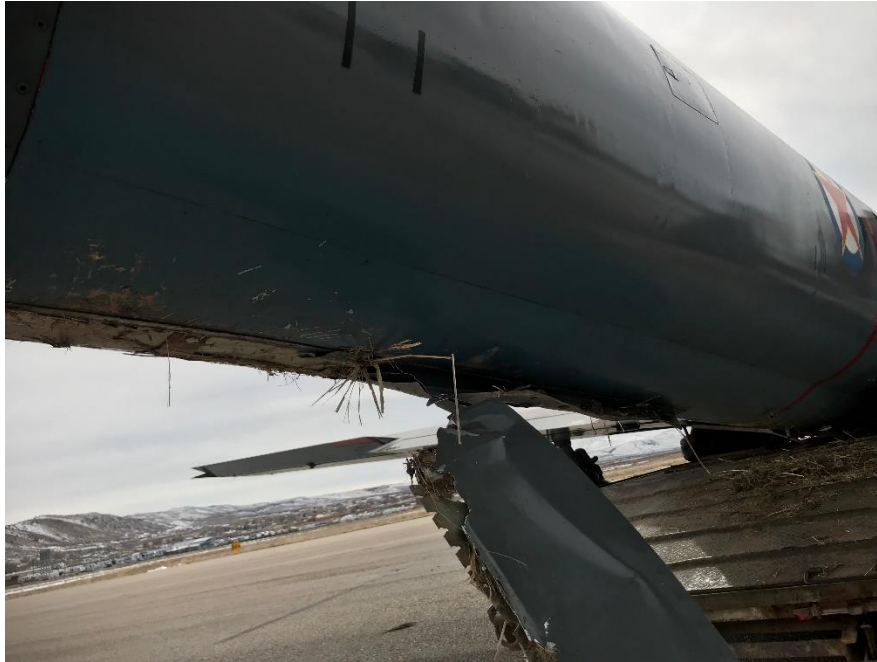
Rear under carriage fuselage damage.
