# Continental Motors

## ENGINE EXAMINATION REPORT

| ENGINE MODEL | IO-550-B (converted by Tornado Alley Turbo for turbo normalized) |
| FILE NUMBER | 17-440 |

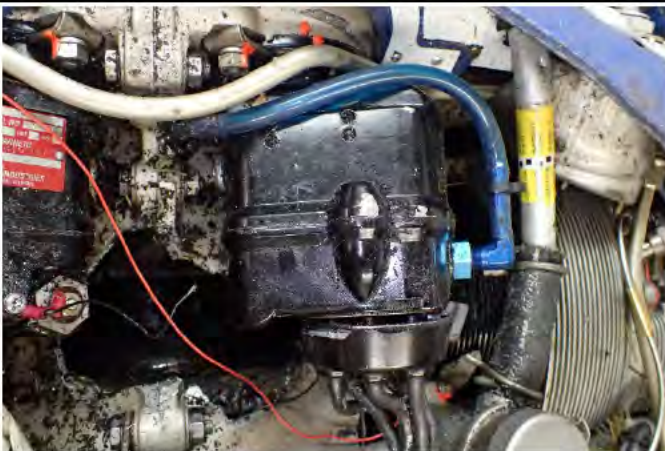
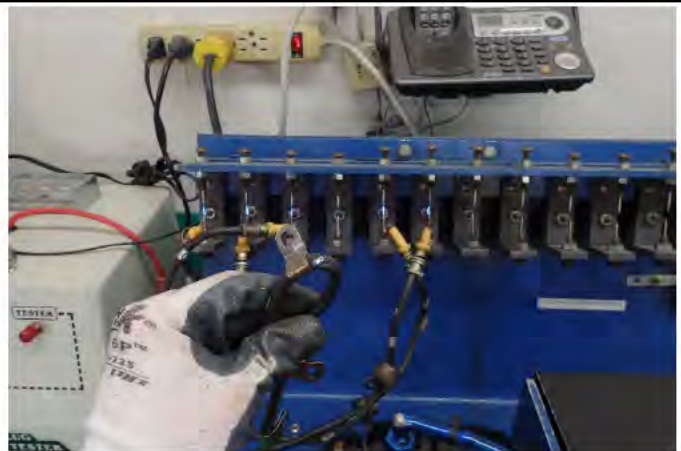
**PAGE 7 of 40****IGNITION SYSTEM****LEFT  
MAGNETO**

**Condition:** The left magneto remained attached to its installation point and displayed mechanical damage; the magneto also displayed signs of slippage on its mounting flange. The mechanical damage was concentrated to the magneto top housing and the capacitor had detached and was not located. The magneto was removed and it was noted that the drive was capable of normal rotation and the points were able to open and close. The top housing was replaced with the right magneto top housing; the magneto was then placed on a test bench. The magneto was capable of producing a spark on all six posts. There were no anomalies noted.

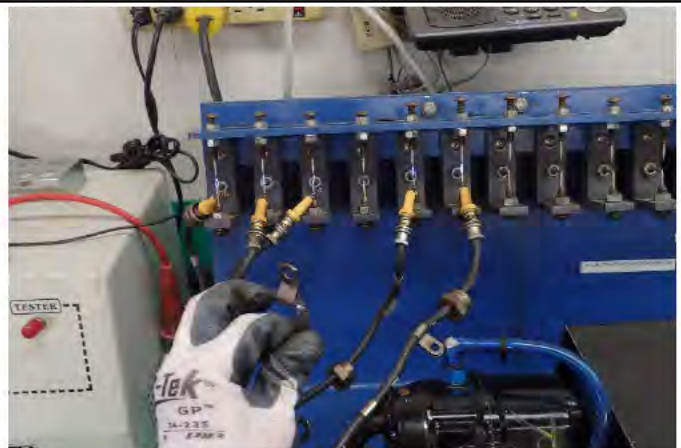
**RIGHT  
MAGNETO**

**Condition:** The magneto remained attached to its installation point and displayed minor mechanical damage. The magneto was removed and it was noted that the drive was capable of normal rotation. The magneto was placed on a test bench and it was noted that the magneto was capable of producing a spark on all six posts. The top housing was removed and the visible internal components displayed normal operating signatures. There were no anomalies noted with the magneto.

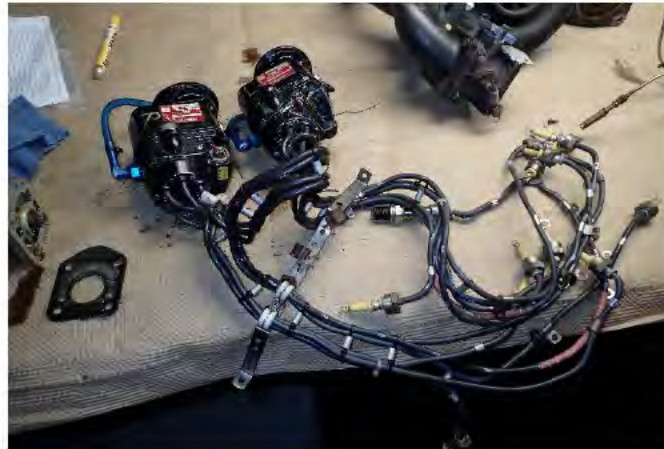
The ignition harness remained attached to both of the magnetos and to each spark plug. The ignition harness displayed impact damage signatures to several of the leads in the form of tearing. There were no anomalies noted with the ignition harness.

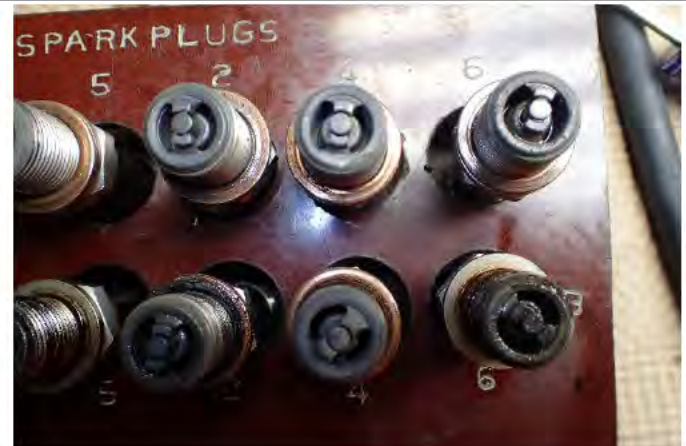
## SPARK PLUGS

All of the spark plugs remained installed in their cylinders and were undamaged. The spark plugs were removed and the electrodes were visually inspected. The electrodes displayed normal wear signatures. The #1 electrodes displayed sooting consistent with a rich mixture and the #2 and the #6 bottom spark plugs were oil soaked consistent with post-accident accumulation.

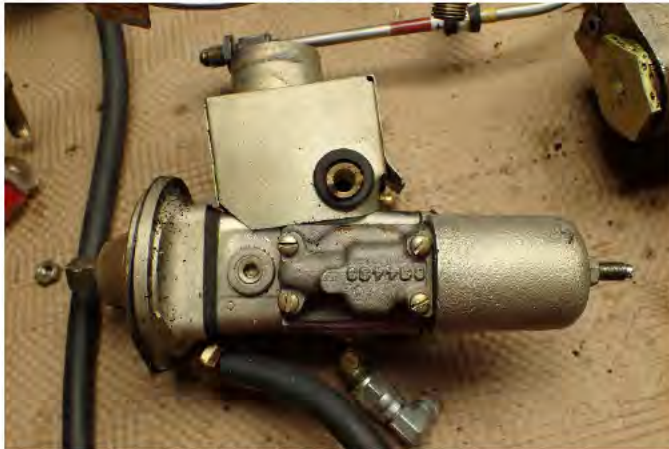
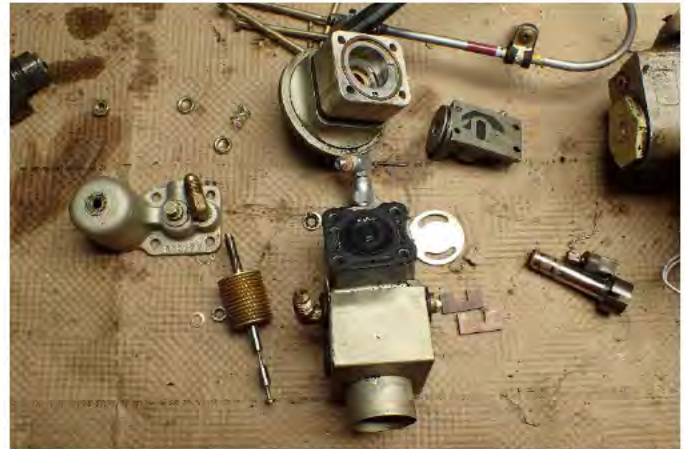
**Condition:** The fuel pump remained attached to its installation point and displayed impact damage signatures; the fuel inlet AN elbow was broken. The fuel pump was removed and it was noted that the drive coupling remained intact. The fuel pump drive was rotated by hand and it was noted that there was significant resistance to rotation. The fuel pump was disassembled and it was noted that the drive shaft displayed corrosion consistent with post-accident accumulation. The internal components displayed normal operating signatures.

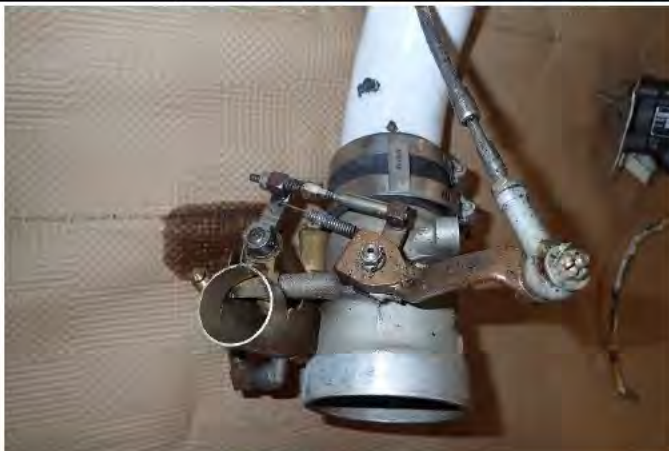
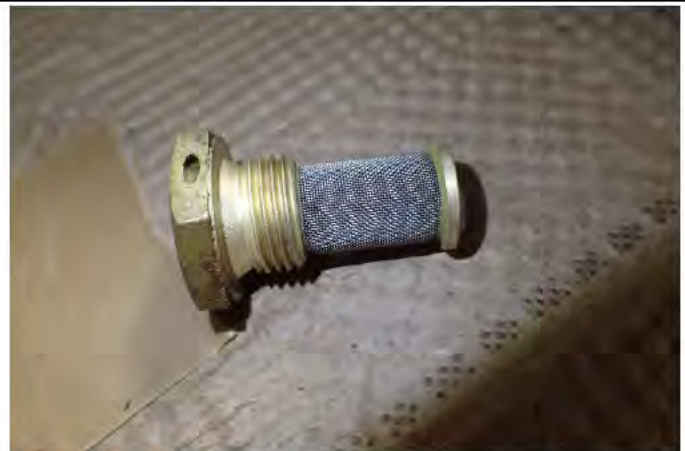
**THROTTLE  
BODY  
METERING UNIT**Manufacturer: Great  
Planes

**Condition:** The throttle and metering assembly remained intact and displayed minor impact damage signatures. Both of the control arms remained secured to their shafts and were capable of normal movement. The fuel inlet screen was removed and it was noted that it was clear of contaminants.

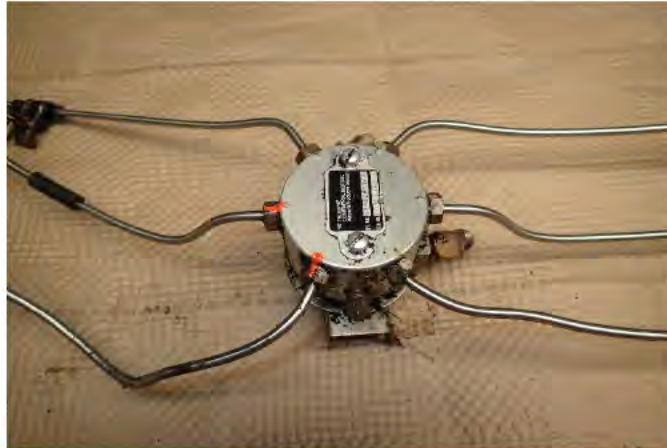
Condition: The fuel manifold valve remained intact and was undamaged. There were no signs of fuel leaks around the manifold valve. There were no anomalies noted with the manifold valve

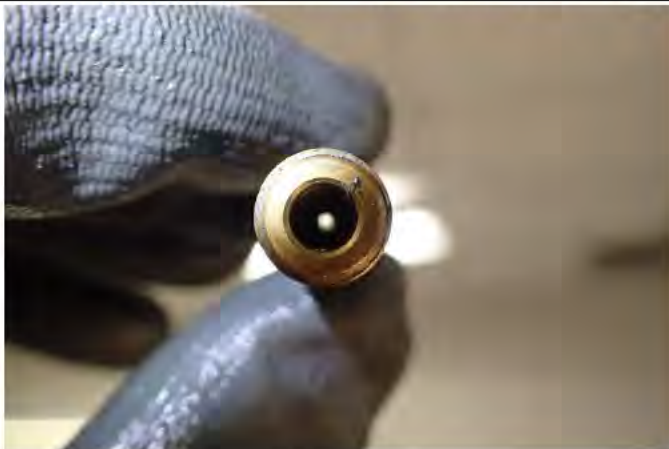
## FUEL NOZZLES AND LINES

Condition: The fuel nozzles remained intact and were undamaged. The nozzles were removed and it was noted that all of the nozzles were clear of any blockages. There were no anomalies noted with the nozzles.

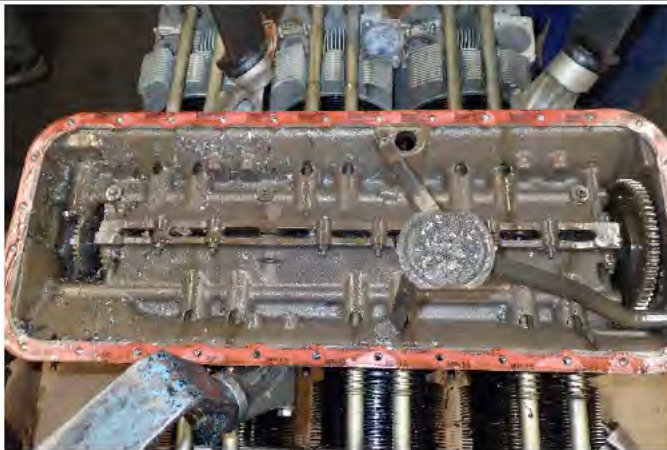
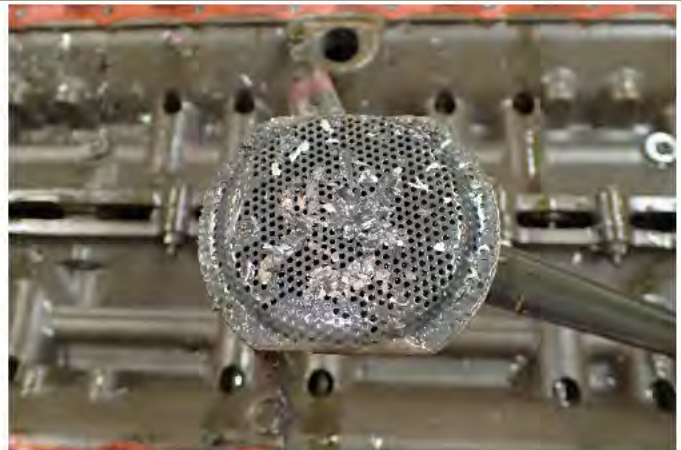
Condition: The oil sump remained attached and displayed some impact damage signatures. The oil sump was removed and it was noted that there was a significant amounts of metallic material within the sump.

Condition: The oil pick-up tube and screen remained attached to its installation point and was undamaged. The pick-up screen displayed metallic material within the screen.

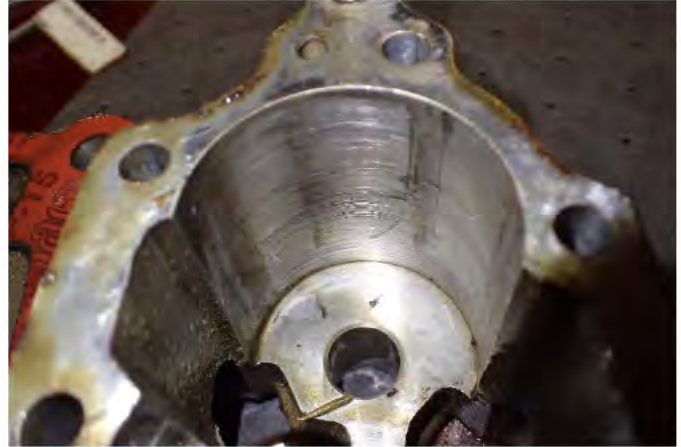
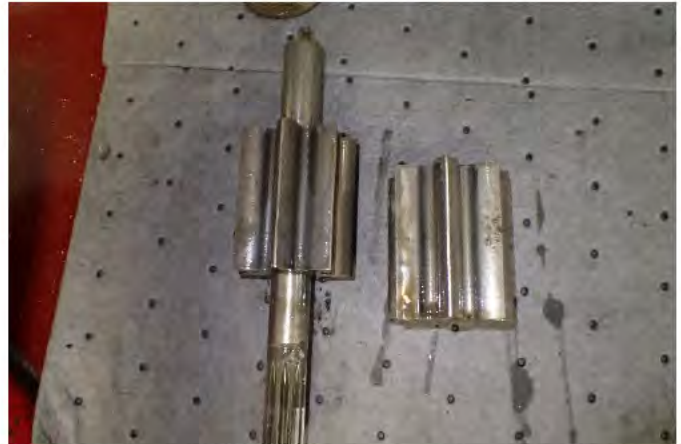
The oil pump remained attached to its installation point and was undamaged. The oil pump was removed and disassembled. The internal portion of the oil pump housing displayed scoring consistent with hard particle passage. The oil pump gears and oil pressure relief valve remained intact and displayed normal operating signatures.

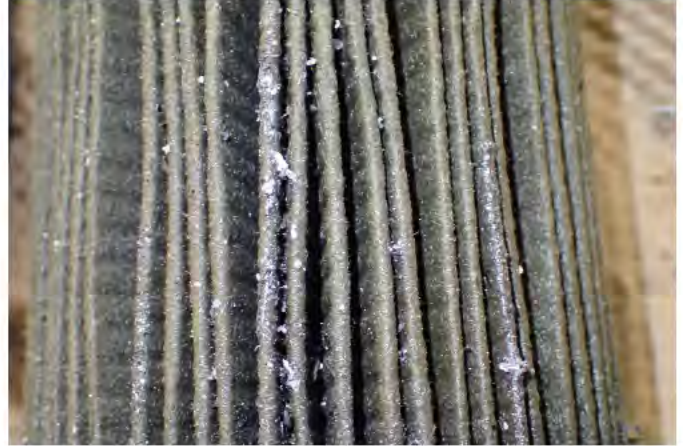
The oil filter remained attached to the oil filter adapter and was undamaged. The oil filter housing was cut open and the filter pleats were visually inspected; there was a significant amount of metallic material within the filter pleats.

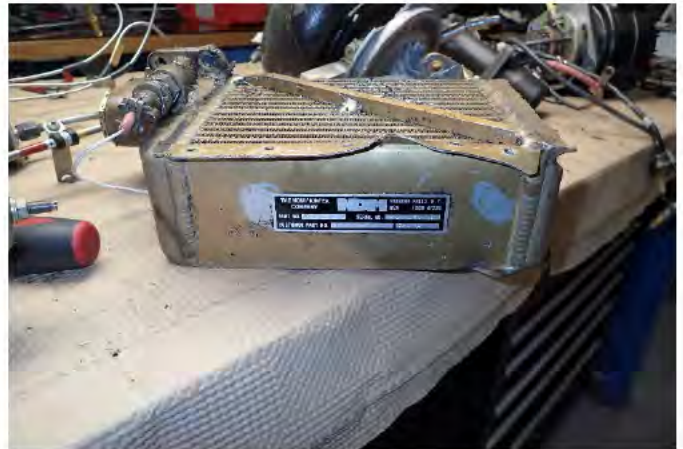
## OIL COOLER

The oil cooler remained attached to its installation point and displayed impact damage signatures. There were no anomalies noted with the oil cooler.

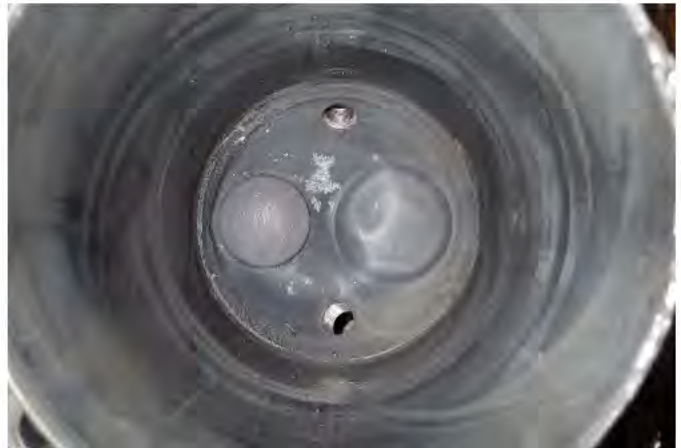
The cylinder remained attached to its cylinder bay and there wasn't any noticeable impact damage. The cylinder was removed and it was noted that the cylinder skirt displayed mechanical damage signatures. The cylinder bore and valve heads displayed normal operating and combustions signatures. The overhead components (valves, valve springs, and rocker arms) displayed normal operating and lubrication signatures.

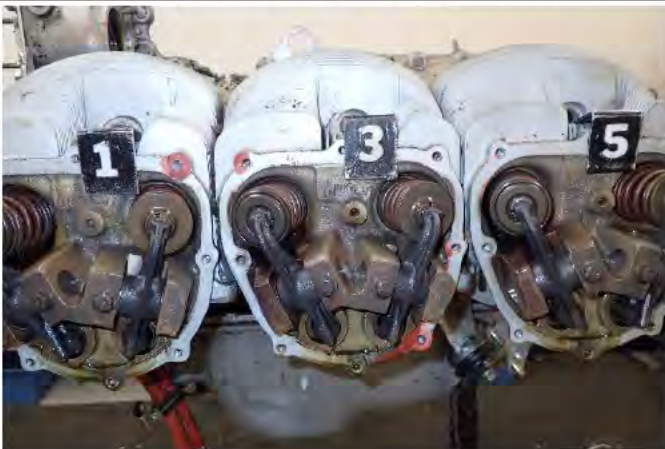
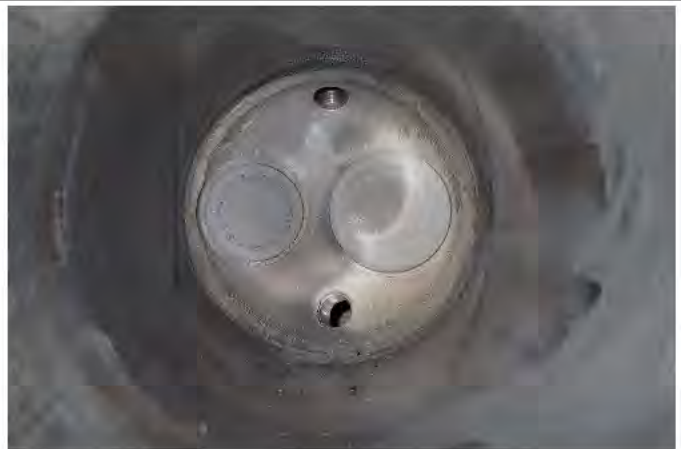
**CYLINDER #3**

The cylinder remained attached to its cylinder bay and there wasn't any noticeable impact damage. The cylinder was removed and it was noted that the cylinder skirt displayed mechanical damage signatures. The cylinder bore and valve heads displayed normal operating and combustions signatures. The overhead components (valves, valve springs, and rocker arms) displayed normal operating and lubrication signatures.

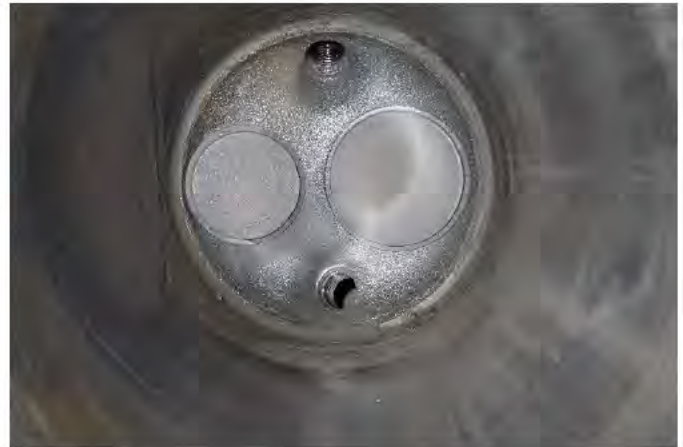
Condition: The cylinder remained attached to its cylinder bay and there wasn't any noticeable impact damage. The cylinder was removed and it was noted that the cylinder skirt displayed mechanical damage signatures. The cylinder bore and valve heads displayed normal operating and combustions signatures. The overhead components (valves, valve springs, and rocker arms) displayed normal operating and lubrication signatures.

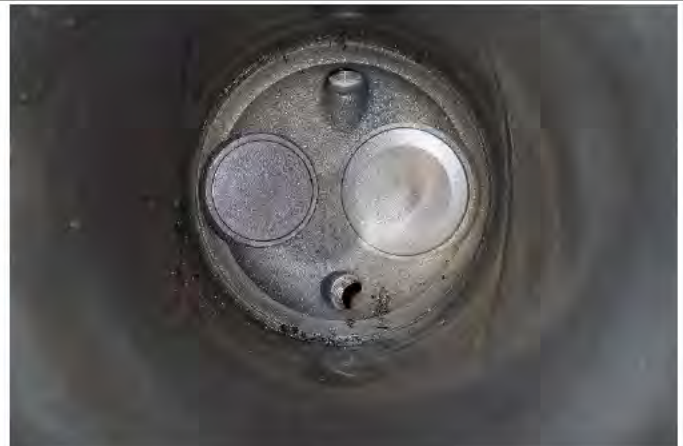
## CYLINDER #2

Condition: The cylinder remained attached to its cylinder bay and there wasn't any noticeable impact damage. The cylinder was removed and it was noted that the cylinder skirt displayed mechanical damage signatures. The cylinder bore and valve heads displayed normal operating and combustions signatures. The overhead components (valves, valve springs, and rocker arms) displayed normal operating and lubrication signatures.

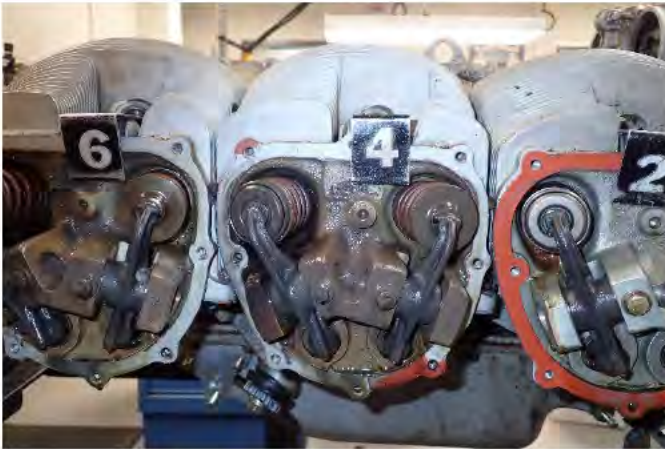
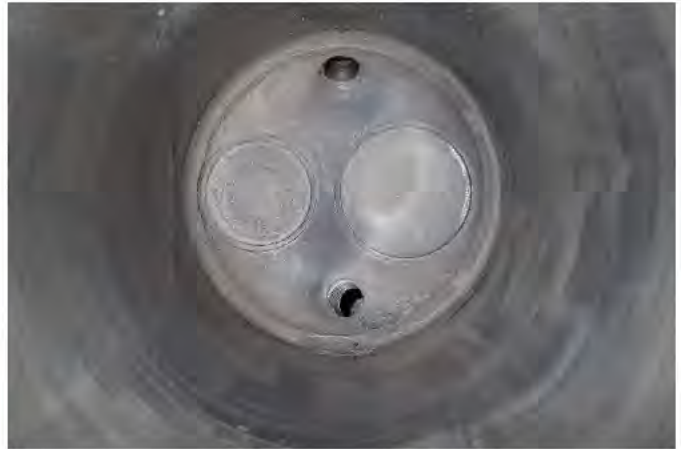
**Condition:** The cylinder remained attached to its cylinder bay and there wasn't any noticeable impact damage. The cylinder was removed and it was noted that the cylinder skirt displayed mechanical damage signatures. The cylinder bore and valve heads displayed normal operating and combustions signatures. The overhead components (valves, valve springs, and rocker arms) displayed normal operating and lubrication signatures.

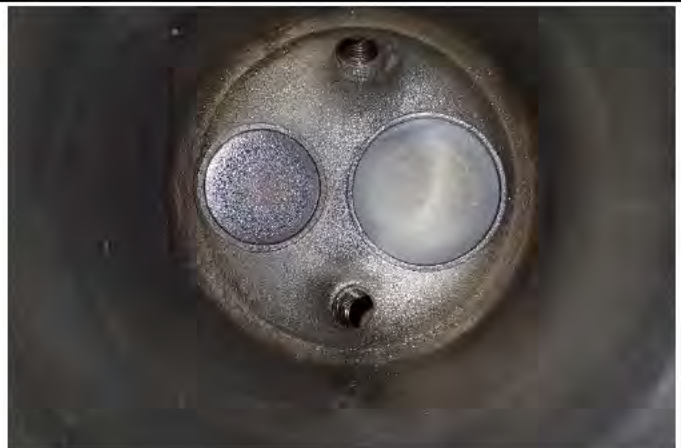
**CYLINDER #6**

**Condition:** The cylinder remained attached to its cylinder bay and there wasn't any noticeable impact damage. The cylinder was removed and it was noted that the cylinder skirt displayed mechanical damage signatures. The cylinder bore and valve heads displayed normal operating and combustions signatures. The overhead components (valves, valve springs, and rocker arms) displayed normal operating and lubrication signatures.

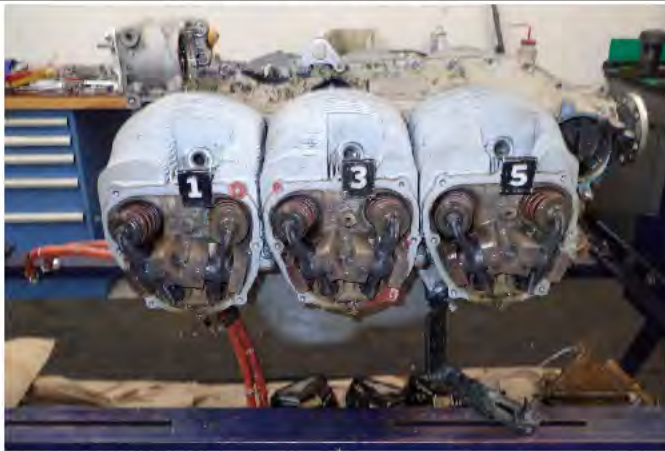
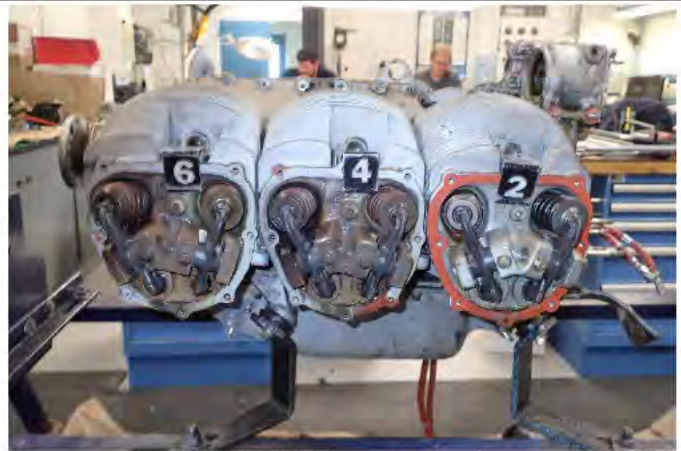
Condition: All of the valves remained intact and were undamaged. All of the valve heads displayed normal operating and combustion signatures. There were no anomalies noted with the valves.

Condition: All of the rocker arms remained intact and were undamaged. The rocker arms displayed normal operating and lubrication signatures. There were no anomalies noted with the rocker arms.

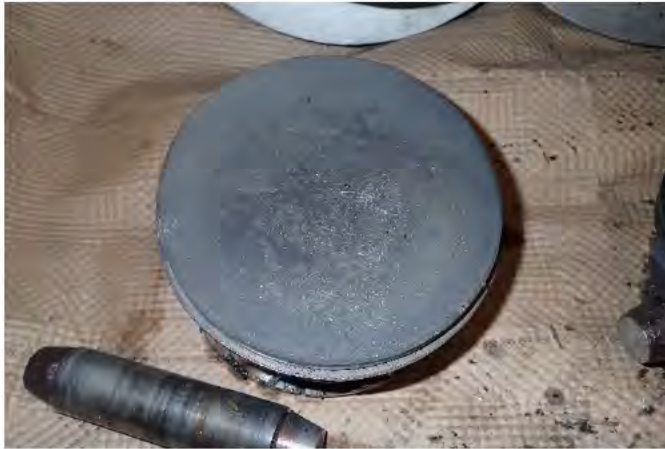
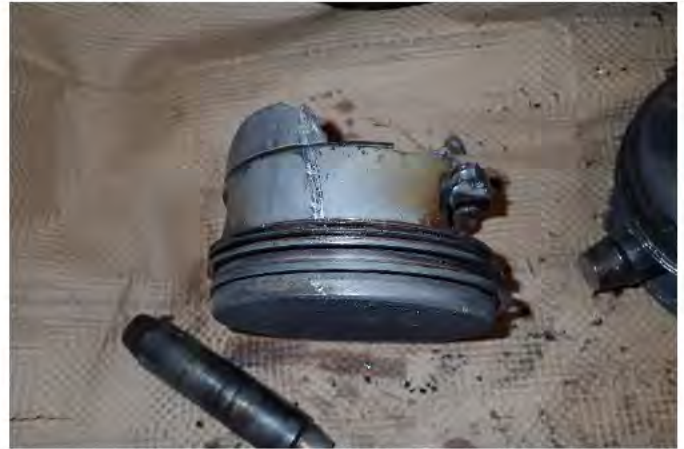
The piston remained attached to its connecting rod and displayed a significant amount of mechanical damage to the rear of the piston. The piston face displayed normal operating and combustion signatures. The rear piston ring displayed mechanical damage and was broken; the rest of the piston rings remained within their grooves and were undamaged. There were no anomalies noted with the piston.

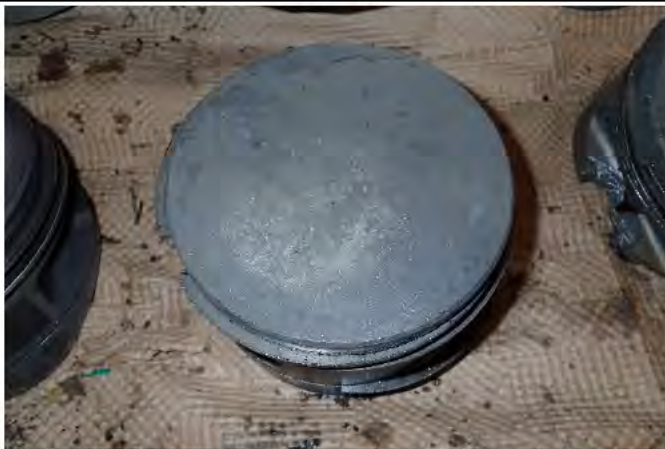
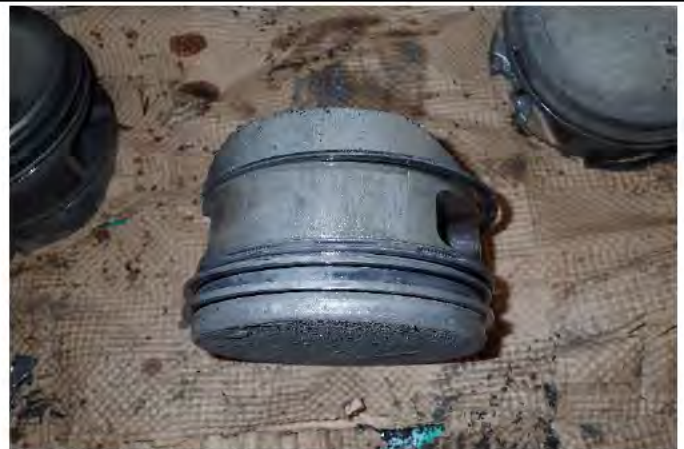
**#3 PISTON,  
RINGS AND PIN**

The piston remained attached to its connecting rod and displayed scoring along the piston skirt. The piston face displayed normal operating and combustion signatures. The piston rings remained within their grooves and displayed normal operating signatures.

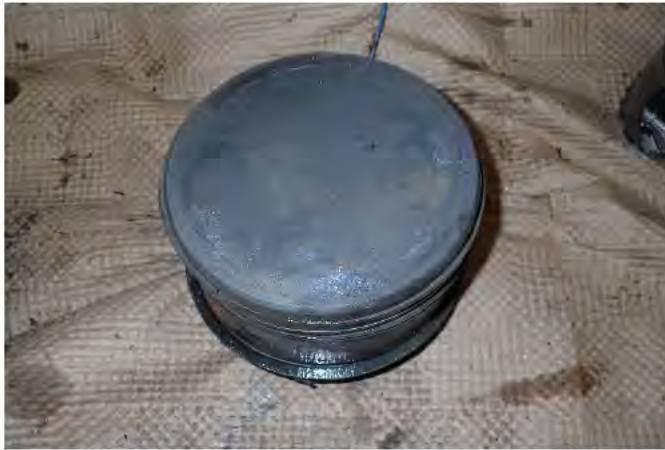
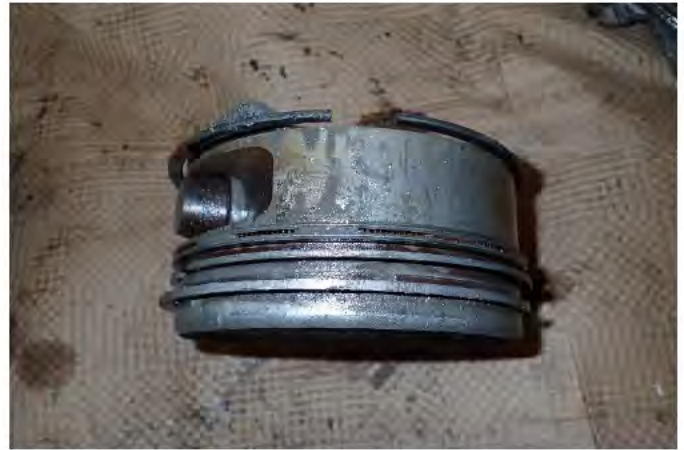
The piston remained attached to its connecting rod and displayed a significant amount of mechanical damage to the rear of the piston. The piston face displayed normal operating and combustion signatures. The rear piston ring displayed mechanical damage and was broken; the rest of the piston rings remained within their grooves and were undamaged. There were no anomalies noted with the piston.

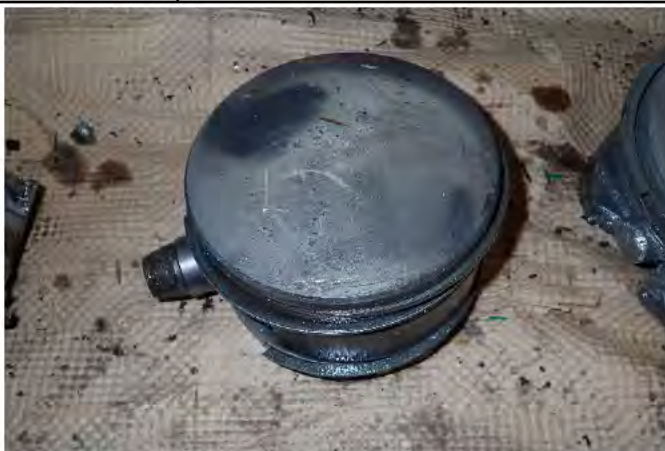
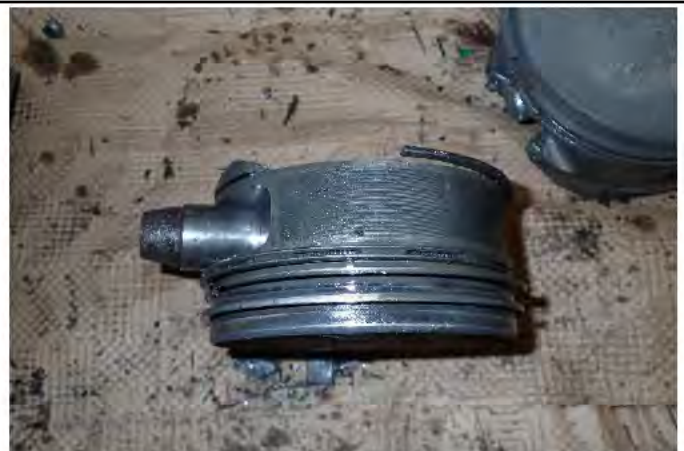
## #2 PISTON, RINGS AND PIN

The piston remained attached to its connecting rod and displayed a significant amount of mechanical damage to the rear of the piston. The piston face displayed normal operating and combustion signatures. The rear piston ring displayed mechanical damage and was broken; the rest of the piston rings remained within their grooves and were undamaged. There were no anomalies noted with the piston.

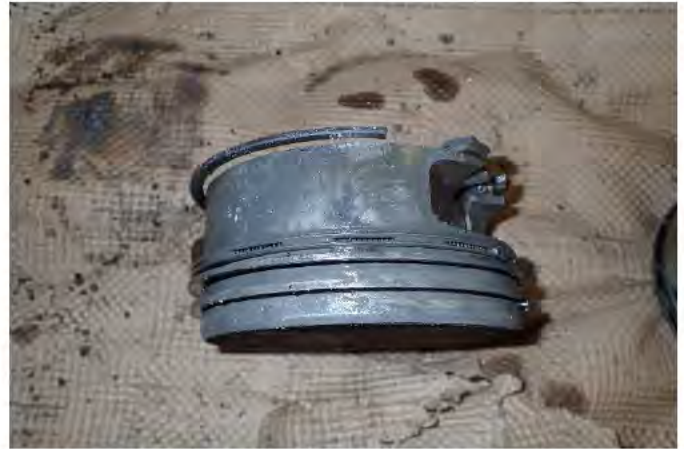
The piston remained attached to its connecting rod and displayed a significant amount of mechanical damage to the rear of the piston. The piston face displayed semicircular indentations consistent with valve strikes; there were no signs of detonation or preignition. The rear piston ring displayed mechanical damage and was broken; the rest of the piston rings remained within their grooves and were undamaged. There were no anomalies noted with the piston.

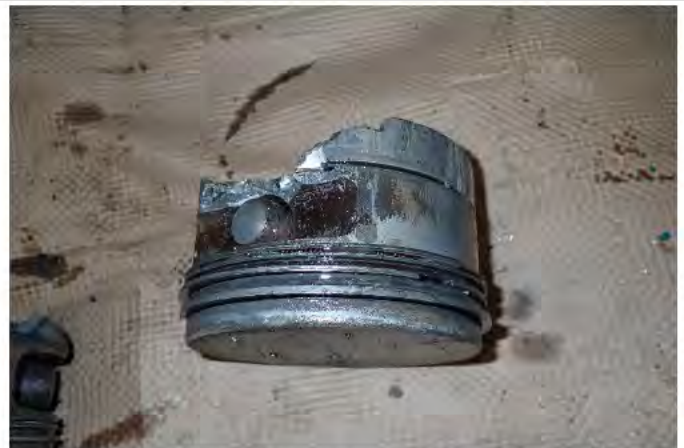
**#6 PISTON,  
RINGS AND PIN**

The piston remained attached to its connecting rod and displayed a significant amount of mechanical damage to the rear of the piston. The piston face displayed normal operating and combustion signatures. The rear piston ring displayed mechanical damage and was broken; the rest of the piston rings remained within their grooves and were undamaged. There were no anomalies noted with the piston.

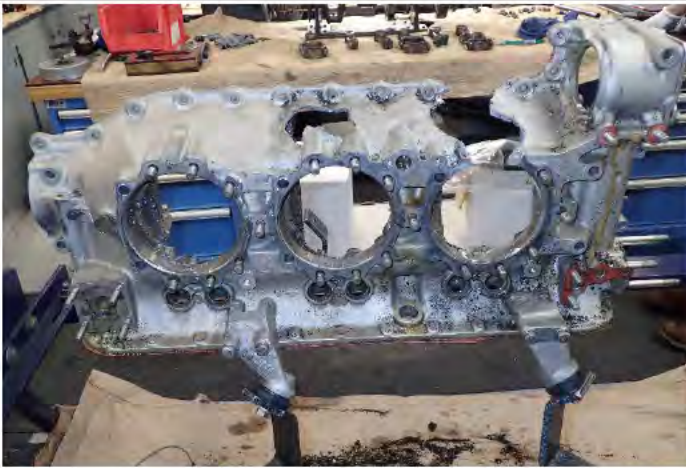
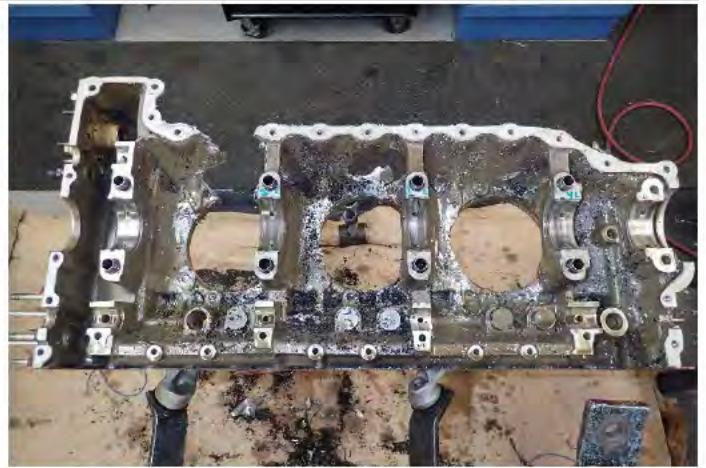
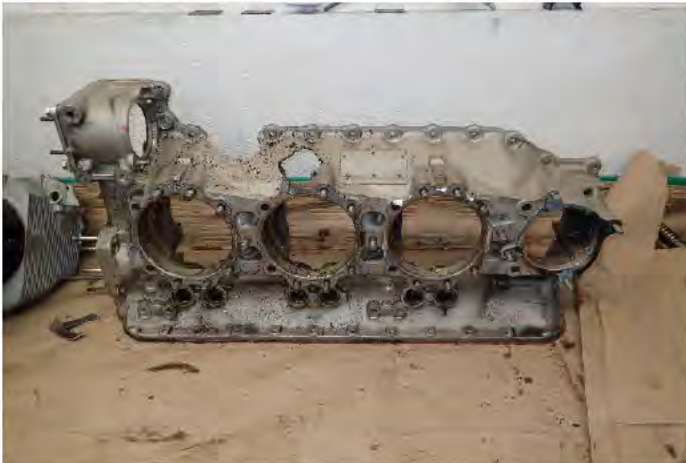
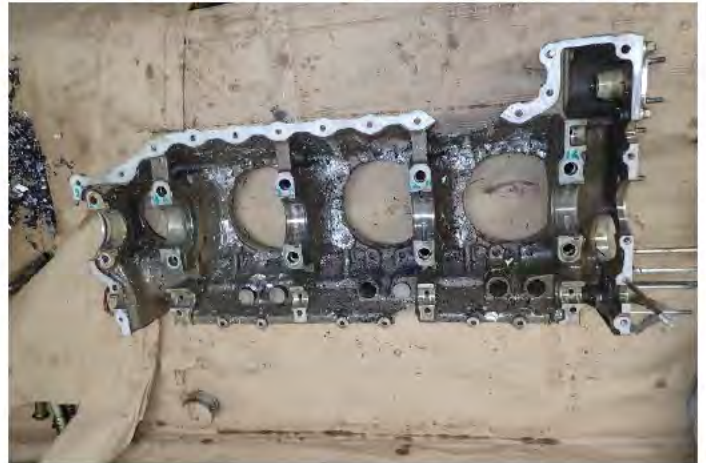
The crankcase displayed two large holes in the top of the crankcase consistent with an internal engine failure. The crankcase halves were removed and the internal portions of the crankcase were visually inspected. The internal crankcase displayed mechanical damage to several locations. The bearing supports displayed normal operating signatures and there were no signs of fretting or bearing shift. It was noted that there was a coating of grey sealant material consistent with silicon sealant applied to the crankcase backbone mating surfaces.

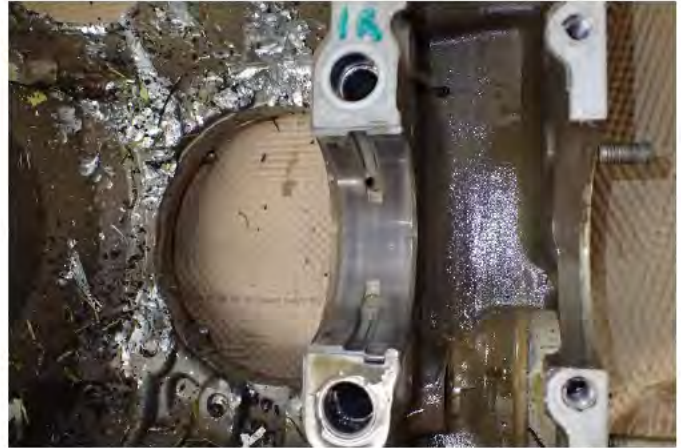
The bearings remained within the bearing supports and there were no signs of bearing shift. The bearings displayed normal operating and lubrication signatures.

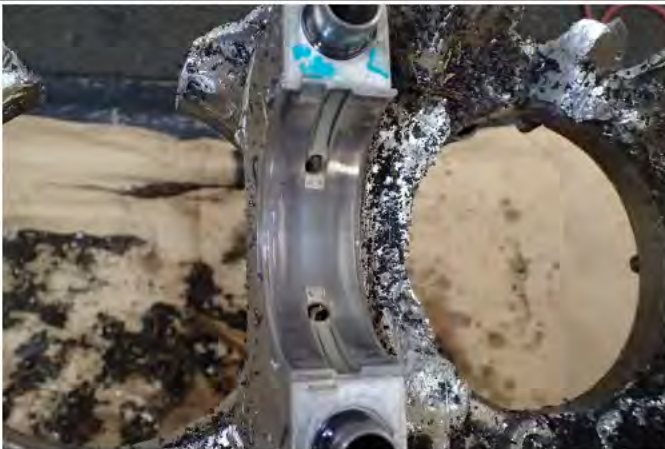
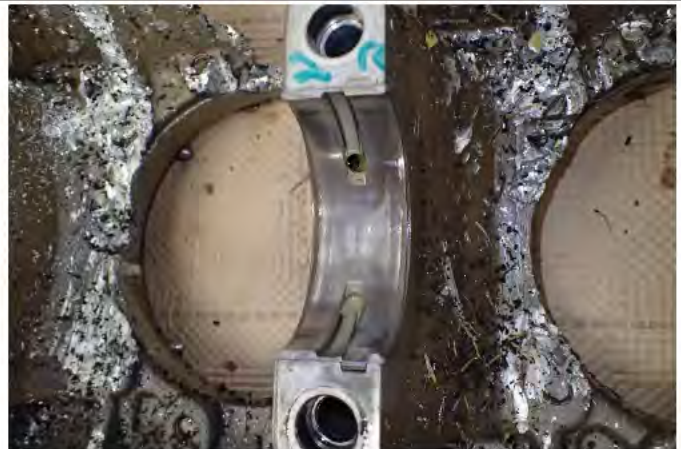
## #2 MAIN BEARINGS

The bearings remained within the bearing supports and there were no signs of bearing shift. The bearings displayed normal operating and lubrication signatures.

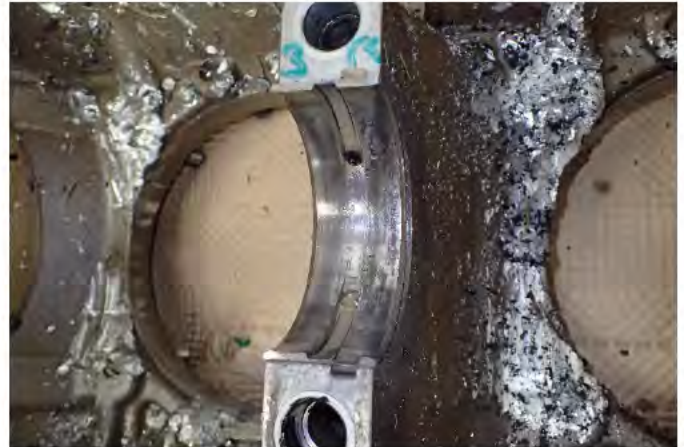
The bearings remained within the bearing supports and there were no signs of bearing shift. The bearings displayed smearing and damage consistent with lubrication distress.

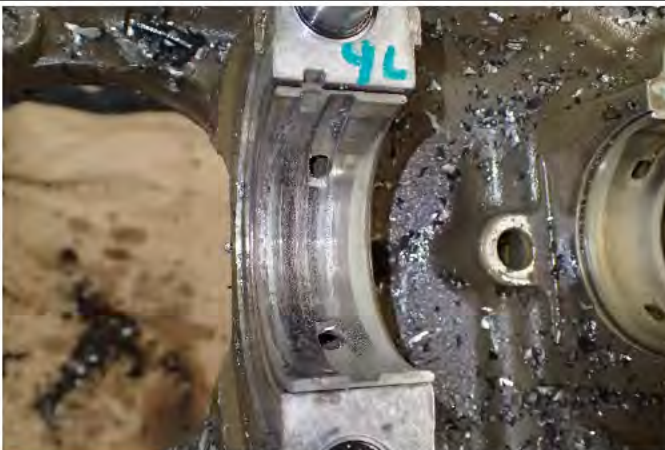
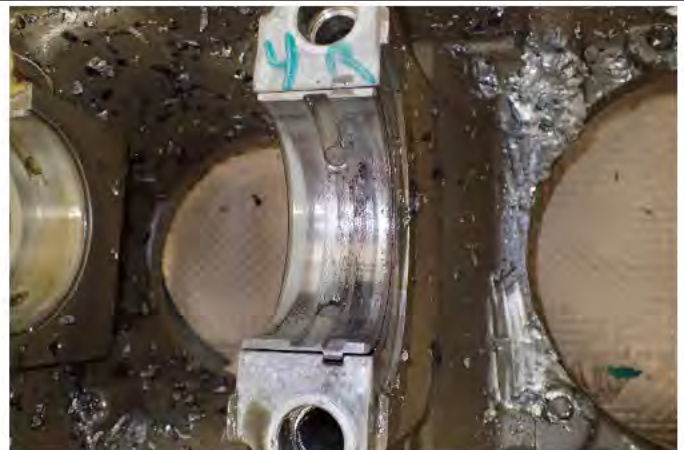
## #4 MAIN BEARINGS

The bearings remained within the bearing supports and there were no signs of bearing shift. The bearings displayed smearing and damage consistent with lubrication distress.

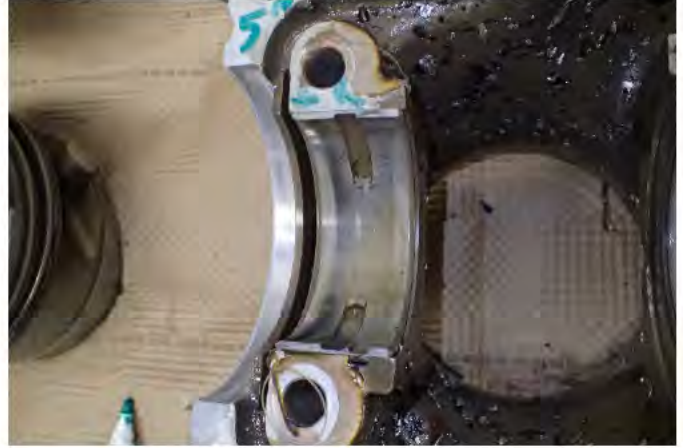
The bearings remained within the bearing supports and there were no signs of bearing shift. The bearings displayed normal operating and lubrication signatures.

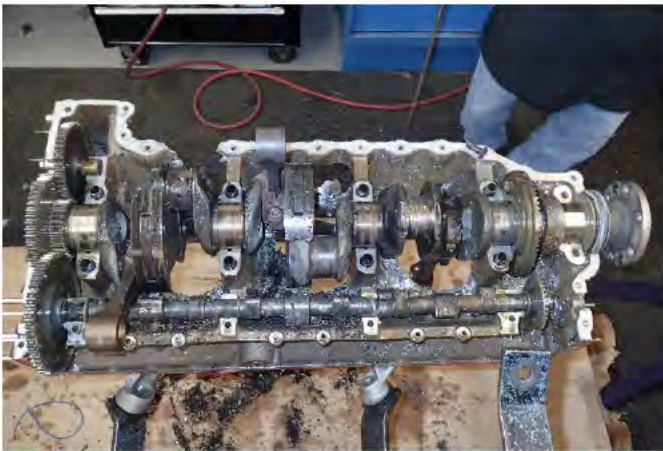
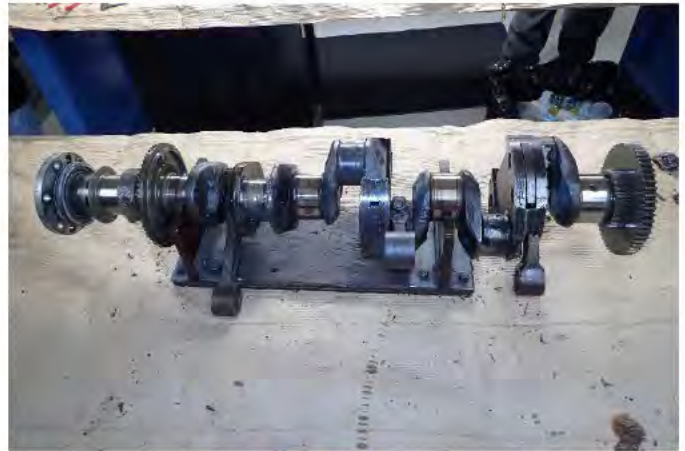
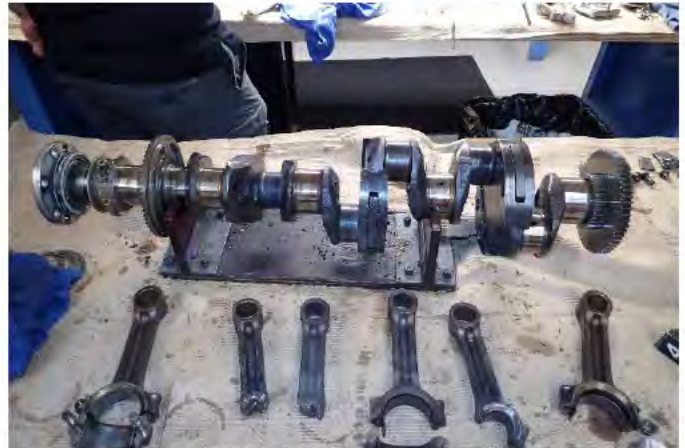
The crankshaft remained intact and there were no signs of impact damage signatures. The main bearing journals displayed normal operating signatures. The #1 and the #6 connecting rod journals displayed normal operating signatures. The #2, #3, #4, and the #5 connecting rod journals displayed thermal damage signatures consistent with lack of lubrication; the #4 and the #5 connecting rod journals displayed mechanical damage. The #4 connecting rod oil galley was blocked with redeposited metal. The rest of the oil galleries were clear of any blockages. The crankshaft gear remained intact and was undamaged.

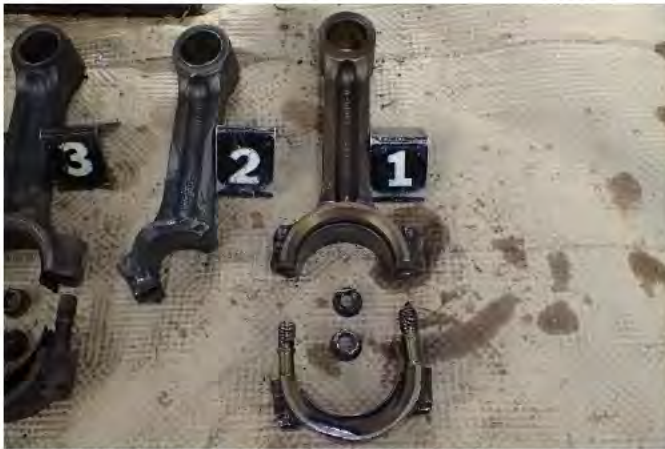
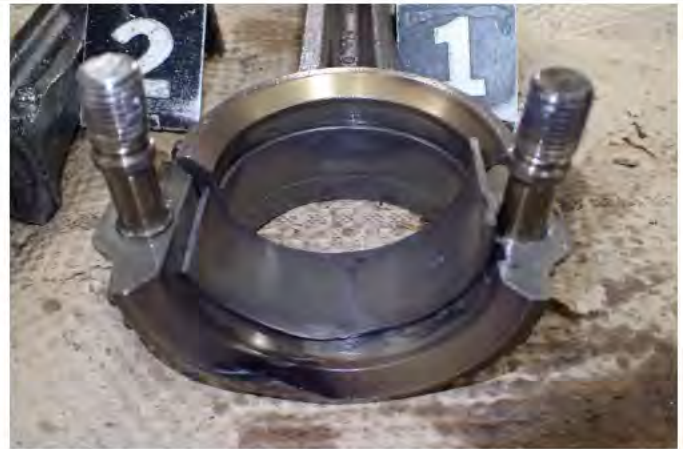
Condition: The connecting rod remained attached to its journal and to the piston pin. The connecting rod displayed mechanical damage to the connecting rod cap; the rod also displayed normal operating signatures. There were no anomalies noted with the connecting rod.

Condition: The bearings remained within the bearing supports and displayed mechanical damage signatures. The bearings displayed the initial signatures of lubrication distress.

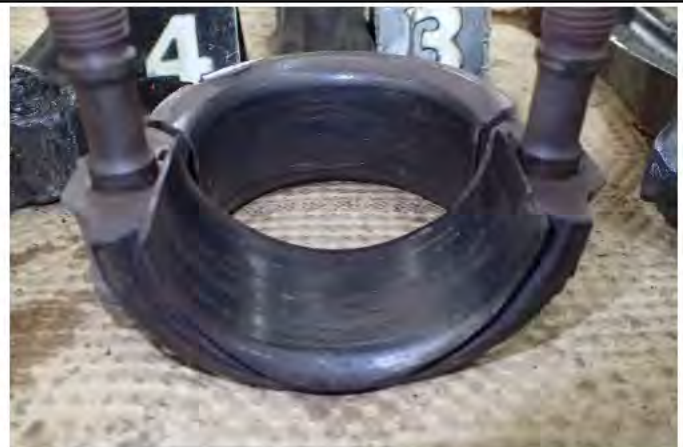
## #3 CONNECTING ROD

Condition: The connecting rod remained attached to its connecting rod journal and to its piston pin. The connecting rod displayed thermal discoloration consistent with lubrication distress.

Condition: The bearings remained within the bearing supports and displayed significant amount of damage consistent with lack of lubrication; the bearing surfaces were smeared and the bearings were slightly extruded.

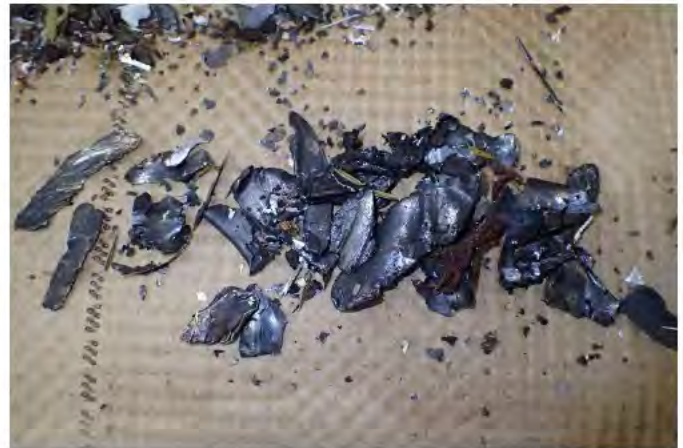
Condition: The connecting rod had released from its journal and remained attached to its piston pin. The connecting rod displayed a significant amount of thermal damage consistent with lubrication distress as well as mechanical damage.

Condition: Small portions of bearing material were located within the oil sump. The located bearing material displayed significant thermal damage signatures consistent with lubrication distress.

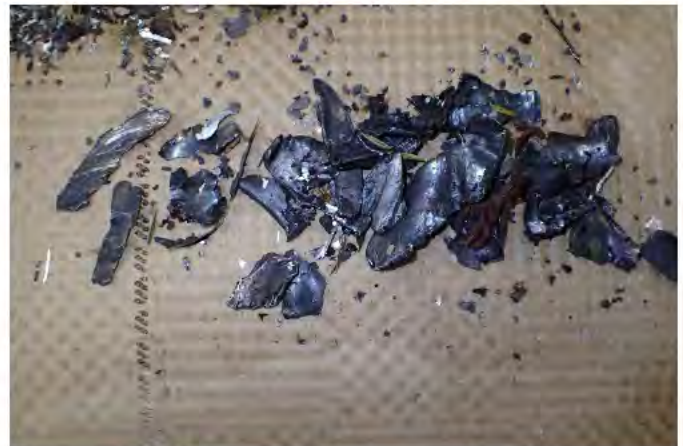
## #2 CONNECTING ROD

Condition: The connecting rod had released from its journal and remained attached to its piston pin. The connecting rod displayed a significant amount of thermal damage consistent with lubrication distress as well as mechanical damage.

Condition: Small portions of bearing material were located within the oil sump. The located bearing material displayed significant thermal damage signatures consistent with lubrication distress.

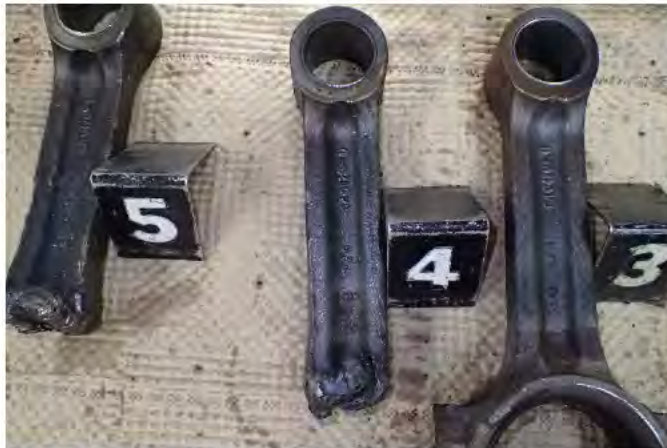
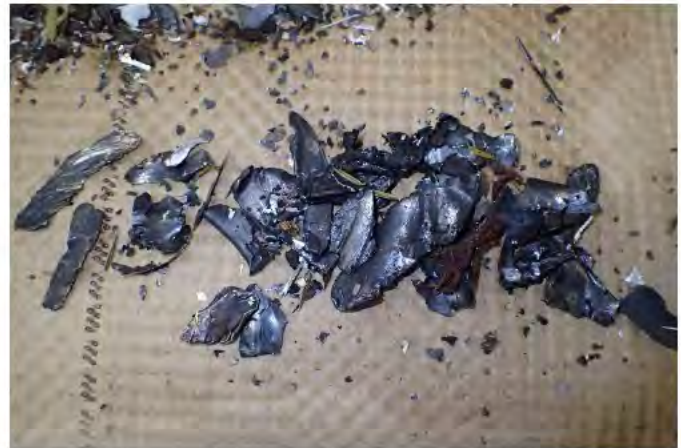
The connecting rod had released from its journal and remained attached to its piston pin. The connecting rod displayed a significant amount of thermal damage consistent with lubrication distress as well as mechanical damage.

Small portions of bearing material were located within the oil sump. The located bearing material displayed significant thermal damage signatures consistent with lubrication distress.

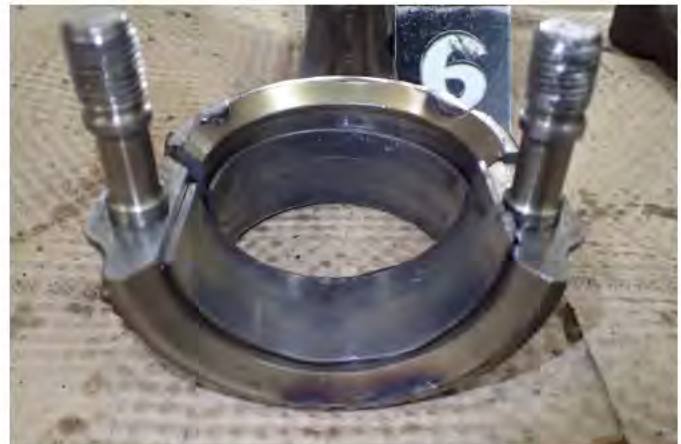
## #6 CONNECTING ROD

The connecting rod remained attached to its journal and to its piston pin. The connecting rod displayed mechanical damage signatures as well as normal operating signatures. There were no anomalies noted with the connecting rod.

The bearings remained within the bearing supports and displayed minor mechanical damage signatures. The bearings displayed the initial stages of lubrication distress.

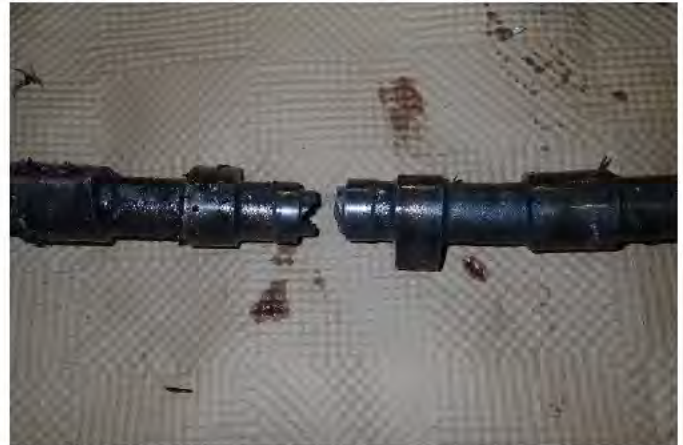
The camshaft displayed significant mechanical damage and was broken into two pieces. The fracture was at the #3 camshaft journal; the forward portion of the camshaft displayed bending and impact marks and the damage corresponded with the same area as the released #5 connecting rod.

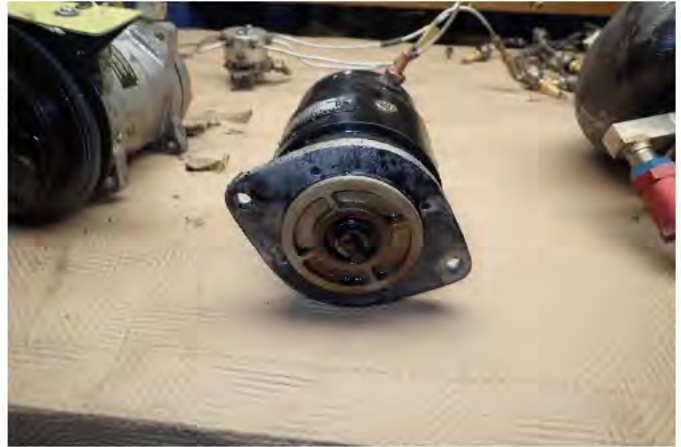
The starter remained attached to its installation point and was undamaged. There were no anomalies noted with the starter.
