# Continental Motors

## ENGINE EXAMINATION REPORT

| ENGINE MODEL | IO-550-B (converted by Tornado Alley Turbo for turbo normalized) |
| FILE NUMBER | 17-440 |

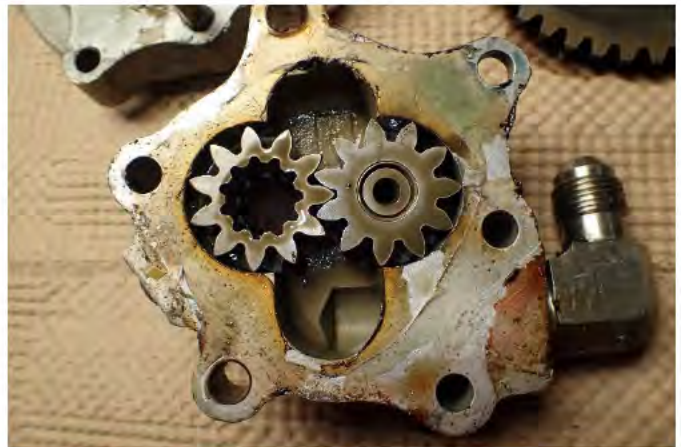
**STARTER ADAPTER**

The starter adapter remained attached to its installation point and was undamaged. The starter adapter was removed and was partially disassembled to view the scavenge pump. The scavenge pump displayed normal operating signatures. There were no anomalies noted.

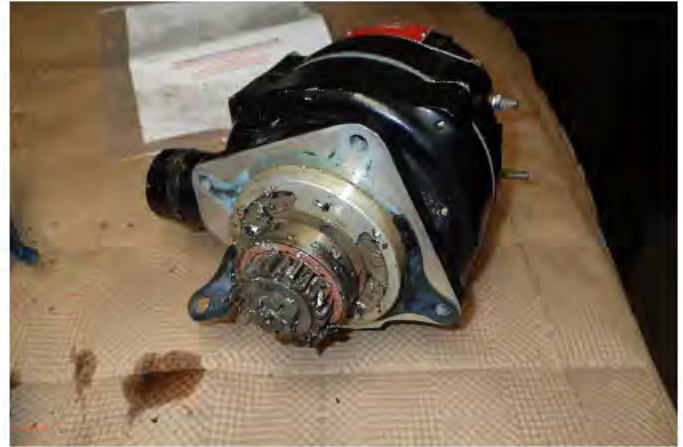
The alternator remained attached to its installation point and was undamaged. The alternator was removed and it was noted that the drive coupling remained intact. There were no signs of oil leaks around the alternator. There were no anomalies noted with the alternator.

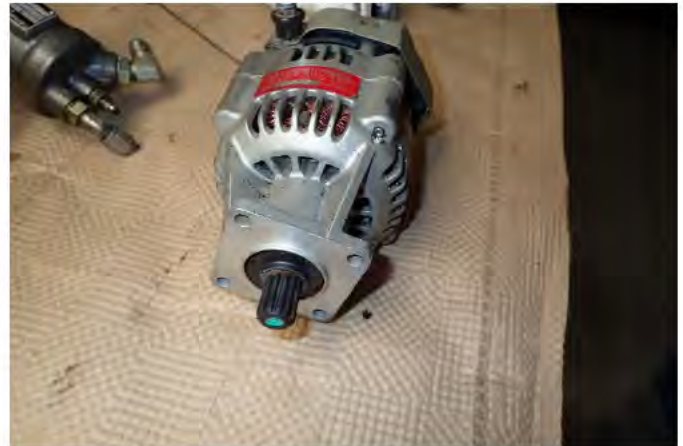
## STANDBY ALTERNATOR

The standby alternator remained attached to its installation point and was undamaged. There were no oil leaks noted around the alternator installation point. There were no anomalies noted with the alternator.

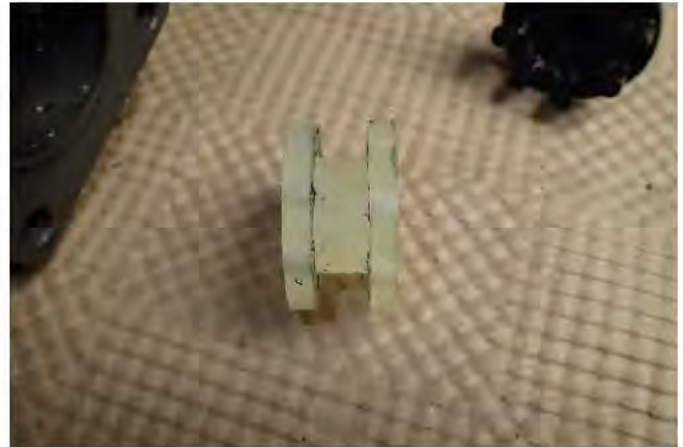
The vacuum pump remained attached to its installation point and displayed minor impact damage signatures. The vacuum pump was removed and it was noted that the vacuum pump was capable of normal rotation and the drive coupling was intact. There were no signs of oil leaks around the vacuum pump.

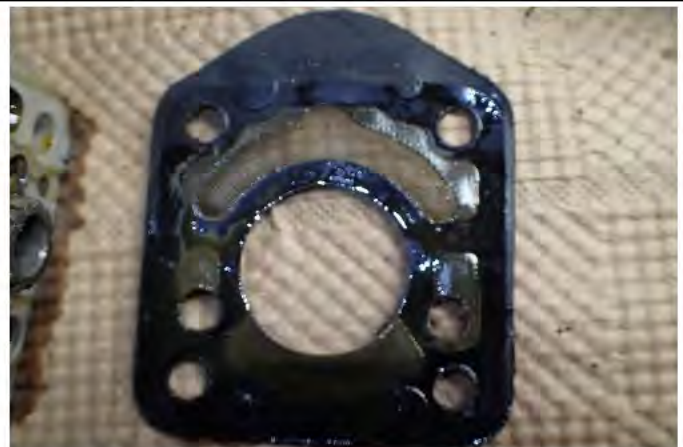
**PROPELLER  
GOVERNOR**

The propeller governor remained attached to its installation point and was undamaged. The governor was removed; it was noted that the drive coupling remained intact and the gasket screen was not blocked. The governor was disassembled and it was noted that all of the internal components displayed normal operating signatures.

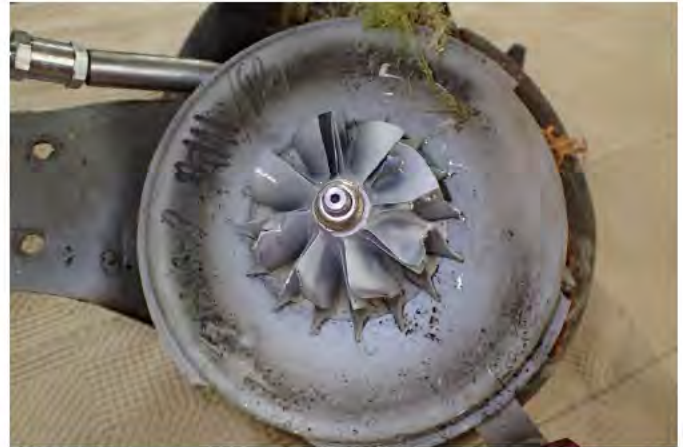
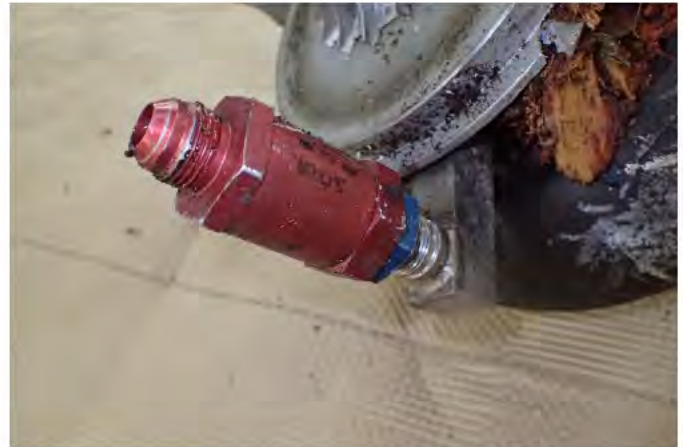
**Condition:** The turbocharger had been removed by the recovery personnel to facilitate shipping. The turbocharger displayed some impact damage signatures. The turbine and compressor wheels were capable of normal rotation and displayed normal operating signatures. According to the Textron Aviation investigator the oil line B-nut attached to the scavenge pump check valve was found loose during the initial examination at the salvage facility.

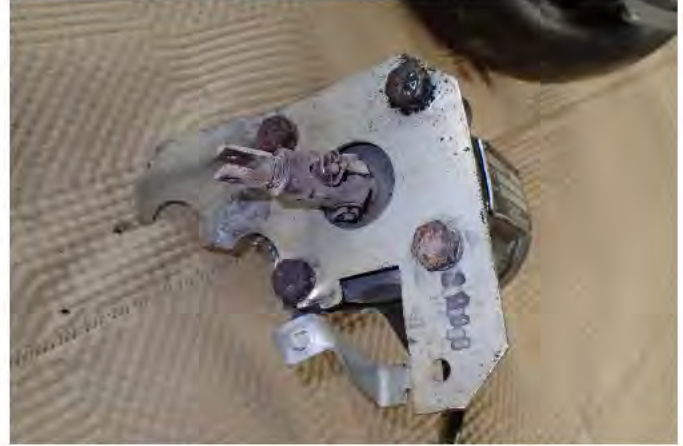
The wastegate had broken free from its installation point and displayed impact damage signatures. There were no anomalies noted with the wastegate.
