## Air Safety Investigations Aircraft Incident/Accident Technical Report

| Aircraft Incident/<br>Accident Information | Year: 2003 | Make: Beechcraft | Model: A36 |
| | Serial number: E-3503 | | Registration: N207PC |
| Senior Air Safety Investigator: Henry J. Soderlund | | Report #: ASI-18-AT-T | Report date: 08-20-18 |

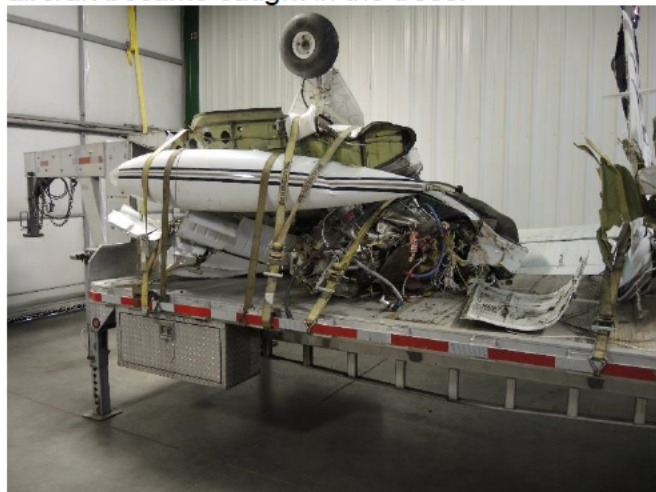
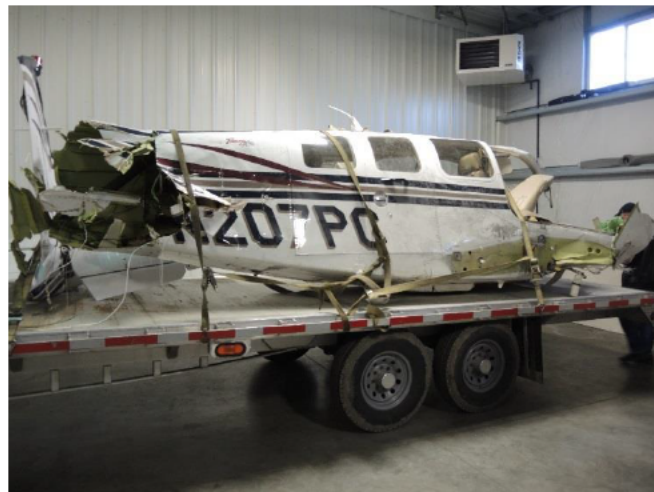
The aircraft reportedly impacted trees followed by terrain. During the impact sequence parts of the aircraft became caught in the trees.

Aircraft at storage facility.

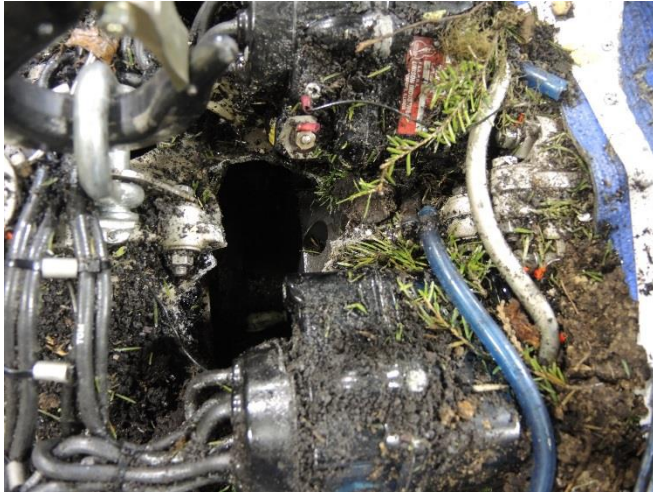
Three holes were observed in the top of the crankcase; one between the number 1 and 2 cylinders, one over the number 3 cylinder and one over the number 4 cylinder. The number 2 and 4 connecting rods were found separated from the crankshaft.

Hole in crankcase between cylinders 1 and 2

During the examination of the engine at the manufacturer's facility several bearings displayed lubrication distress. Connecting rods 2, 4, and 5 had separated from the crankshaft. Evidence of metal passage was observed inside the oil pump.

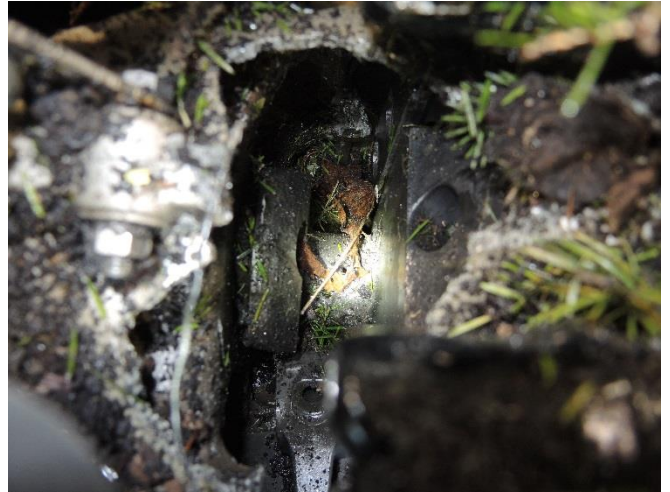
Crankshaft journal for cylinder 2 without connecting rod attached

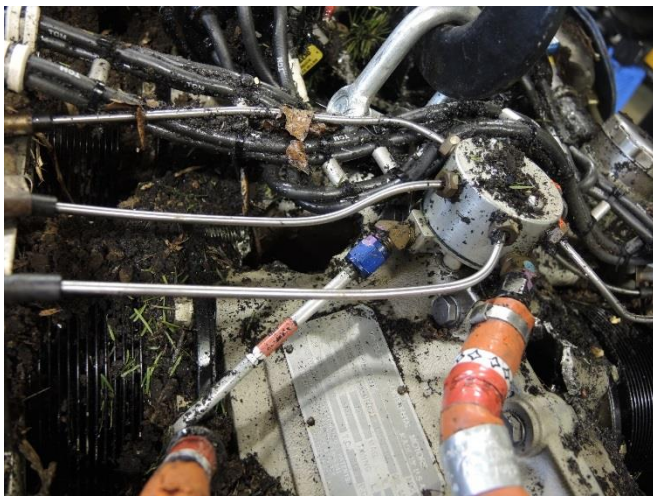
Hole over cylinder 3

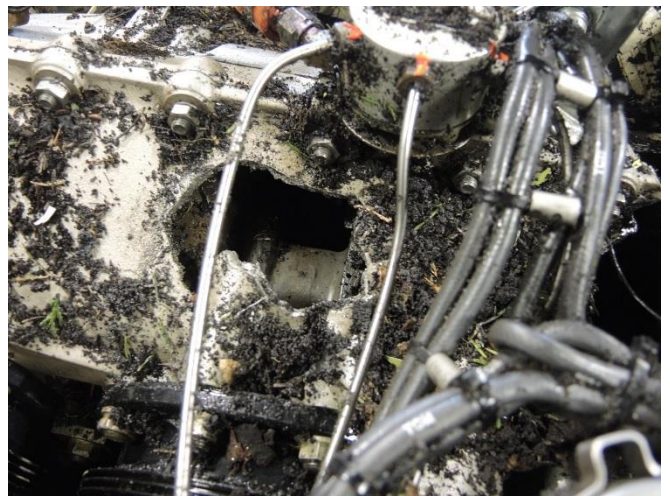
Hole over cylinder 4 showing crankshaft journal for cylinder 4 without connecting rod attached.

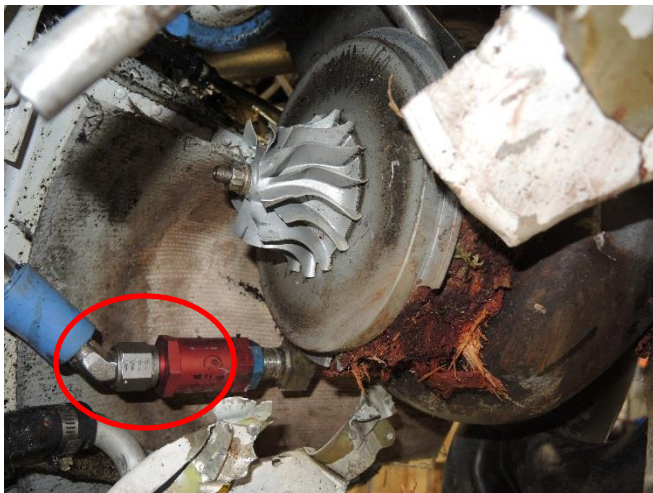
The turbocharger oil drain line from the check valve to scavenge pump was found hand tight at the check valve connection (circled above).
