NATIONAL TRANSPORTATION SAFETY BOARD  
Office of Aviation Safety  
Western Pacific Region

EXAMINATION REPORT

WPR12LA102

Location: Ogden, Utah  
Date: March 5, 2018  
Aircraft: Experimental MAC Cub, N669WH, Serial Number: 001  
NTSB IIC: Tealeye Cornejo

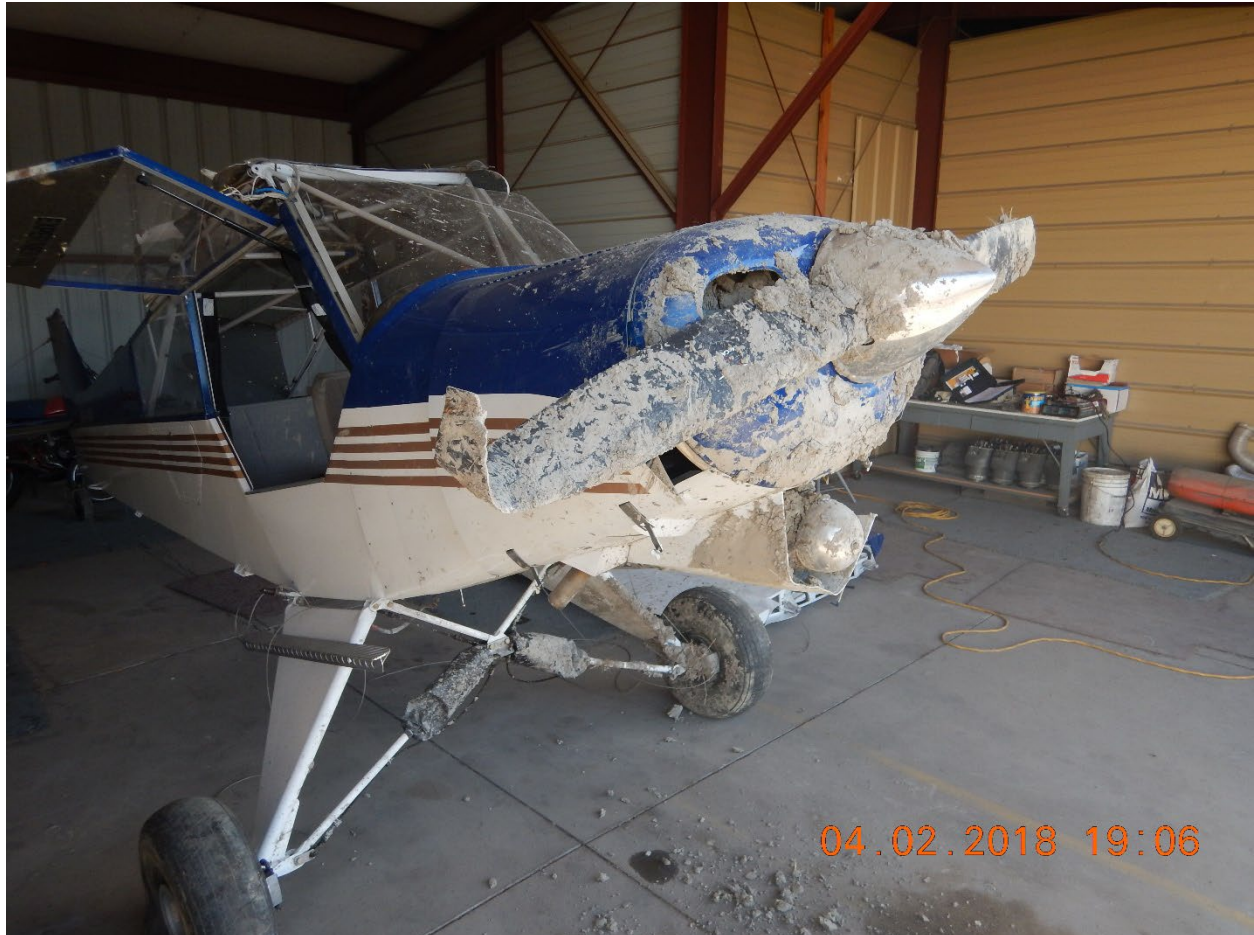
Photo 1 - View of Airplane in Hangar (Photo Courtesy of NTSB)

The engine was examined at the Skypark Airport at the pilot's hangar. The wings had been removed to facilitate the recovery. The air intake filter exhibited evidence of impact damage.

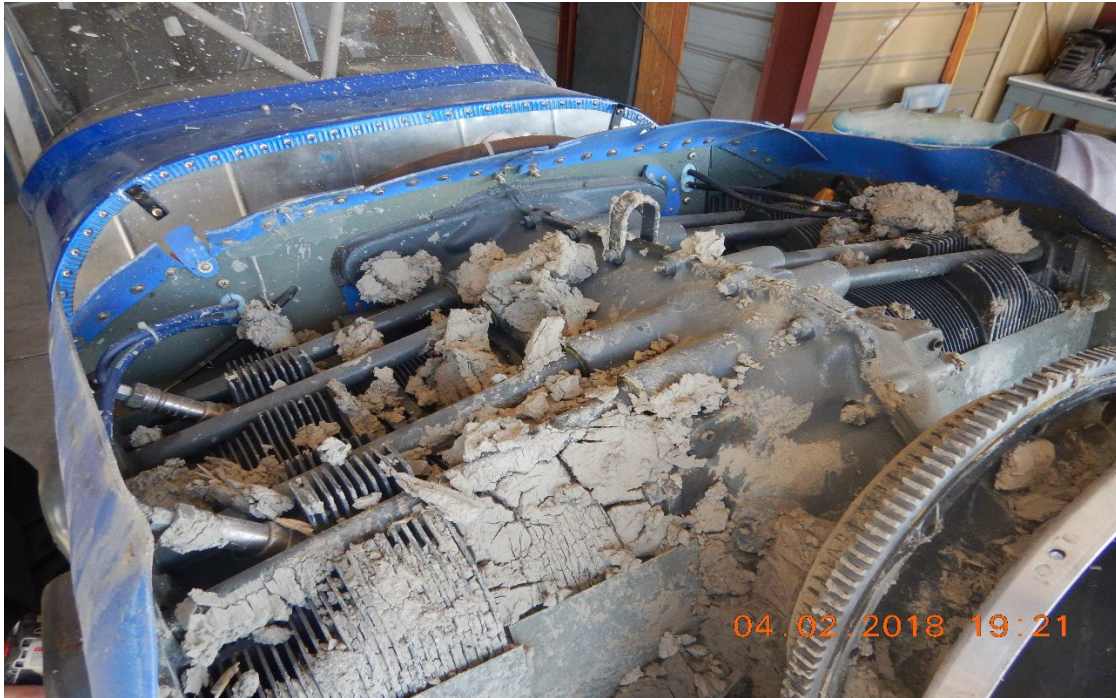
Photo 2 - View of Engine (Photo Courtesy of NTSB)

The engine cowling was removed. The rocker box covers, and top spark plugs were also removed. A borescope was used to examine all four-cylinder barrels with no anomalies noted.

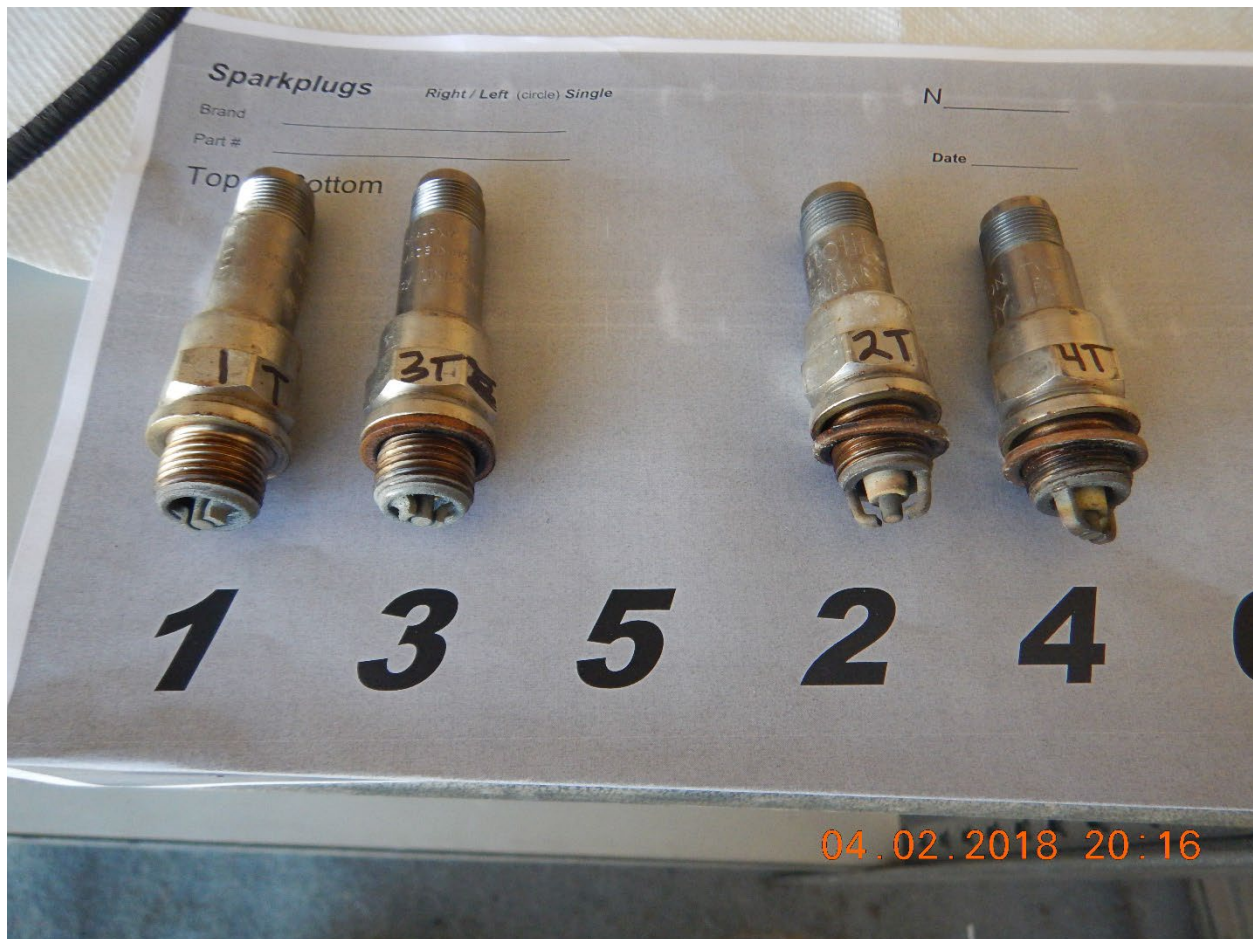
Photo 3 - Spark Plugs (Photo Courtesy of NTSB)

According to the Champion Aerospace Aviation check-A-Plug chart AV-27, the electrodes exhibited a normal wear pattern.

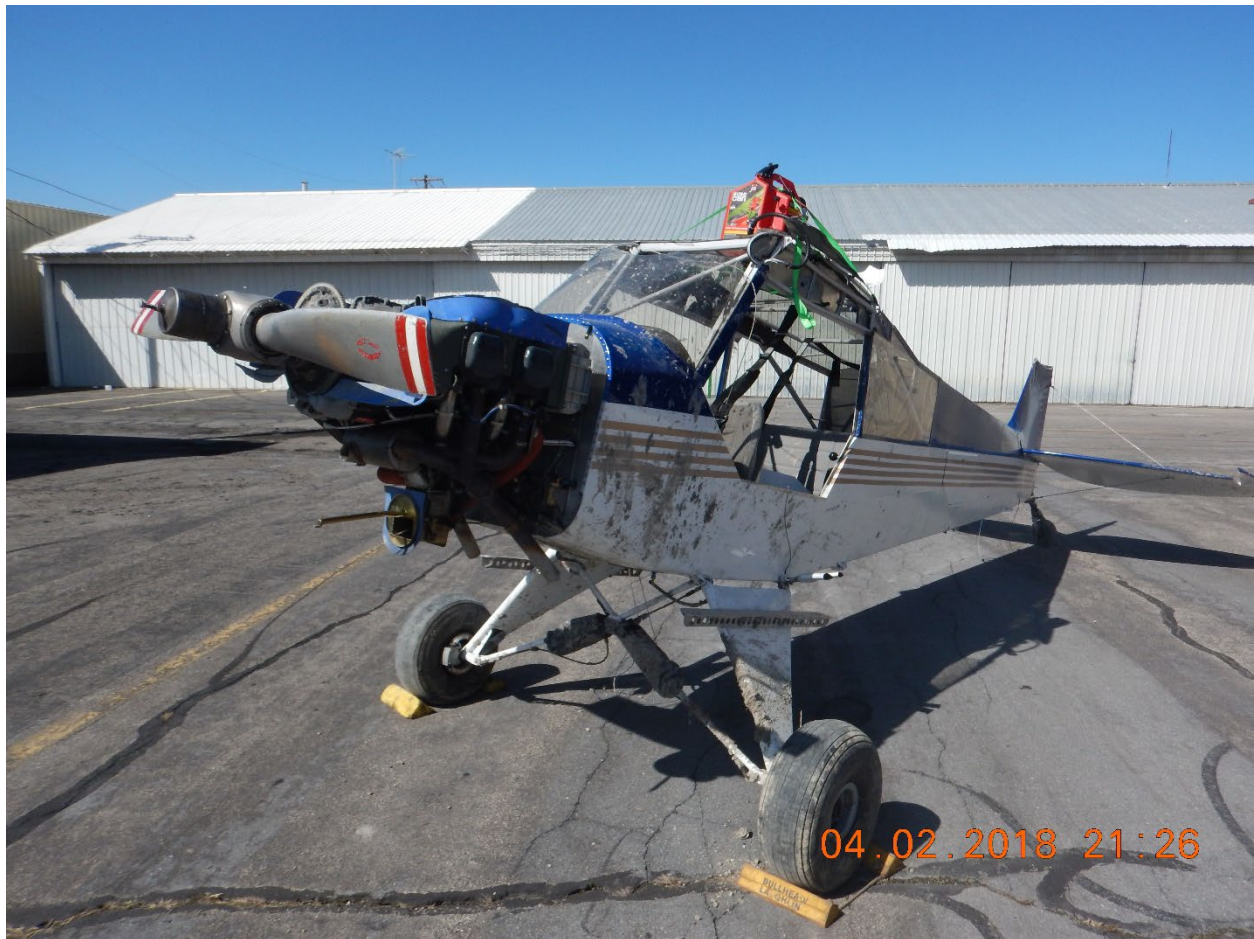
Photo 4 - View of Airplane with Fuel Tank (Photo Courtesy of NTSB)

A surrogate fuel tank was connected to the left forward fuel line to facilitate an engine run. The engine started, was run up to 2,300 rpm. The engine rpm was reduced to 1,500 rpm where a carburetor heat, electronic ignition switch, and magnetos were cycled through with no anomalies noted. The engine run lasted about 2 minutes.
