## **NATIONAL TRANSPORTATION SAFETY BOARD**

### **AIRFRAME AND ENGINE EXAMINATION SUMMARY**

**WPR18LA105**

| Aircraft: | Piper PA28-180, N6611J |

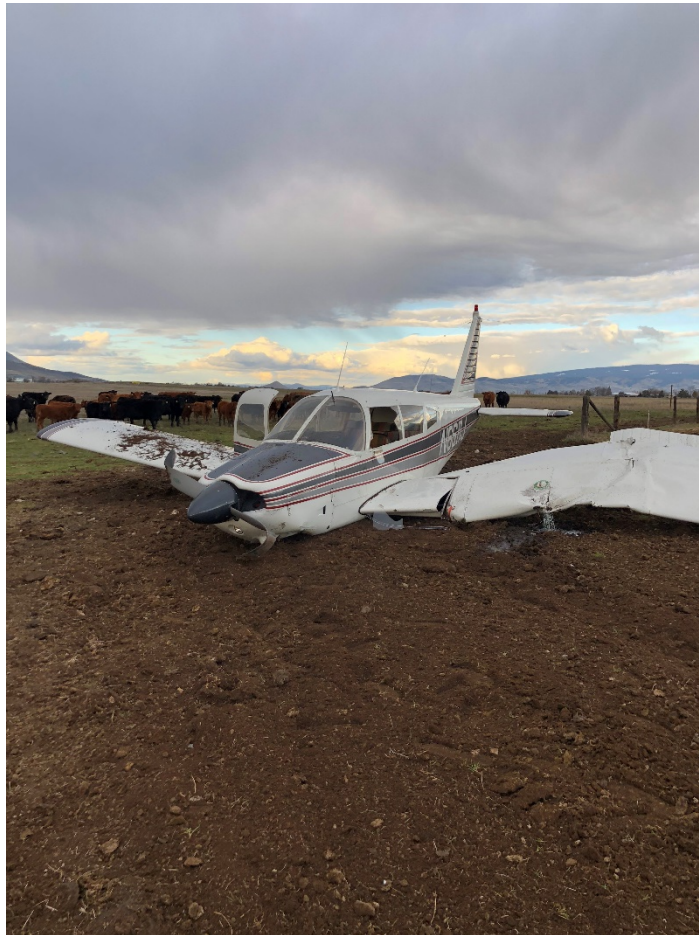
Photo 1. Airplane wreckage

The left wing was separated from the fuselage to facilitate recovery efforts. The left wing was impact damaged and exhibited “W” shaped deformation around the aileron bellcrank area of the wing. An

approximate 24"x24" section of inboard leading-edge wing was separated at its rivet lines from the remainder of the wing. The main gear remained secured to the wing. The pitot port was observed to be obstructed with a material consistent to that of soil, but the static port was clear of obstruction. The fuel tank exhibited inboard leading-edge impact damage and no fuel was observed within the fuel tank; however, the recovery personnel reportedly recovered fuel from the wing. The fuel cap was secured to its receptacle and the fuel tank vent and fuel tank pick-up screen was free of obstructions when field tested with low pressure air. The flap and aileron remained attached to their respective wing attach points. The flap was observed in the "up" position, and the flap lever and flap torque tube were indicative of the flaps being retracted/up. The flap control rod was separated to facilitate recovery. The aileron balance weight remained secured to the aileron, and the inboard area of the aileron exhibited deformation. The aileron cables remained attached to the aileron bellcrank assembly which was partially separated from its wing attaching points. The aileron cables separated from their turnbuckles in the center section of the fuselage to facilitate recovery. Aileron control continuity was established from the T-bar chain through the recovery separated area to the aileron.
