## TESTS AND RESEARCH

Investigators from the Safety Board and UL Power Engines examined the wreckage on June 05, 2018 at the facilities of Plane Parts in Sacramento, California

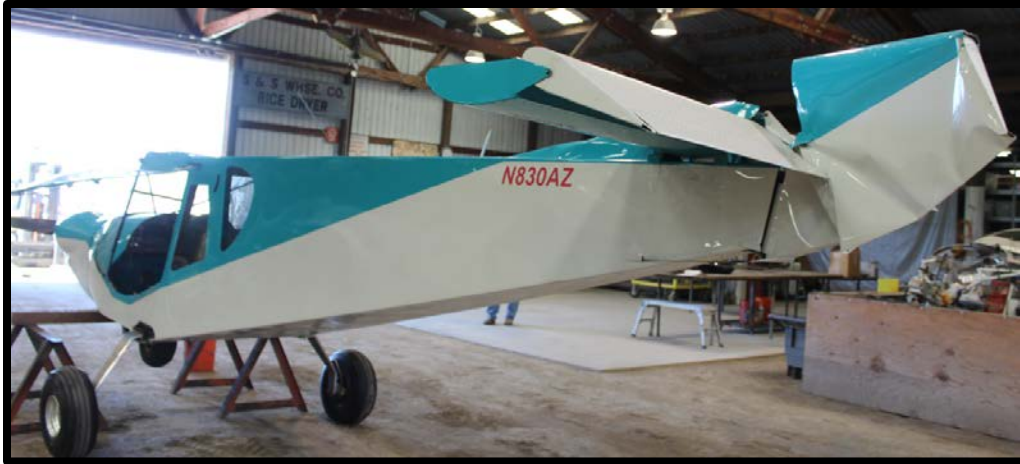
*Picture 01: Wreckage*

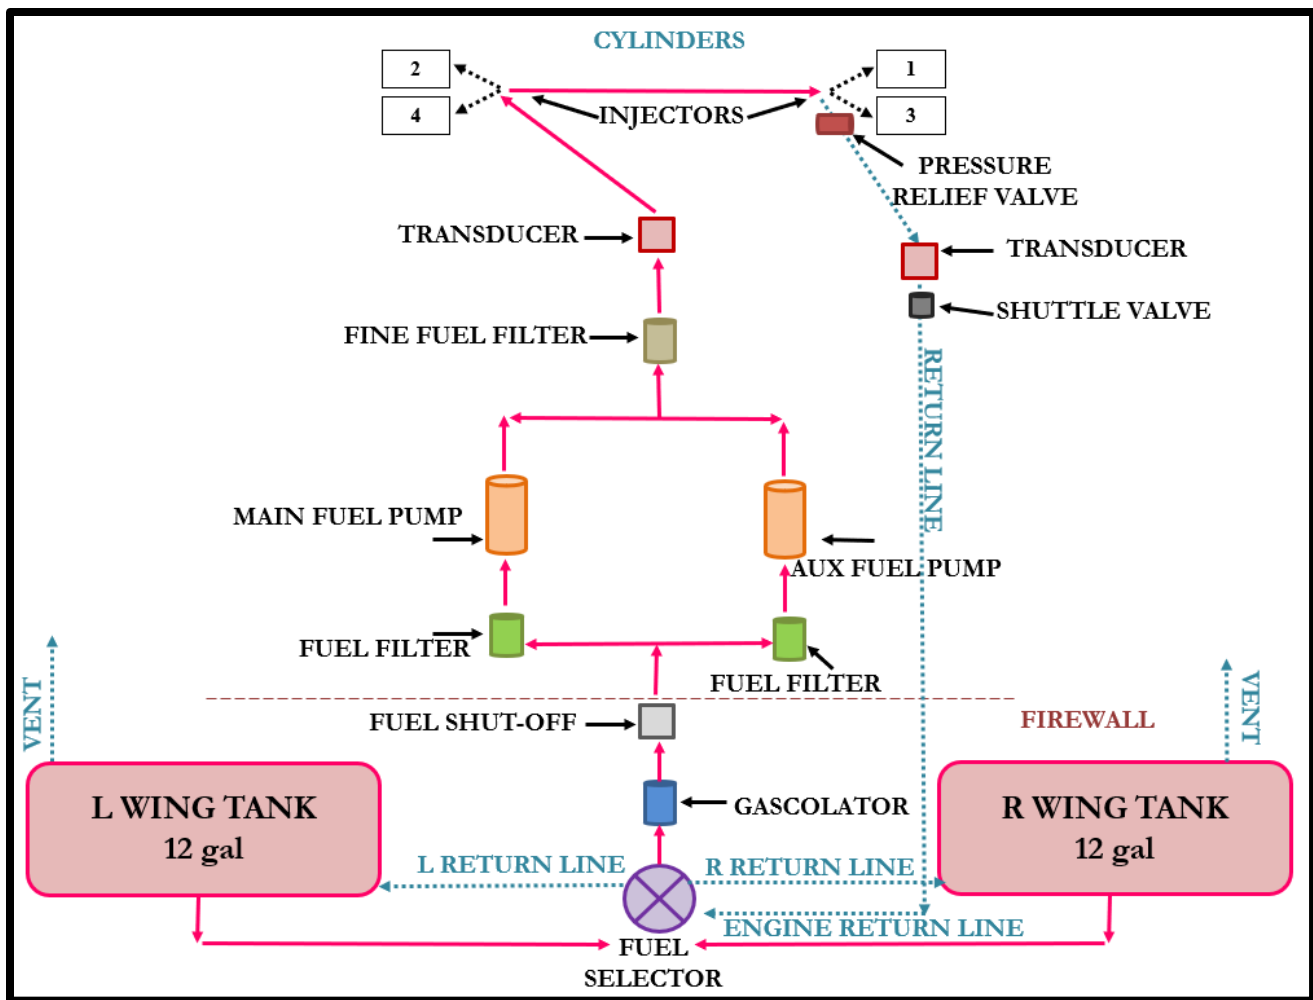
A post accident examination revealed that airplane's fuel system was a pressurized design where fuel flowed from the metal tanks in the inboard section of each wing to the engine. The connectors on the wings were a quick-disconnection type, where a collar had to be pulled back to connect the lines (fuel supply and return) from the tanks to the fuselage. The fuel was routed from the tanks to a selector valve. The selector was electronically activated from the panel switch which contained a right and left position. The fuel line then continued to a gascolator. From the gascolator, the fuel line was routed along the left side of the fuselage to a fuel shut-off valve located near the pilot's floor area.

The fuel continued through the firewall where there was a 90-degree elbow and the fuel would flow to either of the 2 fuel filters that were mounted on the firewall. Each respective filter was located just below the auxiliary fuel pump and the main fuel pump, where the fuel lines then combined and continued to the main fuel filter. The fuel line then was routed to a transducer and then to the injectors on the left side (cylinders Nos. 2 and 4) and then over the top of the engine to the right side (cylinders Nos. 1 and 3). The fuel return line from the cylinders was on the right side of the engine and routed to the pressure relief valve. From there, the fuel continued passing through another transducer and a check valve before going through the firewall. Thereafter, the fuel returned to the selector and was routed to the tank selected on the fuel selector.

Picture 02: Fuel System as Found on the Airplane

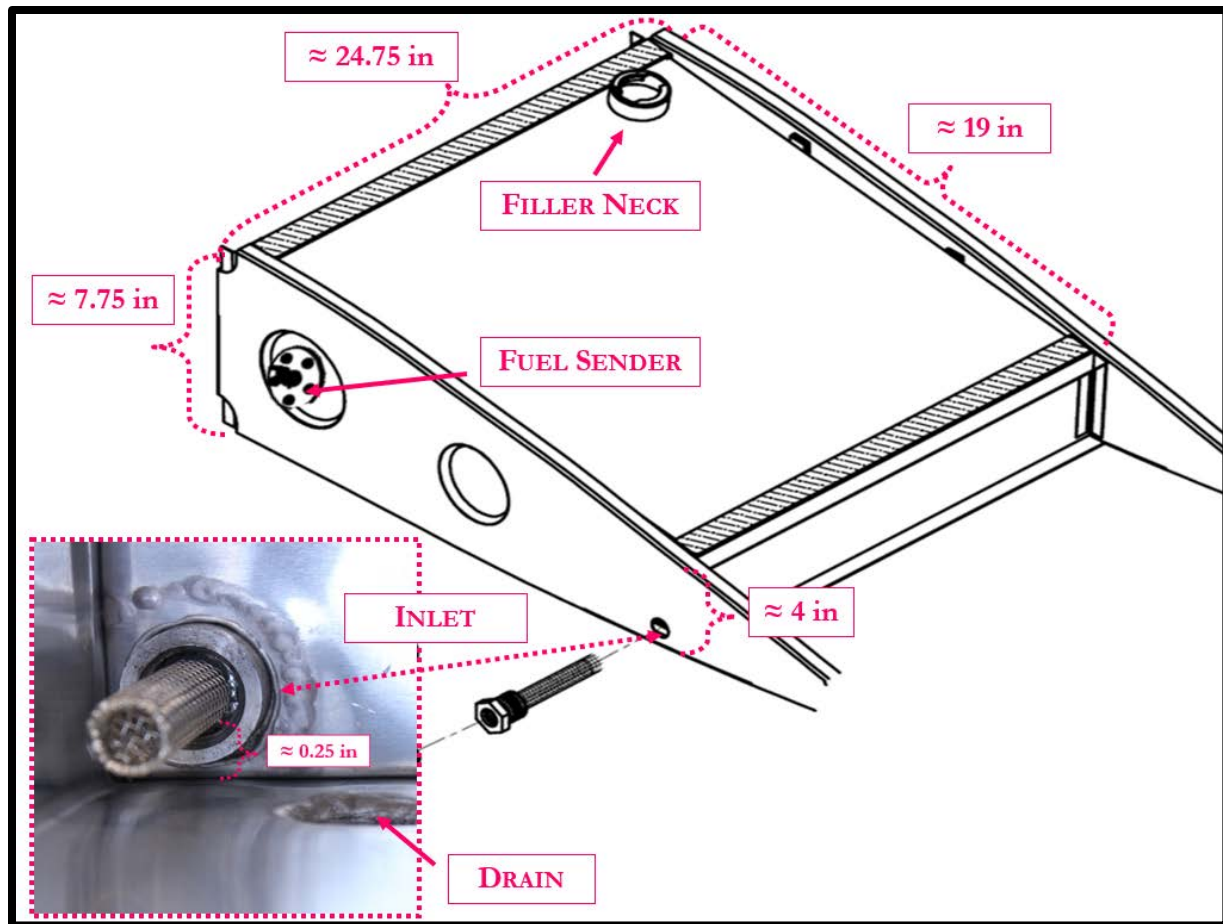
The metal tanks were rectangular 24.75 in long by 19 in wide and the forward height was about 7.75 in with the aft wall height about 4 in. The fuel inlet was located on the inboard wall of the tank in the aft area and had a screen attached. The inlet was about 0.25 in above the floor of the fuel tank.

Picture 03: Wing Fuel Tanks

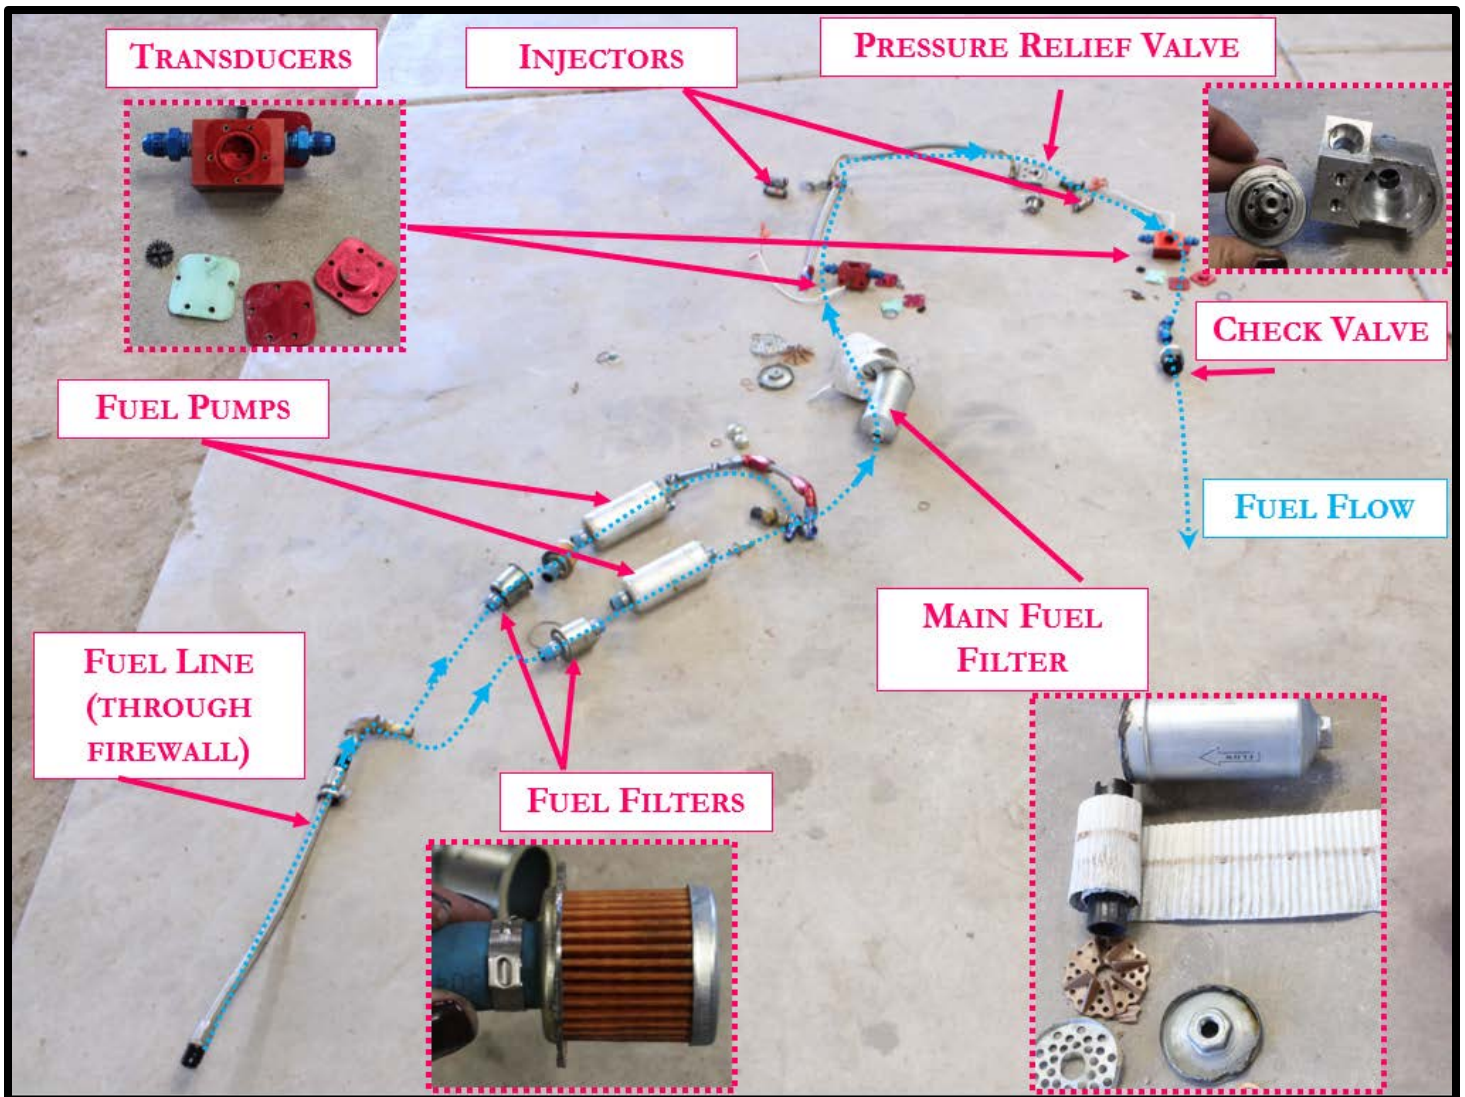
Investigators disconnected the fuel line between the fuel selector and gascolator and activated the fuel pumps. No suction could be felt, but the fuel pumps could be heard operating. The fuel line was then disconnected between the fuel shut-off and the gascolator and again no suction could be felt. The line was then disconnected at the 90-degree elbow forward of the firewall and the slight suction could be felt (momentary surges). The fuel line between the fine filter and the transducer was loosened and the suction at the line from the 90-degree elbow produced a strong suction and fuel forcefully came out of the loosened line.

The lines were all removed and found to be clear. The filters were disassembled and were clean with no debris noted. Removal of the paper element in the main filter revealed a material contained in the pleats, which was consistent with an adhesive that was used to bind the element to the casing. The transducers were disassembled and the wheels spun freely. The fuel injectors were free of debris. The pressure relief valve was disassembled and no anomalies were found.

*Picture 04: Fuel System Examined*

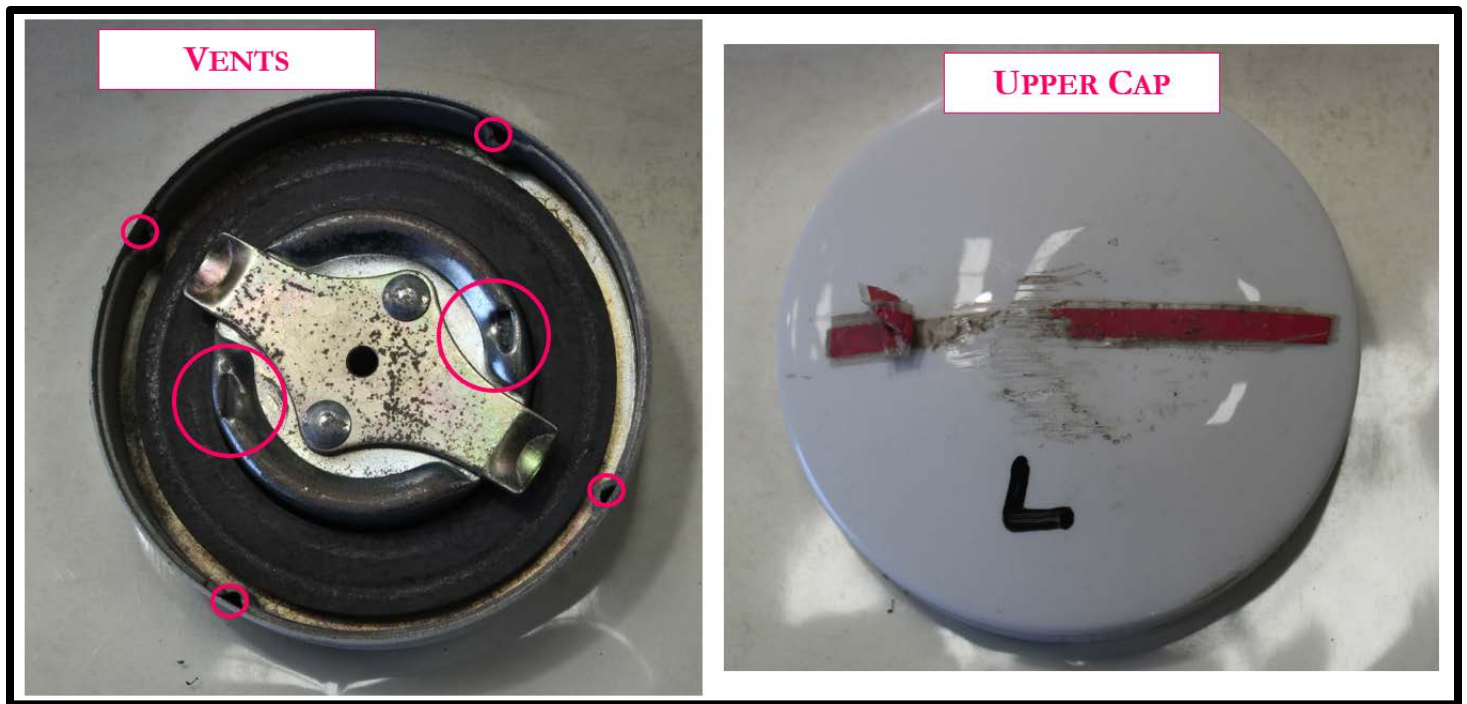
The fuel caps remained secure on the tanks. When investigators forced air into the inlet, the left tank pressurized until removing the fuel cap. The same occurrence with the right tank, but with less pressurization occurring and air could be heard escaping the cap.

*Picture 05: Fuel Caps*

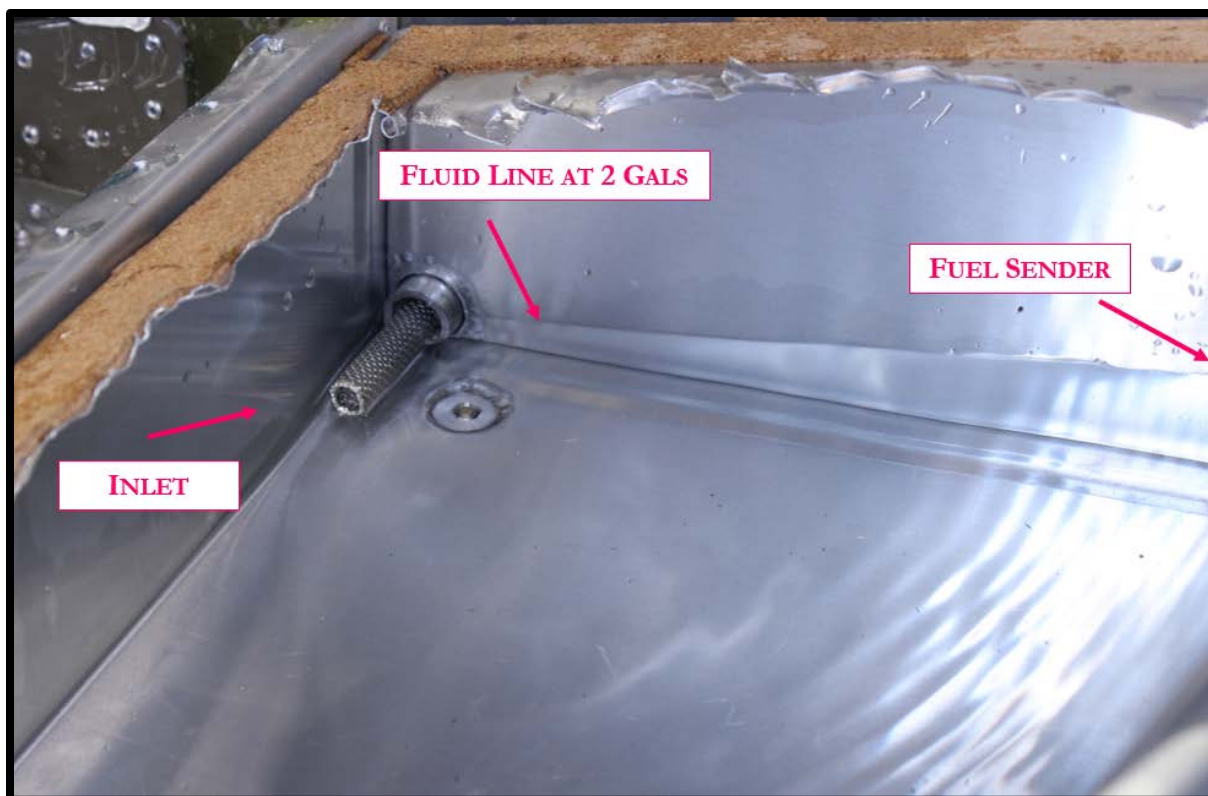
Investigators added 2 gallons of water in the left tank and attempted to position the wing in an estimated wings-level attitude. The water came to the lower lip of the inlet just touching the lower surface of the cylindrical screen body consistent with the fluid not being available to the enter the inlet if the wing changed attitude of being tilted forward (replicating a descent) or right (replicating a right turn).

*Picture 06: Fuel Tank with 2 Gallons Added in Estimated Wings-Level Attitude.*
