## EXAMINATION

#### EXAMINATION NOTES FROM MECHANIC NEIL BUNGARD

Inspection of Airborne XT-912 Mustang III 19 meter wing (N107PW) at Deer Valley Airport. The Inspection of the Airborne XT-912 Mustang 19 meter wing at Deer Valley Airport revealed some interesting results. I will outline several issues that could have contributed to loss of control of the aircraft and offer my opinion of the most likely cause.

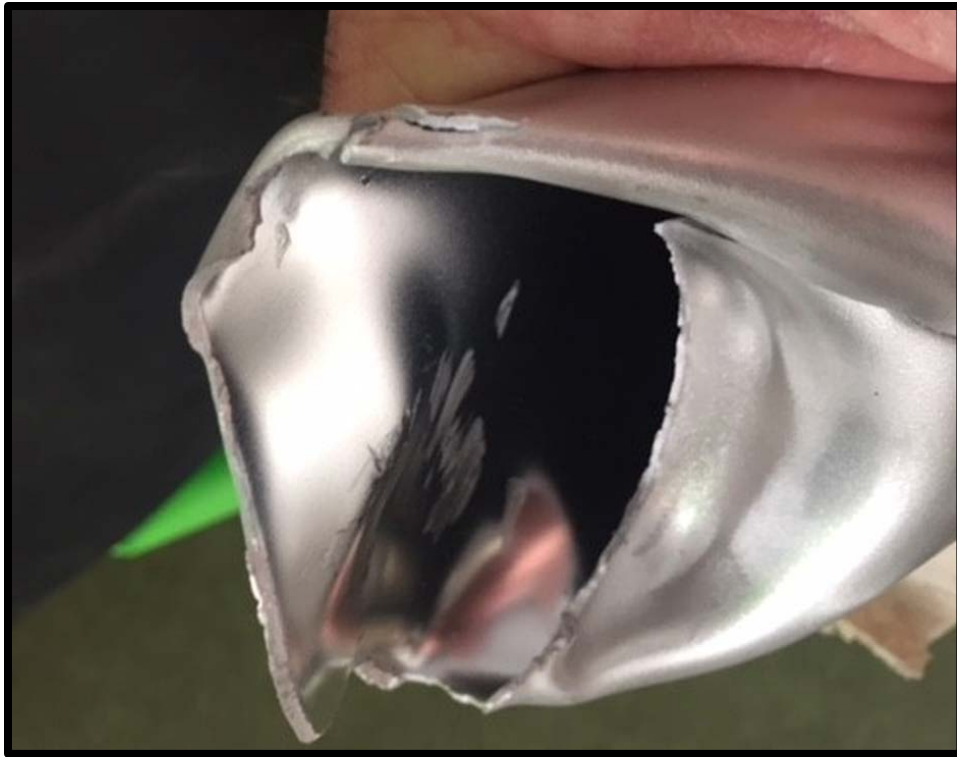
*Figure 1: Fracture Surface*

The left outboard leading edge was clearly 'snapped' off as a result of impact but the right outboard leading edge showed signs that indicate that it stayed intact long enough to create wear to the fractured edges. In addition, the fractured edges had material embedded in its structure which is consistent with a rubbing motion against some other material. The cloth at the fracture site of the right outboard leading edge appeared to be frayed rather than torn which is consistent with the fractured edge of the tube rubbing the cloth to failure.

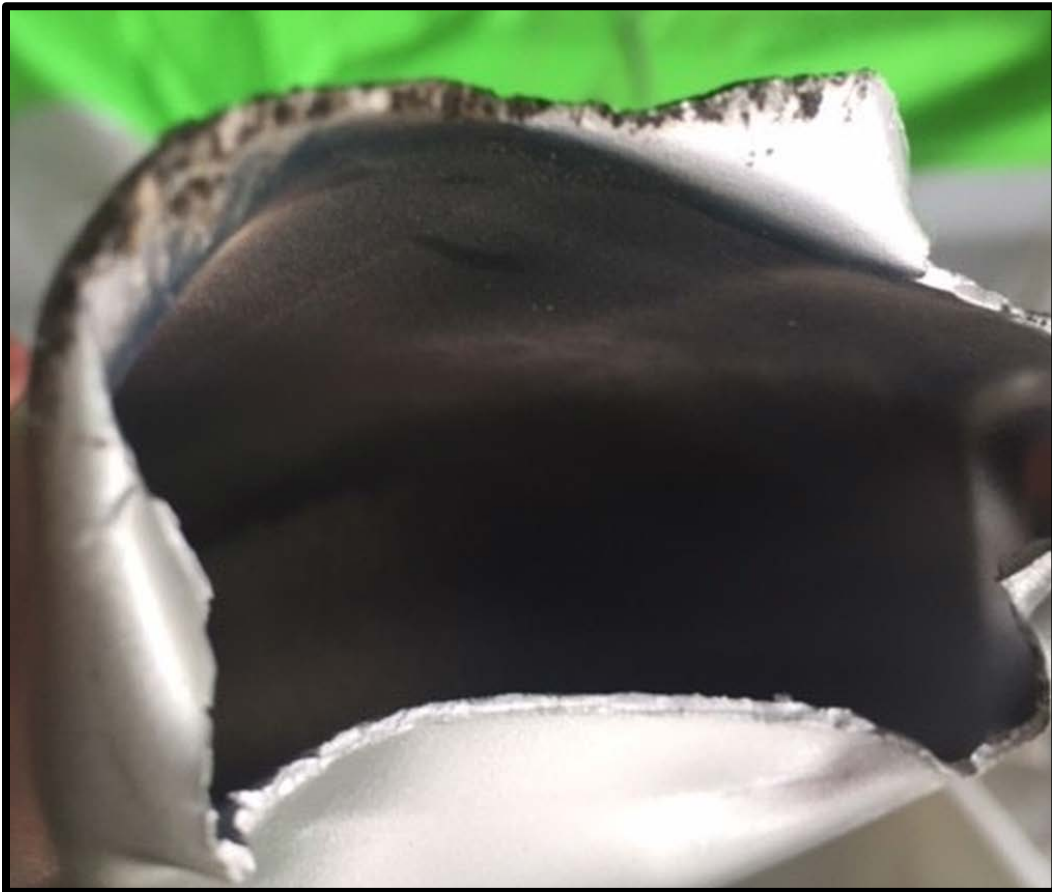
*Figure 2: Alternate View of Fracture Surface*

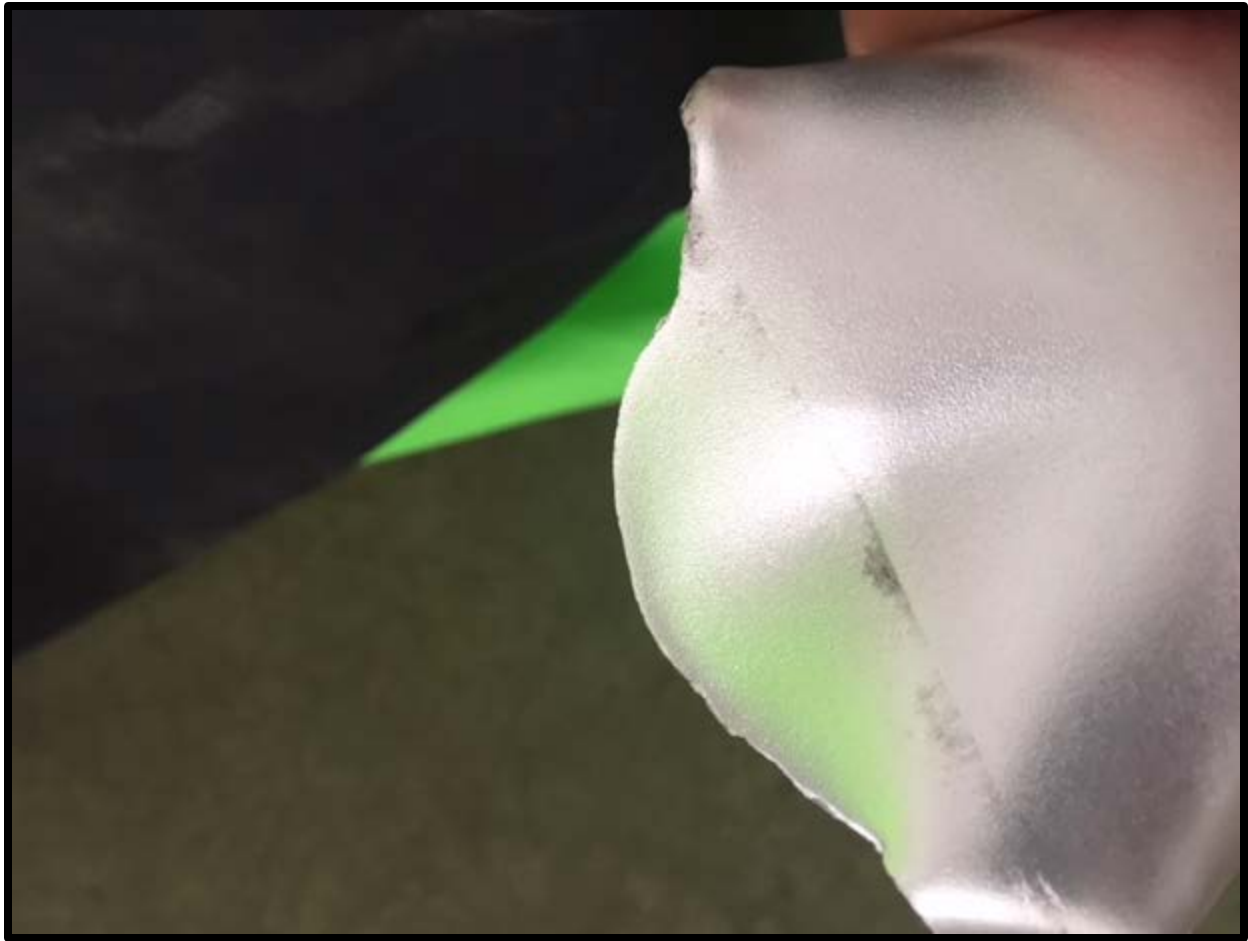
Figure 3: Fracture Upper Surface
