# Continental Motors

## ENGINE EXAMINATION REPORT

| ENGINE MODEL | TSIO-360-KB |
| FILE NUMBER | 17-513 |

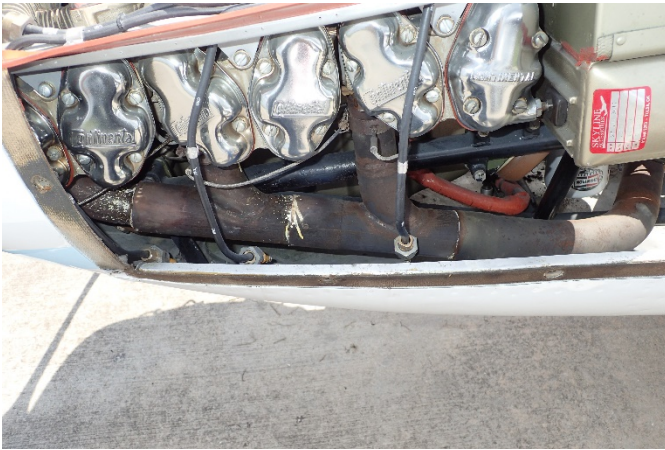
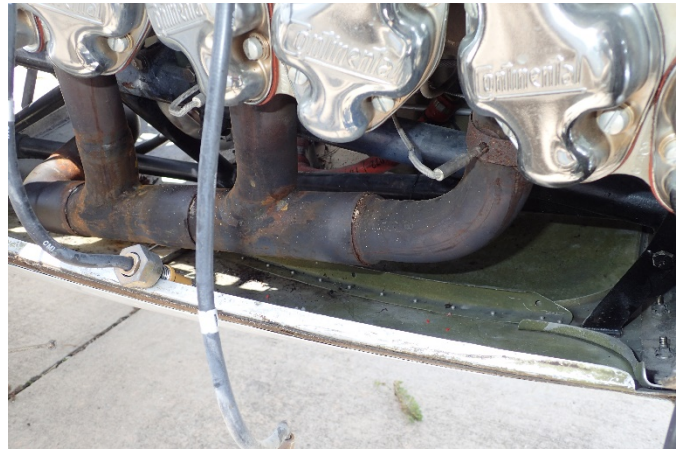
#### EXHAUST SYSTEM

The exhaust system remained attached to the engine and to the turbocharger. The V-band clamps were noted to be attached to their installation points. There were no signs of exhaust leaks or other anomalies noted.

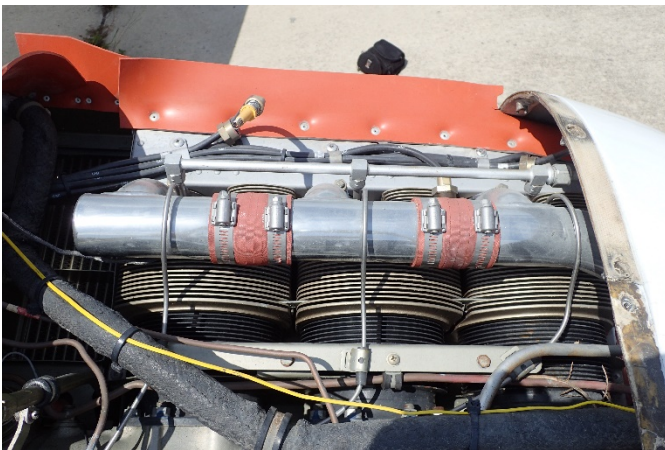
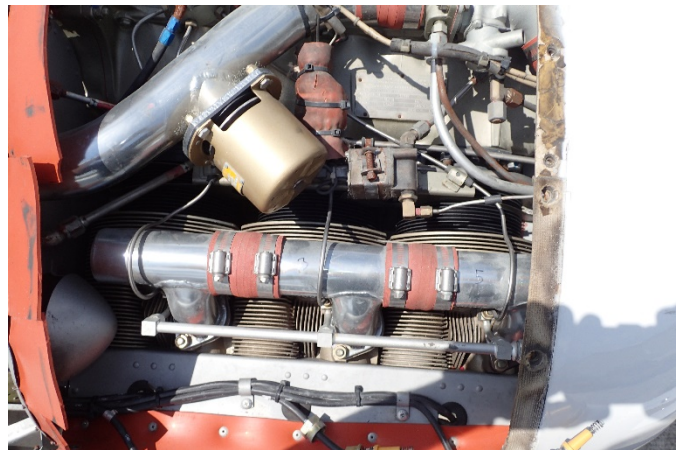
#### INDUCTION SYSTEM

The induction system remained attached to the engine and was undamaged. There were no signs of induction leaks noted. The induction air filter was removed and visually inspected; there were no signs of blockages noted.

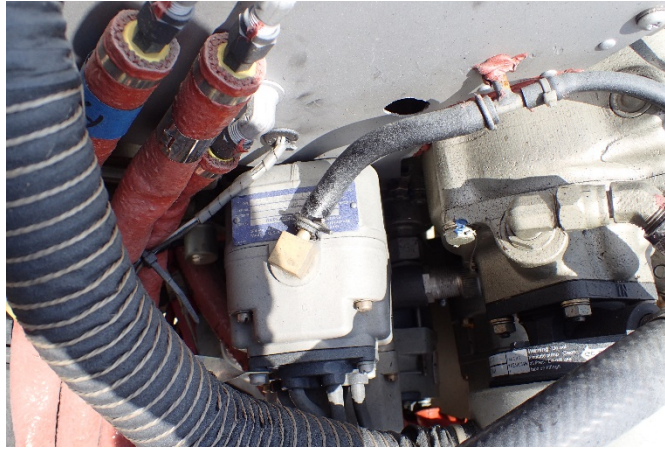
**PAGE 7 of 27****IGNITION SYSTEM****LEFT MAGNETO**

The magneto remained attached to its installation point and was undamaged. There were no anomalies noted with the magneto.

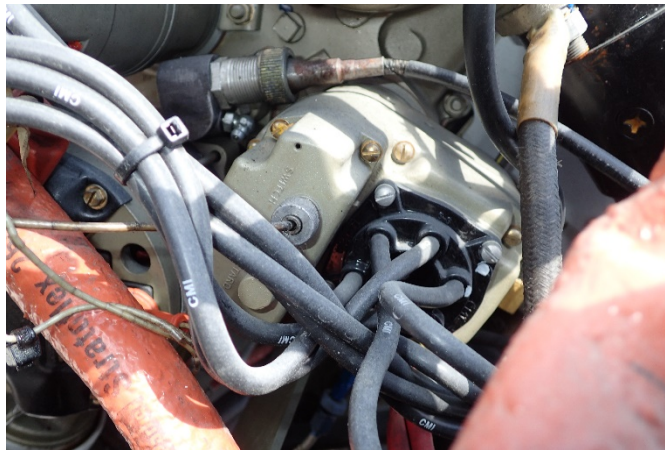
**RIGHT  
MAGNETO**

The magneto remained attached to its installation point and was undamaged. There were no anomalies noted with the magneto.

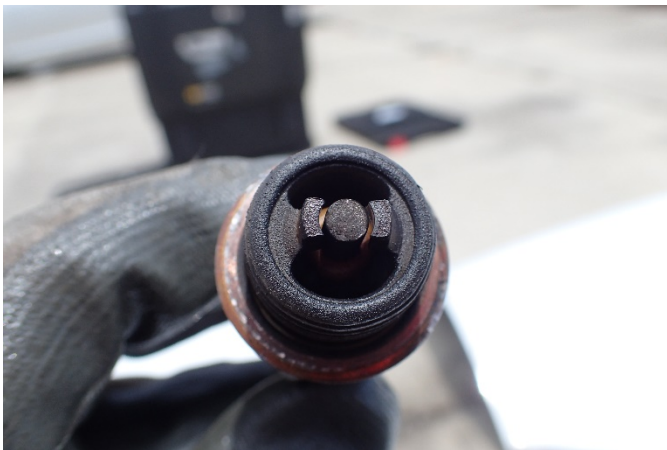
#1 Top Spark Plug

All of the spark plugs remained installed in their cylinders and were undamaged. The top spark plugs were removed and the electrodes were visually inspected. The electrodes displayed normal operating and wear signatures when compared with Champion Aviation Service Manual AV6-R. The bottom spark plugs were inspected using a lighted borescope. It was noted that the #1, #3, and the #5 bottom spark plugs were oil soaked consistent with post-accident accumulation. The bottom spark plugs displayed normal operating and combustion signatures. There were no anomalies noted.

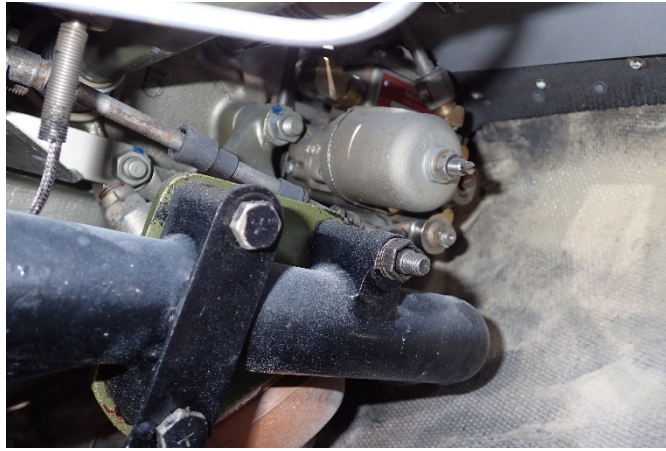
### FUEL PUMP

The fuel pump remained attached to its installation point and was undamaged. There were no signs of fuel leaks around the fuel pump. The mixture control arm remained attached to the control rod end and to the mixture shaft. Mixture control continuity was established by moving the control in the cockpit and observing mixture arm movement. It was noted that the mixture control was improperly rigged; the mixture control would not hit the mixture idle cut off stop when the control in the cockpit was moved to idle cut off.

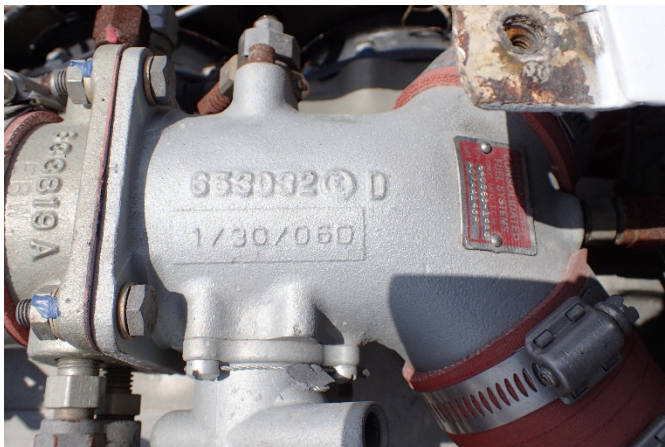
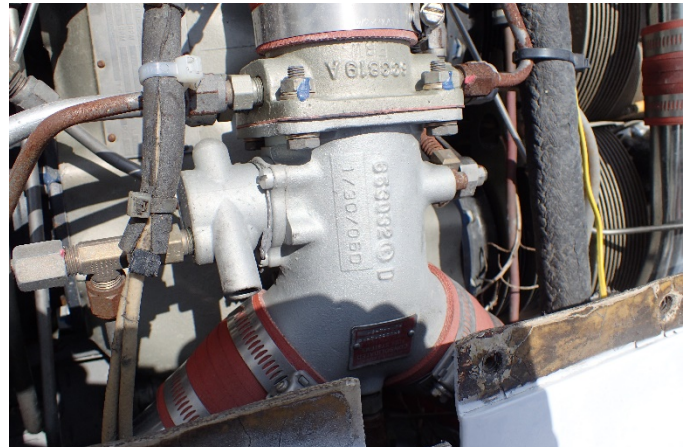
### THROTTLE BODY METERING UNIT

The throttle and metering assembly remained attached to its installation point and was undamaged. There were no signs of fuel leaks around the assembly and the fuel lines were secure. The throttle control arm remained secured to the throttle shaft and to the throttle control cable rod end. Throttle control cable continuity was established by moving the control in the cockpit and observing control arm movement. There were no anomalies noted.

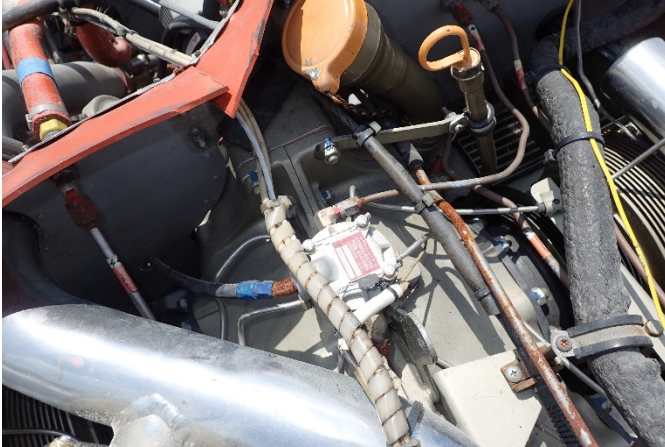
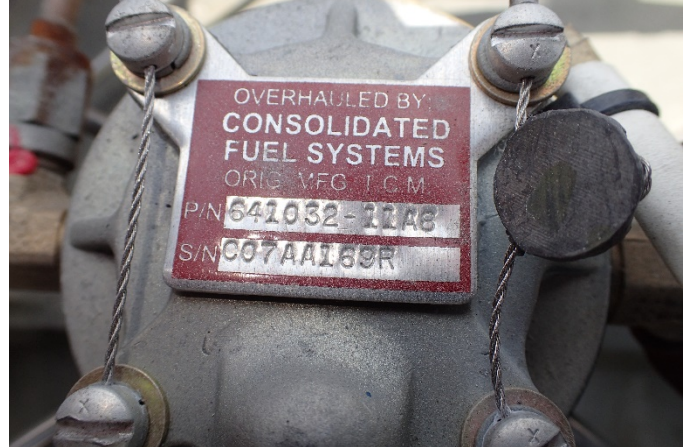
## FUEL MANIFOLD VALVE

The fuel manifold valve remained attached to its installation point and was undamaged. There were no signs of fuel leaks around the manifold valve. There were no anomalies noted.

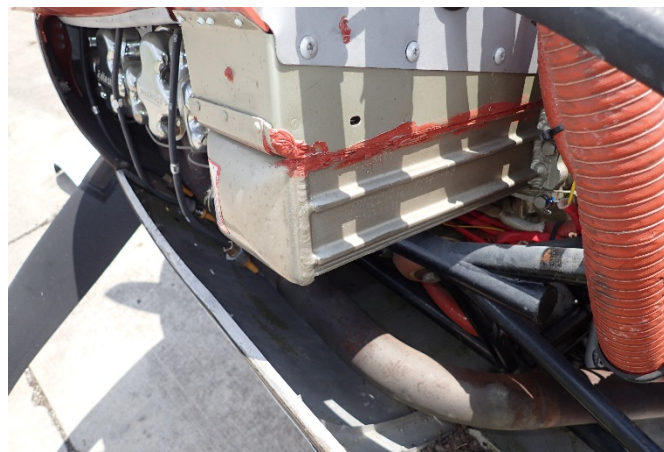
**OIL COOLER**Manufacturer: Not observed  
(overhauled by Skyline  
Accessories)

The oil cooler remained attached to its installation point and was undamaged. There were no anomalies noted.

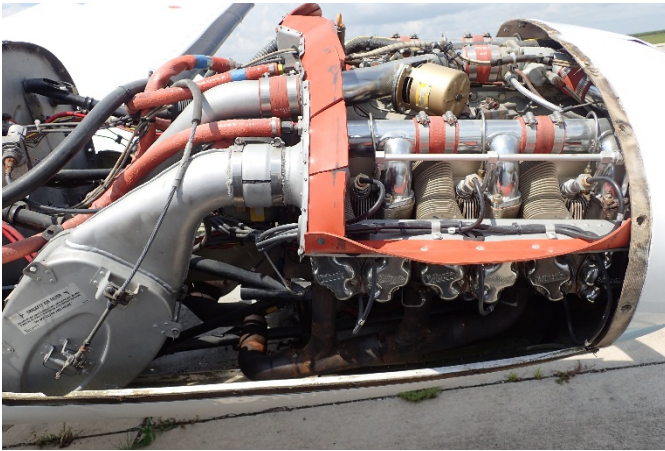
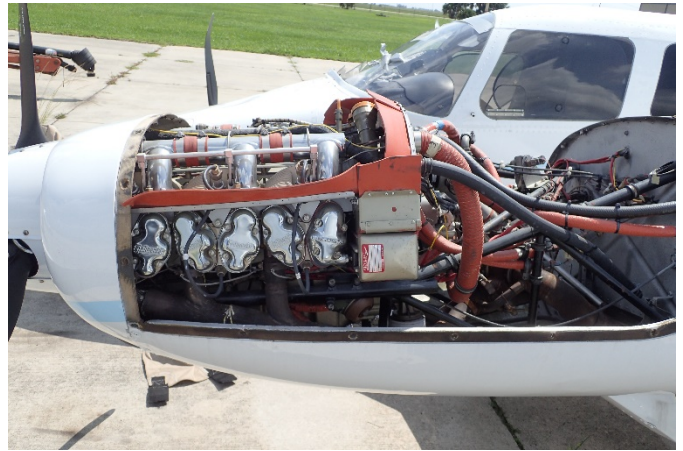
#### CYLINDERS

**Condition:** All of the cylinders remained attached to their cylinder bays and were undamaged. The top spark plugs were removed and the cylinders were inspected using a lighted borescope. The cylinder bores, piston faces, and valve heads displayed normal operating and combustion signatures. The crankshaft was rotated and all of the cylinders displayed good thumb compression and suction. There were no anomalies noted with the cylinders.

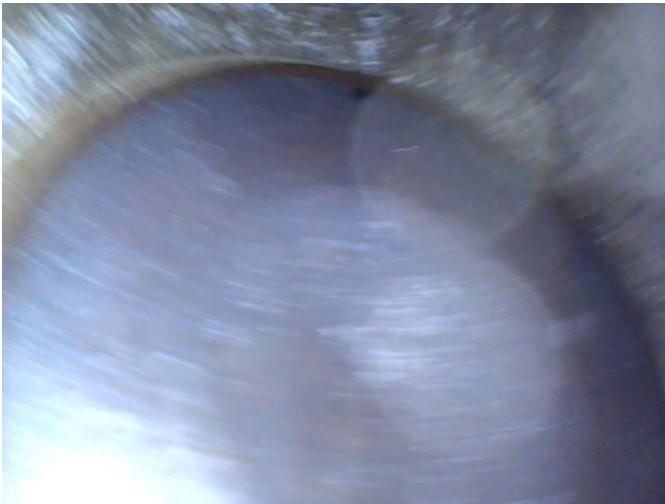
#1 Exhaust Valve

**Condition:** The valve heads were inspected using a lighted borescope. The valve heads displayed normal operating and combustion signatures.

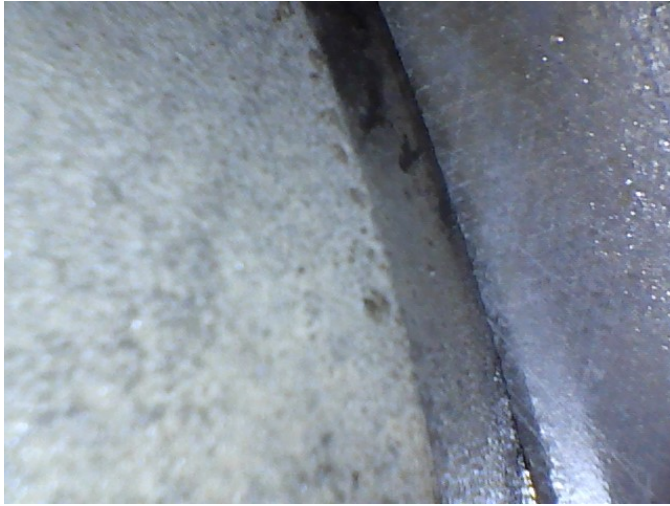
#1 Piston

The piston faces were inspected using a lighted borescope; the piston face displayed normal operating and combustion signatures. It was noted there was very little combustion deposits on the piston faces which is consistent with an engine that has been recently overhauled.

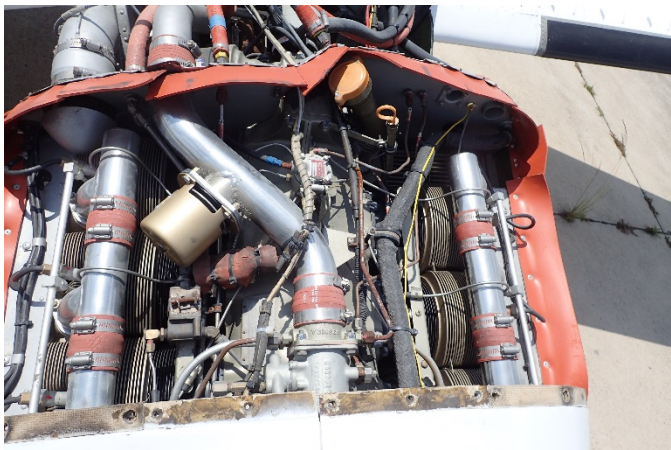
| Condition: | The crankcase remained intact and was undamaged. There were no anomalies noted with the crankcase. | | | |

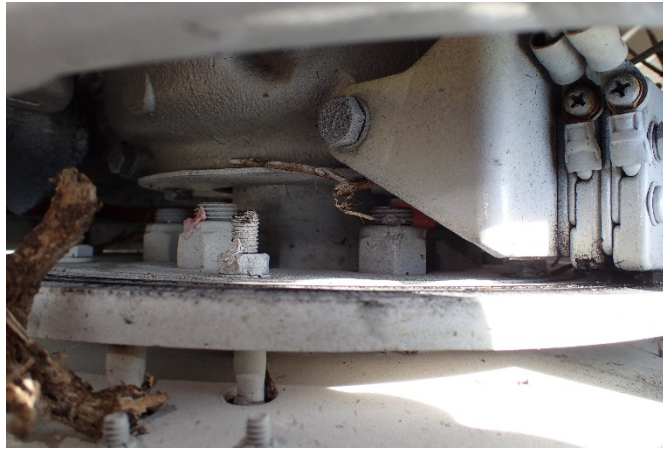
The propeller flange remained attached to the crankshaft and there were no cracks noted in the visible portion of the crankshaft. The crankshaft was rotated by hand and continuity was established between the internal components of the engine. There were no anomalies noted with the crankshaft.

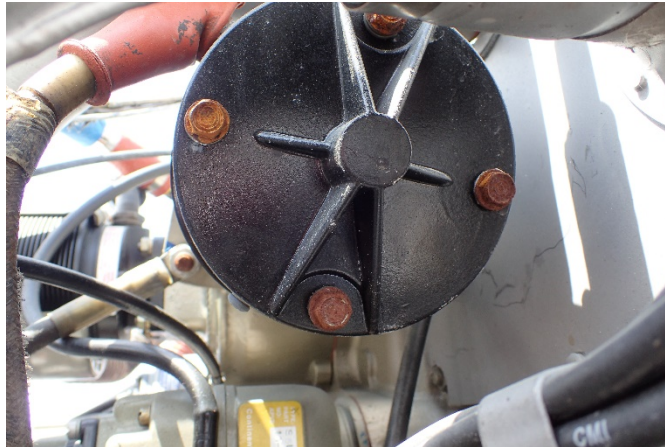
The starter remained attached to its installation point and was undamaged. There were no anomalies noted with the starter.

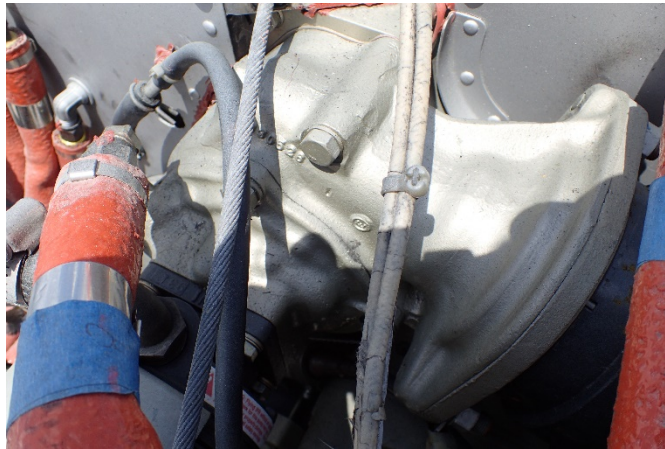
**STARTER  
ADAPTER**

The starter adapter remained attached to its installation point and was undamaged. There were no anomalies noted with the adapter.

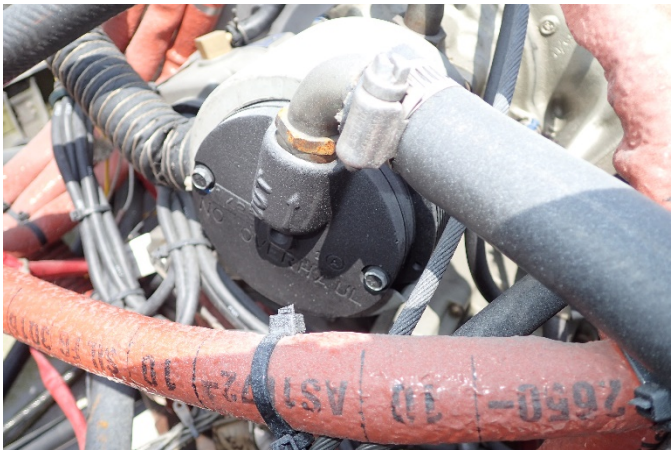
| Condition: | The vacuum pump remained attached to its installation point and was undamaged. There were no anomalies noted with the vacuum pump. | | |

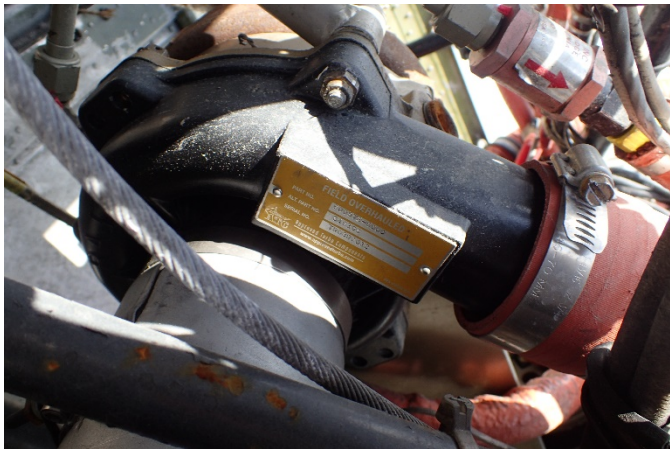
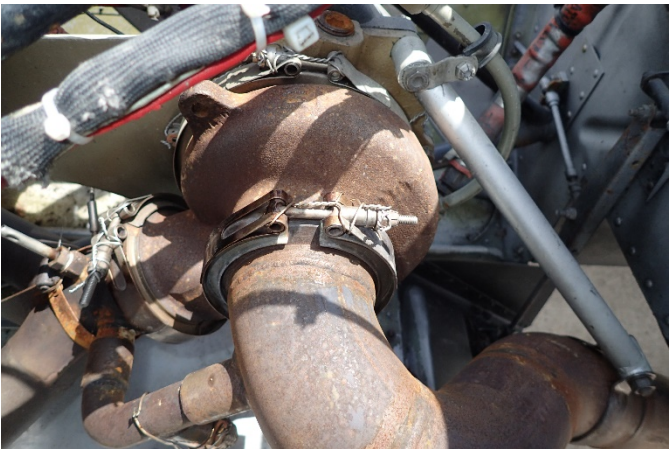
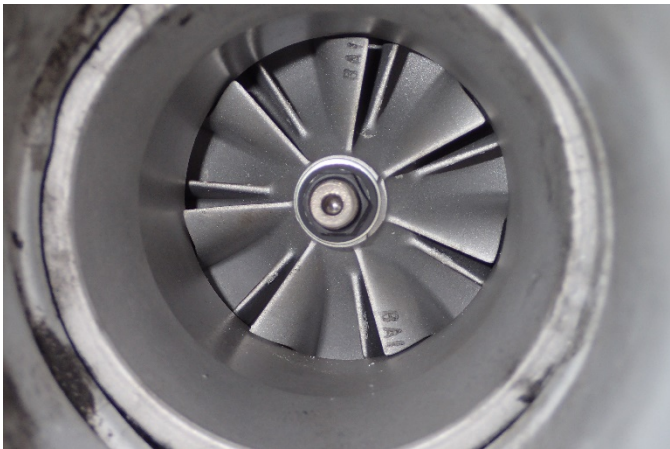
The turbocharger remained attached to its installation point and was undamaged; it was noted that there was a significant amount of corrosion around the turbine portion of the turbocharger. The fixed wastegate remained installed and was secured with safety wire. The overboost valve remained attached to its installation point and was undamaged.

| Condition: | The turbocharger remained attached to its installation point and was undamaged. It was noted that the V-band clamps remained attached to the turbocharger and were undamaged. The turbocharger induction inlet tube was removed and it was noted that the compressor was capable of rotating normally. There were no anomalies noted. | | |

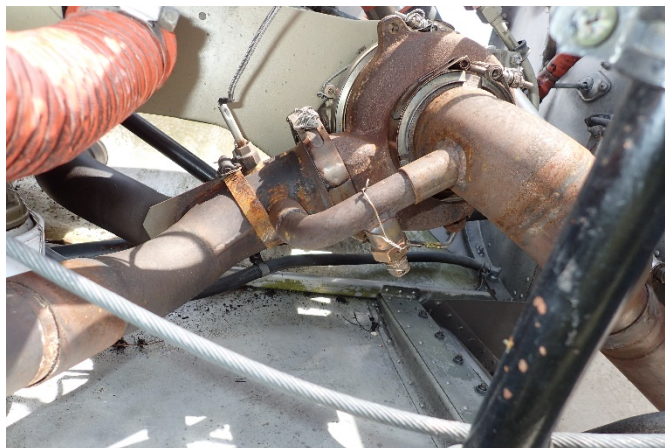
The fixed wastegate remained attached to its installation point and was secured with safety wire. There were no anomalies noted.

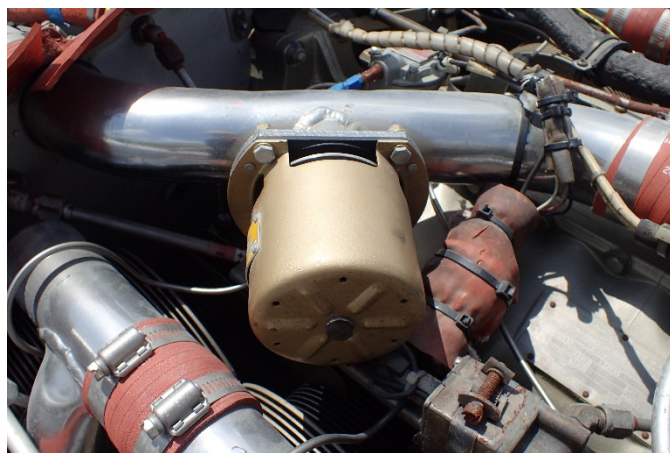
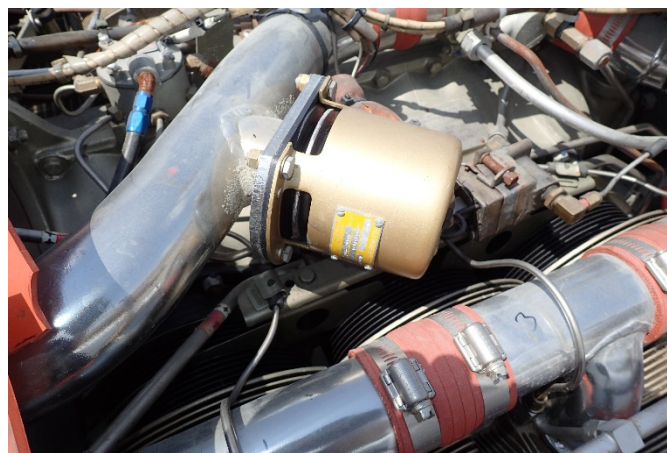
## OVERBOOST VALVE

The overboost valve remained attached to its installation point and was undamaged. The overboost valve was actuated by using a screw driver; the overboost valve operated normally. There were no anomalies noted.

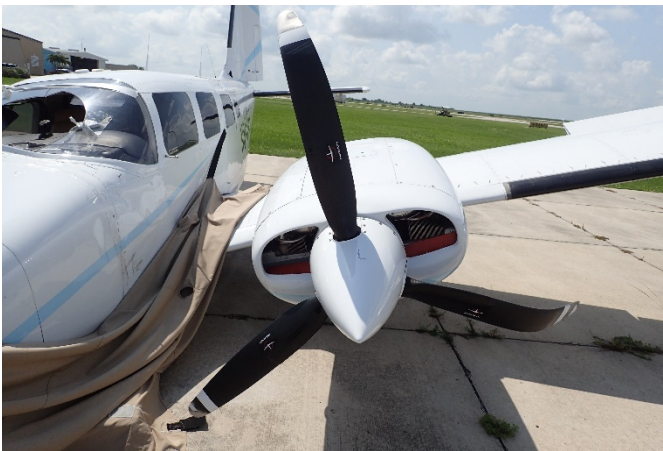
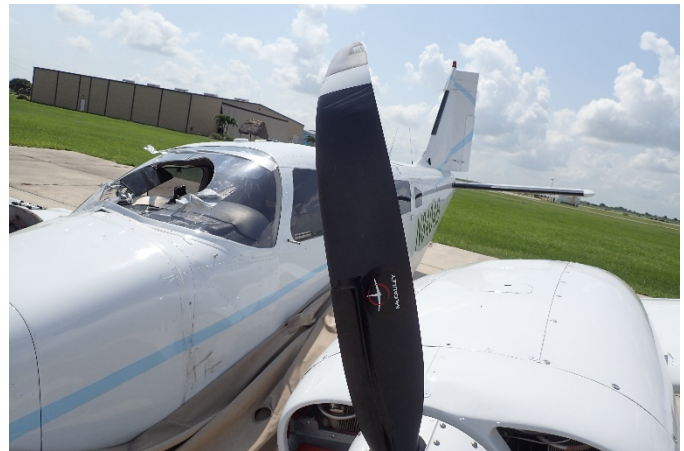
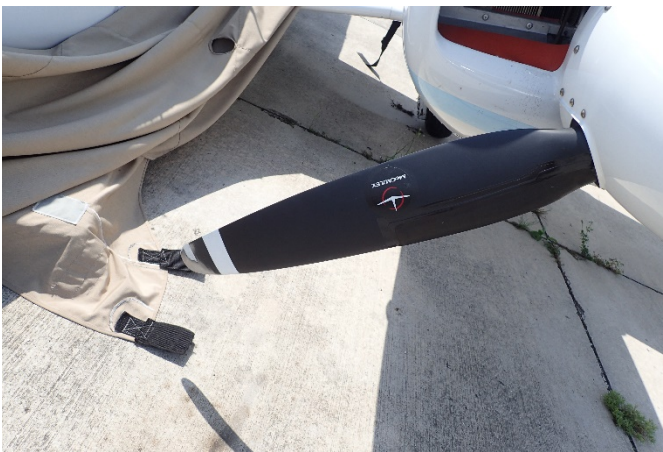
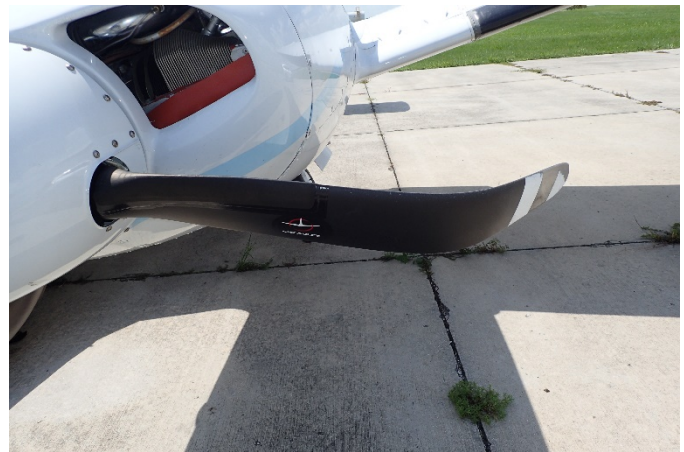
The three blade, variable pitch propeller remained attached to the crankshaft and the three propeller blades displayed impact damage signatures. All of the propeller blades displayed varying amounts of aft bending and polishing at the propeller tips. There were no anomalies noted with the propeller.

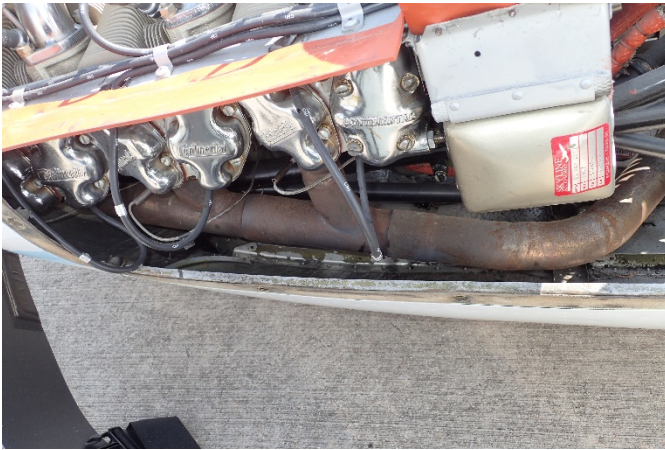
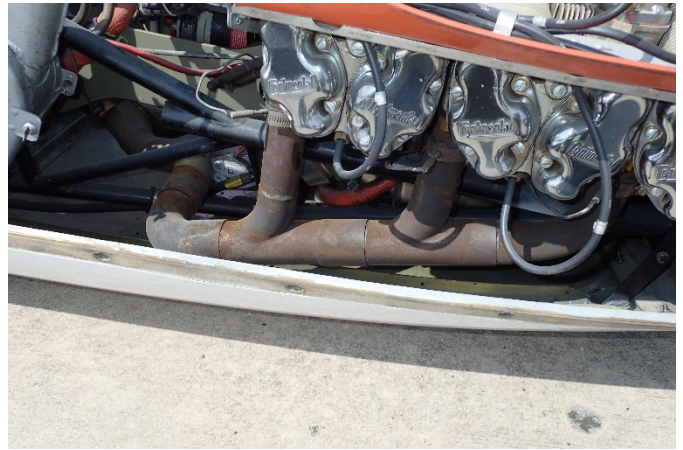
The exhaust system remained attached to the engine and to the turbocharger; the exhaust tailpipe displayed impact damage signatures. There were no signs of exhaust leaks or other anomalies noted.

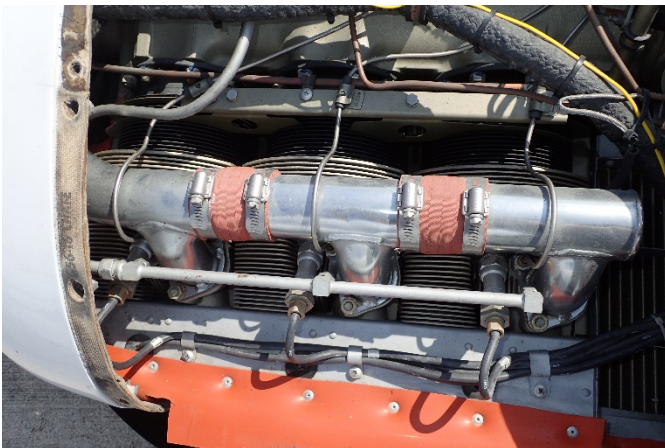
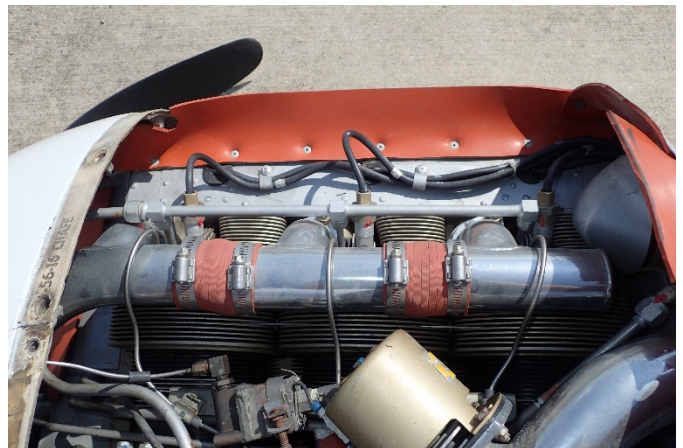
#### INDUCTION SYSTEM

The induction system remained attached to the engine and was undamaged. There were no signs of induction leaks noted. The induction air filter was removed and visually inspected; there were no signs of blockages noted.

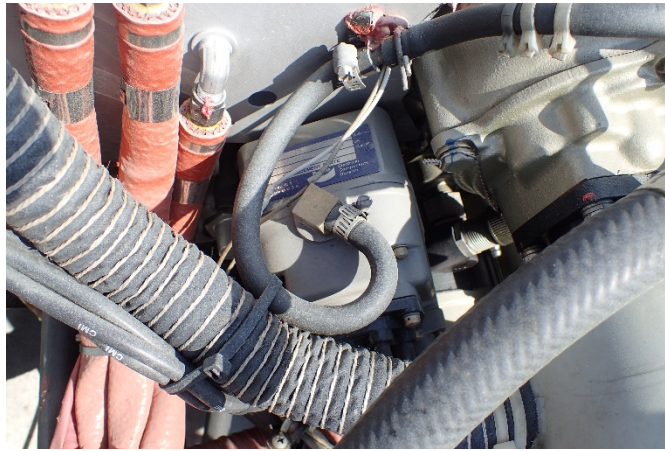
The magneto remained attached to its installation point and was undamaged. Due to the position of the engine the magneto could not be tested. There were no anomalies noted.

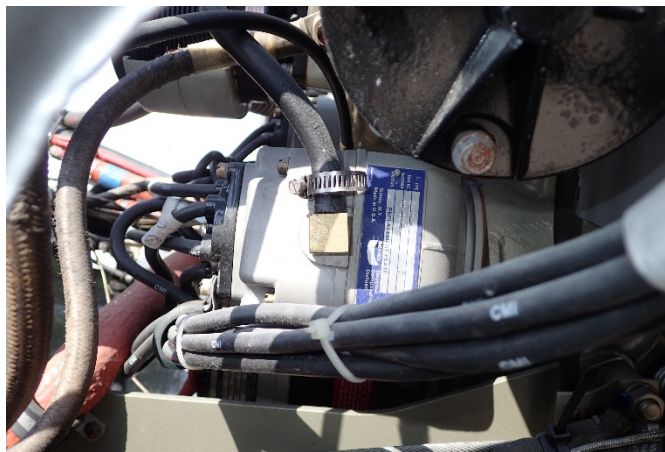
**RIGHT  
MAGNETO**

The magneto remained attached to its installation point and was undamaged. Due to the position of the engine the magneto could not be tested. There were no anomalies noted.

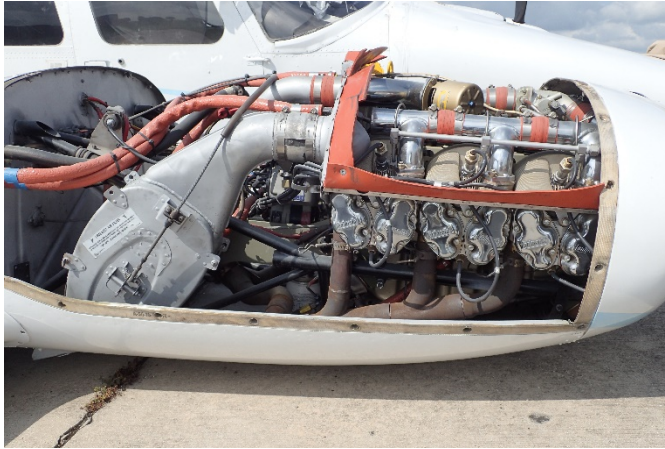
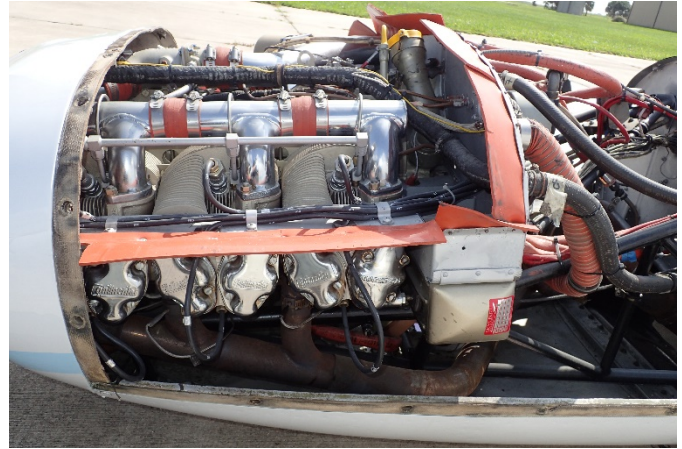
The ignition harness remained attached to both of the magnetos and to each spark plug. The harness was undamaged and there were no anomalies noted.

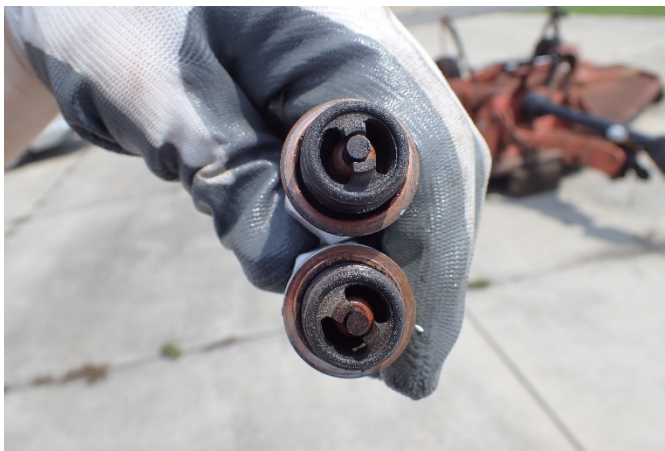
#1 Spark Plugs

All of the spark plugs remained installed in their cylinders and were undamaged. The spark plugs were removed and visually inspected. The electrodes displayed normal operating and wear signatures when compared with Champion Aviation Service Manual AV6-R. There were no anomalies noted.

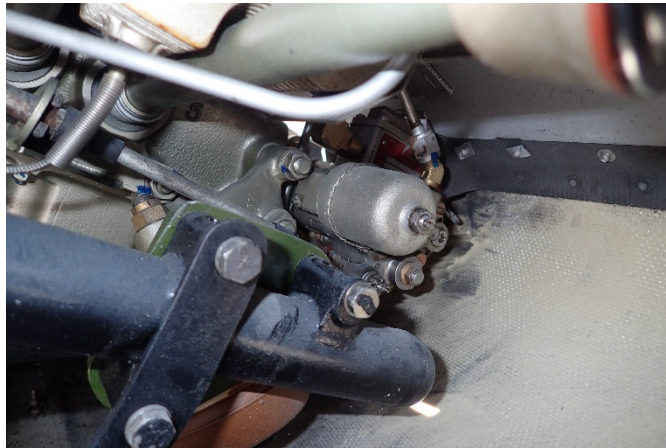
The fuel pump remained attached to its installation point and was undamaged. There were no signs of fuel leaks around the fuel pump. The mixture control arm remained attached to the control rod end and to the mixture shaft. Mixture control continuity was established by moving the control in the cockpit and observing mixture arm movement. There were no anomalies noted.

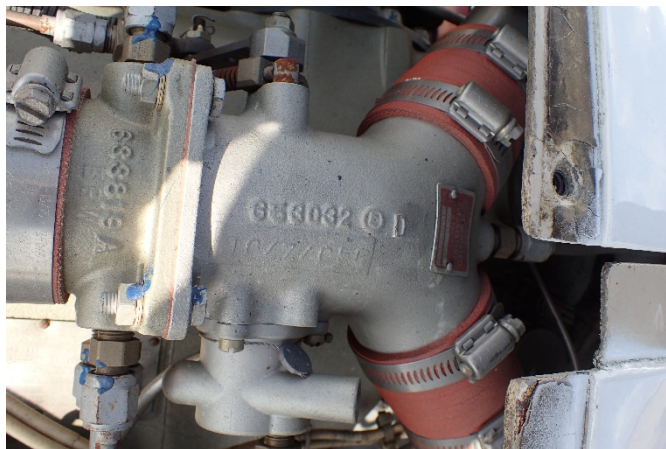
### THROTTLE BODY METERING UNIT

The throttle and metering assembly remained attached to its installation point and was undamaged. There were no signs of fuel leaks around the assembly and the fuel lines were secure. The throttle control arm remained secured to the throttle shaft and to the throttle control cable rod end. Throttle control cable continuity was established by moving the control in the cockpit and observing control arm movement. There were no anomalies noted.

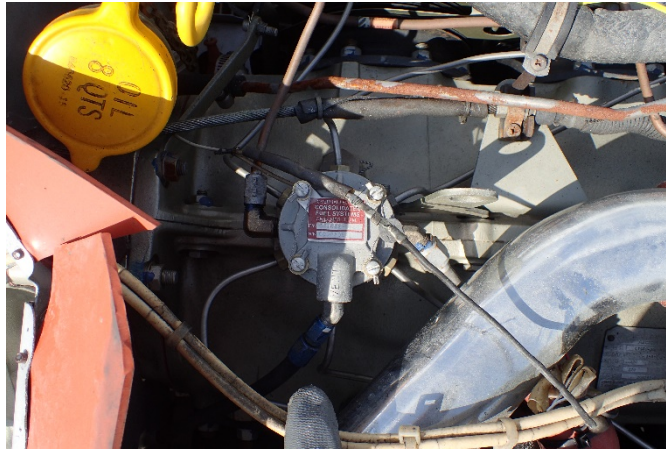
The fuel manifold valve remained attached to its installation point and was undamaged. There were no signs of fuel leaks around the manifold valve. There were no anomalies noted.

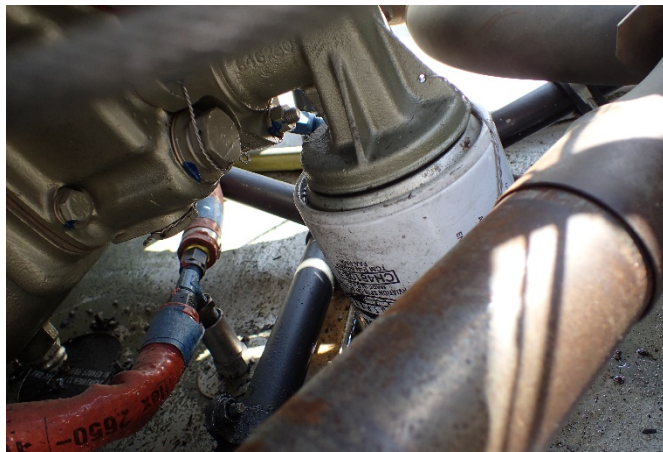
The oil filter remained attached to the oil filter adapter and was undamaged. There were no signs of oil leaks around the filter. There were no anomalies noted.

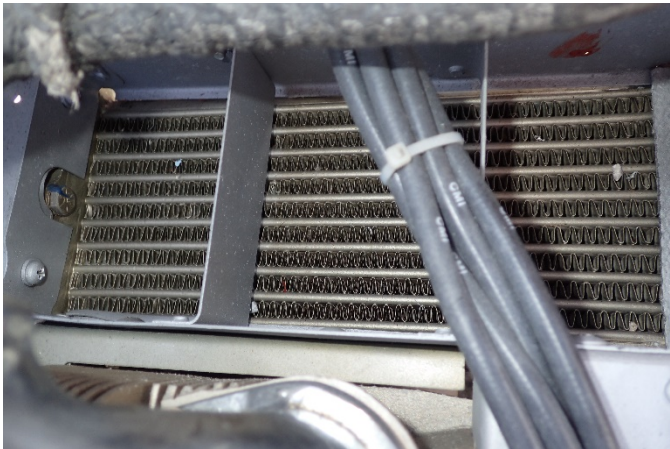
| Condition: | The oil cooler remained attached to its installation point and was undamaged. There were no anomalies noted. | | |

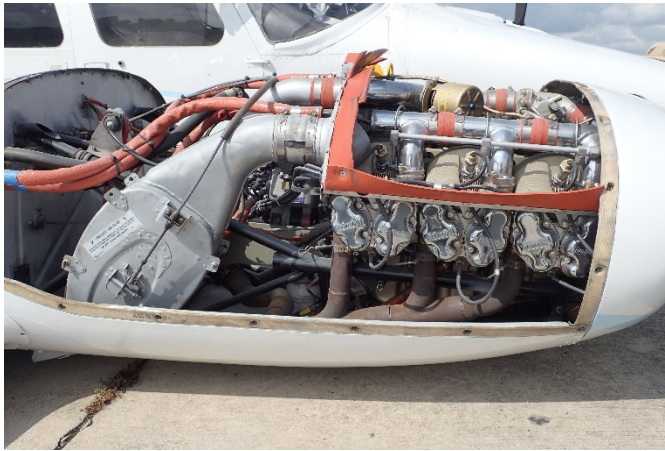
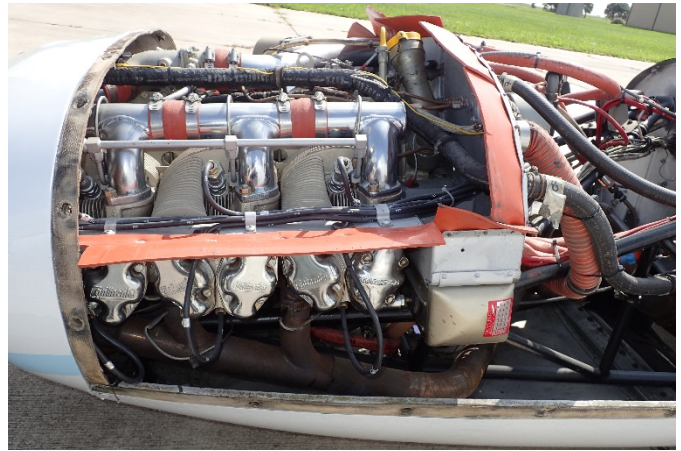
#### CYLINDERS

**Condition:** All of the cylinders remained attached to their cylinder bays and were undamaged. The top spark plugs were removed and the cylinders were inspected using a lighted borescope. The cylinder bores, piston faces, and valve heads displayed normal operating and combustion signatures. Due to the position of the engine the crankshaft could not be rotated, consequently thumb compressions were unable to be checked.

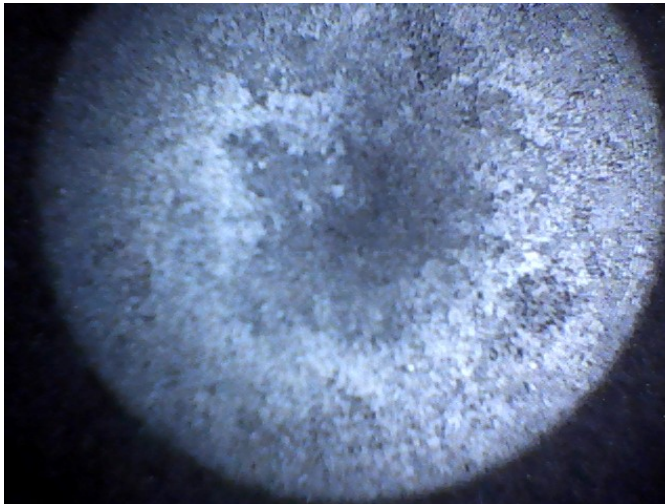
#1 Exhaust

**Condition:** The valve heads were inspected using a lighted borescope. The valve heads displayed normal operating and combustion signatures.

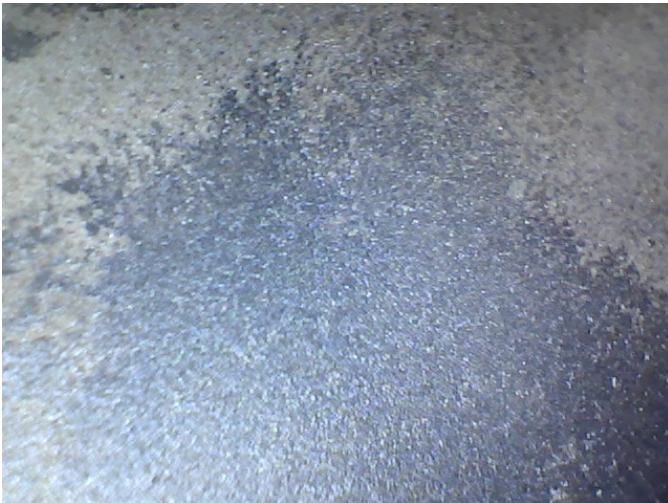
#1 Piston

The piston faces were inspected using a lighted borescope; the piston face displayed normal operating and combustion signatures. It was noted there was very little combustion deposits on the piston faces which is consistent with an engine that has been recently overhauled.

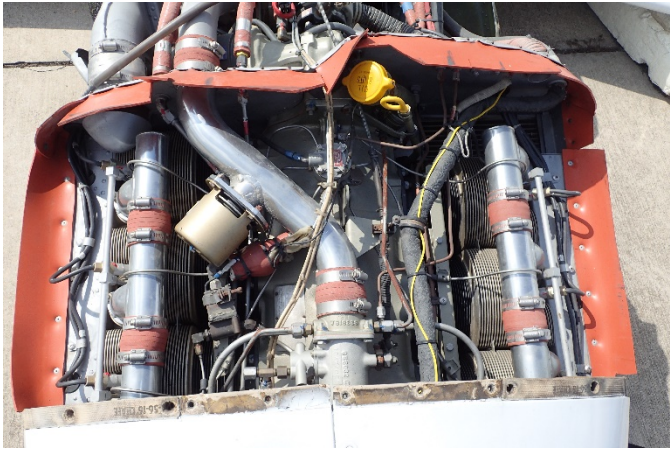
| Condition: | The crankcase remained intact and was undamaged. There were no anomalies noted with the crankcase. | | | |

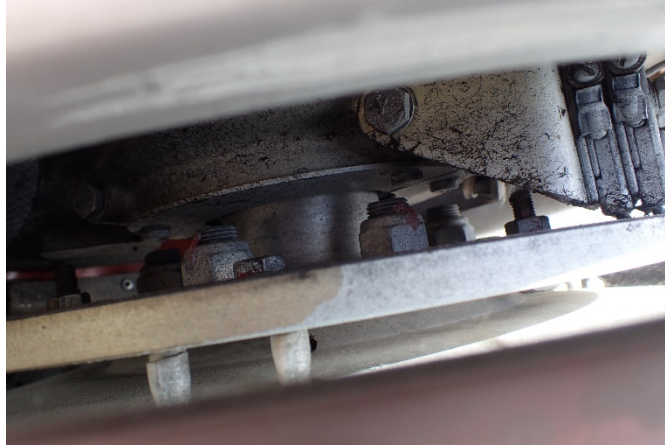
The propeller flange remained attached to the crankshaft and there were no cracks noted in the visible portion of the crankshaft. Due to the position of the engine the crankshaft could not be rotated. There were no anomalies noted with the visible portion of the crankshaft.

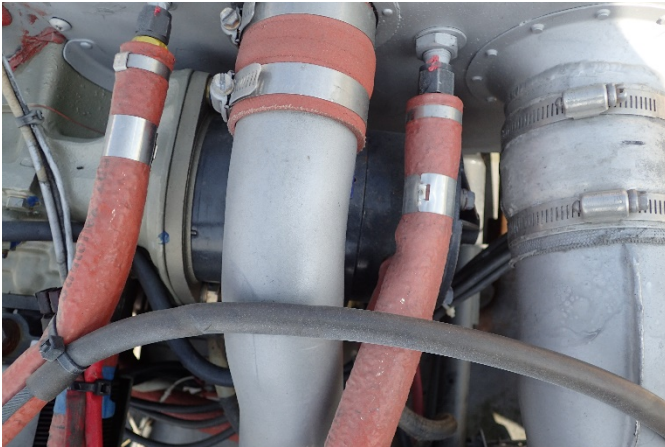
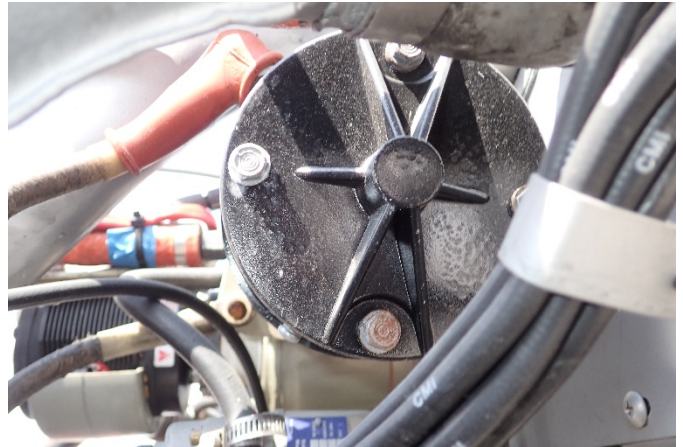
The starter remained attached to its installation point and was undamaged. There were no anomalies noted with the starter.

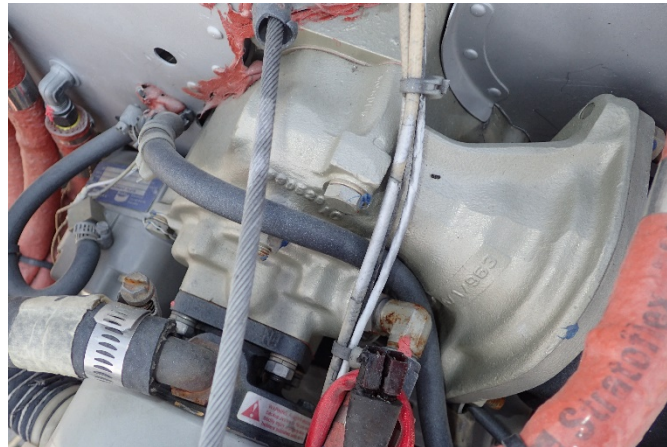
#### STARTER ADAPTER

The starter adapter remained attached to its installation point and was undamaged. There were no anomalies noted with the adapter.

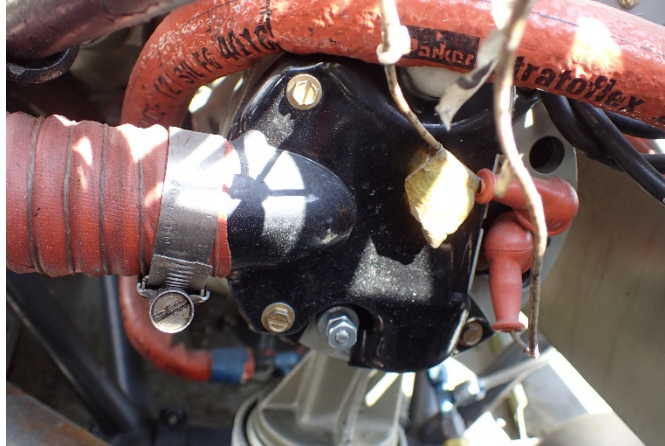
The alternator remained attached to its installation point and was undamaged. There were no anomalies noted with the alternator.

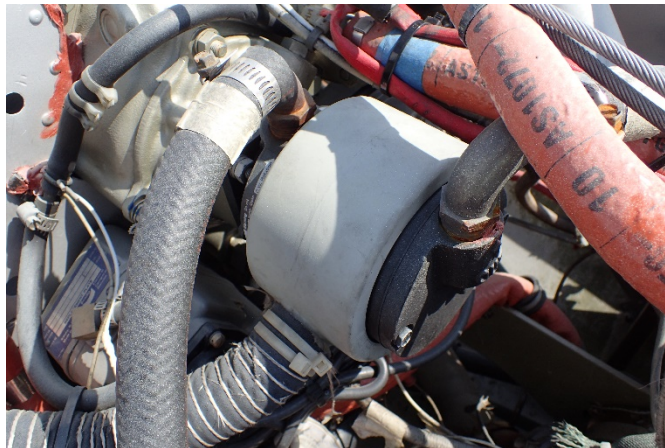
VACUUM PUMP

The vacuum pump remained attached to its installation point and was undamaged. There were no anomalies noted with the vacuum pump.

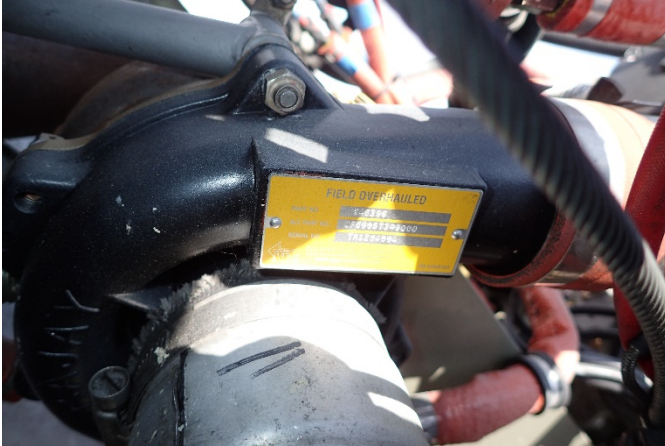
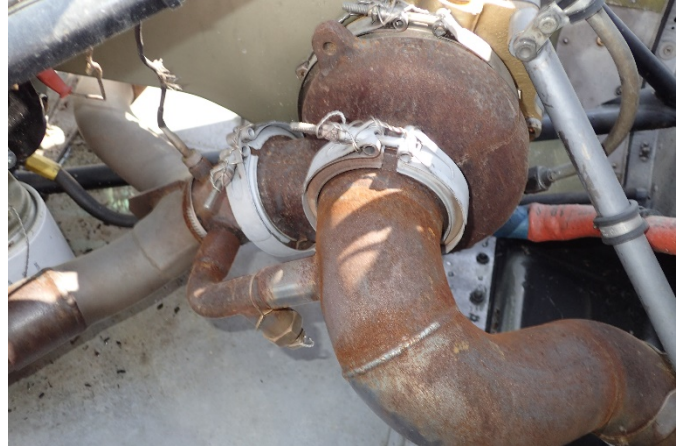
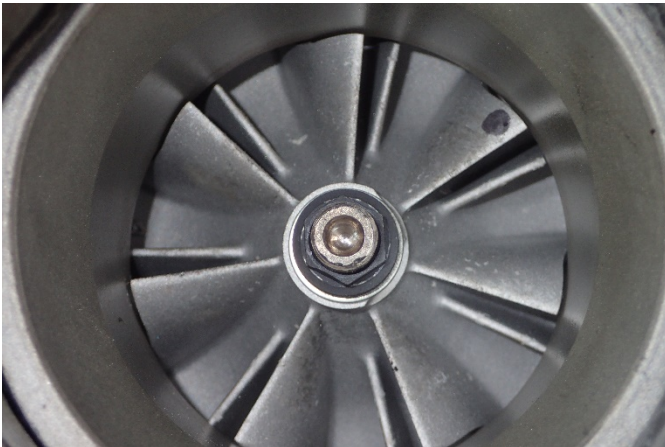
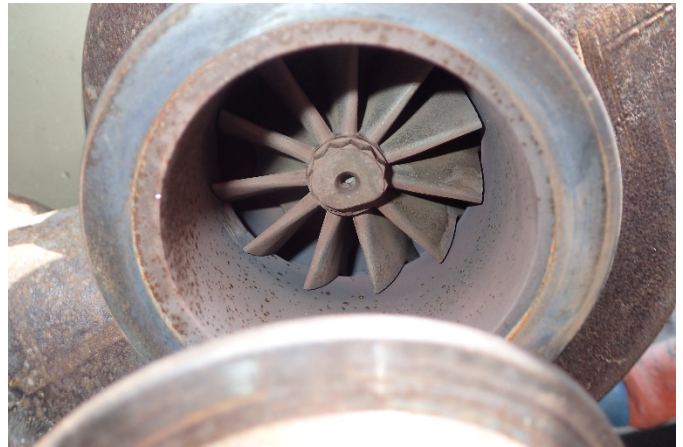
The turbocharger remained attached to its installation point and was undamaged; it was noted that there was a significant amount of corrosion around the turbine portion of the turbocharger. The fixed wastegate remained installed and was secured with safety wire. The overboost valve remained attached to its installation point and was undamaged.

The turbocharger remained attached to its installation point and was undamaged. It was noted that the V-band clamps remained attached to the turbocharger and were undamaged. The turbocharger induction inlet tube was removed and it was noted that the turbocharger had resistance to rotation; after the initial resistance was broken the turbocharger was capable of freely rotating.

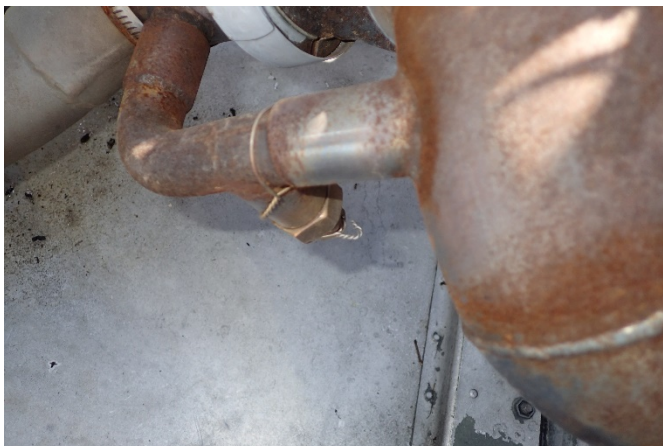
The fixed wastegate remained attached to its installation point and was secured with safety wire. There were no anomalies noted.

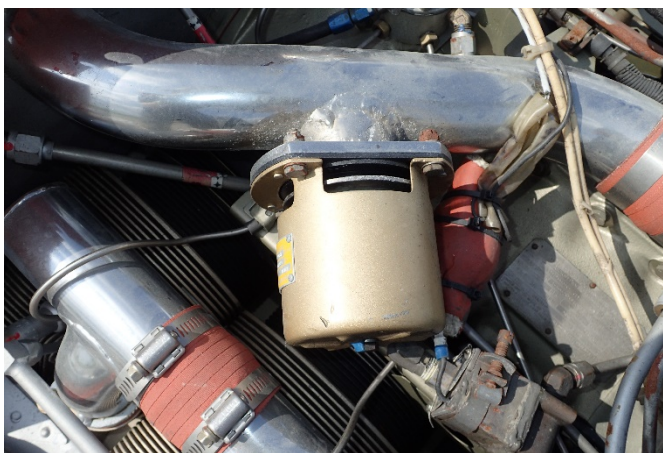
## OVERBOOST VALVE

The overboost valve remained attached to its installation point and was undamaged. The overboost valve was actuated by using a screw driver; the overboost valve operated normally. There were no anomalies noted.
