# Continental Motors

## ENGINE EXAMINATION REPORT

| ENGINE MODEL | TSIO-360-KB |
| FILE NUMBER | 17-513 |

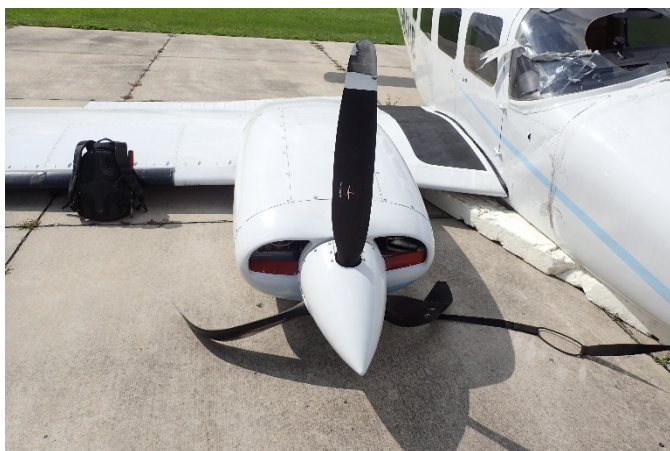
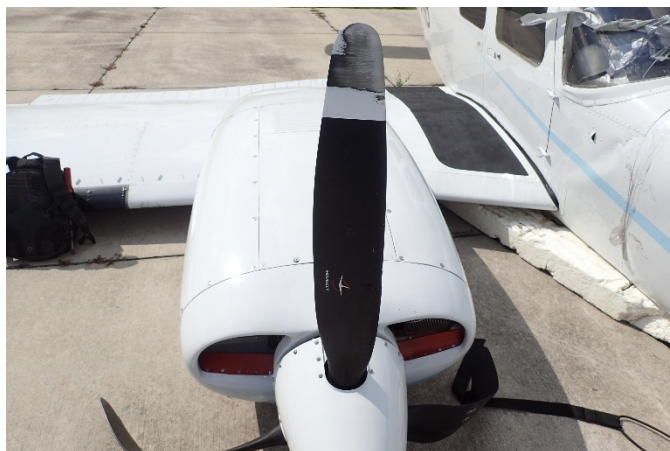
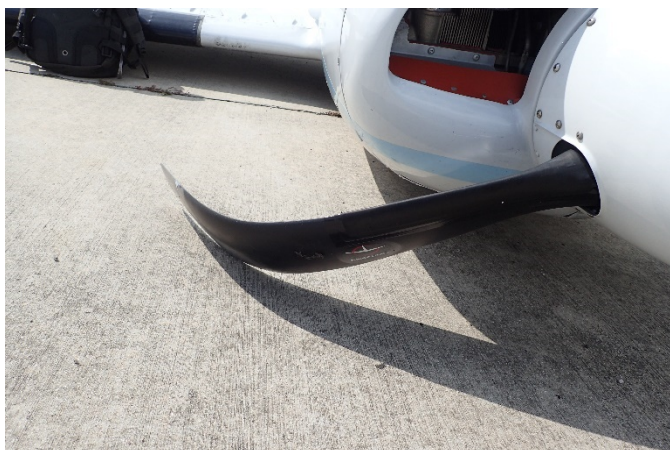
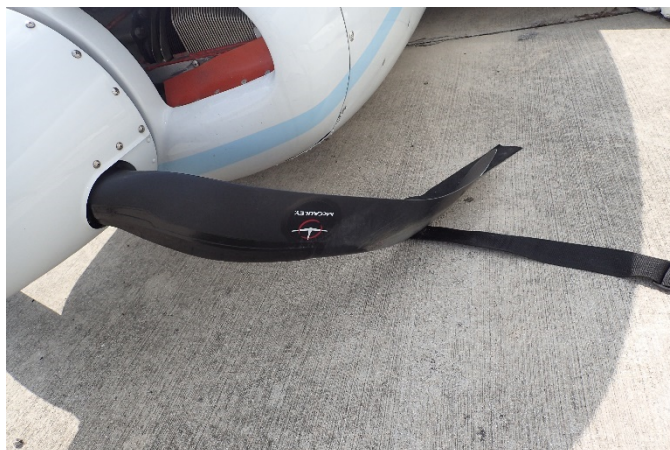
| Condition: | The three blade, variable pitch propeller remained attached to its installation point and displayed impact damage signatures to all three propeller blades. Two of the propeller blades were bent aft and displayed polishing near the propeller blade tips; the third propeller blade displayed polishing of the blade tip. There were no anomalies noted with the propeller. | | |
