## **NATIONAL TRANSPORTATION SAFETY BOARD**

### **SUMMARY OF AIRPLANE EXAMINATION**

| Location: | Andover, New Jersey |
| Aircraft: | Bellanca 7GCBC |

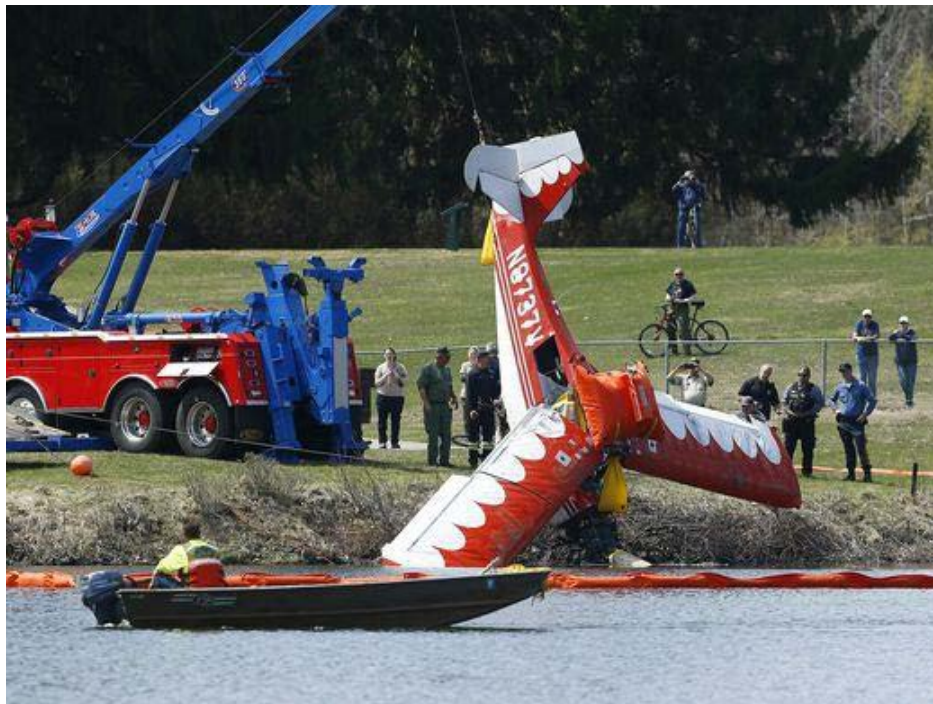
According to the airport manager, the airplane impacted the water about 300 ft and slightly to the right of the departure end of runway 3. It subsequently sank and came to rest about 44 ft beneath the water's surface. The airplane was recovered about 24 hours after the accident. Upon recovery from the lake the airplane was observed to be primarily intact, although the right wing was partially separated. All components necessary for flight were accounted for at the accident site.

Figure 1 - view of airplane during recovery process

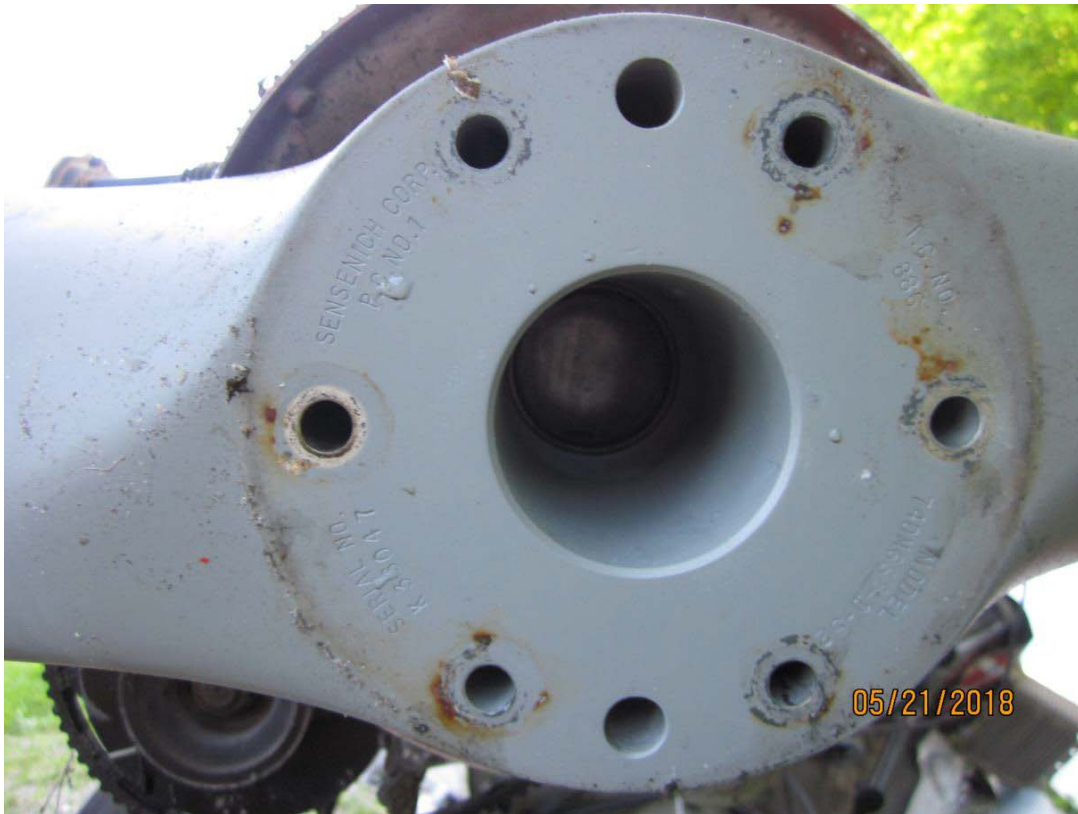
The aluminum Sensenich fixed pitch propeller was found securely installed to the engine crankshaft with blades undamaged.

Figure 2 - view of propeller post recovery

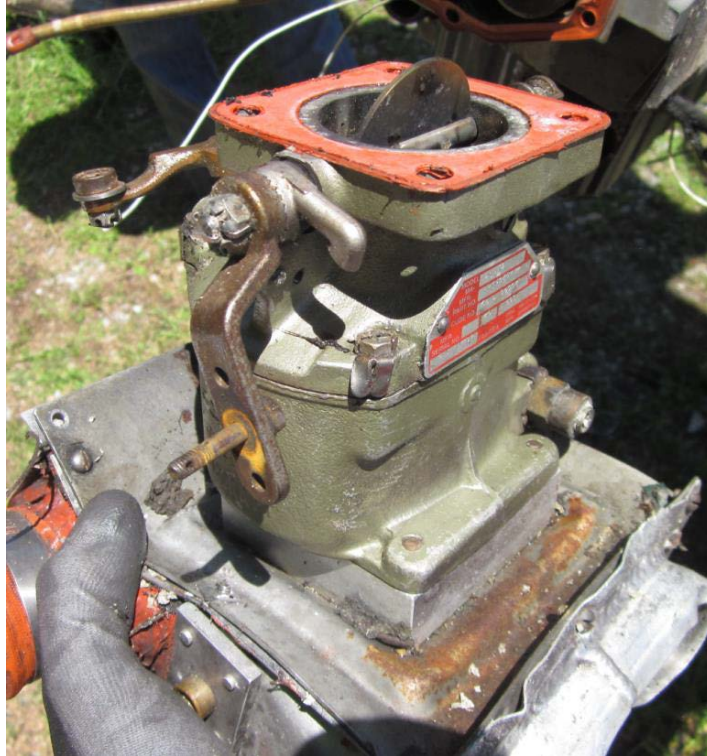
The carburetor was observed securely installed to the engine at the time of the examination. The float bowl was separated and inspected. Water was present within the bowl, and the brass floats showed signs of hydraulic crushing on all sides. It was observed that the throttle arm and throttle plate shaft had a noticeable free play wobble with respect to the throttle body. The carburetor inlet screen was removed and inspected. It was contaminated with a brown material and not allow light from a flashlight to pass through. A small opening on the bottom surface of the screen was open to let light pass through. No other anomalies were noted relative to the fuel system.

Figure 3 - view of carburetor post recovery

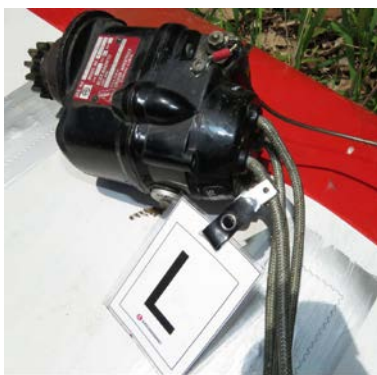
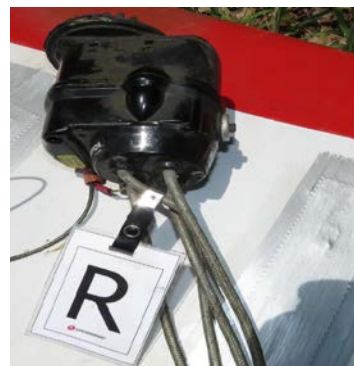
While both magnetos were attached to the engine at the time of the examination, each had been removed previously by the FAA IIC, which precluded timing to the engine from being verified. Spark was produced at all points when rotated by using an electric drill. No issues were detected with either magneto during the examination.

Figure 4 - view of right magneto

Figure 5 - view of left magnet

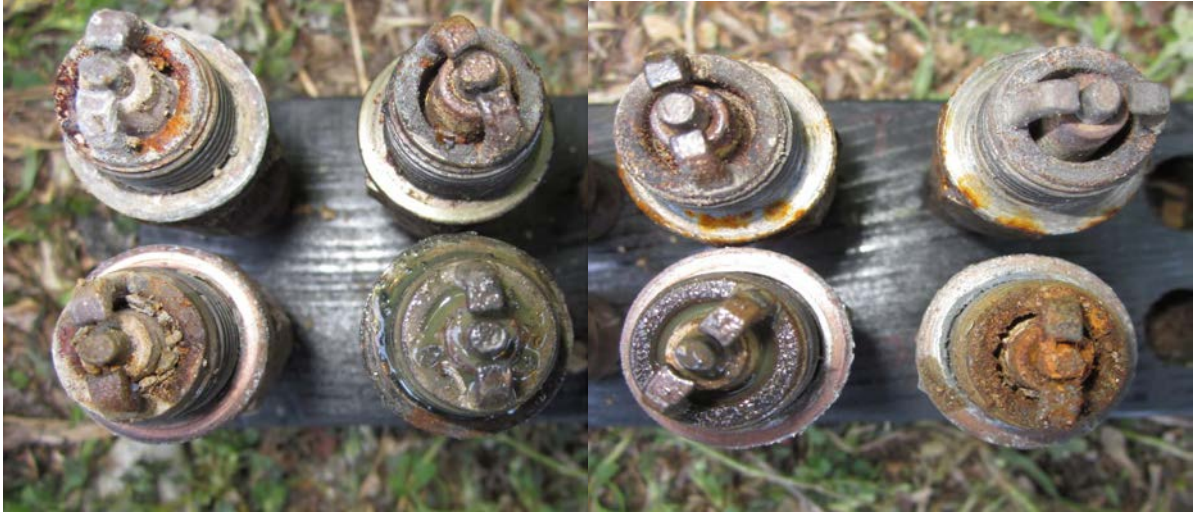
When examined, the spark plugs showed signs of corrosion, which was consistent with the airplane having been submerged in the water for 24 hours. Cylinders showed high levels of deposits that had separated from the piston face and/or combustion chambers. Much of the deposits were visible within the spark plugs, as well as inside each cylinder.

Figure 6 – view of upper and lower spark plugs

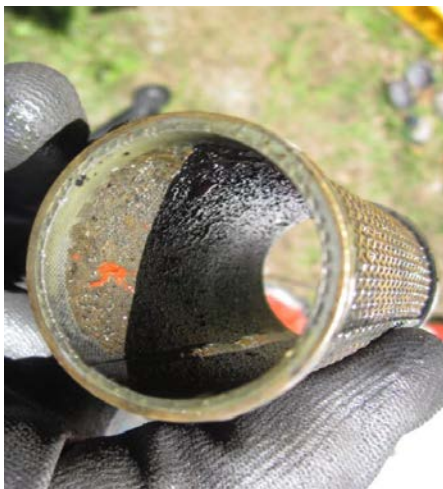
When the oil pressure screen was removed and inspected, it was observed unobstructed with some particles of orange RTV type sealant material within the screen

Figure 7 - view of oil screen

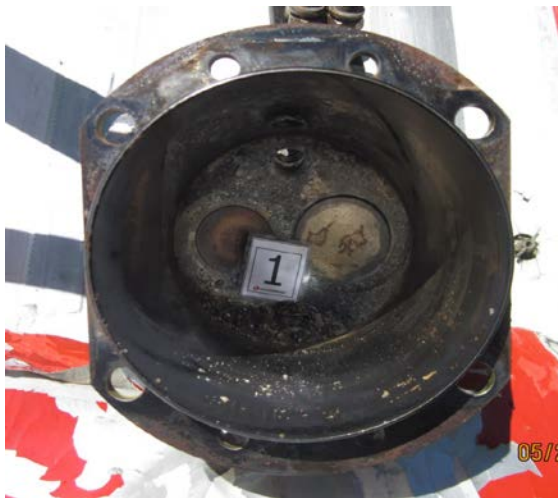
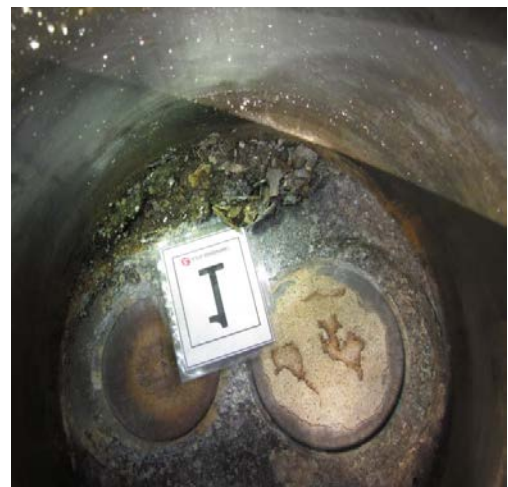
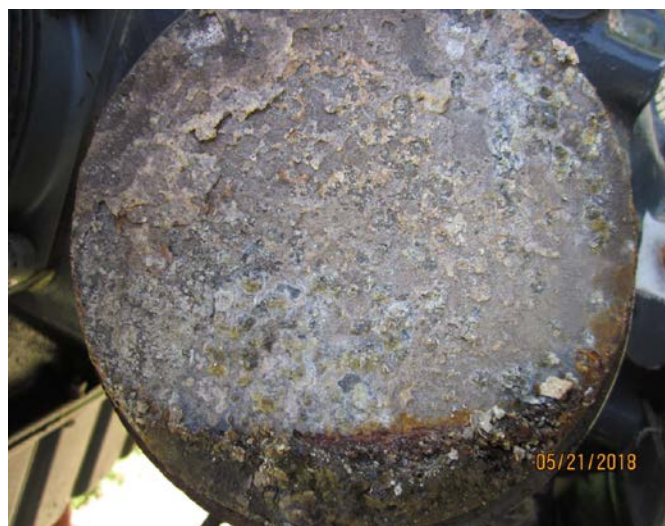
As first viewed, the engine showed signatures consistent with being submerged in water for a period of time. Corrosion was present along with signs on water throughout the engine and cylinders. Engine rotation was achieved by rotating the propeller by hand and thumb compression was achieved on all cylinders showing valvetrain continuity. Varying amounts of combustion deposits were noted throughout the engine on piston faces, cylinders, ports, and sparkplugs. All intake and exhaust pipes were open and unobstructed.

Figure 8 - view 1 of #1-cylinder

Figure 9 - view 2 of #1-cylinder

Figure 10 - view 3 of #1-cylinder
