**TEARDOWN REPORT  
OF ONE MODEL TPE331-10-511M  
TURBOPROP ENGINE  
SERIAL NUMBER P36075C**

**August 29, 2019**

This report, prepared by Honeywell Aerospace, presents the findings of a teardown and inspection conducted on one Honeywell Model TPE331-10-511M engine, Serial Number P36075C. The inspection took place at the Honeywell Investigation Laboratory in Phoenix, Arizona, on October 16 – 18, 2018.

On April 29, 2018, at 15:30 pm local time, a Grumman / Schweizer G-164C/C, single engine agricultural airplane, N6674K, was substantially damaged following a forced landing due to a loss of engine power near Maxwell, CA. The commercial pilot was not injured. The pilot reported, while flying at 200 feet altitude, that the engine surged three times, followed by what he believed was a total engine failure. The aircraft was recovered to a secure facility where the engine was removed and shipped to Honeywell for teardown.

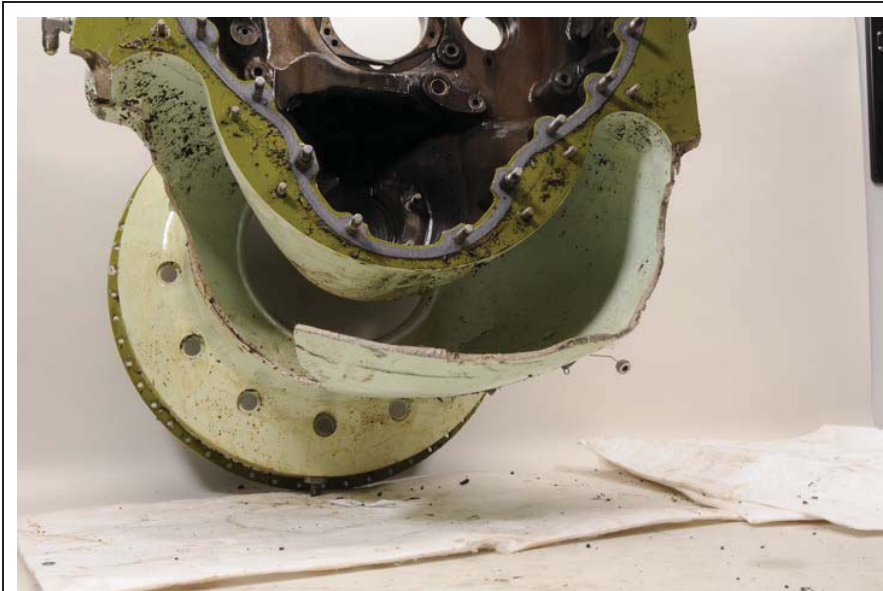
Figure 71. Gearcase Housing (Exterior)

- (a) Exterior (Non Oil-Wetted) of the Gearcase Housing
  - The gearcase housing was intact ([Figure 67](#) - [Figure 70](#)).
  - A portion of the gearcase housing at the bottom of the inlet was damaged with the inlet flange and a portion of the inlet duct on the right side missing, but remained attached to the oil tank ([Figure 71](#)).

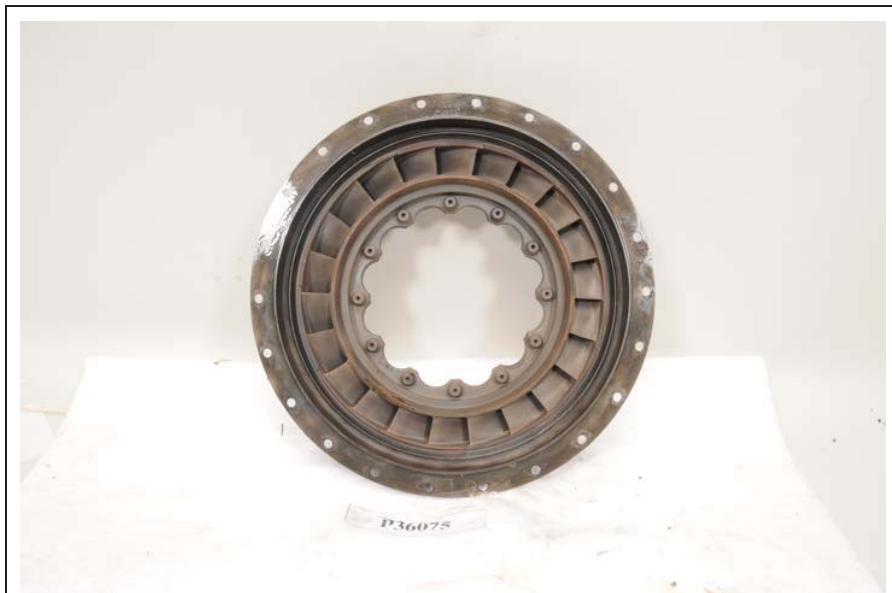
**Figure 141. First-Stage Turbine Stator Assembly**

- There were no shims found between the turbine stator housing and the combustor plenum.
- (c) First-Stage Turbine Stator Assembly
- The first-stage turbine stator assembly was intact and appeared undamaged ([Figure 140](#) and [Figure 141](#)).

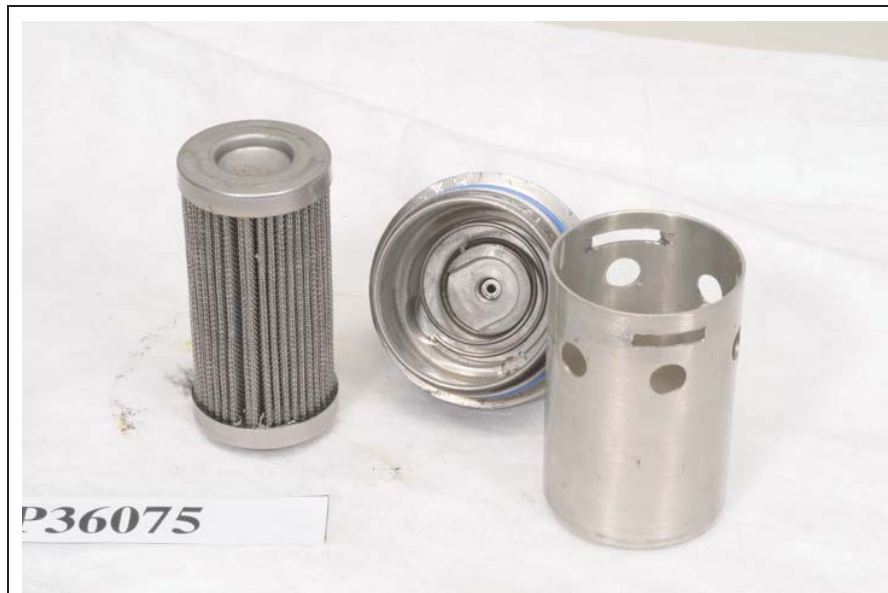
Figure 187. Fuel Filter

- The fuel filter was intact and appeared undamaged ([Figure 187](#)).
- A fuel sample obtained from the fuel filter housing.
- Soft, white material was found in the fuel filter ([Figure 188](#)).
- White debris was noted in the fuel filter cap.

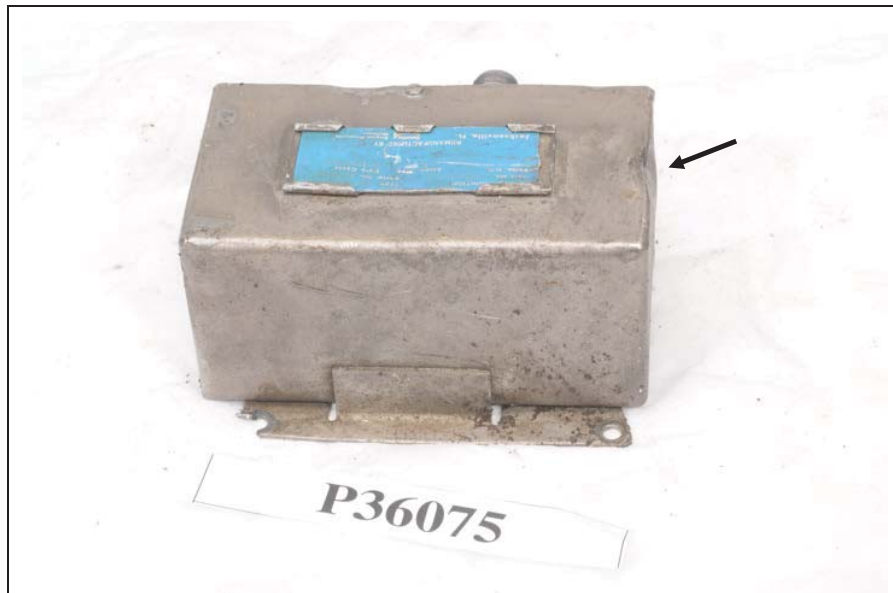
**Figure 199. Ignition Exciter**

- (k) Ignition Exciter
- The connector for the lead to ignitor at the 5 o'clock position on the ignition exciter was missing ([Figure 198](#)).
  - There was a dent on the outer case of the ignition exciter ([Figure 199](#)).

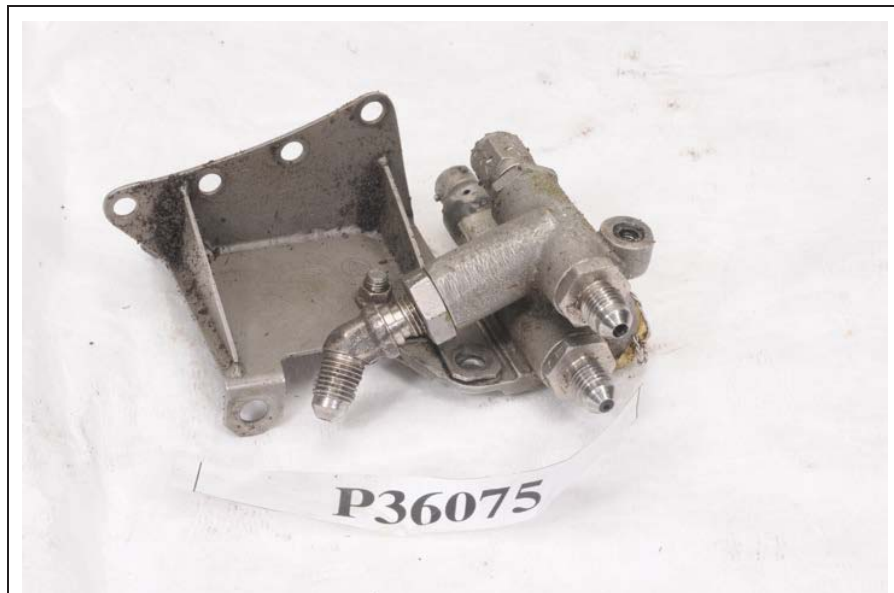
Figure 205. Beta Block

- (s) Beta Block
  - The beta block was intact and appeared undamaged ([Figure 205](#)).
- (t) Beta and NTS Switch Manifold
  - The NTS valve was damaged ([Figure 206](#)).

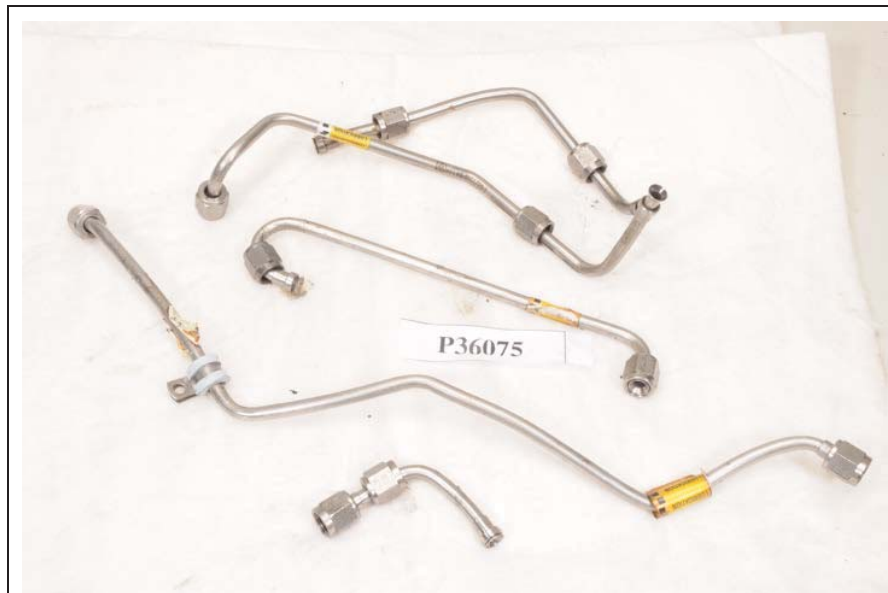
**Figure 213. Lubrication Plumbing**

- (aa) Pneumatic Plumbing
  - The pneumatic system plumbing was intact and appeared undamaged ([Figure 212](#)).
- (bb) Lubrication System
  - The lubrication system plumbing was intact and appeared undamaged ([Figure 213](#)).

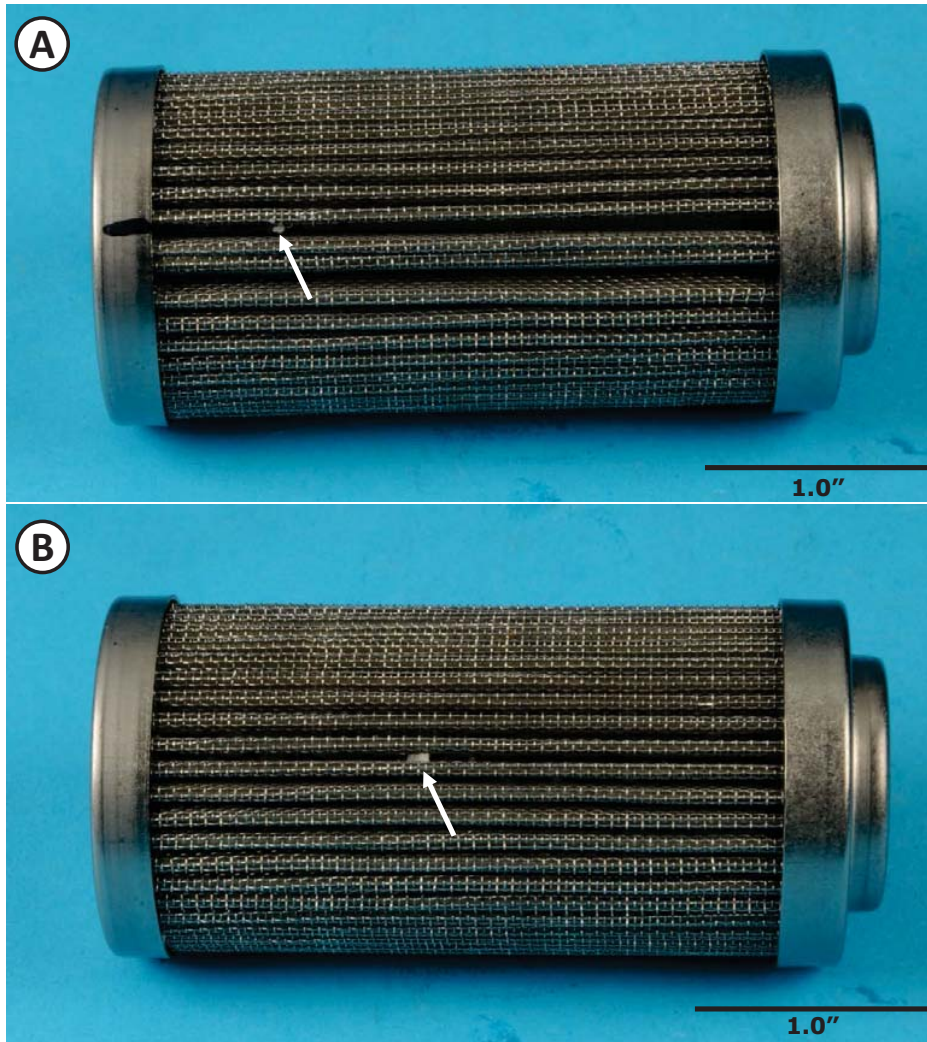
**Figure 1.**

- White colored debris was observed in the fuel filter (Figure 1). Fourier transform infra-red (FTIR) analysis of the debris produced a spectrum suggestive of a fluorinated lubricant (Figure 2). Most of the debris flushed from the fuel filter had a similar composition.

(A-B) Overall views showing the fuel filter in the as-received condition. White colored debris was observed in the filter (white arrows).

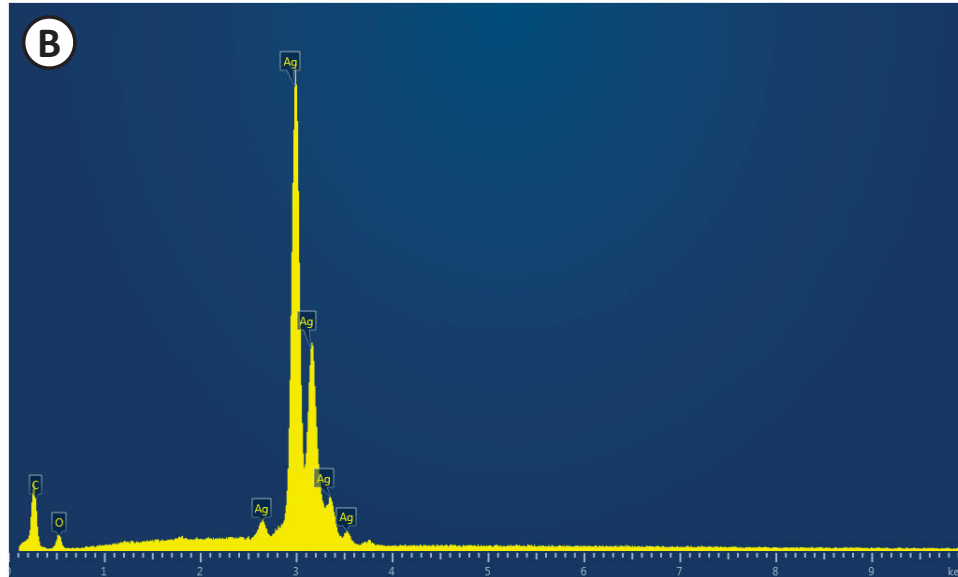
**Figure 5.**

- The metallic debris collected from the ring support gear was silver, as determined by energy dispersive X-ray (EDX) analysis (Figure 5).
- Metallic debris was observed on the submitted spur gear. EDX analysis of the debris produced a spectrum indicative of a material similar to Al 356 (Figures 6-7).

(A) Representative secondary electron (SE) scanning electron microscope (SEM) image showing the metallic debris collected from the ring gear support. (B) Energy dispersive X-ray (EDX) analysis of the particles produced a spectrum rich in silver.

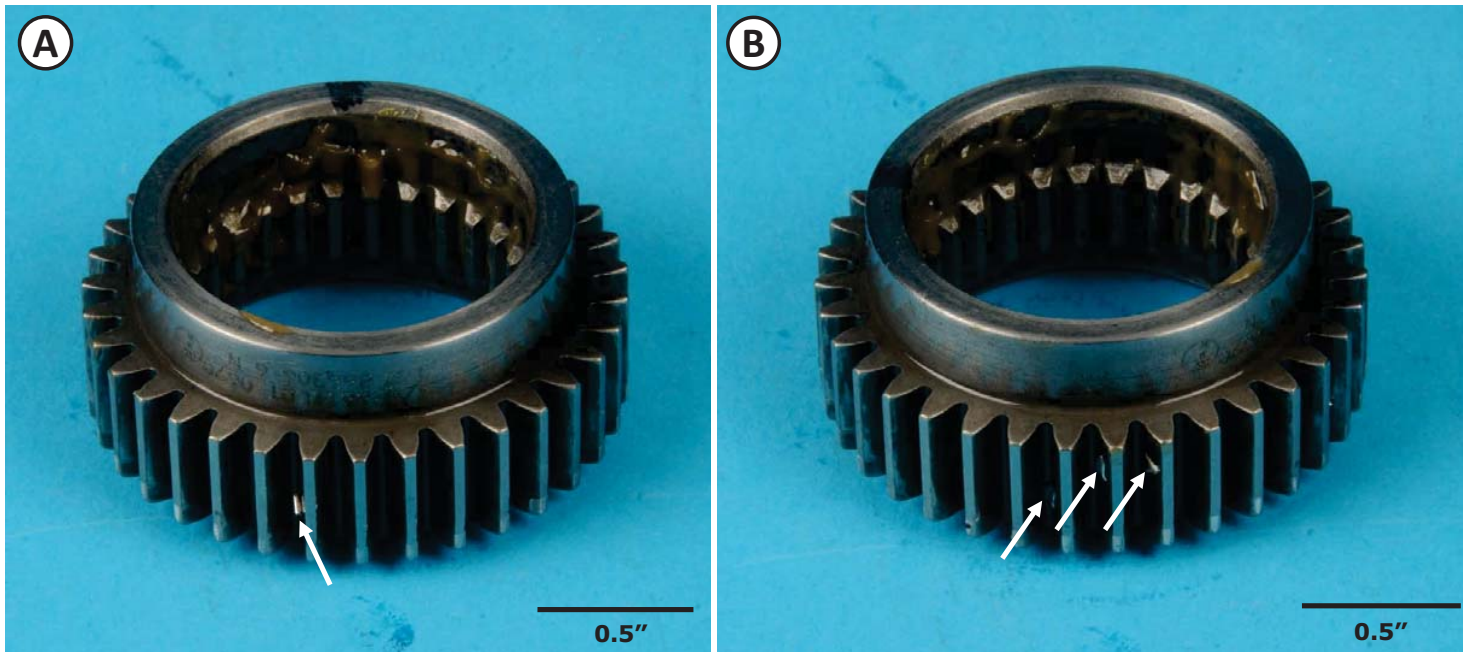
**Figure 6.**

(A-B) Overall photos showing the spur gear (P/N 866306-6) in the as-received condition. Metallic debris was observed on the teeth in some locations (white arrows). A representative EDX spectrum generated from analysis of the debris is shown in Figure 7.

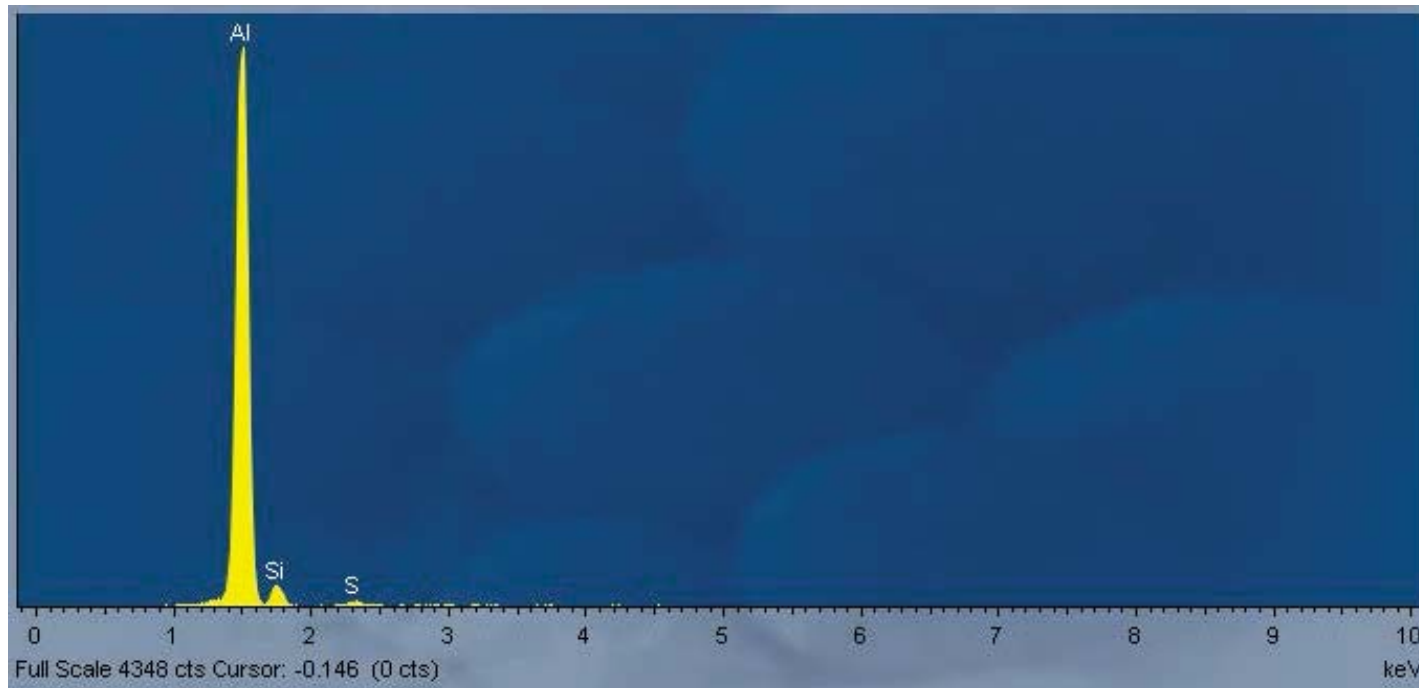
**Figure 7.**

Spectrum generated from EDX analysis of the metallic debris observed on the spur gear (reference Figure 6). The spectrum was indicative of a material similar to Al 356. Note that the torque sensor housing was specified to be made from Al 356.

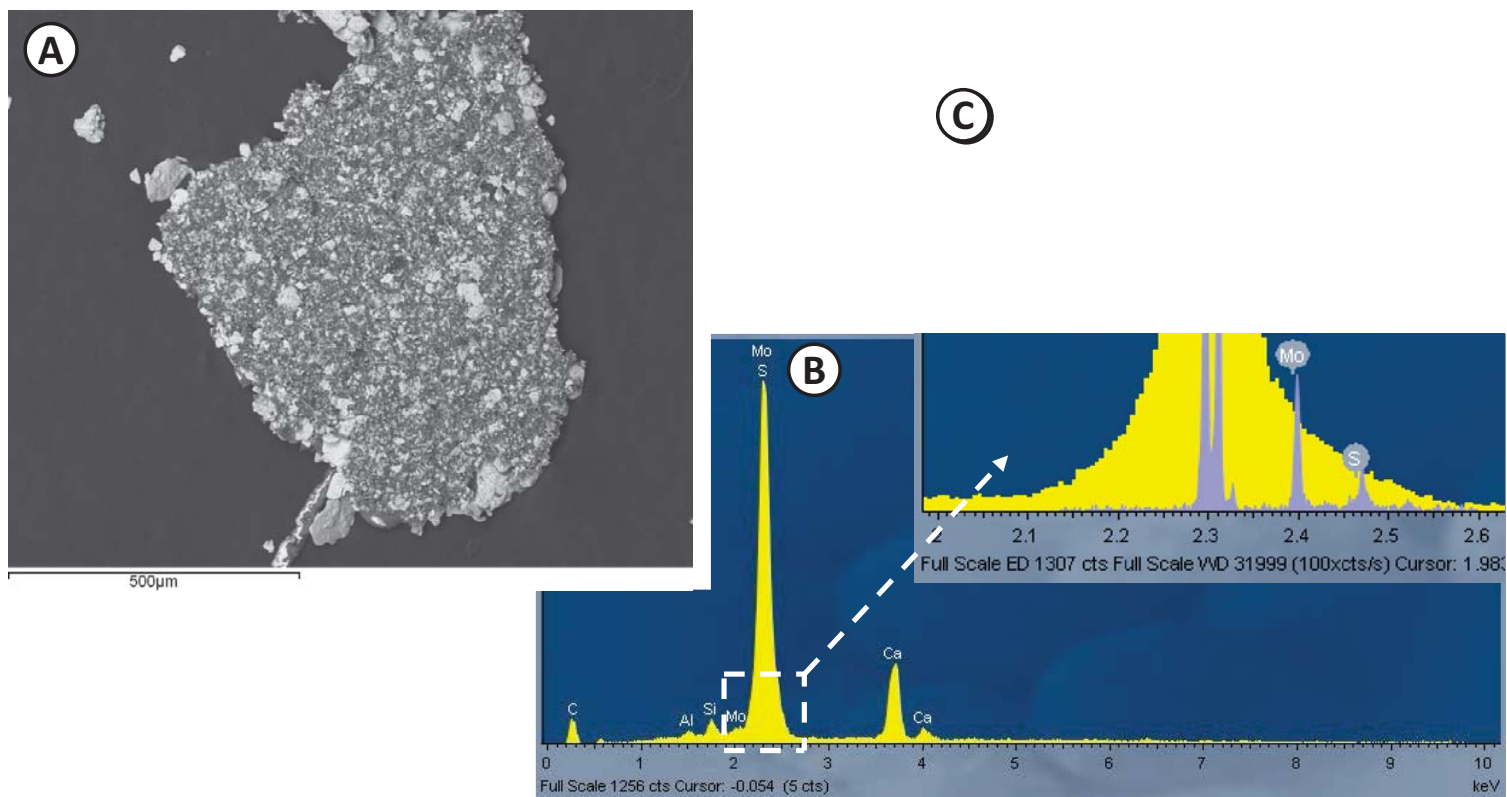
**Figure 8.**

(A) Representative backscattered electron (BSE) SEM image showing debris collected from the flushed spur gear. (B) EDX analysis of the debris produced a spectrum rich in molybdenum and sulfur, with lesser concentrations of calcium, silicon, and aluminum. (C) Enlarged portion of the spectrum shown in (B) with a wavelength dispersive X-ray (WDX) spectrum overlay (blue spectrum). The WDX spectrum confirmed the presence of both molybdenum and sulfur. The spectra were suggestive of molybdenum disulfide.

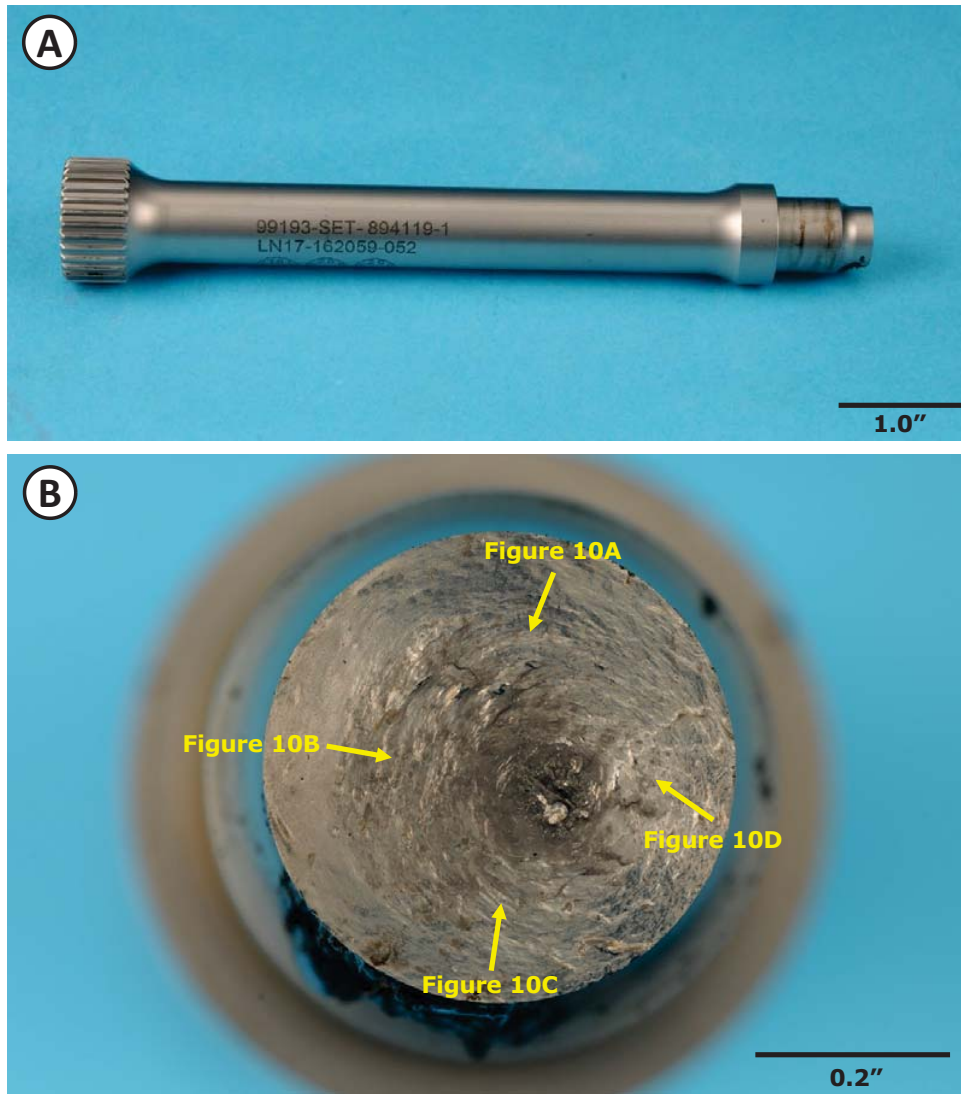
**Figure 9.**

(A) Overall view showing the separated coupling shaft in the as-received condition. (B) Close-up view showing the fracture surface of the coupling shaft. SEM images of the fracture surface are shown in Figure 10, as indicated.

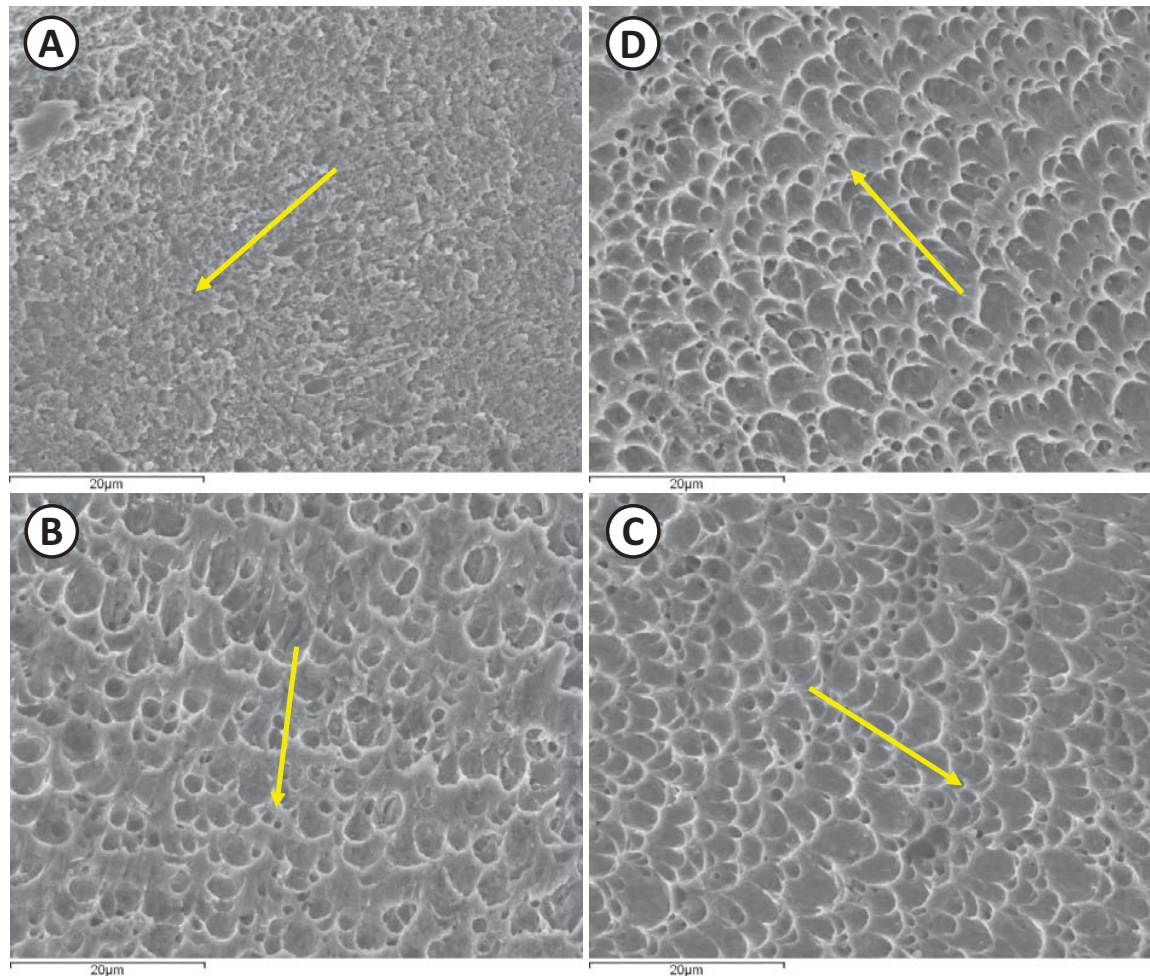
**Figure 10.**

(A-D) SEM images showing the fracture surface on the separated coupling shaft. The fracture features were indicative of torsional overload as indicated by the elongated dimples. The yellow arrows indicate the direction of rotation with respect to the mating fracture surface.
