## **WPR18LA142**

### **Go-Pro File Synopsis**

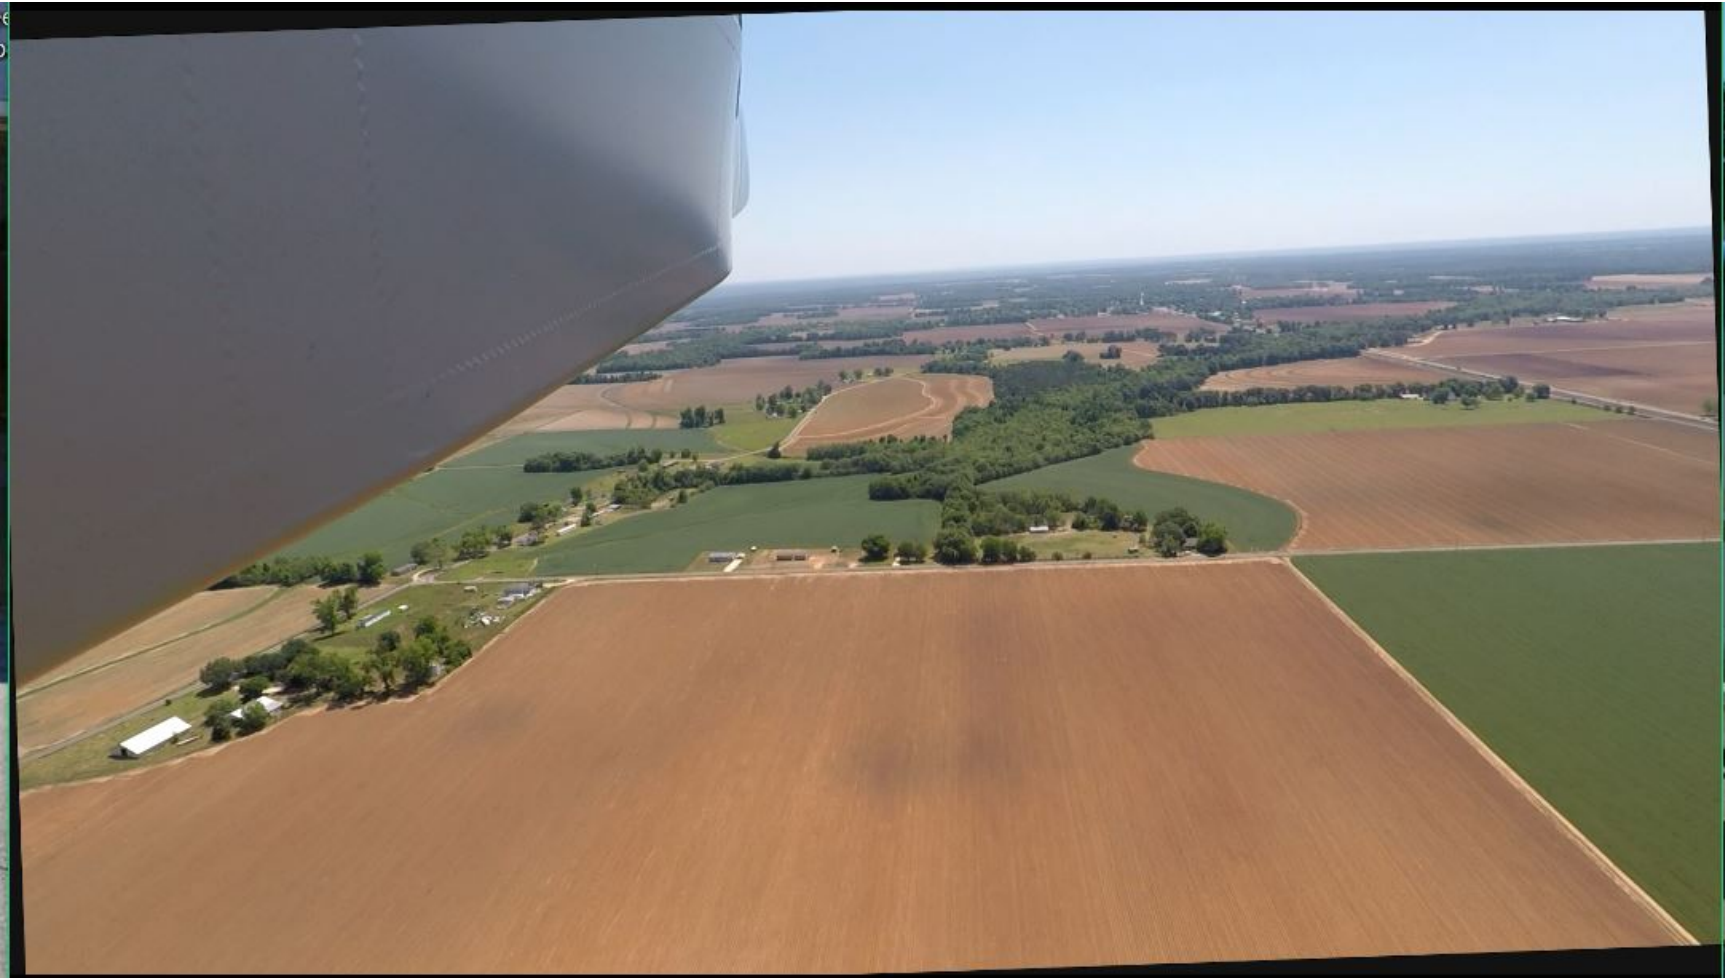
**Figure 3 - Cruise**

The cruise altitude appeared to be between about 500 and 750 ft above ground level

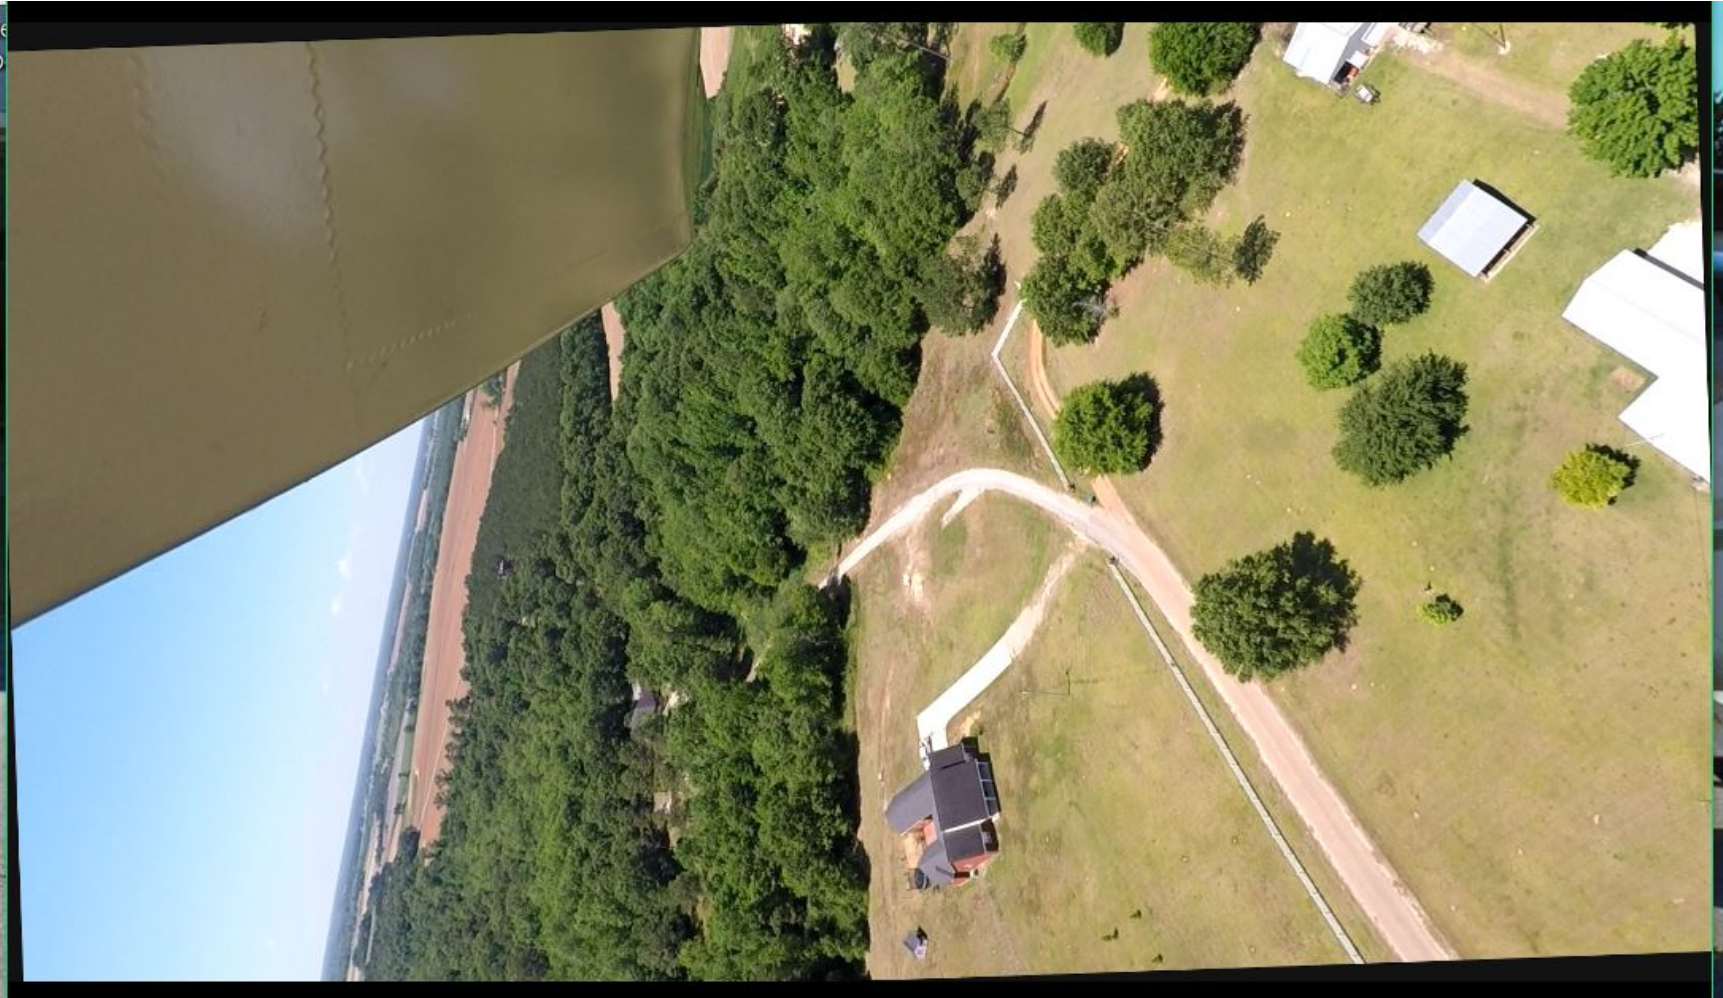
**Figure 4 - Right Bank Just Prior to Accident**

12:30 - Aircraft turns right to southeast heading  
12:49 - Aircraft turns right to south heading  
12:51 - Aircraft begins maneuvers consistent with stall and spin; aircraft first banks and turns sharply right, nose pitches down, and then banks/turns sharply left, descending rapidly during this sequence. The left and right turns both appeared to result in approximate 180° heading changes.

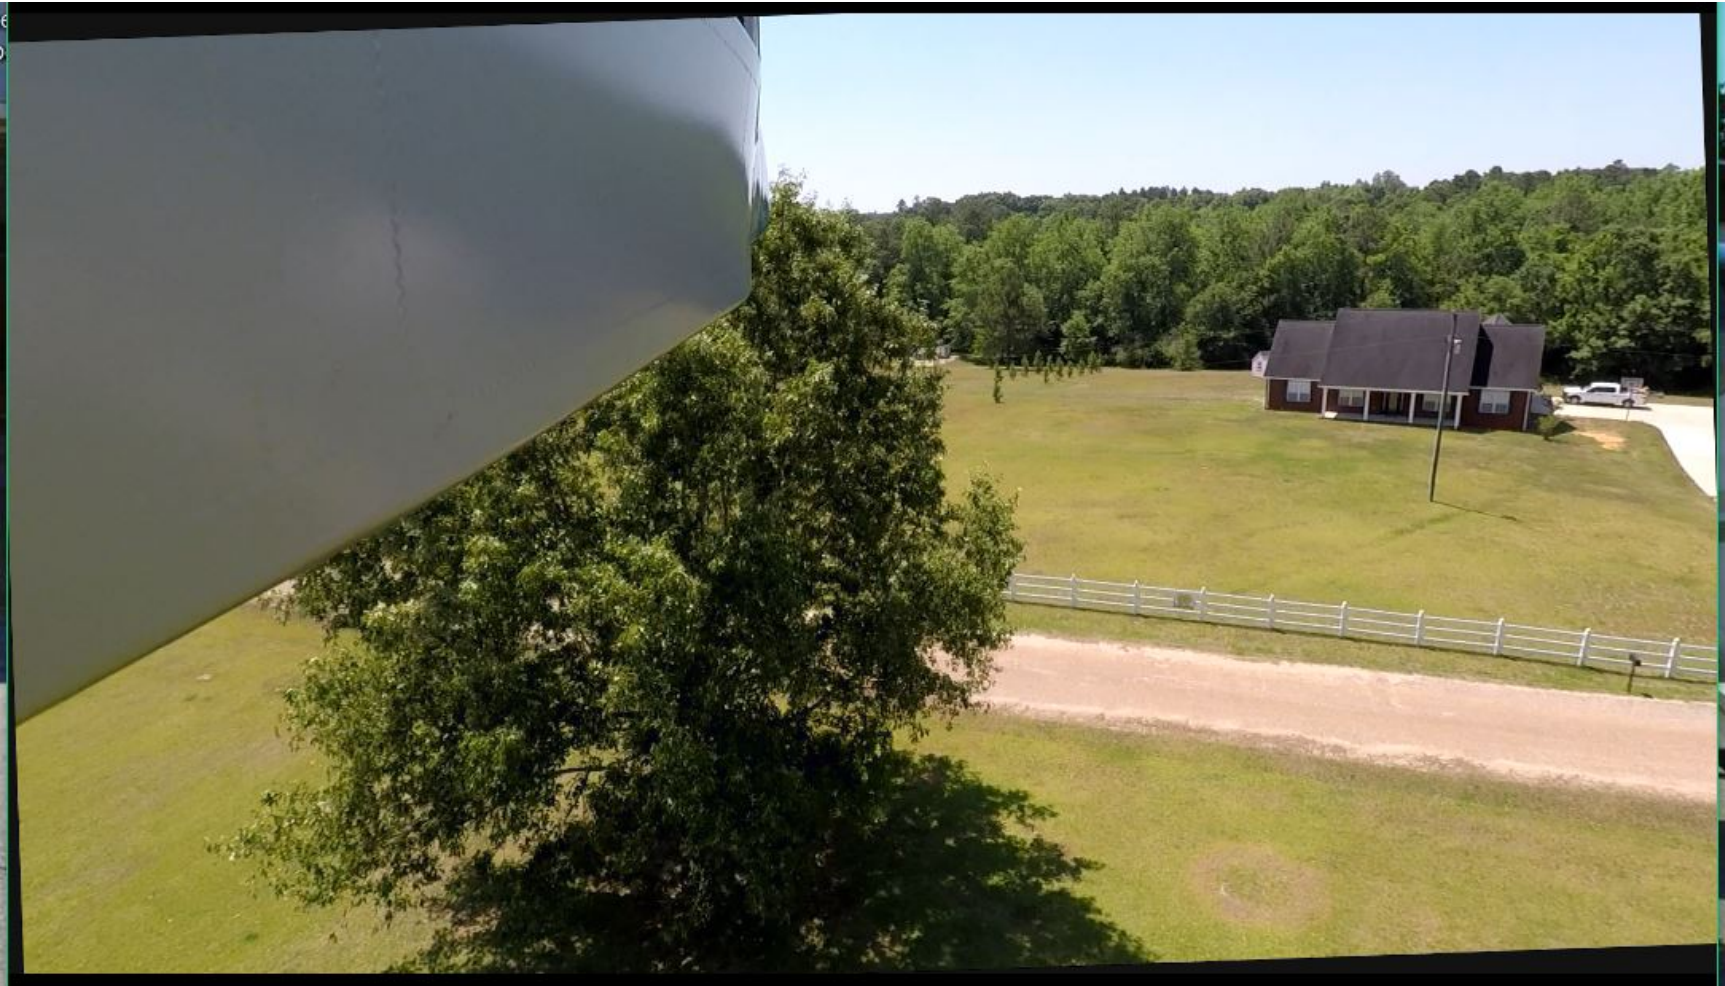
**Figure 6 - Impact Tree**

13:00 - Aircraft strikes tree and then ground. The aircraft was descending rapidly, but with wings level and a forward horizontal velocity component, when it struck the tree.

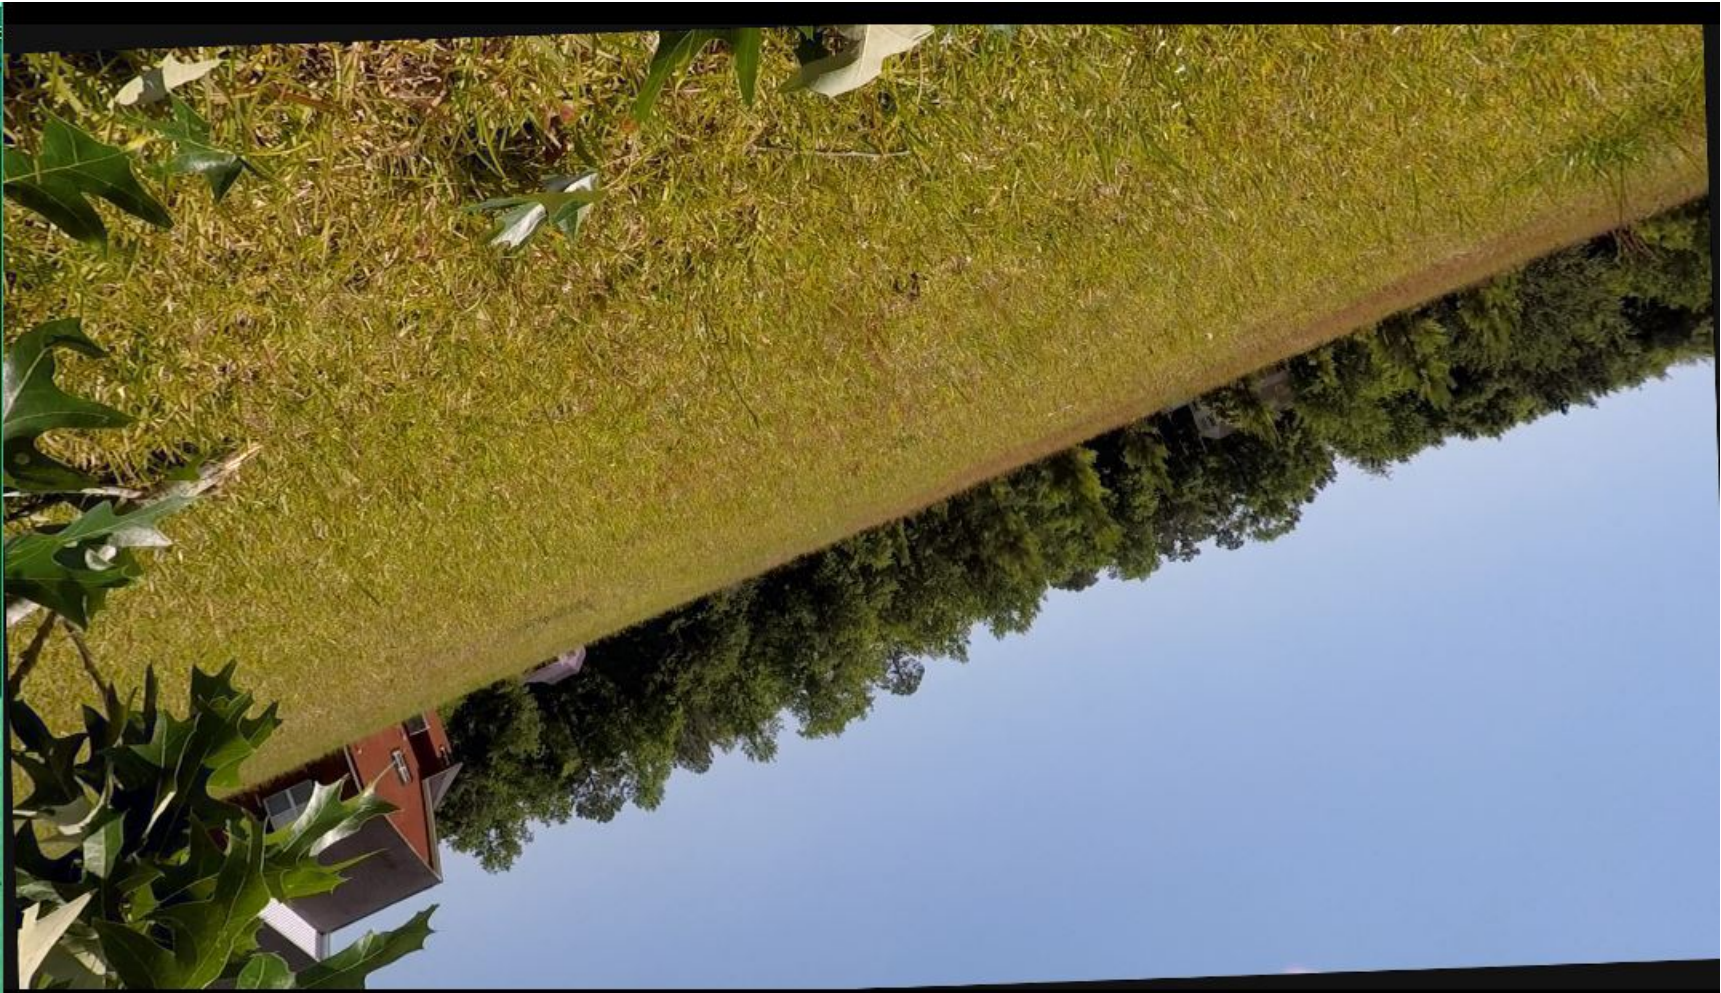
**Figure 8 - Post Impact**

13:17 - Camera vibration (consistent with engine operation) ceases  
17:42 - File end (no activity between 13:17 and 17:42)
