## **NATIONAL TRANSPORTATION SAFETY BOARD**

# **MAGNETO EXAMINATION SUMMARY**

**WPR18LA148**

Location: Hillsboro, Oregon  
Date: May 26, 2018  
Aircraft: Cessna 152, N152GB  
NTSB Investigator-in-Charge: Joshua Cawthra

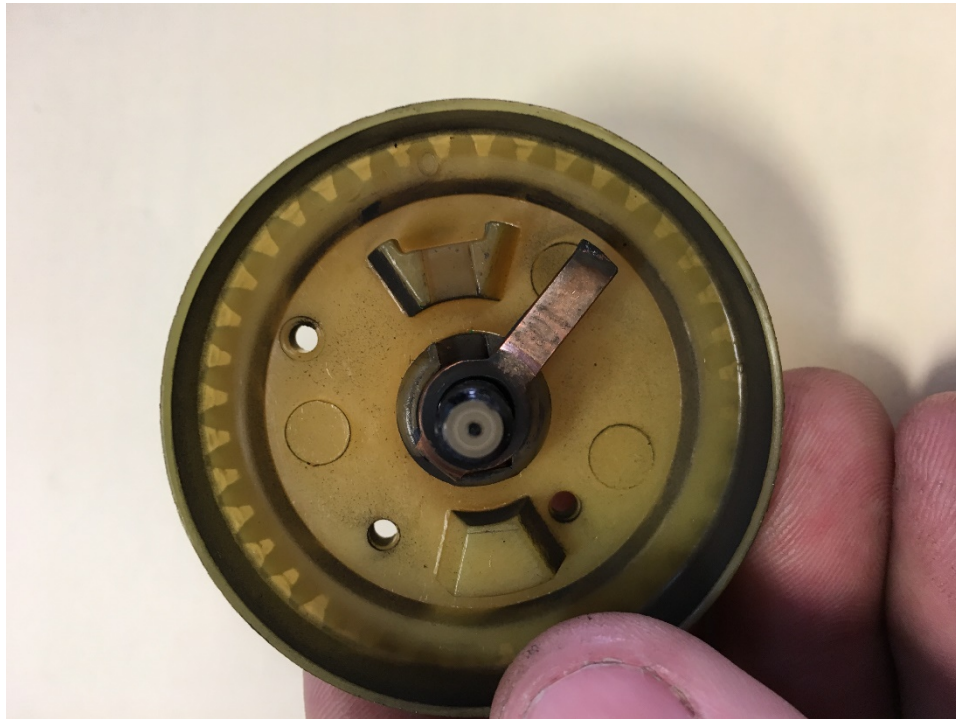
The left magneto, a Slick 4301, serial number 13050158, was intact and undamaged. When the magneto drive shaft was rotated, spark was produced on each post in a random order. The left magneto was disassembled and examined internally. The distributor gear was intact; however, the copper electrode finger was found displaced from the plastic gear assembly. The remainder of the internal components of the left magneto were unremarkable.

**Photo 1: The left magneto distributor gear and copper electrode finger as removed.**

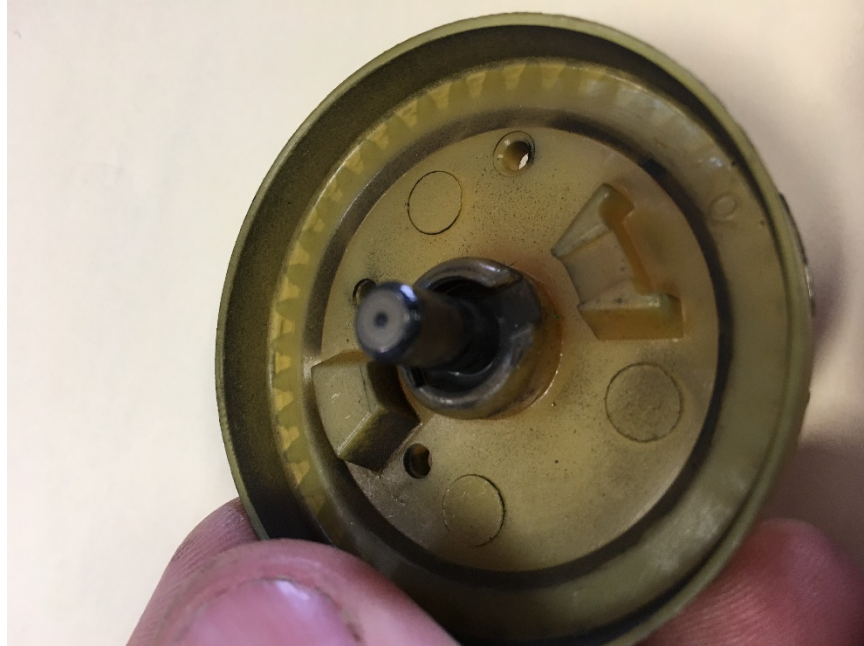
**Photo 2: The left magneto distributor gear.**

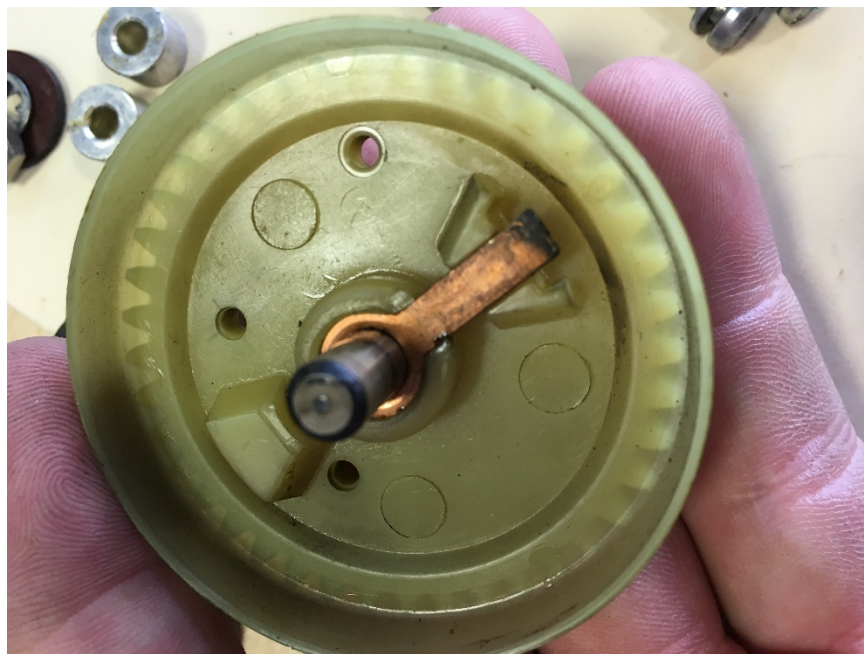
The right magneto, a Slick 4301, serial number 09100255, was intact and undamaged. The right magneto produced spark in firing order when the magneto drive shaft was rotated by hand. The magneto was disassembled, and all internal parts were unremarkable.

**Photo 3: The right magneto distributor gear.**
